HYD-81

May 15, 1940.

From Associate Engineer C. W. Thomas

Subject: Report on inspection trip to correlate hydraulic laboratory design and the field operation of 102-inch River Outlets - Grand Coulee Dam - Columbia Basin Project.

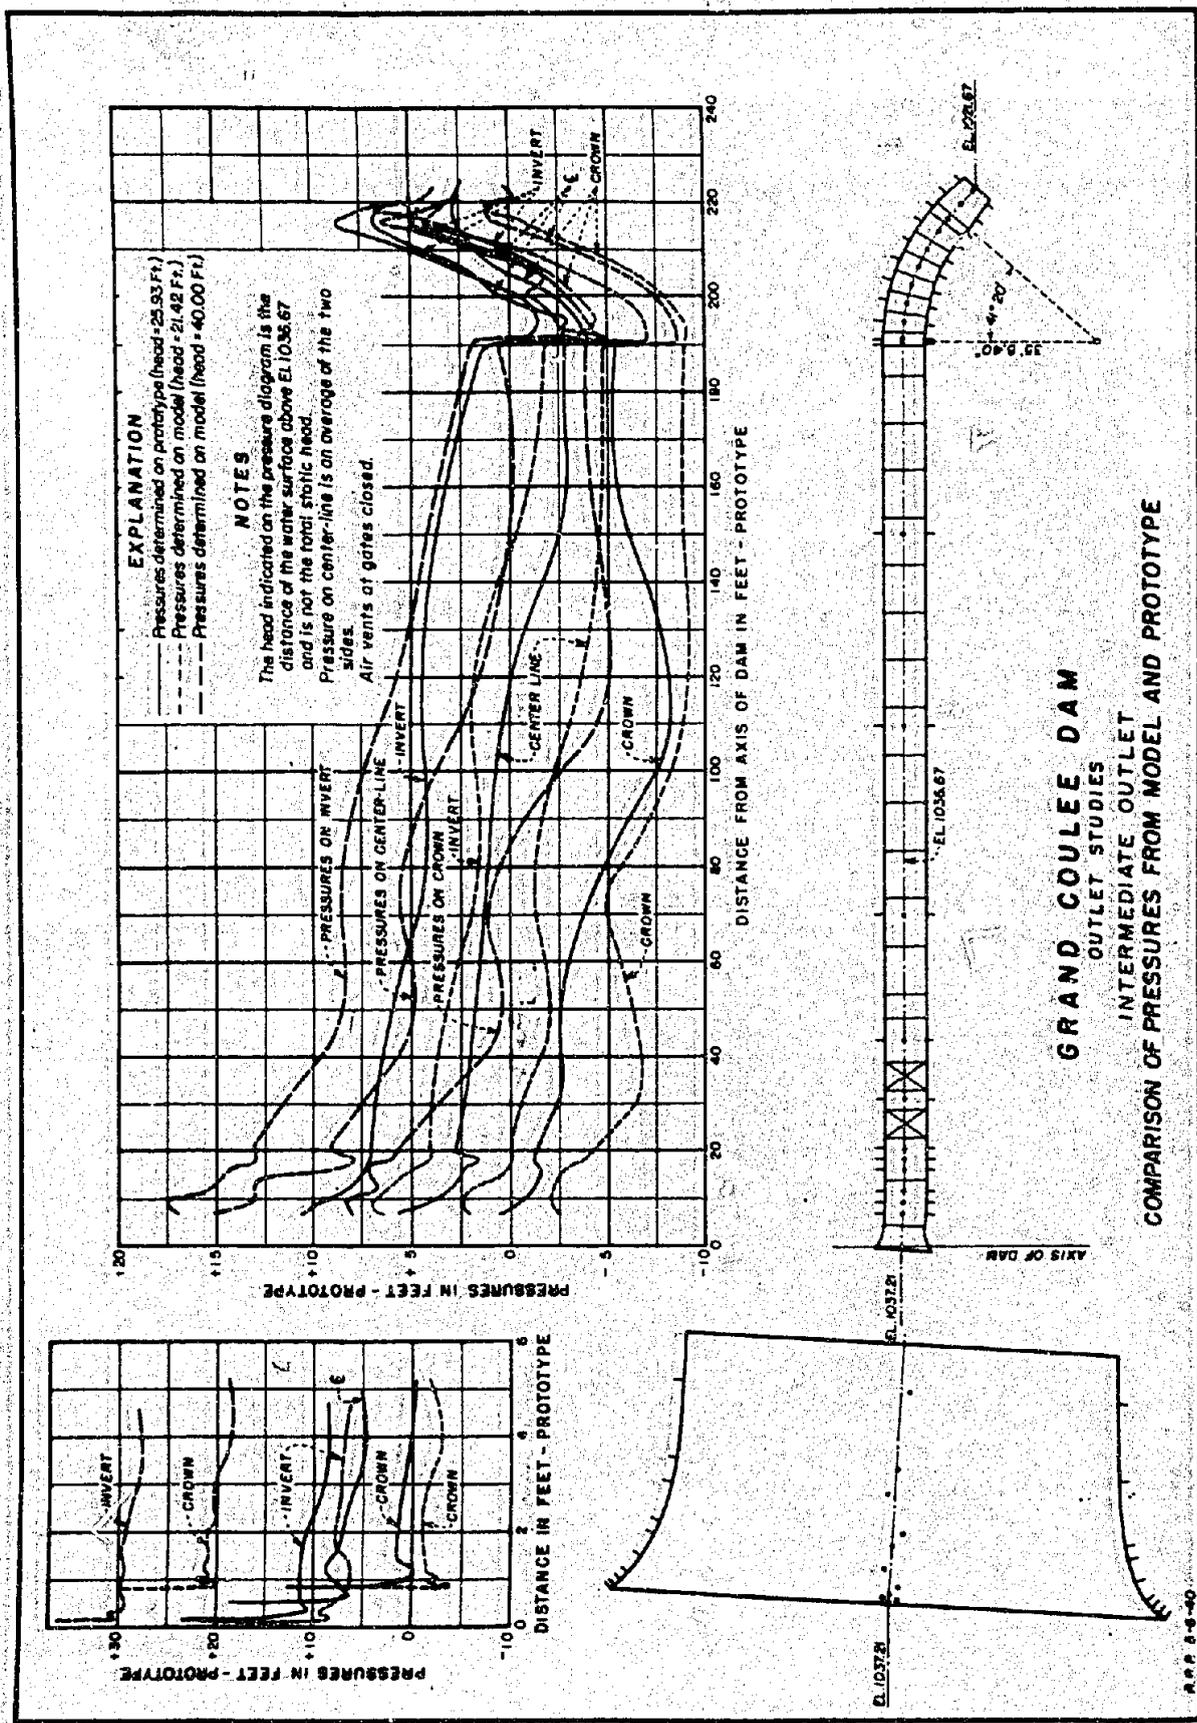
GRAND COULEE DAM
 OUTLET STUDIES
 INTERMEDIATE OUTLET
 COMPARISON OF PRESSURES FROM MODEL AND PROTOTYPE

6. The results of the pressure measurements are shown on figures 4, 5 and 6. A comparison of the pressures obtained from the 1:17 scale model and those obtained from the prototype for similar heads is shown on figure 4. The general characteristics of the pressure curves are quite similar, but the hydrostatic pressures in

the prototype are slightly greater than the pressures in the model. The pressure curves shown are for low heads only and the relationship may change for the higher heads. Figure 5 shows a comparison of the pressures with the air vents to the control gates open and with these vents closed. The conduit does not flow full when the air vents are open. This is true for the entire range of heads tested. For the low head, a large air bubble in the top of the pipe extends from the control gates to the downstream portion of the elbow. This bubble decreases in size as the head increases (figure 6). It should entirely disappear with a slight additional head.

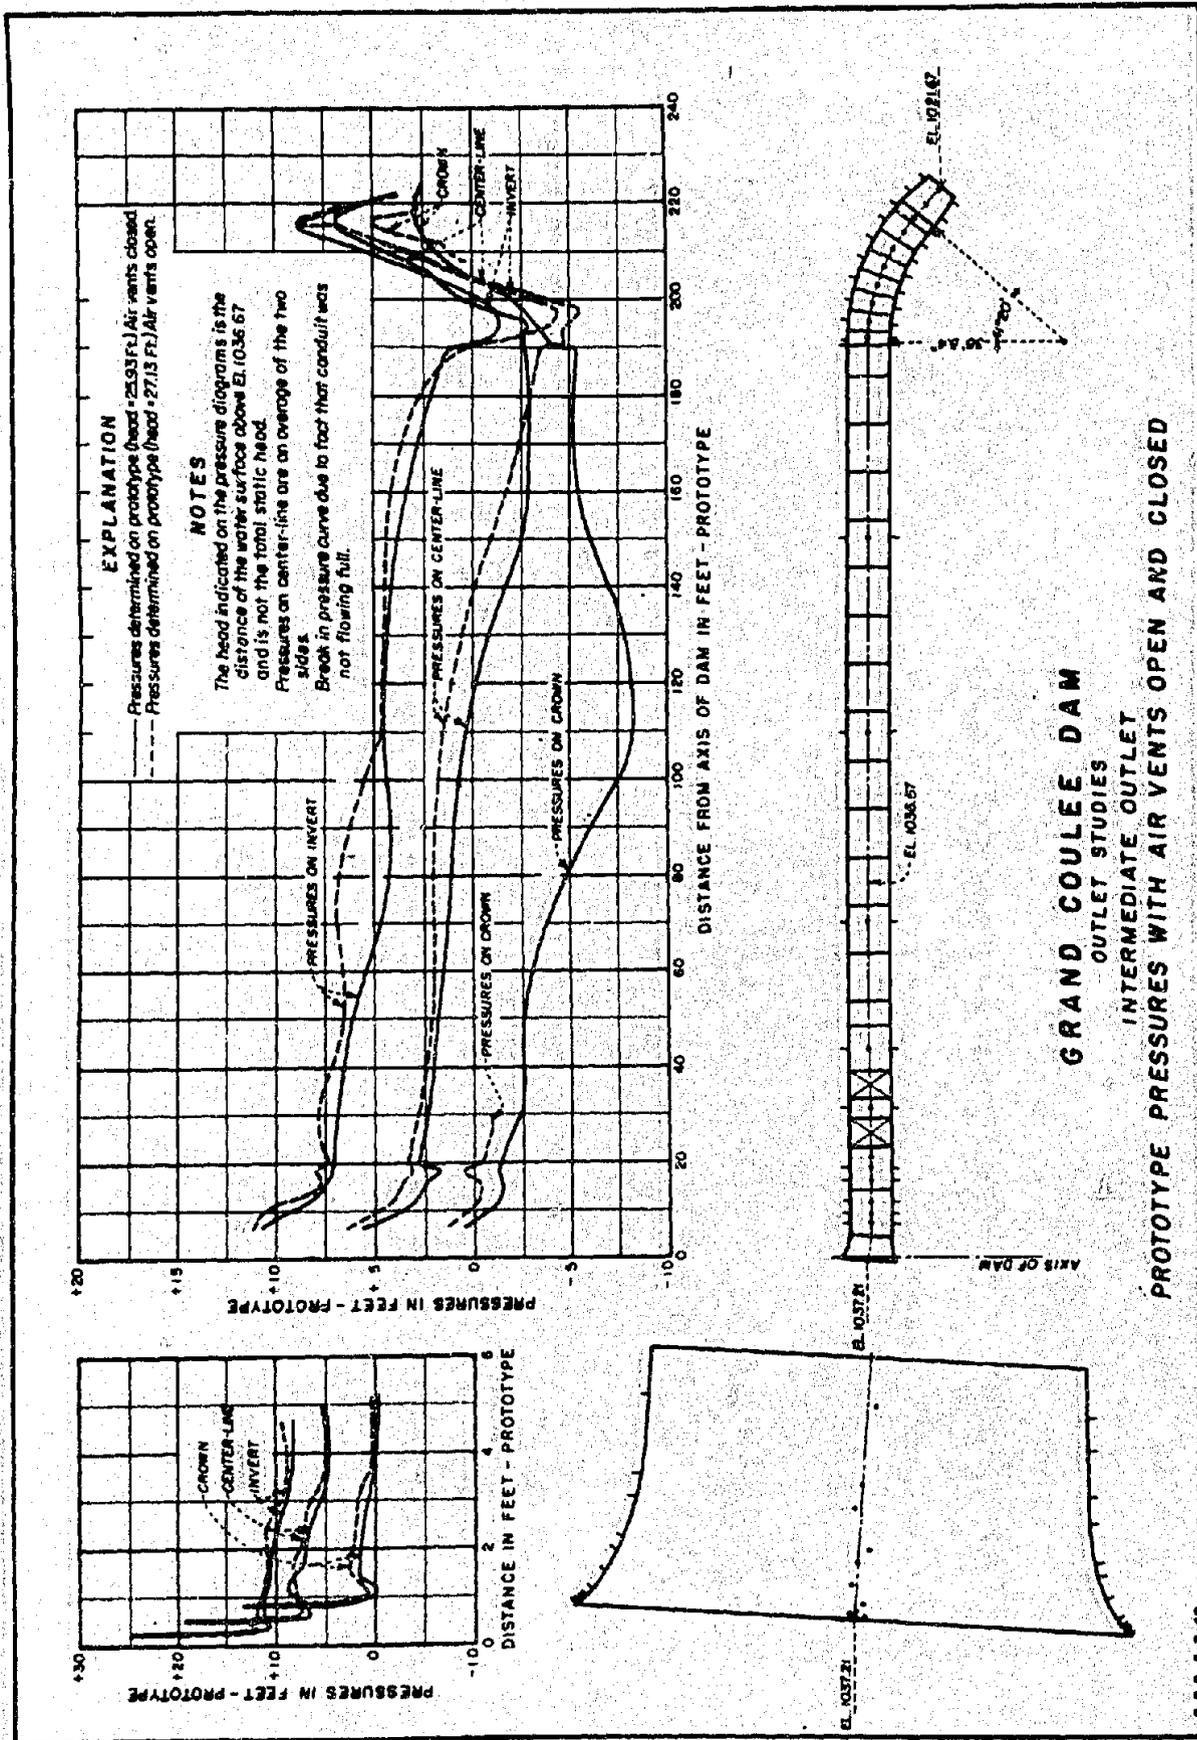
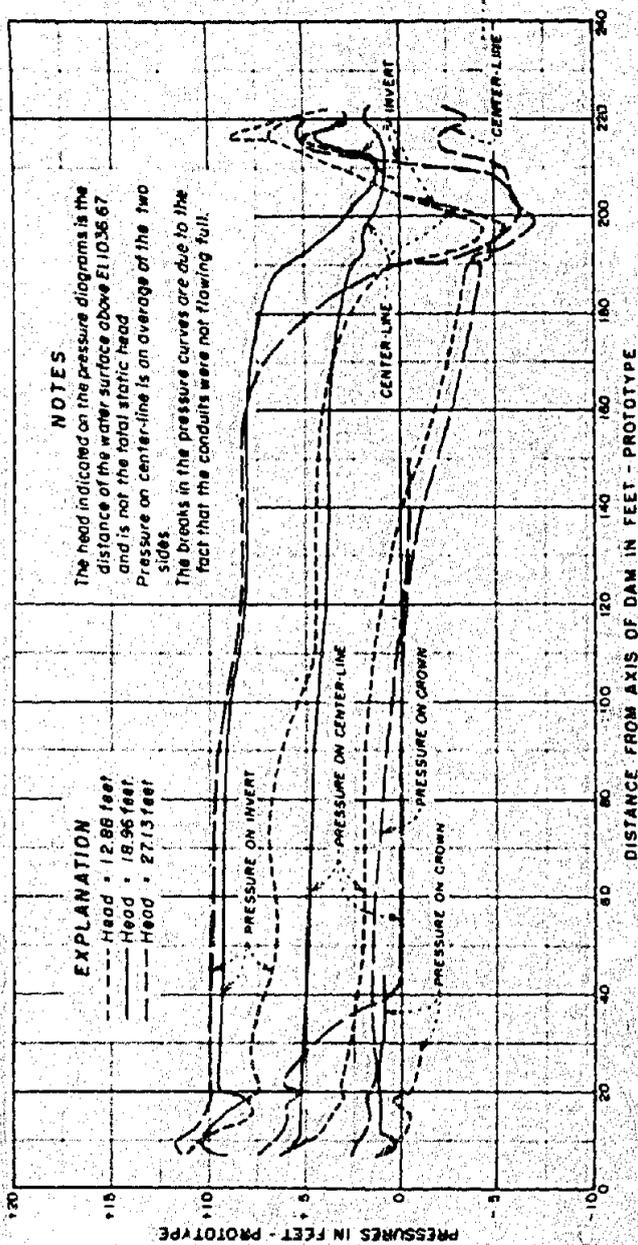
GRAND COULEE DAM
 OUTLET STUDIES
 INTERMEDIATE OUTLET
 PROTOTYPE PRESSURES WITH AIR VENTS OPEN

The head indicated on the pressure diagrams is the distance of the water surface above El. 1036.67 and is not the total static head. Pressure on center-line is an average of the two sides. The breaks in the pressure curves are due to the fact that the conduits were not flowing full.
