CONSTRUCTION TO COPE WITH FAST-FLOWING WATER

J. W. Ball

Engineer, Hydraulic Laboratory Section

Advance print of a paper to be
presented at the Conference for
Construction Engineers to be held
in Denver, Colorado, February 6
to 10, 1950.

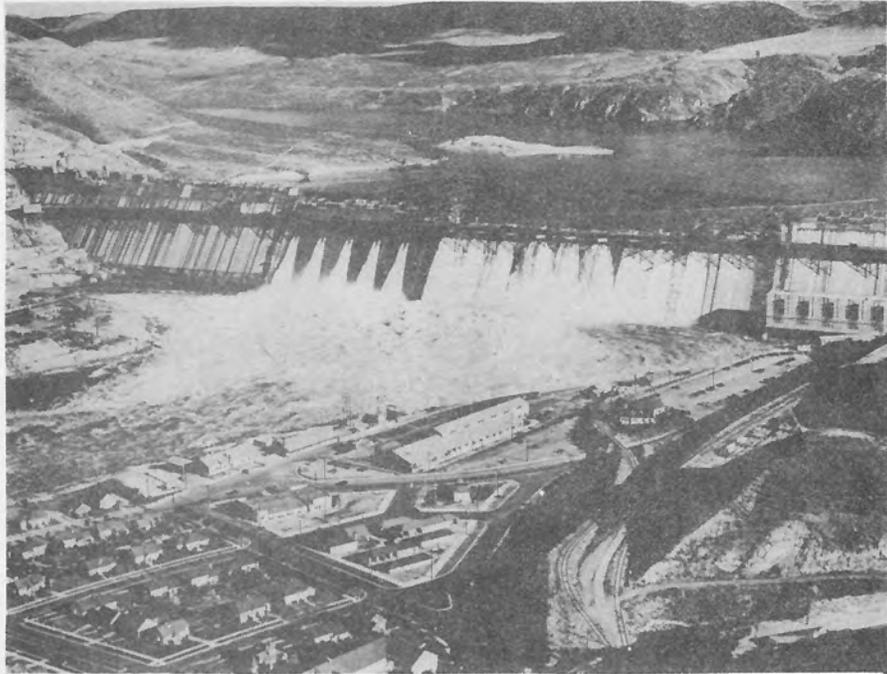
3. Eddying is usually caused by unbalanced flow conditions set up by construction requirements or unsymmetrical operation of a structure after completion. The concentration of large quantities of water over only a portion of the normal flow channel, as was necessary during the construction of Grand Coulee Dam, is an example. The eddy current shown in figure 1 moved large quantities of rock, huge boulders, steel piles, and other construction material (figure 2) dropped near the toe of the dam, upstream into the bucket section where severe erosion occurred as shown by figures 3 and 4. The eroded material has smooth irregular surfaces which in the case of concrete, have the appearance of having been ground and polished; and in the case of metal, appear as grooves having been gouged out with a chisel. Precautions against this type of damage during construction and operation would include:

Figure 1. Eddy induced by flow distribution at Grand Coulee Dam--
1940 Flood Season.

- a. Evenly distributing the flow, if possible
- b. Removal of loose material in the eddy area
- c. Preventing debris or other construction materials to accumulate in possible eddy areas and
- d. Stabilizing the ground surfaces in the eddy area by placing heavy rock or other material on them.

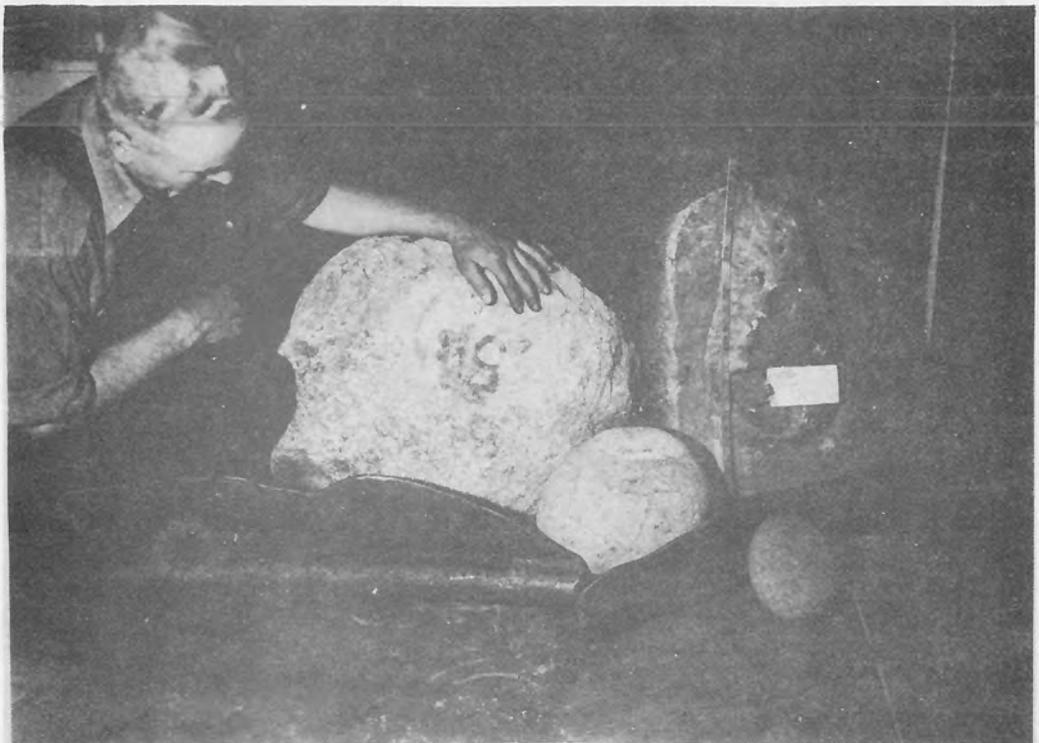
Figure 2. Material removed from spillway bucket--Grand Coulee Dam.

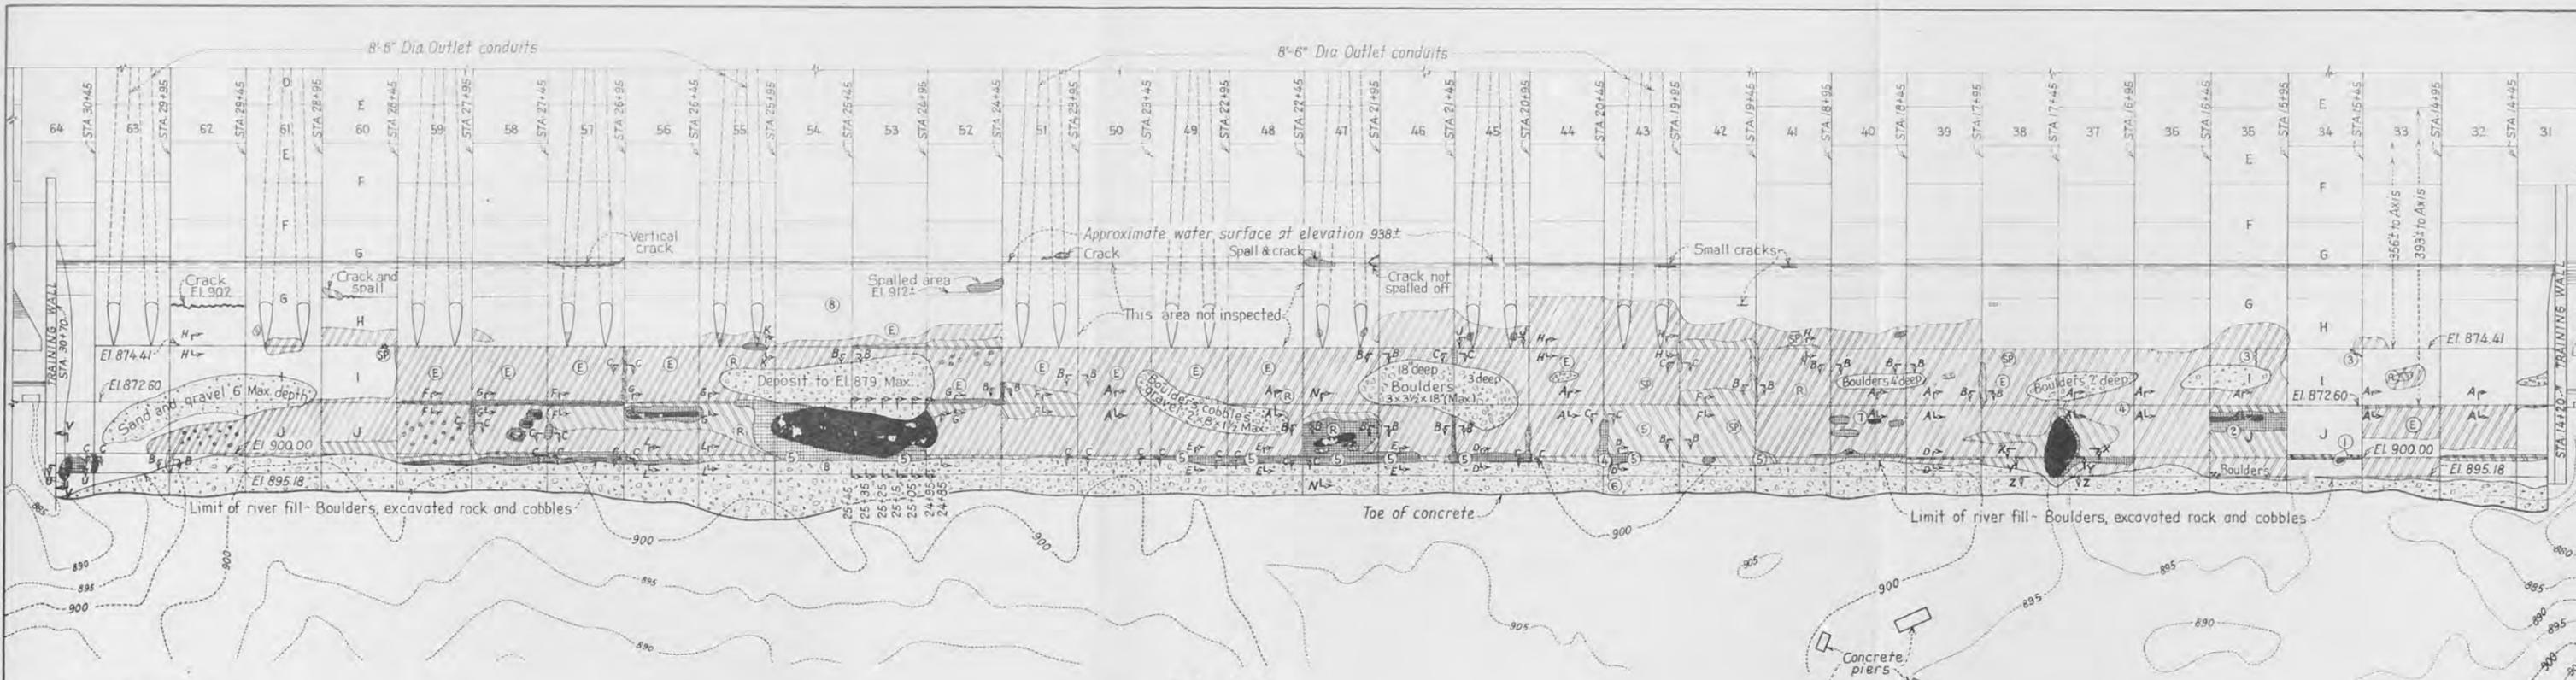
UNITED STATES DEPARTMENT OF THE INTERIOR
BUREAU OF RECLAMATION
COLUMBIA BASIN PROJECT-WASHINGTON
GRAND COULEE DAM
RESULTS OF SPILLWAY BUCKET INSPECTION
MARCH 1943

This drawing indicates the conditions existing in the spillway bucket as of March 1943. Data obtained from inspections made at later dates are available for inspection at the offices of the Bureau of Reclamation, Coulee Dam, Washington.

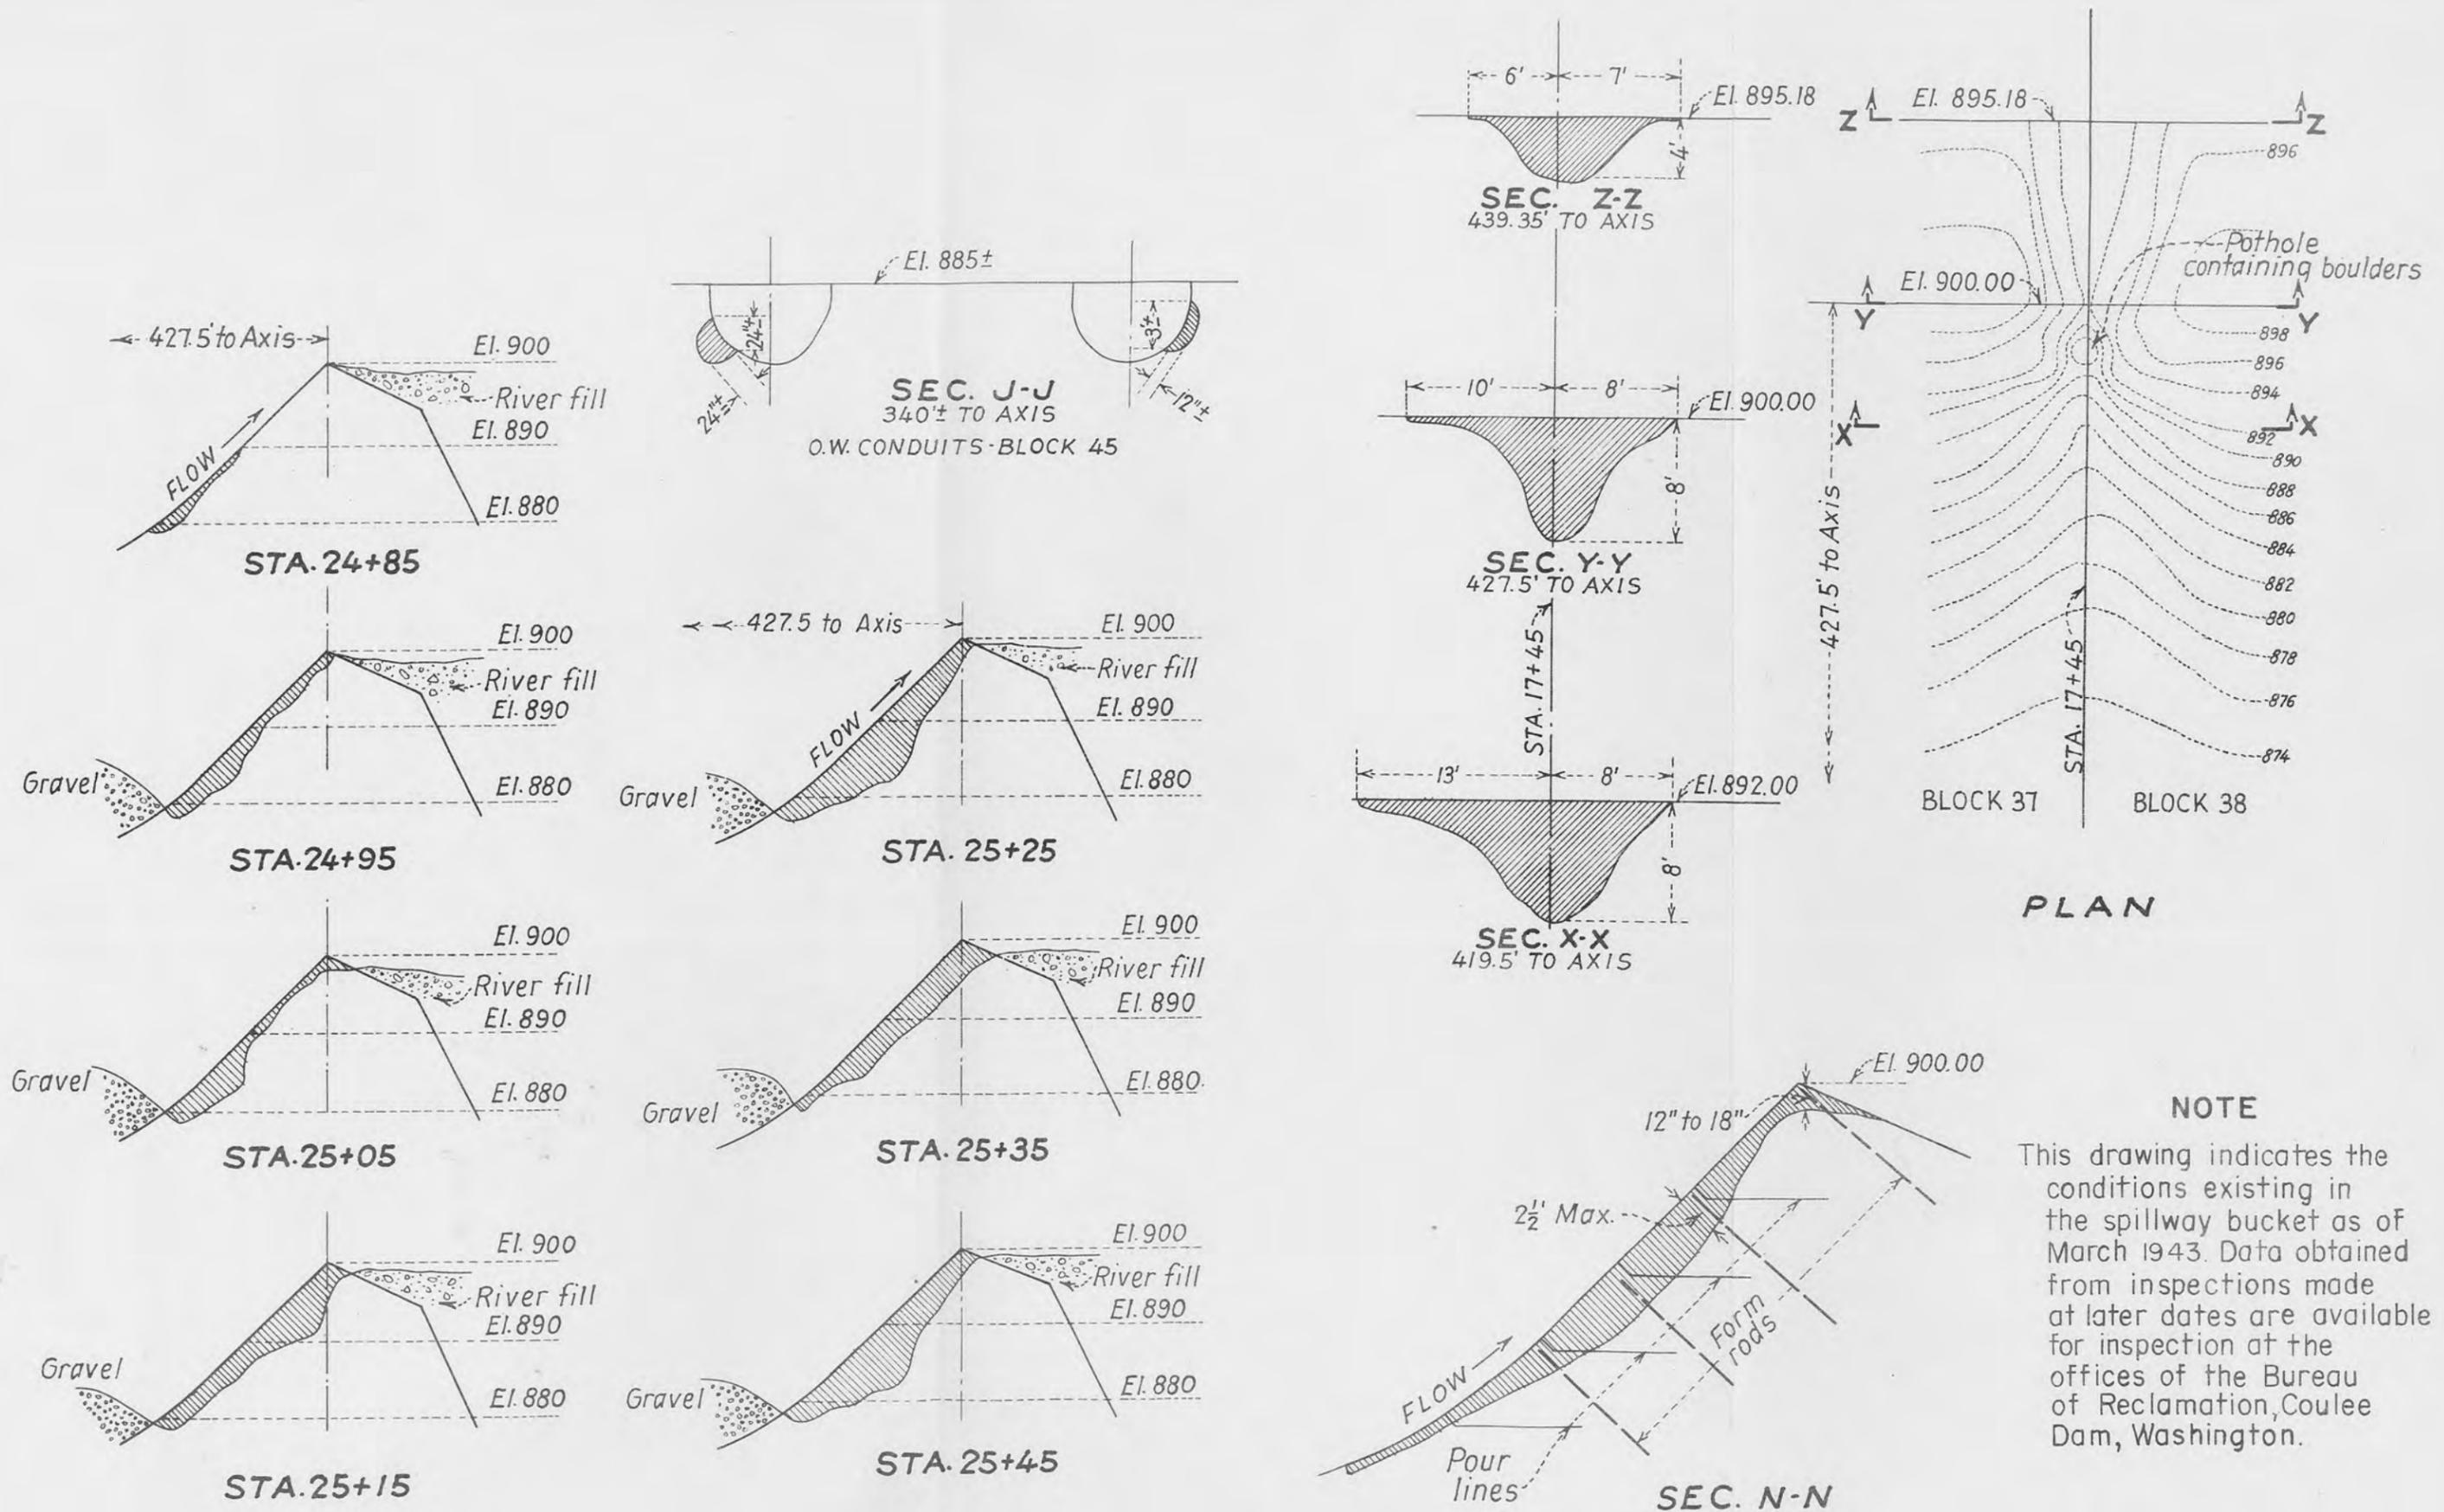
Figure 4. Erosion of Spillway Bucket--Grand Coulee Dam--Inspection March 1943.

Part of Drawing 222-D-7822 Blown up.

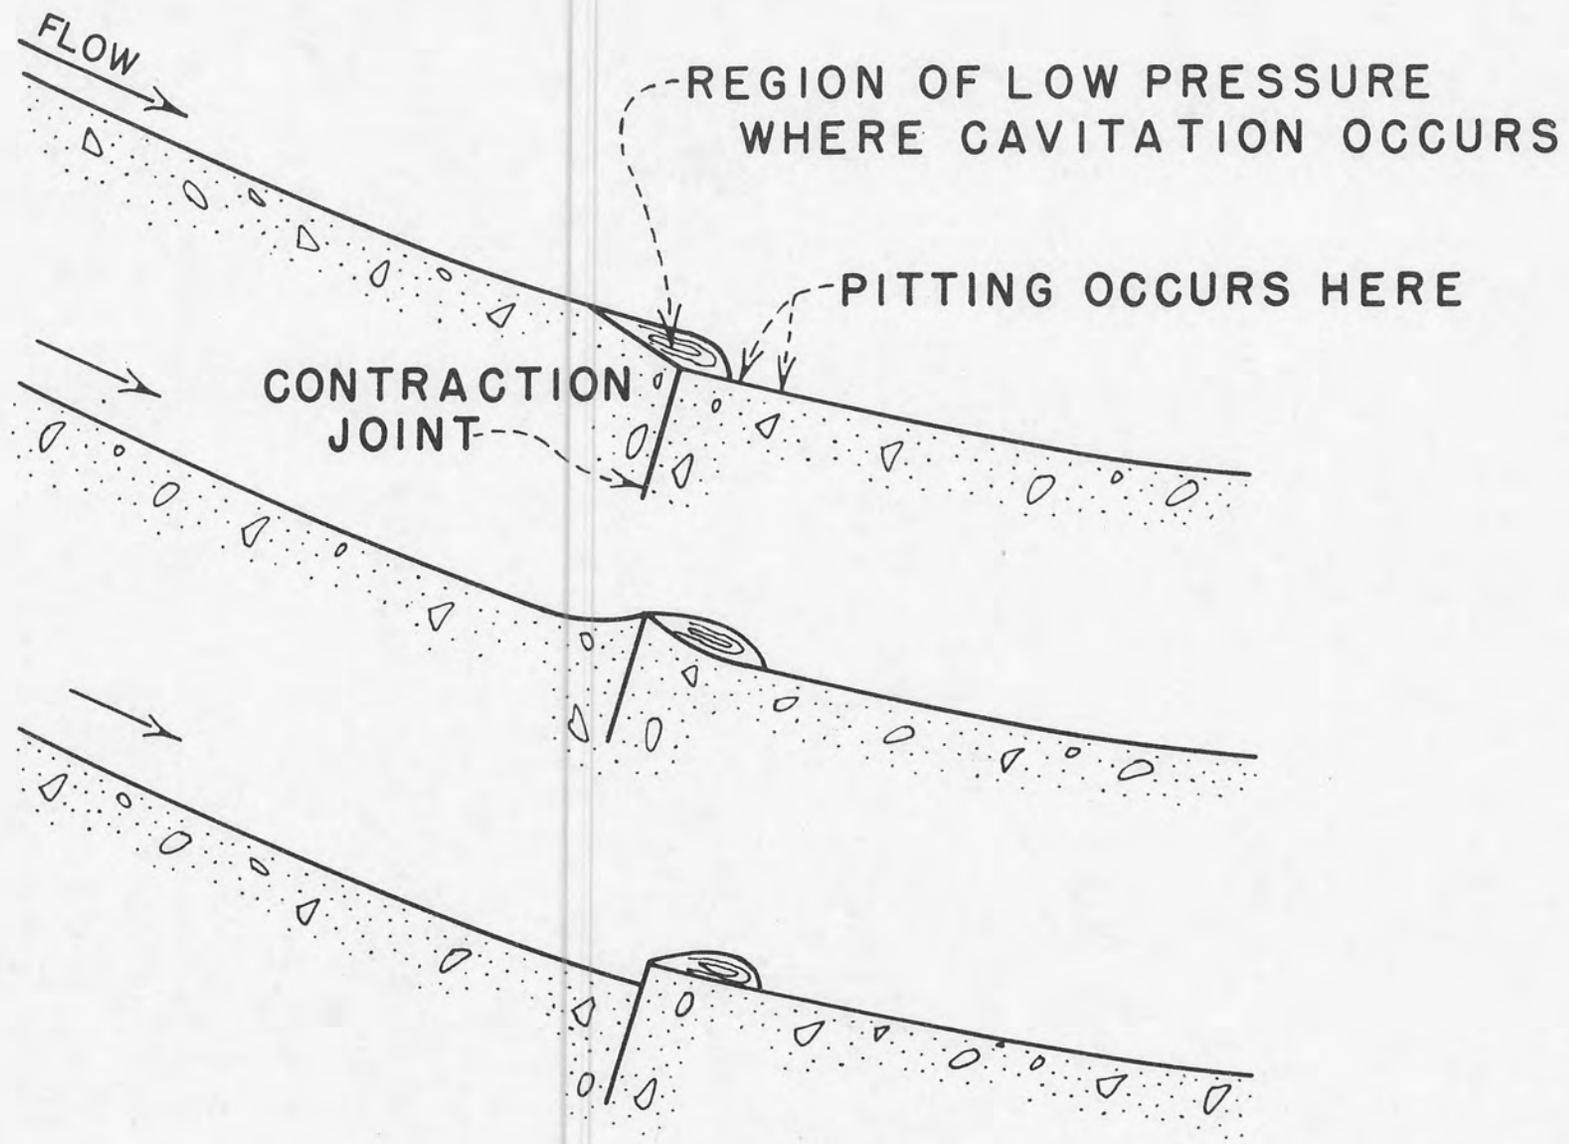
4. The damage produced by cavitation occurs in regions of low-pressure and high-water velocities where there are severe changes of alinement in the surface over which the water is flowing as indicated in figure 5, or where there is too rapid an increase in cross-sectional area of the water passage. The surface is rough and has the appearance of being formed of numerous small crater-like depressions or pits and thus the action is called pitting. The piece of steel and concrete test specimens on this platform are examples. (Section of Ross Dam penstock and concrete blocks.)

FIGURE 5 COMMON MISALIGNMENTS INDUCING CAVITATION

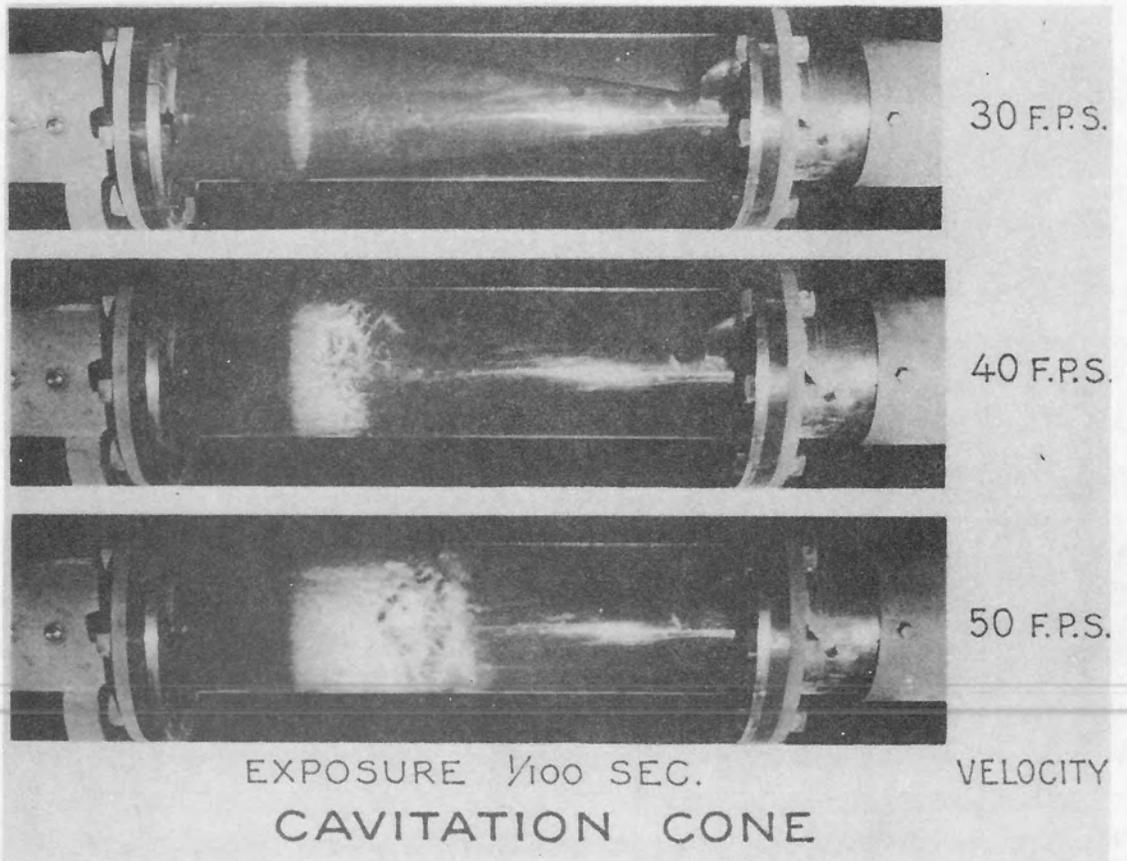
9. The general appearance of cavitation is a white, milky cloud resembling steam, as shown in figure 6. As a matter of fact, the cloud is a cold, low-pressure steam in the form of bubbles (cavitation bubbles). The cavitation action occurs with such rapidity that it cannot be studied in detail visually. Motion pictures taken at speeds up to 20,000 frames per second have been used to study the phenomenon. These will be shown later.

Figure 6. Appearance of Cavitation.

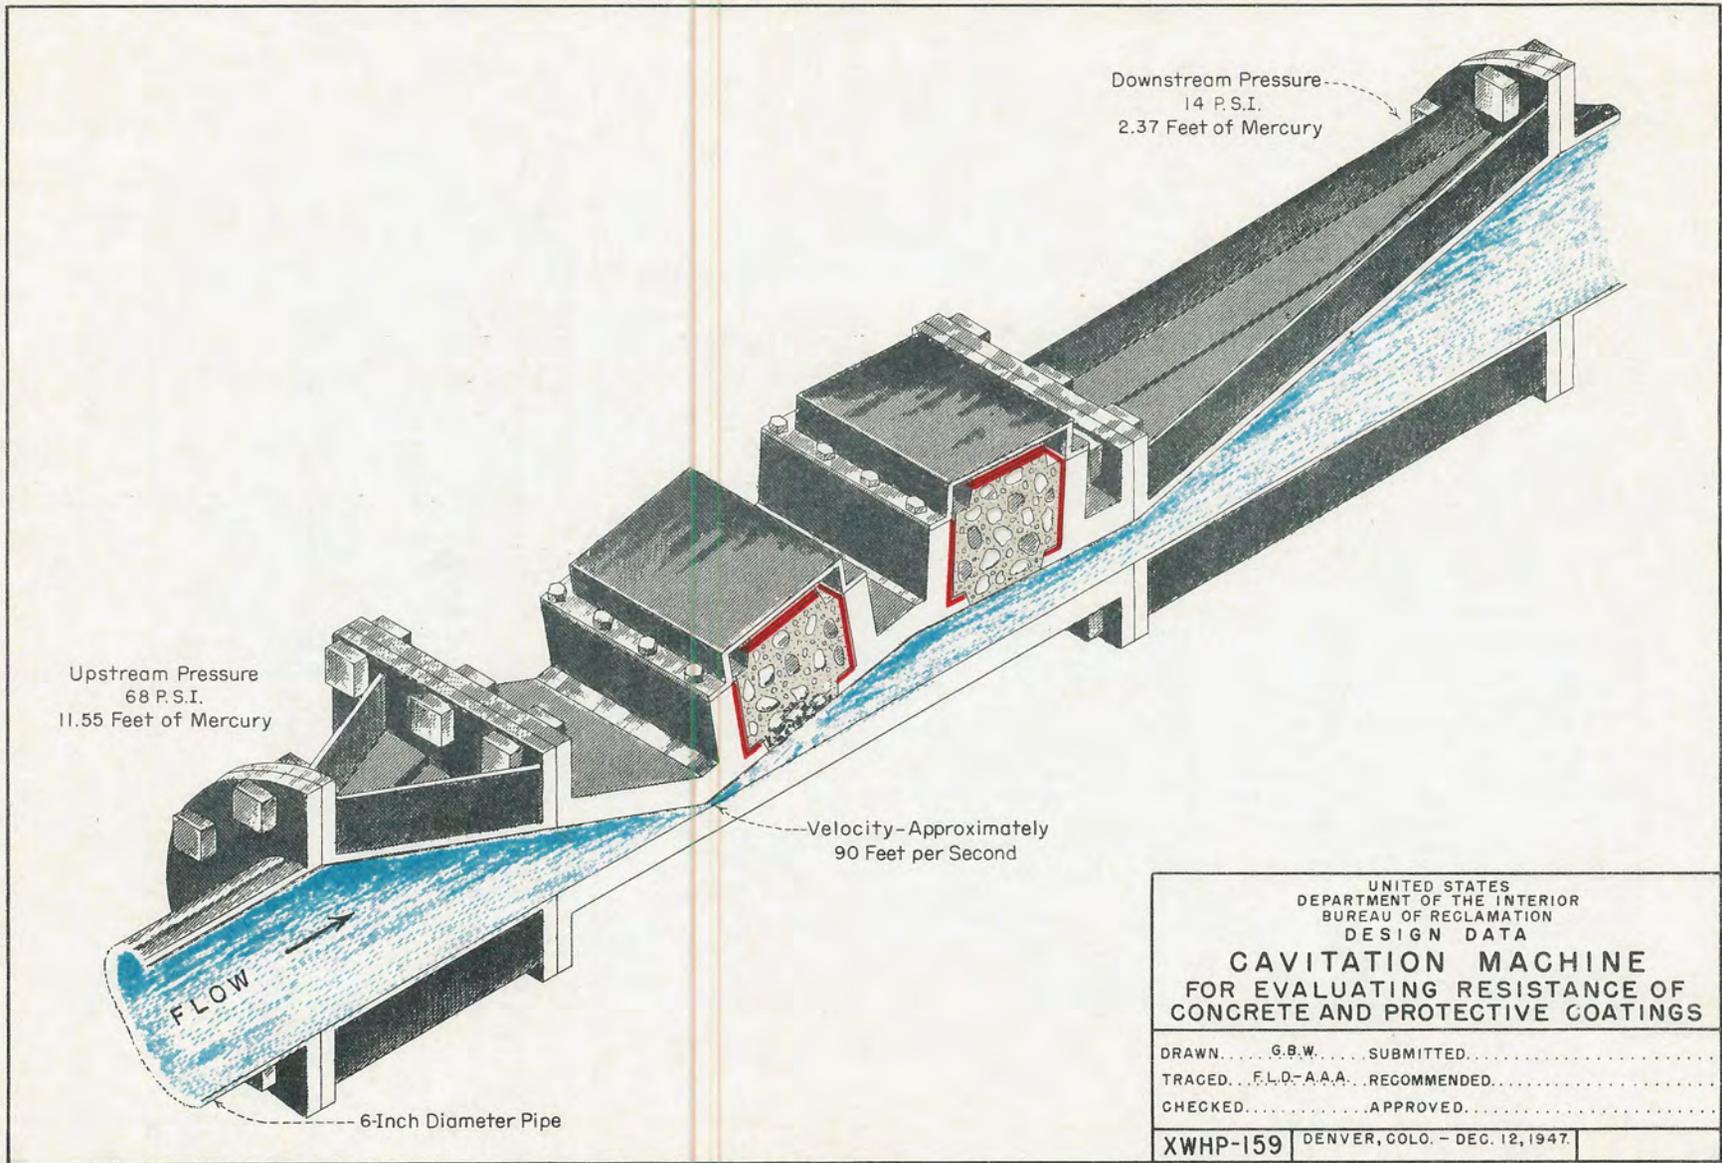
Figure 7.

while that in a test apparatus in the laboratory is more of a crackling or popping nature as indicated by the sound from this speaker which is attached to the apparatus operating in the laboratory. Figure 7 shows a section through this apparatus. (Note the expanding section and position of concrete test blocks.) Some of the damaged test blocks are shown in figure 8.

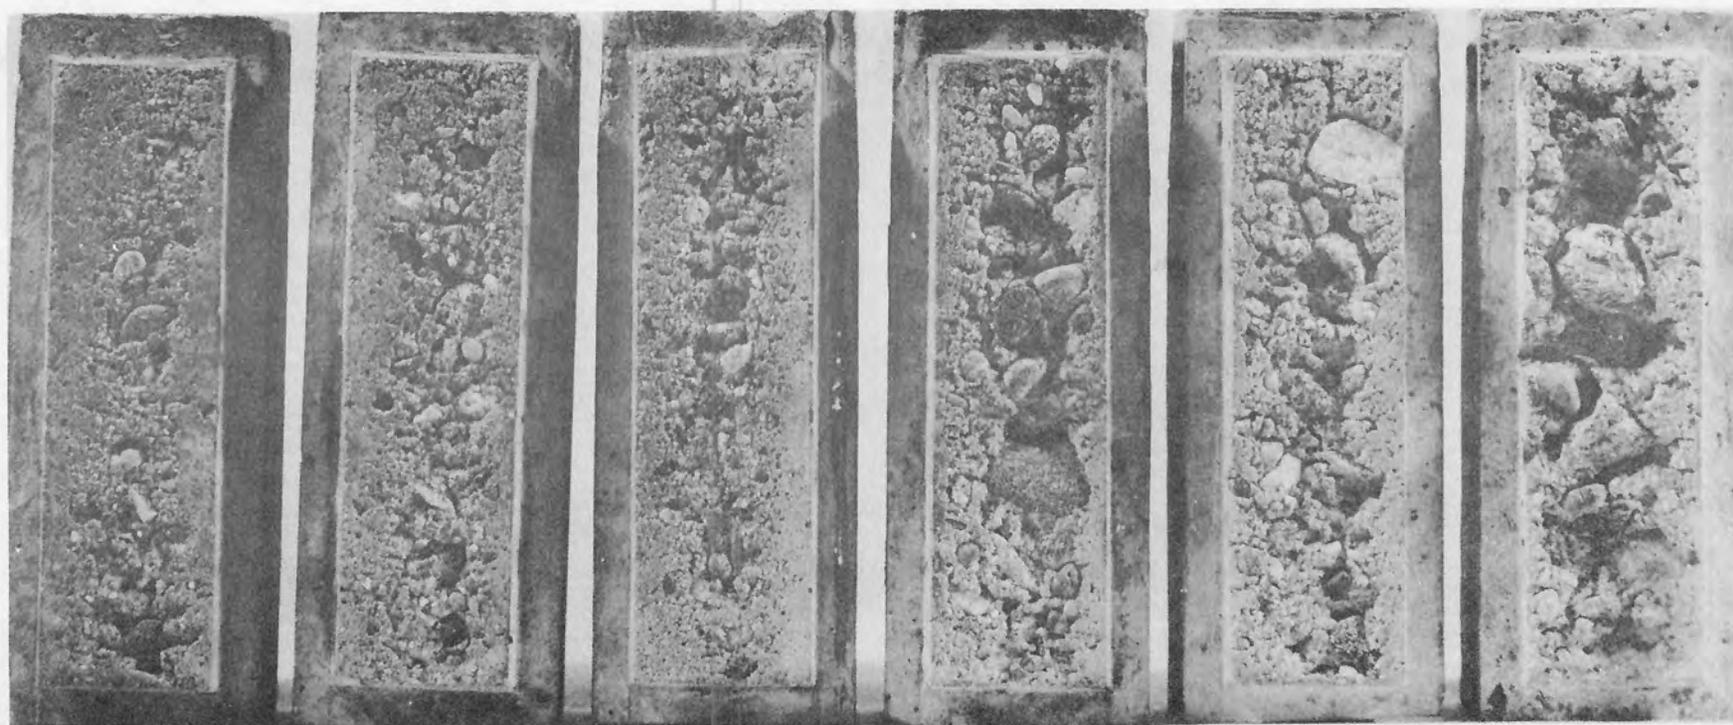
Figure 8. Cavitation-erosion of concrete specimens.

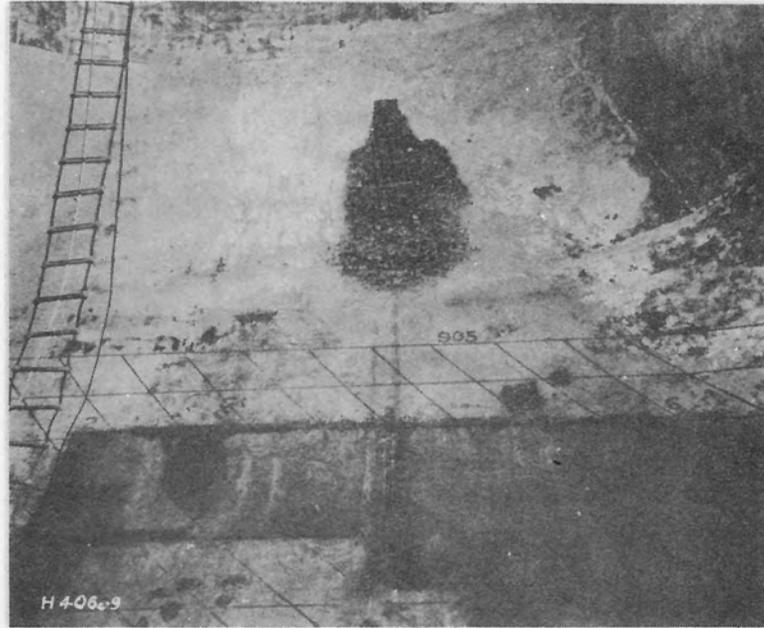
valves were placed to discharge their flow into the tubes for the release of water during the repair of underwater portions of the spillway. Figure 9 shows the extent of damage after 23-hour operation of one of the valves. A survey of the area revealed that the surface was not continuous but had an offset of one-half inch as illustrated in figure 10. Through inquiry, it was learned that during construction one edge of a steel form had been deformed to coincide with the edges of the already placed adjacent concrete. The change in the form resulted in a one-half inch discontinuity, ideal for producing cavitation when high-velocity water passed over it. An area in which the pressure was reduced to the vapor pressure of water formed immediately downstream from the discontinuity. Cavitation occurred in this area and caused pitting a short distance downstream. The damage was accelerated when an old patch in the area was torn out by the pressure changes and vibrations accompany the cavitation. As a corrective measure, the concrete was removed from the area to a depth of about 18 inches and the surface repaired to eliminate the severe recession in the surface as illustrated in figure 10. There was no damage in this area by subsequent operations as shown in figure 11, although above the repair further damage was caused by loss of a patch.

Figure 9. Erosion caused by operation of temporary needle valve
in draft tube--Grand Coulee Dam.

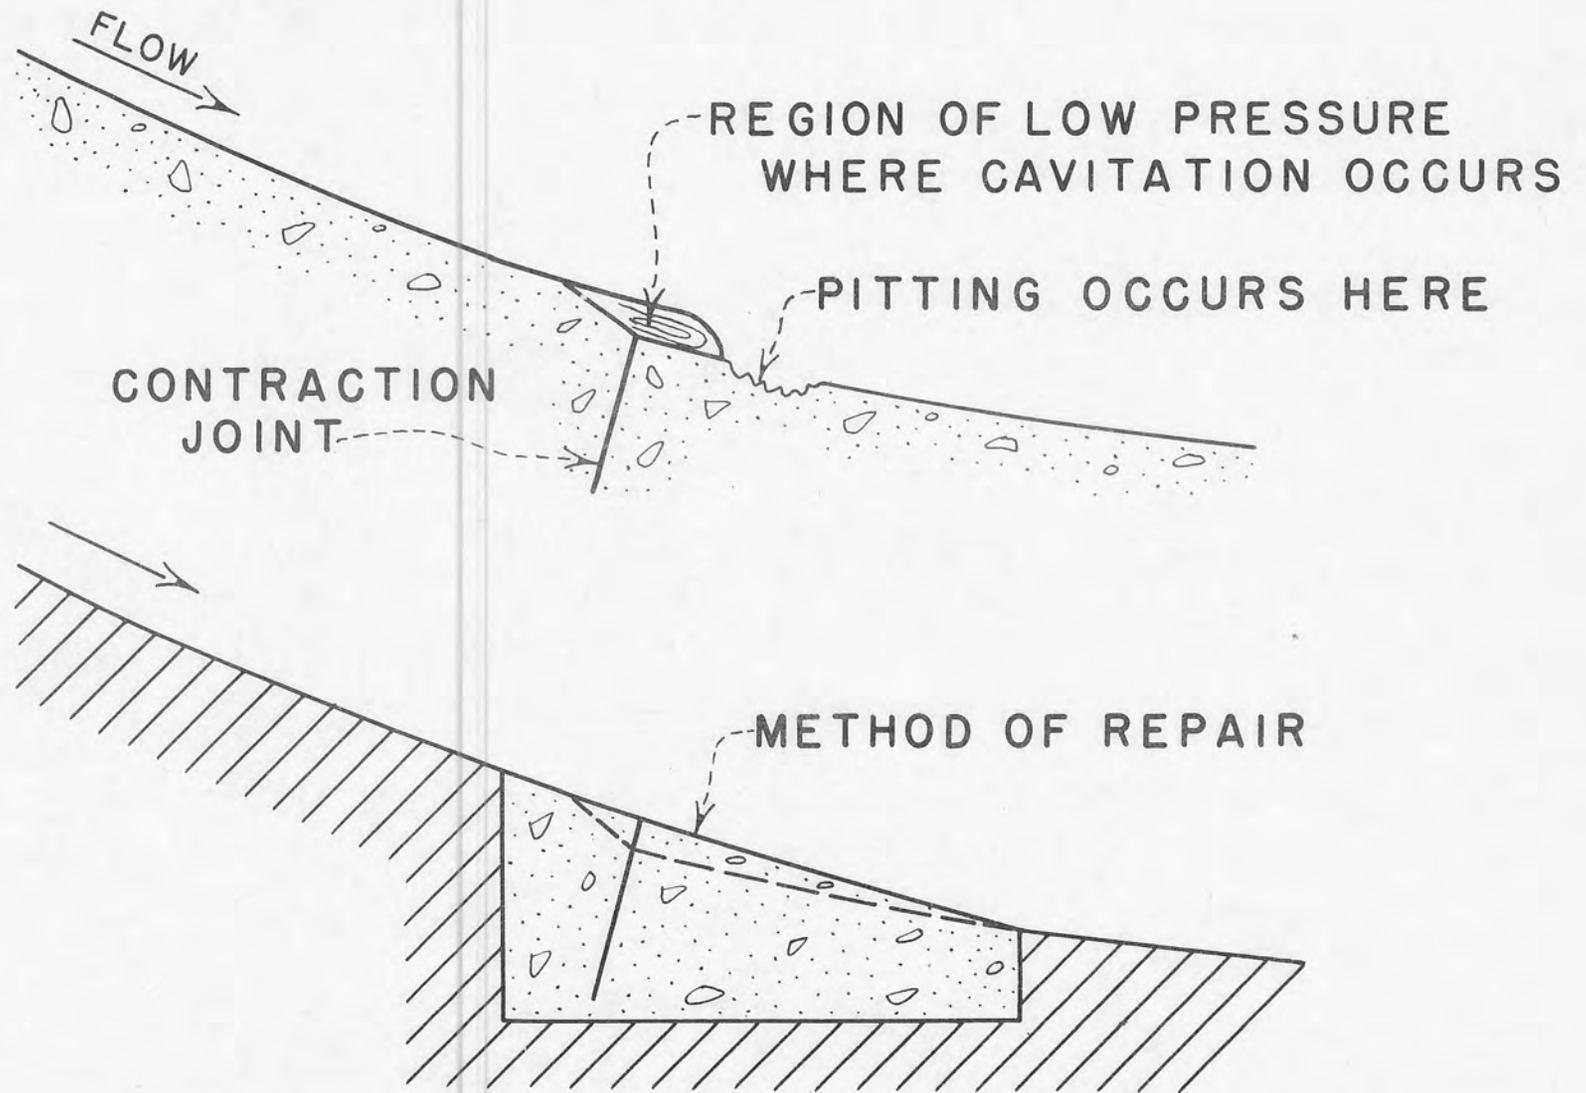
FIGURE 10 JOINT MISALIGNMENT AND REPAIR METHOD OF DRAFT TUBE AT GRAND COULEE DAM

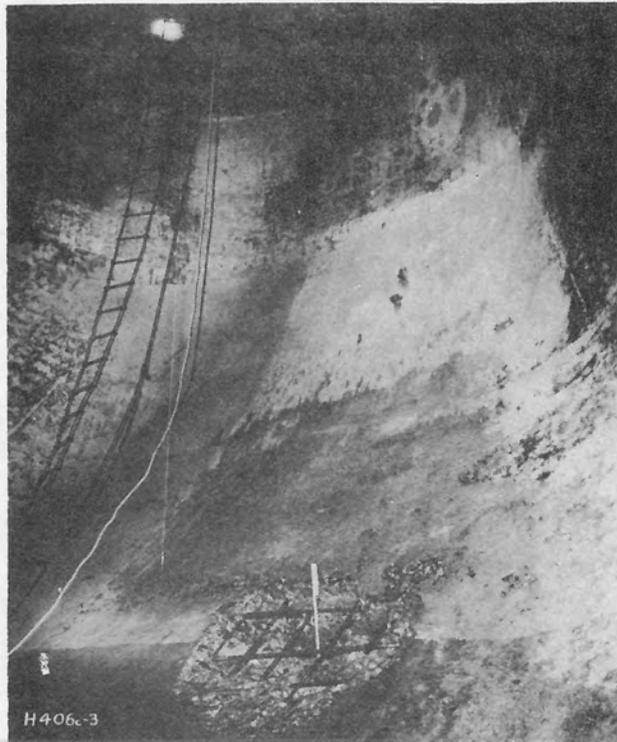
Figure 11. Repaired area (^{upper}lower portion of photograph) shows no damage by subsequent operations. Loss of patch (^{upper}lower portion of photograph) caused new erosion.
