PROTOTYPE BEHAVIOR OF MORNING-GLORY SHAFT SPILLWAYS

J. N. Bradley

**A paper for the
Summer Convention, ASCE,
Denver, Colorado, June 1952**

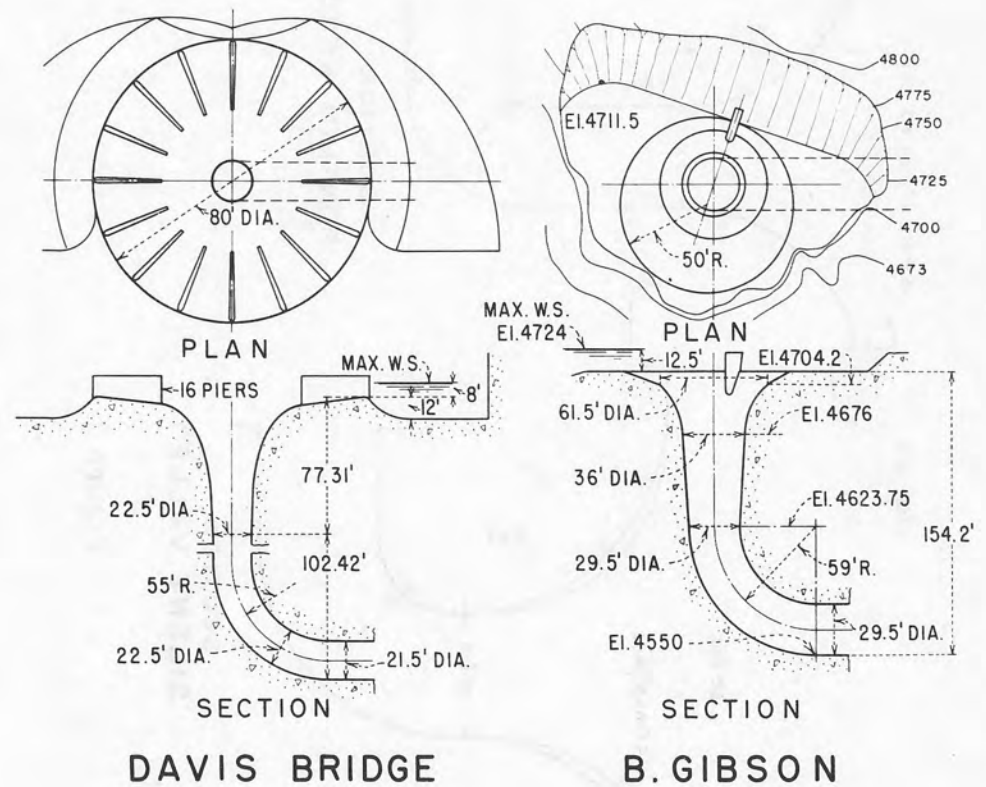
Figure 2

Davis Bridge spillway on the Deerfield River near Whitingham, Vermont, was completed about 1925. This spillway (Figure 2) was designed for a maximum discharge of 27,000 cfs, a drop of 180 feet, and a head on the crest of 8 feet. Reports indicate that this structure has discharged a number of times for short periods. The maximum discharge occurred in the September hurricane flood of 1938 when the water reached an elevation of 6 feet on the crest. The computed discharge at that time was about 19,000 second feet, or 72 percent of capacity. The spill during this flood exceeded 10,000 second feet, for about 15 hours' duration. Inspection after the flood showed no appreciable erosion of the concrete in the horizontal part of the tunnel. Several small erosion pockets were apparent at the vertical bend, but it was not certain whether this was caused by erosion due to velocity or spalling due to freezing and thawing of the concrete surfaces. In any event, the repairs were of a minor nature. The report goes on to say that all ice and debris which passed over the crest between the piers has readily gone through the spillway. Logs and trees 50 to 60 feet long have passed through the spillway at times. The spillway makes some noise when it is in operation, but this can be heard only a short distance from the dam, and vibration appears to be no problem.

The Gibson spillway on the North Fork of the Sun River in Montana, a Bureau of Reclamation dam, was completed about 1926. This structure (Figure 2) was designed for 50,000 cfs, a drop of 160 feet, with 20 feet of head over the crest. Later the crest portion was altered and six radial gates were installed. The report states that during the month of May 1938, a total of 435,000 acre feet of water flowed through the spillway. The peak of this flow amounted to 13,000 second feet, or 26 percent of capacity. Upon inspection of the tunnel in 1948, two spots about 5 feet in greatest dimension, oval in shape, and about 2 inches deep, prominently displayed erosion in the vertical bend. Water passing through the spillway in the 1948 season caused them to show additional erosion. From the irregular and misaligned nature of the vertical bend, it would be unfair to tie down the responsibility for this erosion to any one cause. The report goes on to state that no ice has passed through the spillway, but large trees have passed through it during flood season with no apparent damage. Noise was reported to have been considerable, increasing as the discharge, but this was not particularly objectionable. Vibration was considered normal, and in no way detrimental. With radial gates, vortex action is no problem.

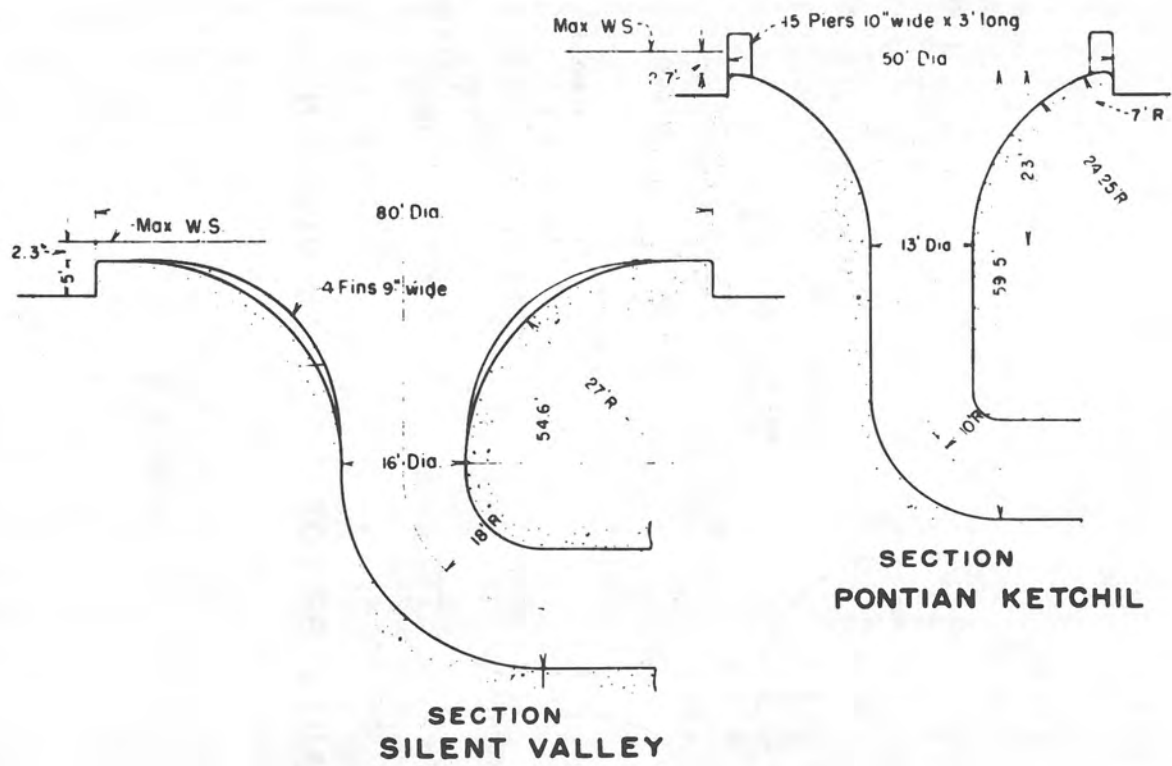
Figure 3

Two British conservatively designed morning-glory spillways were completed in 1926 and 1927, the Silent Valley in Ireland and the Pontian Ketchil in Singapore (Figure 3). The Silent Valley spillway was designed for a capacity of 2,600 cfs, a 55-foot fall and 2.3 feet of head on the crest. The Pontian Ketchil spillway was designed for a discharge of 2,700 cfs, a fall of 60 feet, and a head of 2.7 feet on the crest. Mr. Binnie informs us that the Silent Valley and Pontian Ketchil spillways have operated as expected without appreciable erosion of any kind and without unusual repairs. Apprehension that erosion might occur caused the designers of the Silent Valley spillway to line the vertical bend with cast iron. The Pontian Ketchil spillway is situated in the Malayan forest where cyclonic storms occur of such intensity as to uproot large trees and carry them for considerable distances. Many of

these have passed through the spillway without damage. Antivortex devices consist of four fins on the Silent Valley spillway and 15 piers on the Pontian Ketchil spillway.

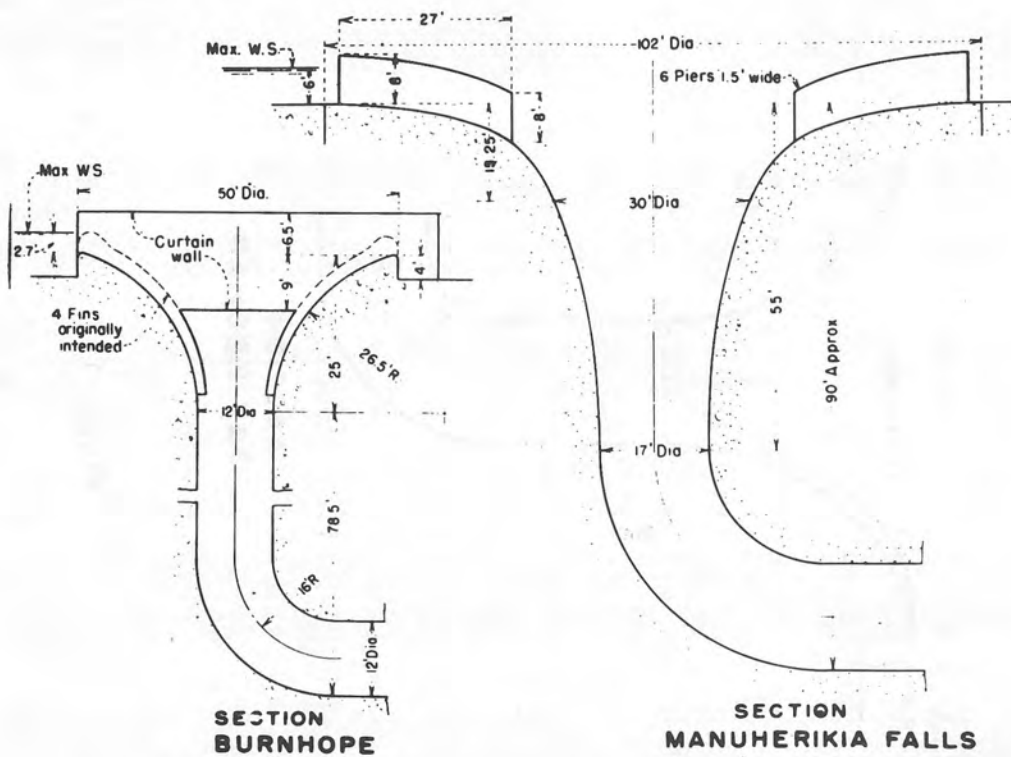
Figure 4

The capacity of another English spillway, the Burnhope (Figure 4) in Durham County, is 2,600 cfs, 2.7 feet of head on the crest, and approximately 100 feet of drop. The vertical bend in the Burnhope spillway was purposely lined with cast iron to prevent erosion. One moderate flood of 1,500 cfs, or 55-percent capacity, has been recorded with no undesirable operating conditions or damage. In this design a curtain wall extends across the center of the spillway parallel to the horizontal tunnel.

The Manuherikia Falls spillway in New Zealand (Figure 4) is designed for 15,000 cfs, a drop of 90 feet and a head of 6 feet on the crest. This spillway has passed several small floods since 1935, aggregating about 2 feet of head on the crest, besides a moderately large one in November 1948. In 1948, the spillway passed a maximum flow of 5,000 cfs, representing one-third of capacity for a depth of 3 feet over the crest. The report states that there are signs of wear at the circumferential construction joints in the morning-glory proper to about 25 feet below crest level. Some of the concrete has been eroded to a depth of about 3 inches at these joints. Frost action may have caused some of the erosion, as there is seepage through the rock surrounding the spillway. The remainder of the vertical shaft is in good condition. The vertical curve, however, shows erosion at construction joints, amounting to about 3 inches. The floor in the horizontal section of the tunnel shows general wearing of the concrete surface of approximately 1 inch. Some of this occurred when the tunnel was used for stream diversion. Very little debris or ice has passed through this spillway, and no objectionable noises have been noted. Six piers serve to counteract vortex action.

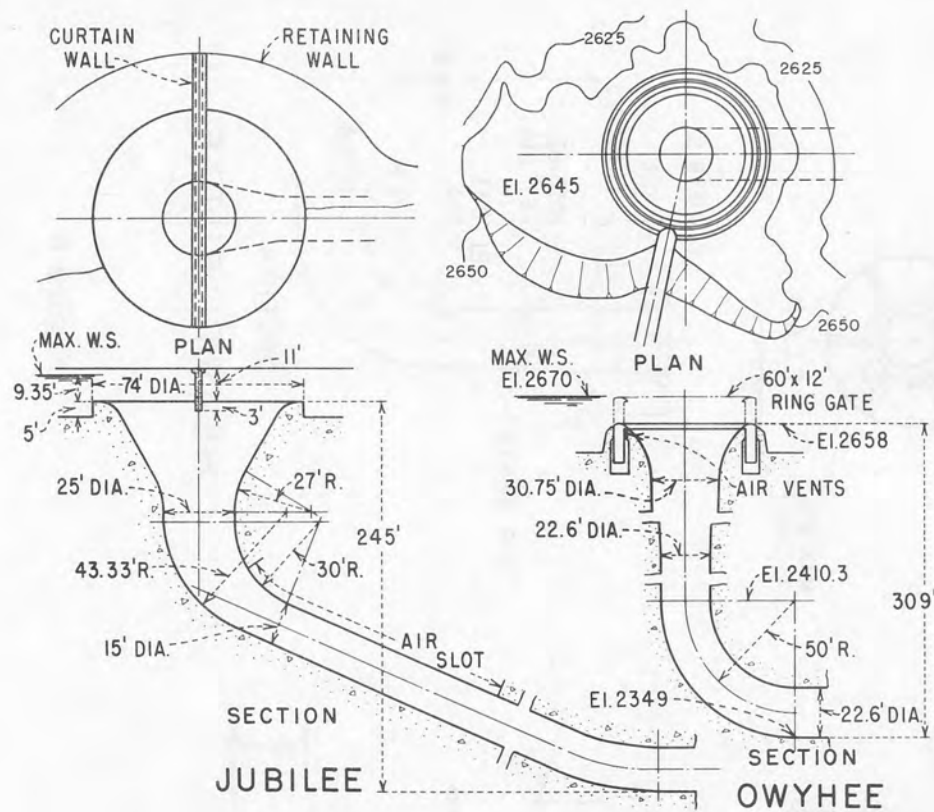
Figure 5

The Jubilee spillway (Figure 5), the largest English spillway up to this time, has a capacity of 17,000 cfs, a drop of 245 feet, and a head of 9.4 feet on the crest. There was evidently some concern as to the advisability of dropping the water 245 feet into a vertical shaft (100 feet greater than in any former spillway), which is evidenced by the inclined shaft. The only information on Jubilee spillway states that it has operated as expected. Discharges have been small or moderate, and no erosion is reported. This is the first spillway in which special air venting has been employed. A curtain of water tends to seal the tunnel at the entrance to the inclined shaft for the higher discharges. An air duct was, therefore, provided downstream from the curtain of water in the inclined portion of the tunnel. It is interesting to note that the curtain wall on this spillway is normal to the one on Burnhope.

The Owyhee spillway in Idaho (Figure 5), constructed in the early thirties by the Bureau of Reclamation, was a daring design at the time, with a capacity of 30,000 cfs, dropping 300 feet through a vertical shaft. The spillway was designed for a maximum head of 12 feet on the crest. A floating ring gate was incorporated in the crest portion. The ring gate operates on the same principle as the drum gate used on straight overfall spillways. It is raised by admitting water to the chamber beneath and lowered by draining

water from the chamber. All reports from the Owyhee spillway (on which we have kept special watch) are favorable. A large flow occurred through the spillway during a 3-month period in the spring of 1936, when approximately 300,000 acre feet of water was passed. The maximum discharge recorded was 15,000 second feet, or one-half capacity. Since then smaller discharges have passed through the spillway frequently. The spillway operated at 18,000 cfs or 60 percent of capacity in 1952. Inspection of the vertical shaft, elbow, and horizontal tunnel downstream has disclosed no indication of erosion of any kind. These inspections have been conducted frequently since the spillway first operated in 1936. No evidence of vibration has been apparent in the spillway and the jet does not flutter even with the gate in a raised position. Incidentally a single pier serves as an anti-vortex device and also houses the ring-gate operating equipment.

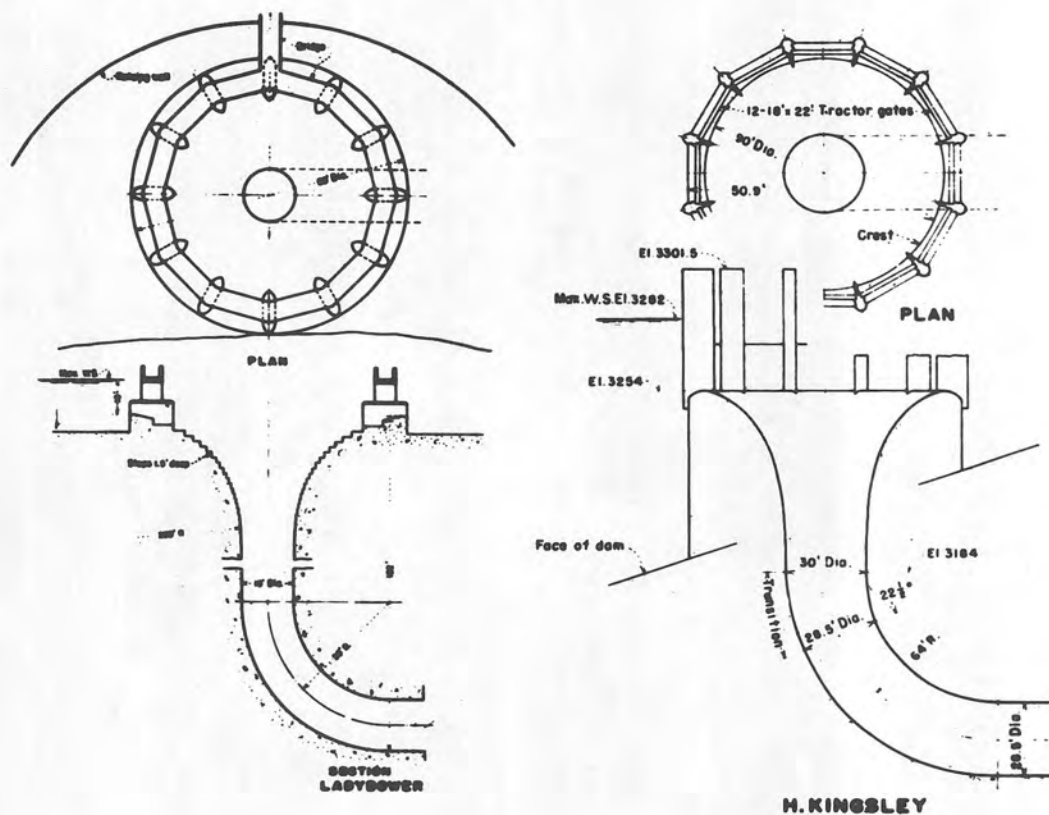
Figure 7

The Lady Bower (Figure 7) is the latest in English morning-glory spillways. Constructed in the middle 1930's it was designed to operate at a maximum of 10 feet of head on the crest with 122 feet of drop. The report states that the spillway has operated several times with no objectionable features. No erosion of the concrete has so far been experienced, either in the tunnel or at the vertical bend. The internal step form of design was arrived at by model studies. The report states that the step design is cheaper to construct but is less efficient than the smooth morning-glory shape. The crest is surmounted with 12 piers.

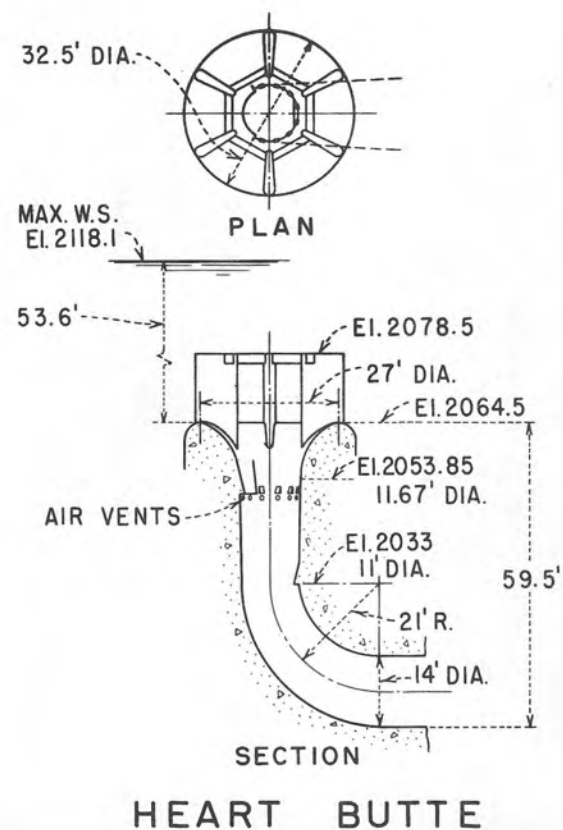
Figure 8

The spillway for the Heart Butte (Figure 8), recently constructed by the Bureau of Reclamation, is unique in that it is designed to operate principally submerged. Both operate in conjunction with retention reservoirs. The Heart Butte Dam spillway is located in North Dakota. It was designed

for a capacity of 5,600 cfs, with a drop from headwater to tail water of 106 feet, and operates submerged at a maximum head of 54 feet on the crest. Free flow occurs for heads up to 6 feet. Submerged flow occurs for heads above 6 feet. A large vortex forms for heads from 6 to 20 feet. For heads from 20 to 54 feet, vortices are either small or nonexistent. The six piers on the crest serve to break up the large vortex into a number of smaller ones reducing fluctuations in discharge and resulting in improved flow conditions. This dam was completed in 1949, and in the Spring of 1950 passed a major flood. The spillway operated for approximately 1 month and passed 148,000 acre feet of water. The maximum flow into the reservoir during the flood was 24,000 cfs, while the maximum discharge released through the spillway amounted to 3,800 cfs. An inspection after this flood showed erosion at two points in the vertical bend. In each case the eroded areas were about 8 inches in diameter and a maximum of 1 inch deep. This spillway again went into operation in 1951 and 52.
