BUREAU OF RECLAMATION  
HYDRAULIC LABORATORY

Memorandum

April 3, 1951

Operating characteristics of some of the hydraulic structures on Colorado-Big Thompson Project east of the Continental Divide

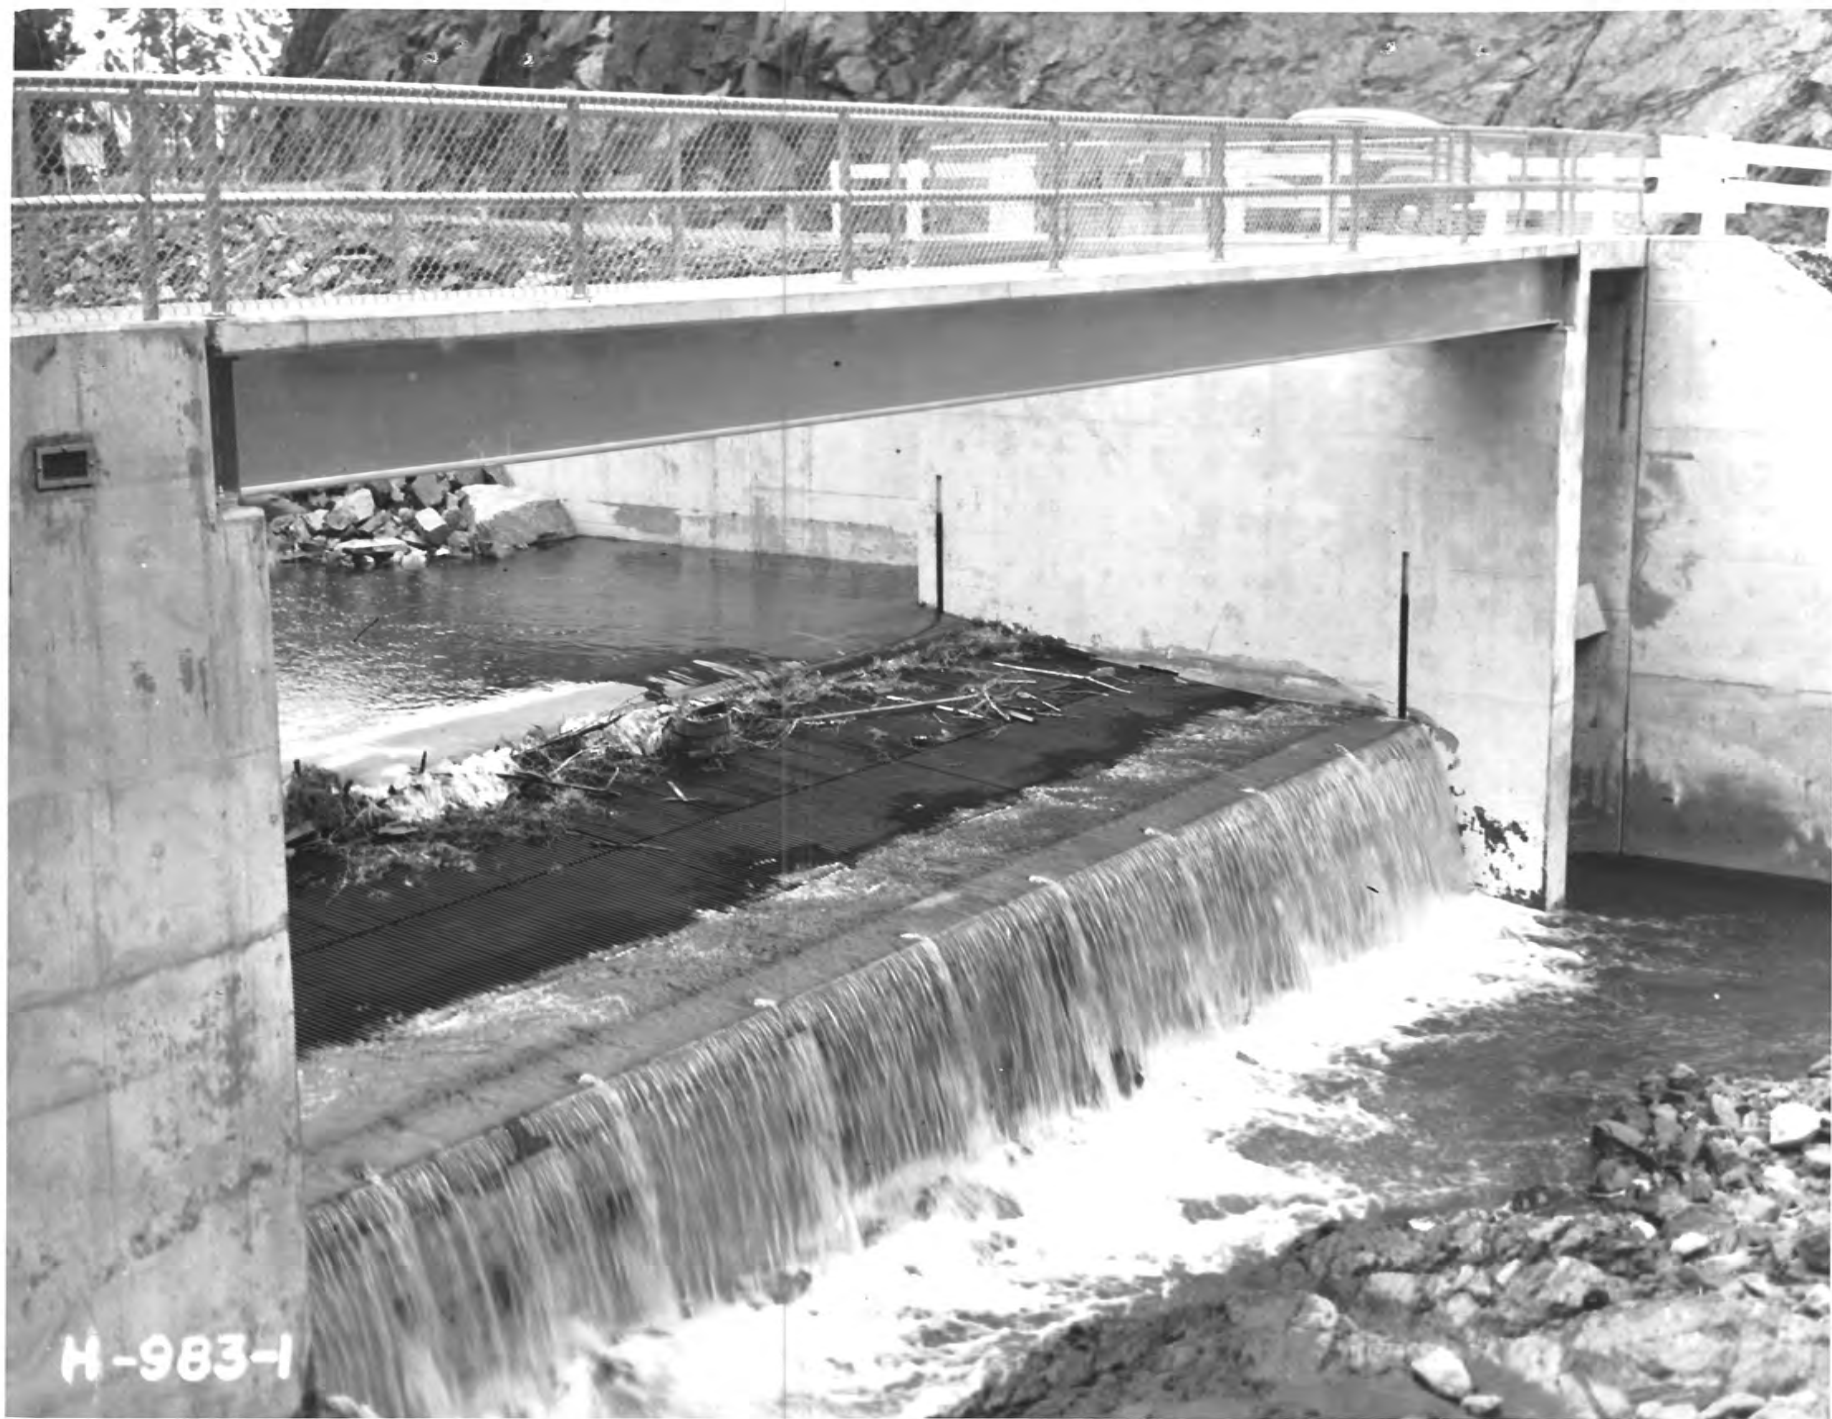
3. The next stop was at the inlet to the tunnel diversion from the Big Thompson to the Horsetooth Supply conduit. Water was being diverted at this structure into the tunnel, and the grating was apparently keeping the coarser material out of the inlet to the tunnel. No unusual features were observed at this structure. A photograph of flow conditions is enclosed.

H-983-1. Close-up of diversion structure on Big Thompson River to tunnel entrance of Herseetooth Supply Conduit.

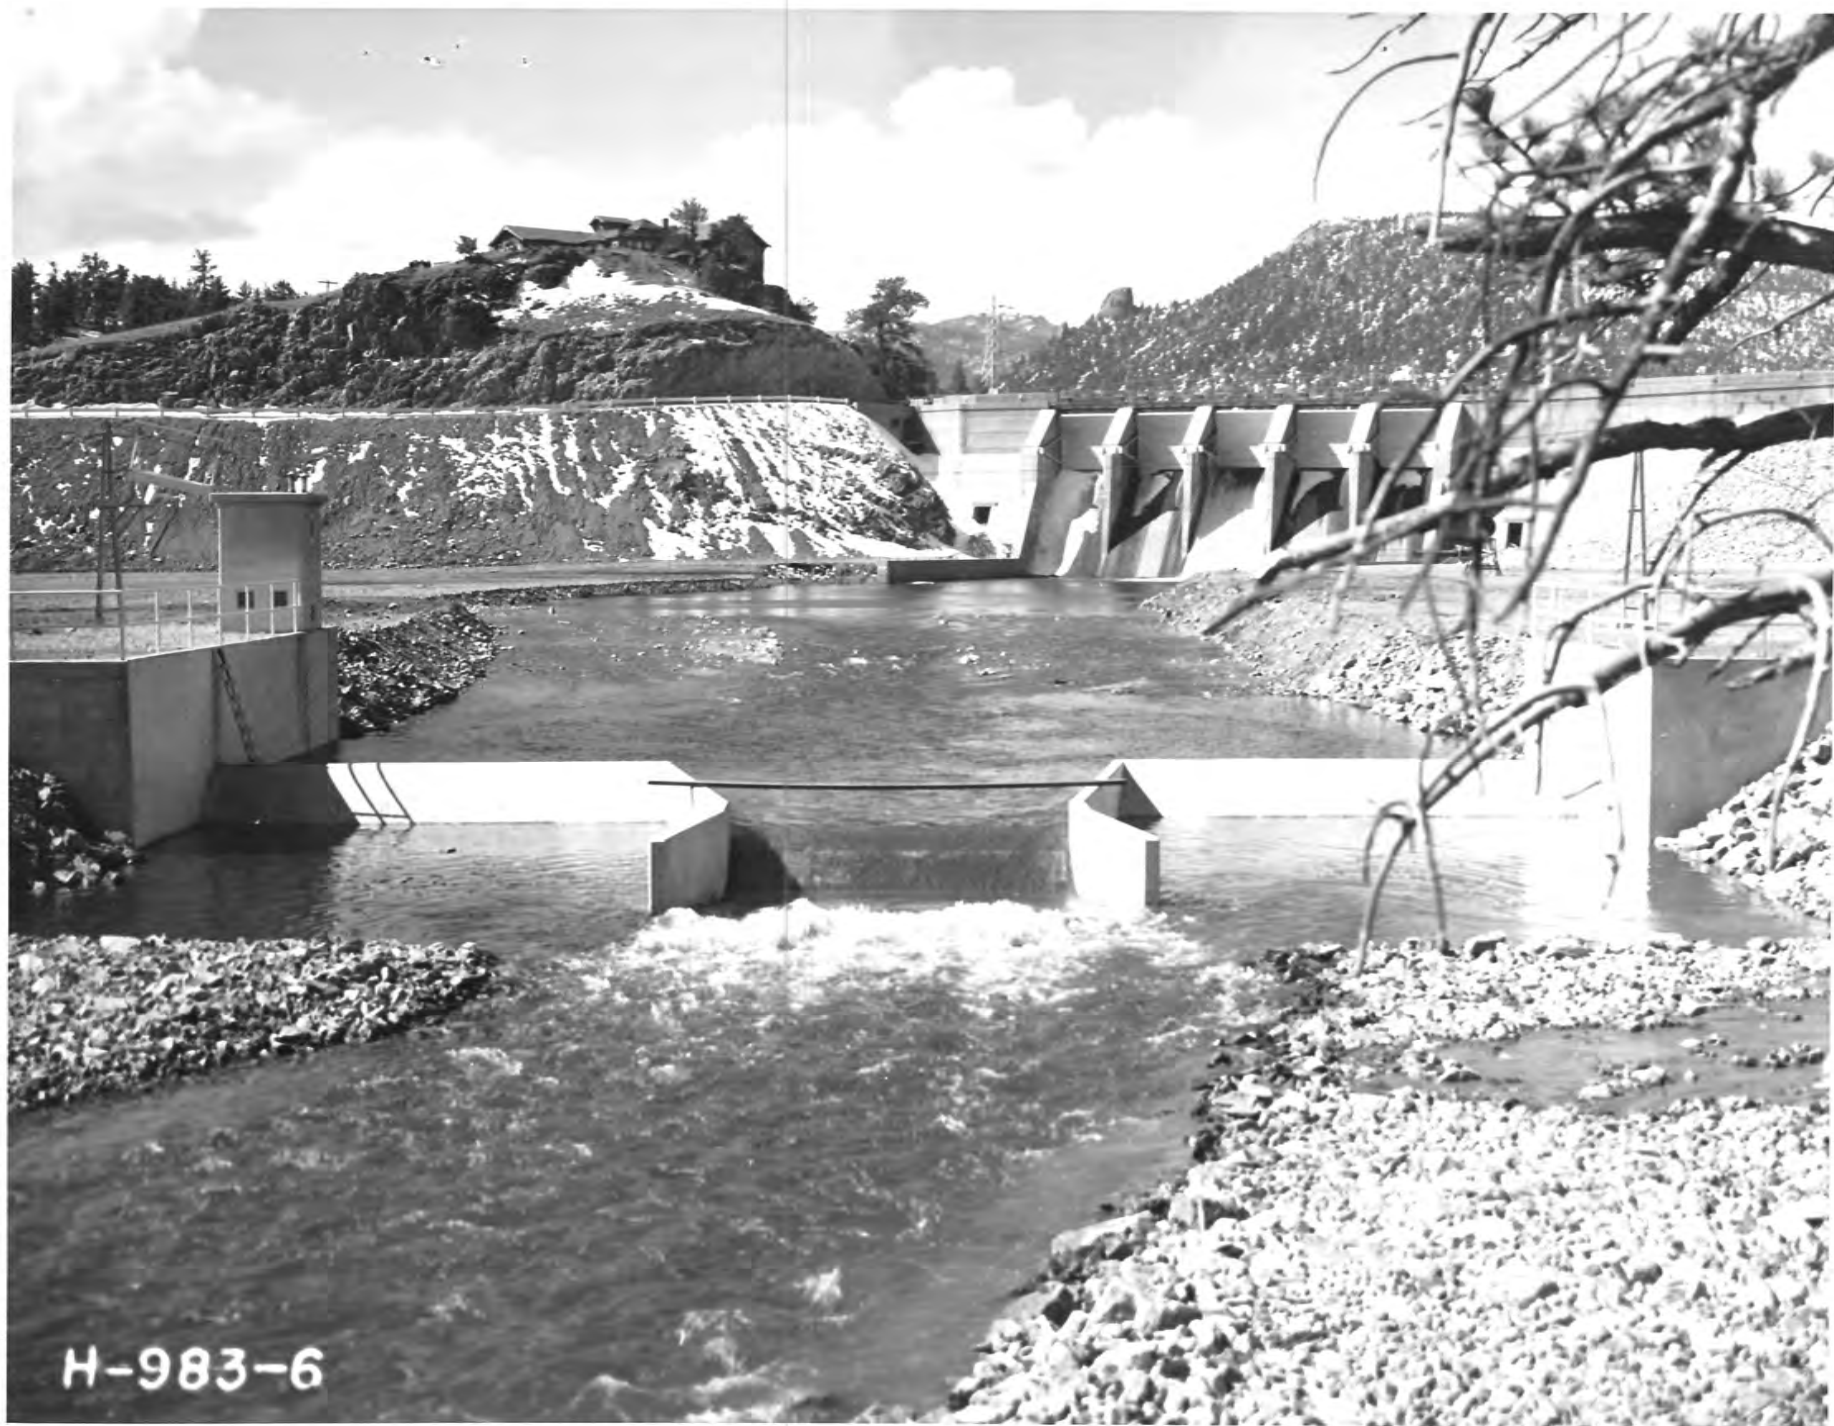
H-983-6

4. The next stop was at the Parshall measuring flume below Olympus Dam. A concrete structure has been built in the bed of the Thompson River at this location. Normal releases from the dam will be measured through a 15-foot throat Parshall flume. The flume is flanked on each side by an ogee crest approximately 20 feet long joined to vertical abutments that extend above the crest some 10 feet. The structure is in excellent condition, and it appears that a good accurate measurement will be obtained of the releases from Estes Lake

through Olympus Dam. A shelter house and, presumably, a recorder inside is installed on the right bank of the river. A cable-type rating station has been installed upstream from the ogee structure. There may be some difficulty in obtaining a continuous rating curve for this structure because there may be a break at the transition point where the Parshall flume will no longer carry the discharge, and the flow over the ogee is of shallow depth. It is possible that the rating for the Parshall flume, which is built with a moderate depth (it appeared to be about 2 feet to 30 inches deep), can be projected through this transition by obtaining a current meter rating of the ogee crest. The curve may have a definite break in it, but it may be possible to connect the two portions of the curve, the one from the Parshall and the one from the ogee, so that a reasonable degree of accuracy may be obtained even through this transition section. A photograph of this installation is enclosed.

H-983-6. The 15-foot Parshall flume and measuring control below Olympus Dam--Taken from the bed of Devils Gulch. Flow from Devils Gulch entering from right of picture downstream from Parshall flume.

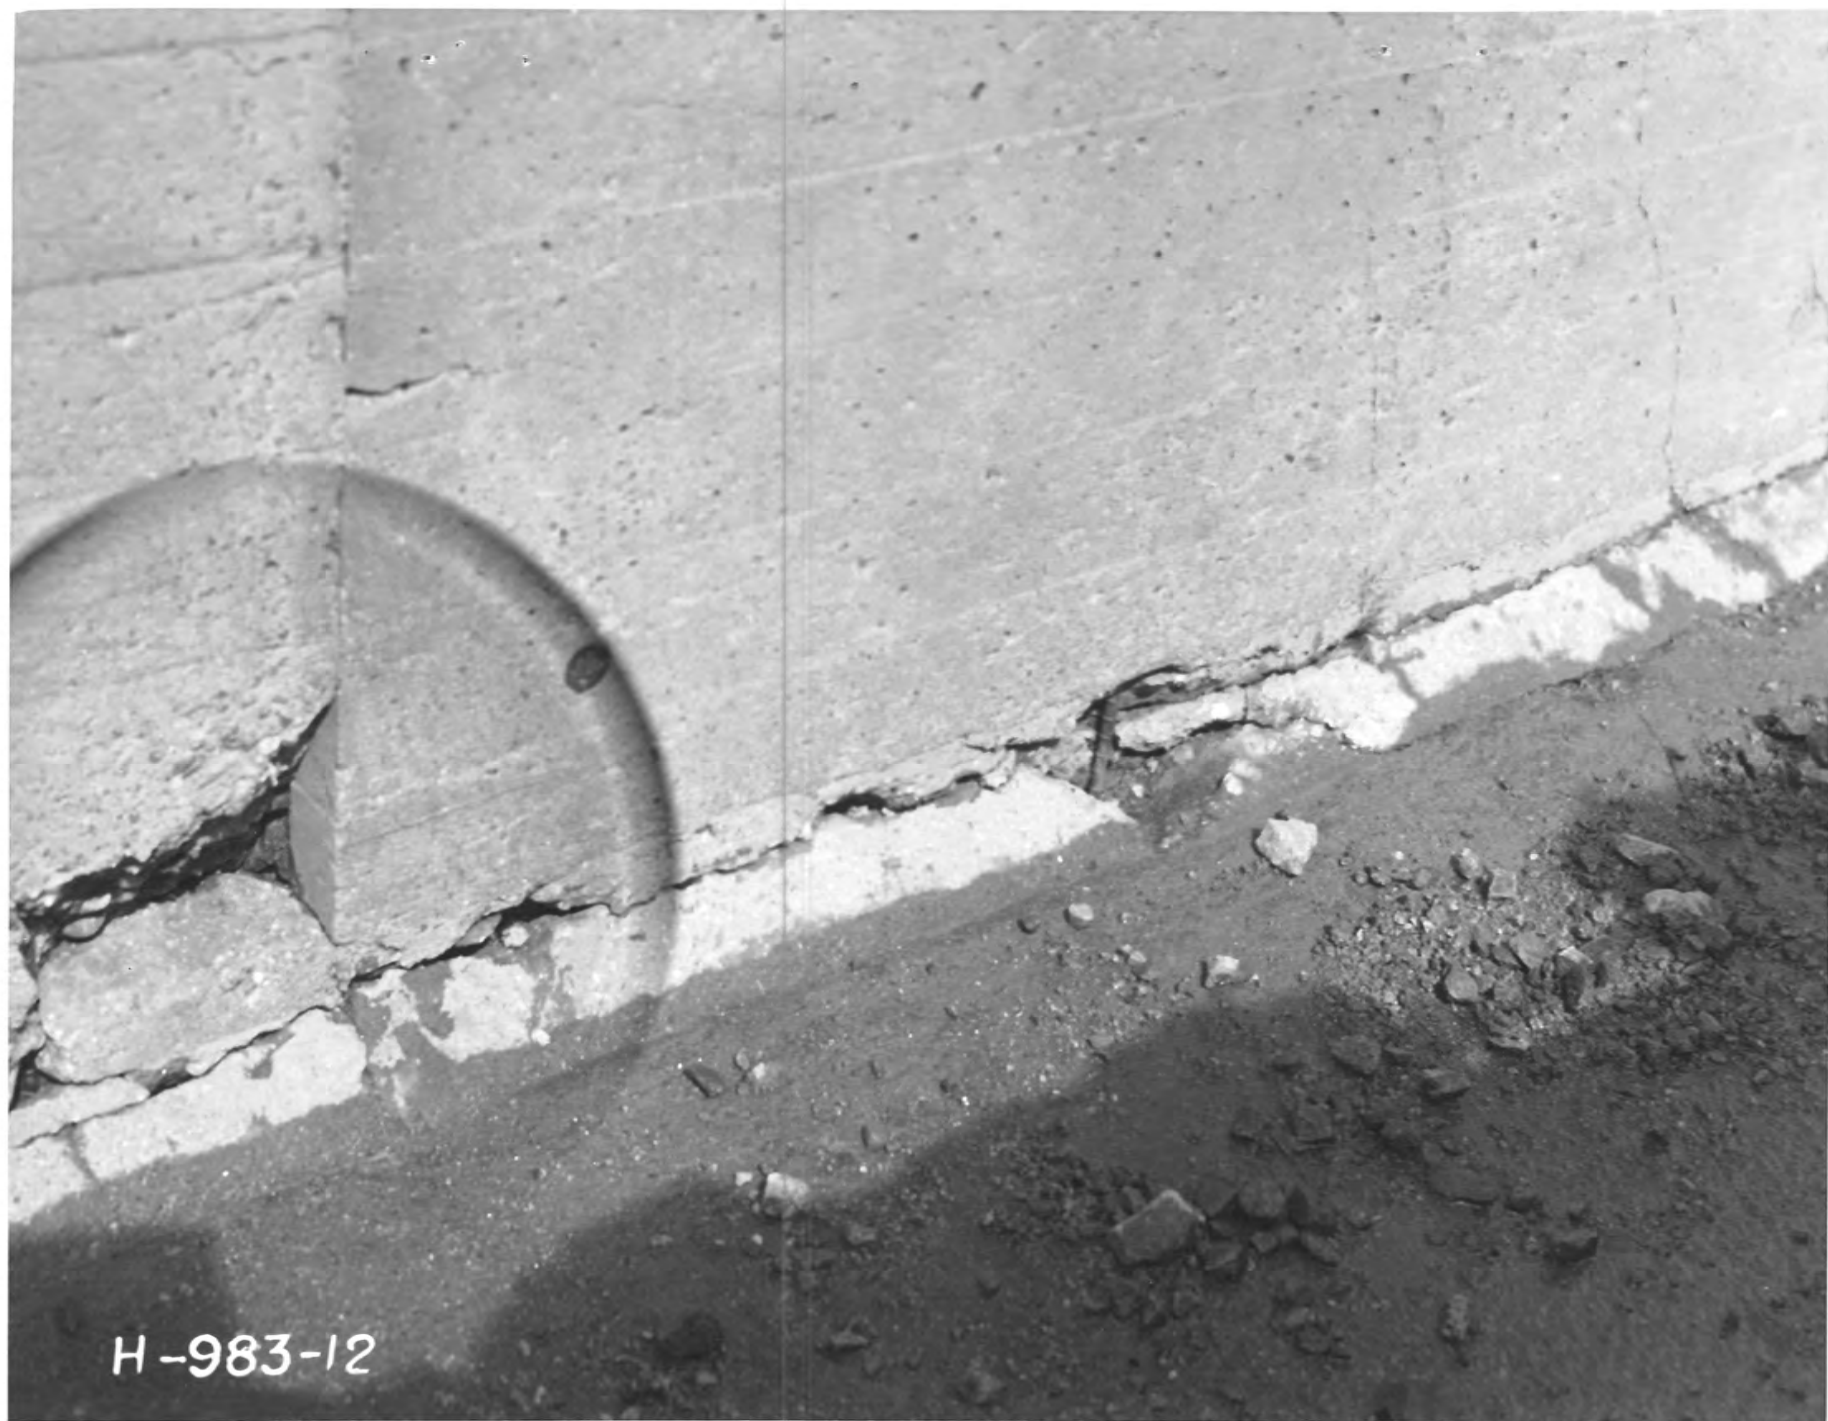
H-983-12

7. This chute was originally built of reinforced concrete in the form of a 6- by 6-foot tube. The cover had been blown off from the high watermark of the reservoir down to the level portion

of the outlet, about 13 feet of the horizontal section remained. Pictures were taken of the shattered concrete and the condition of the chute. It was interesting to note that the entire structure was badly shattered as if subjected to tremendous forces. A longitudinal crack extends along the bottom of the chute. Another crack exists where the walls have been loosened from the bottom slab. No measurements were made of the length of the slab that had been removed, but a complete report is being prepared by the project regarding the extent of the damage and proposed repairs. I worked my way up the chute to enter the covered portion. Just above the high water line of the reservoir, where the cover remains on the chute, the concrete appears to be in good condition. There is one longitudinal crack running up the bottom of the chute, but the sides and top appear, from a very cursory examination without a light, to be in fair condition. There were some peculiar markings on both sides of the chute just above the high watermark. They appeared to slope downward and fan out from a point near the bottom and may be stress cracks. A picture showing this pattern, together with other views of the damage, is enclosed.

16. While viewing this phenomenon the reason for the failure of the structure could be visualized. When the siphon was discharging the water was swept away from the exit of the chute. During the interium period that was necessary for the forebay to fill, the water in the lake rushed toward the structure. Since this time was approximately double the time that the flow was discharging, an

appreciable reverse velocity could be acquired. When the cover was on the chute and the lake at normal level, the 36 square feet of exit area was under a static pressure of more than 56,000 pounds. If a reverse velocity prevailed, the momentum would increase as the square of this velocity. Although no calculations have been made the collision between the next slug of water down the chute and this reverse flow would certainly produce tremendous pressures and resultant stresses in the structure if the two flows were opposed.

H-983-12. Bypass chute at Marys Lake Power Plant showing shattered concrete at junction of left wall and bottom in curved portion of chute.

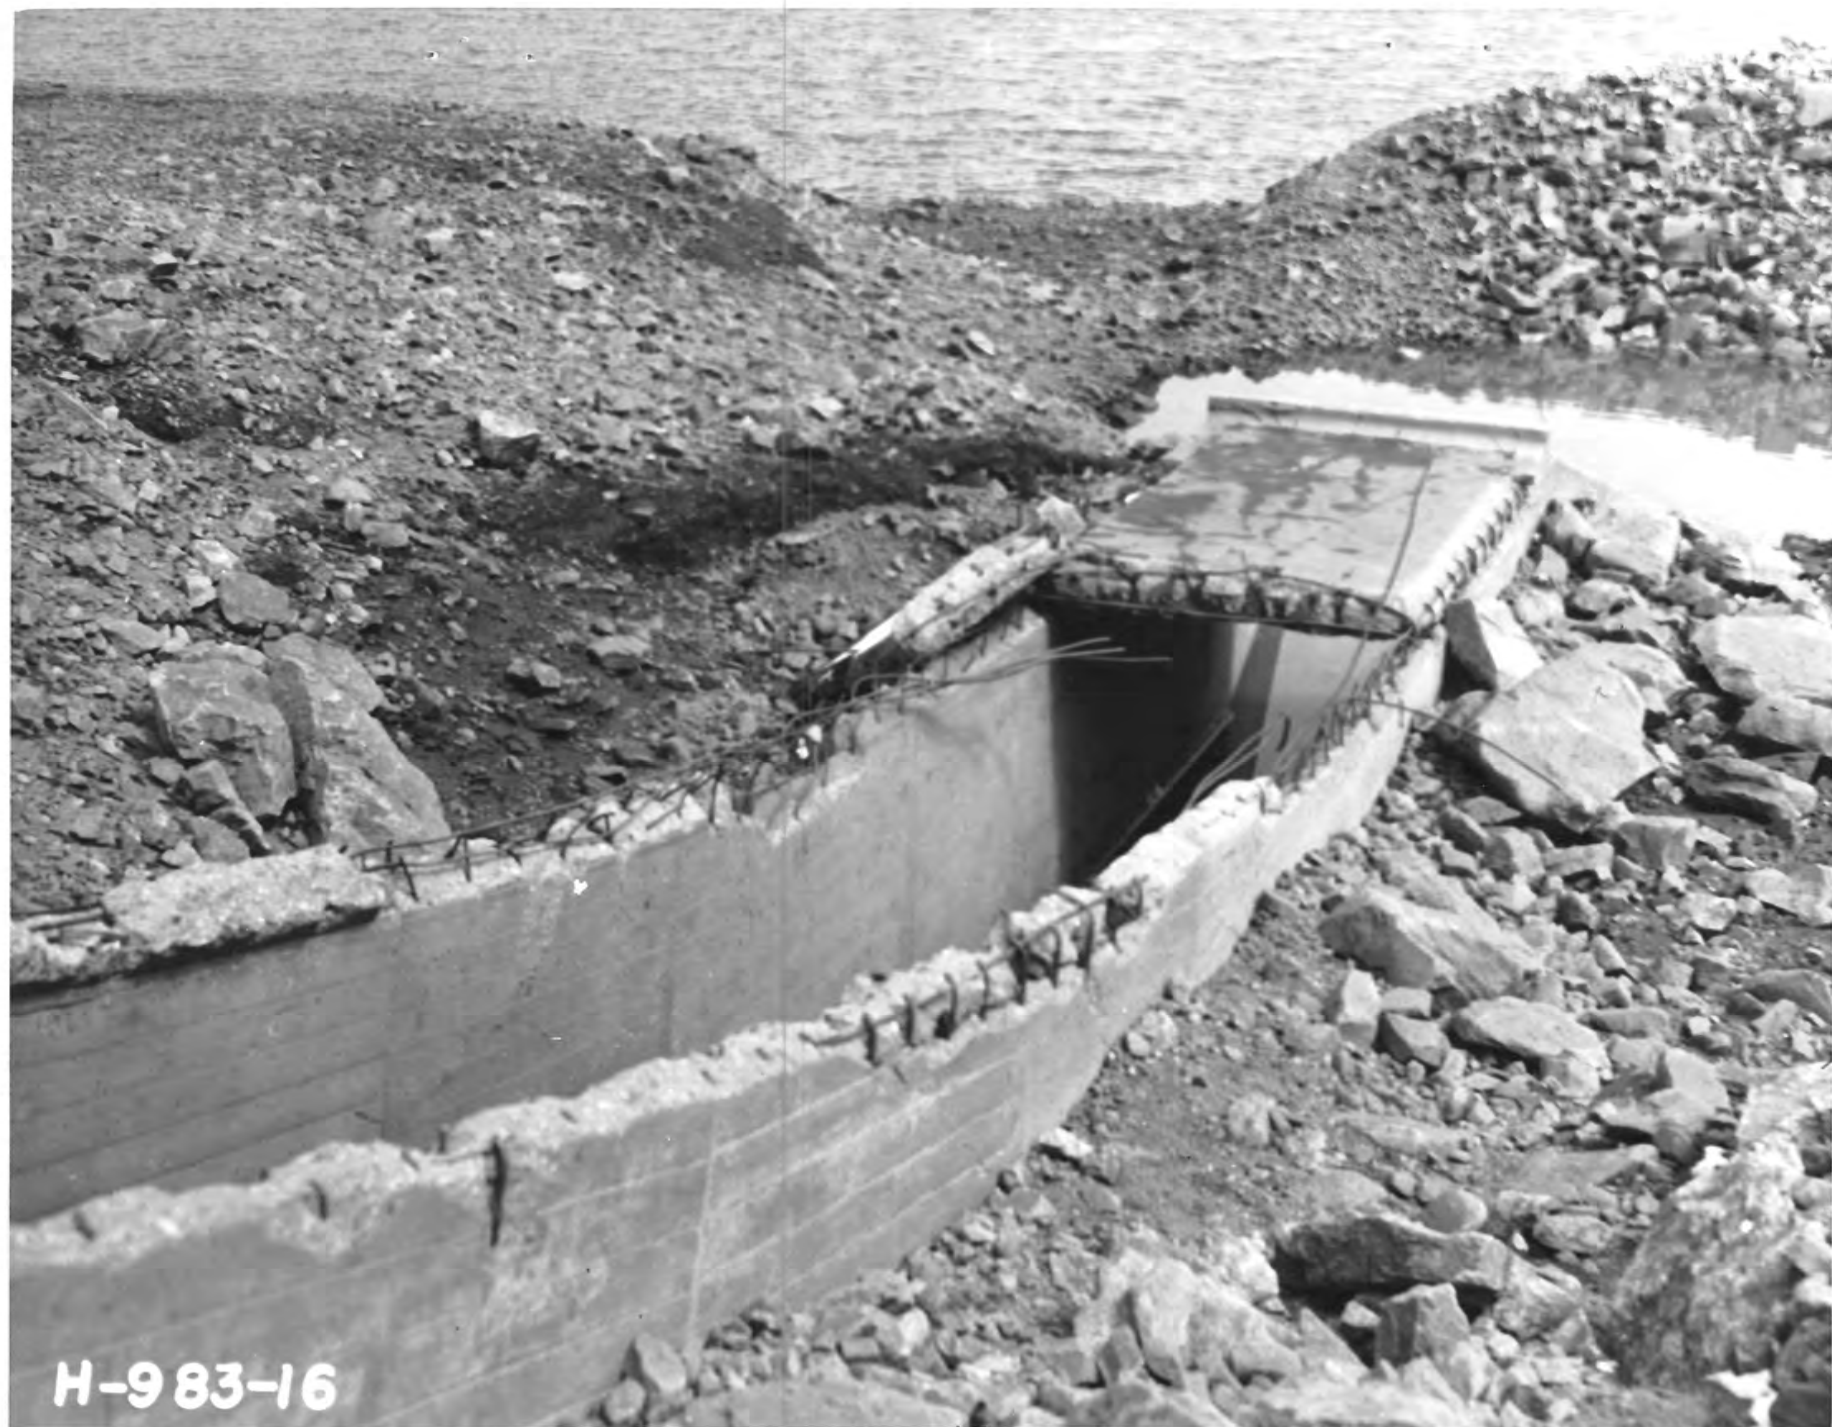
H-983-16

H-983-16. Bypass chute at Marys Lake Power Plant--Looking downstream at damaged structure from right side--Showing 13 feet of cover remaining.

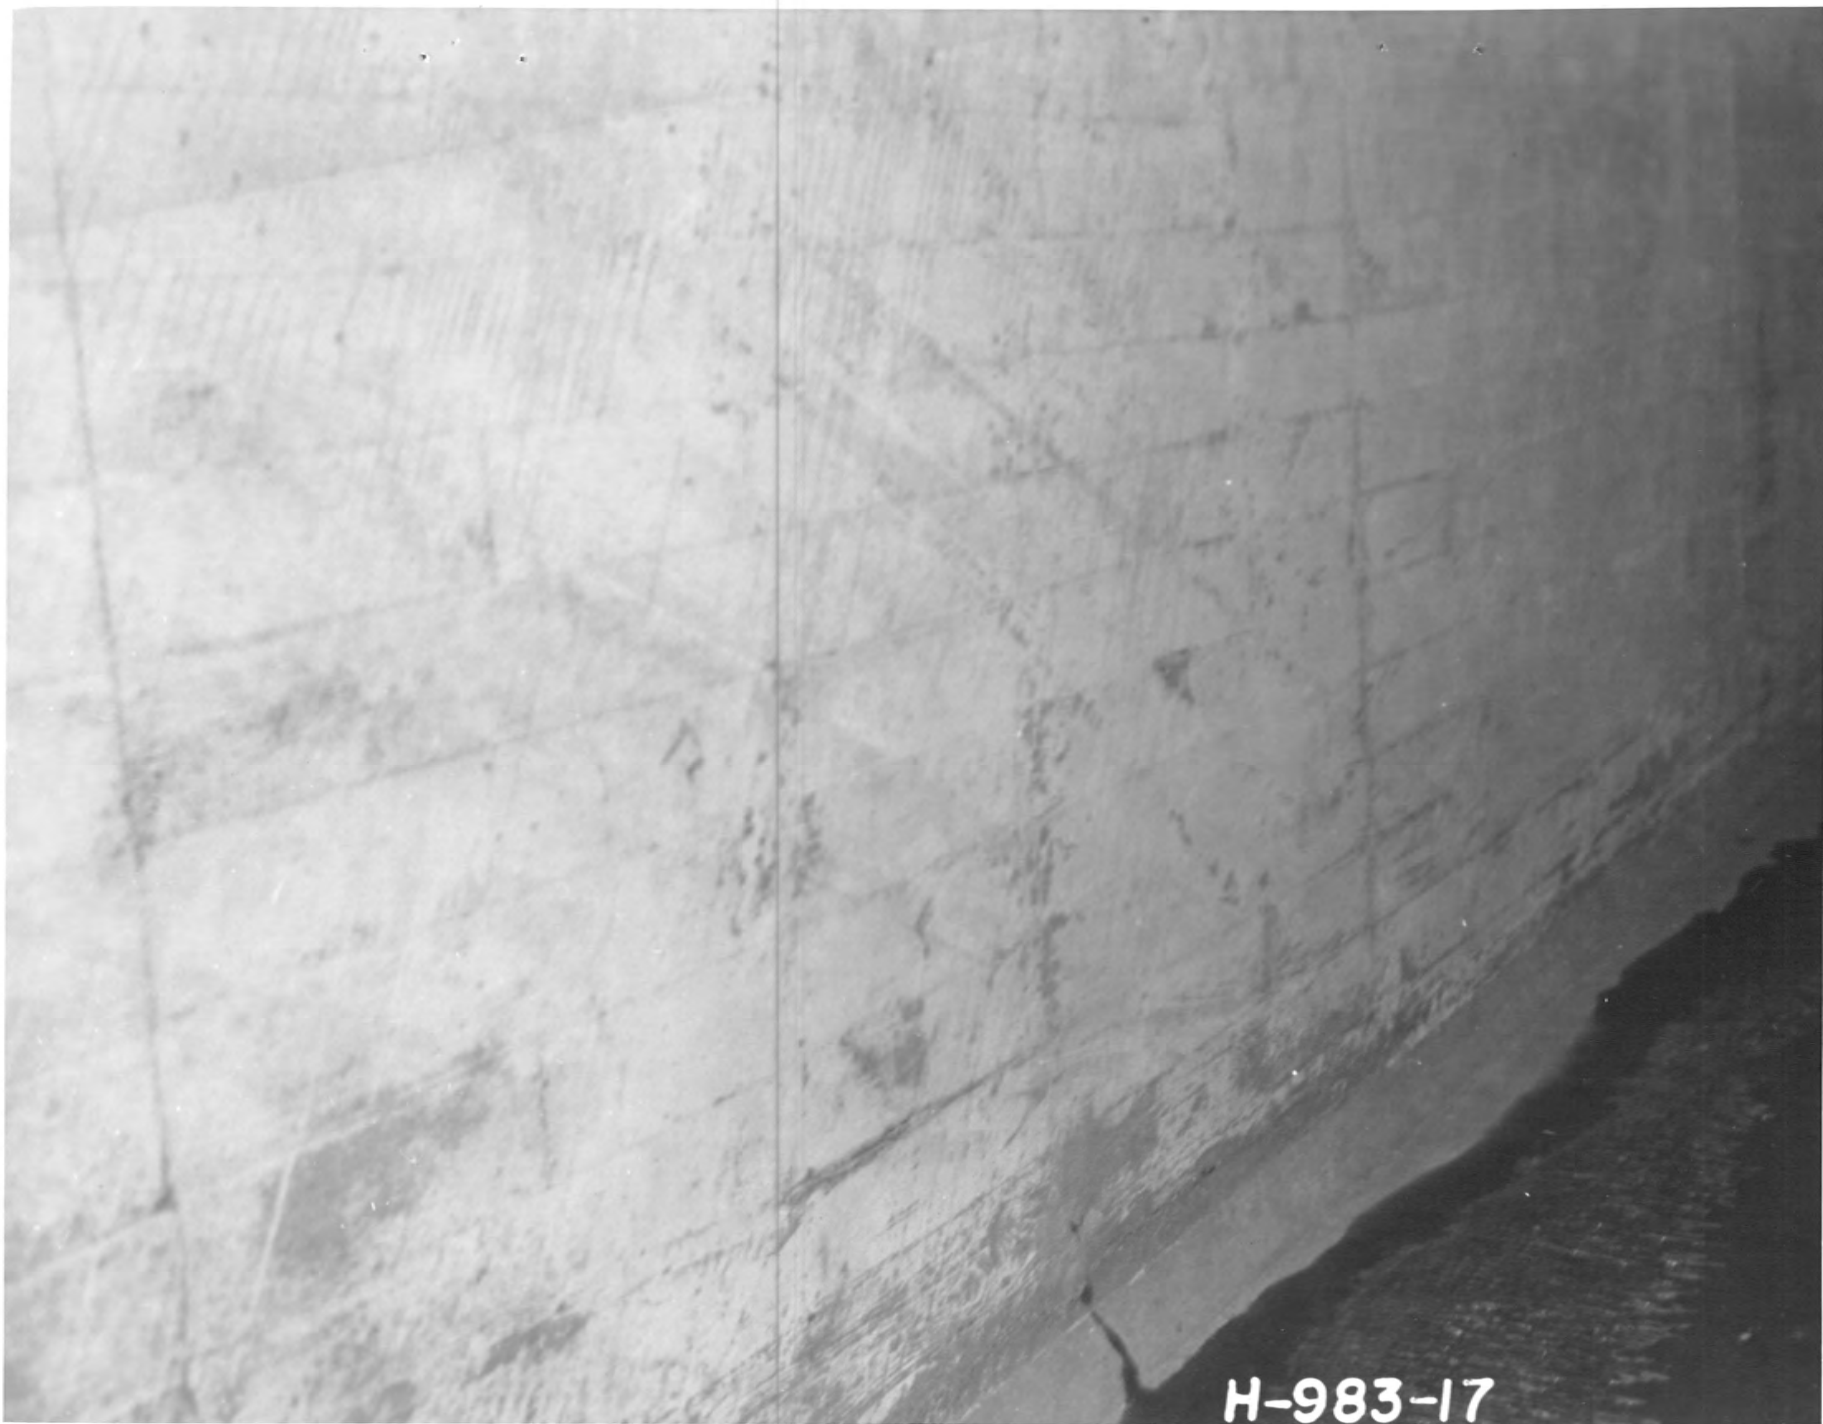
H-983-17

H-983-17. Pattern on right wall of chute near high water surface elevation of the lake.

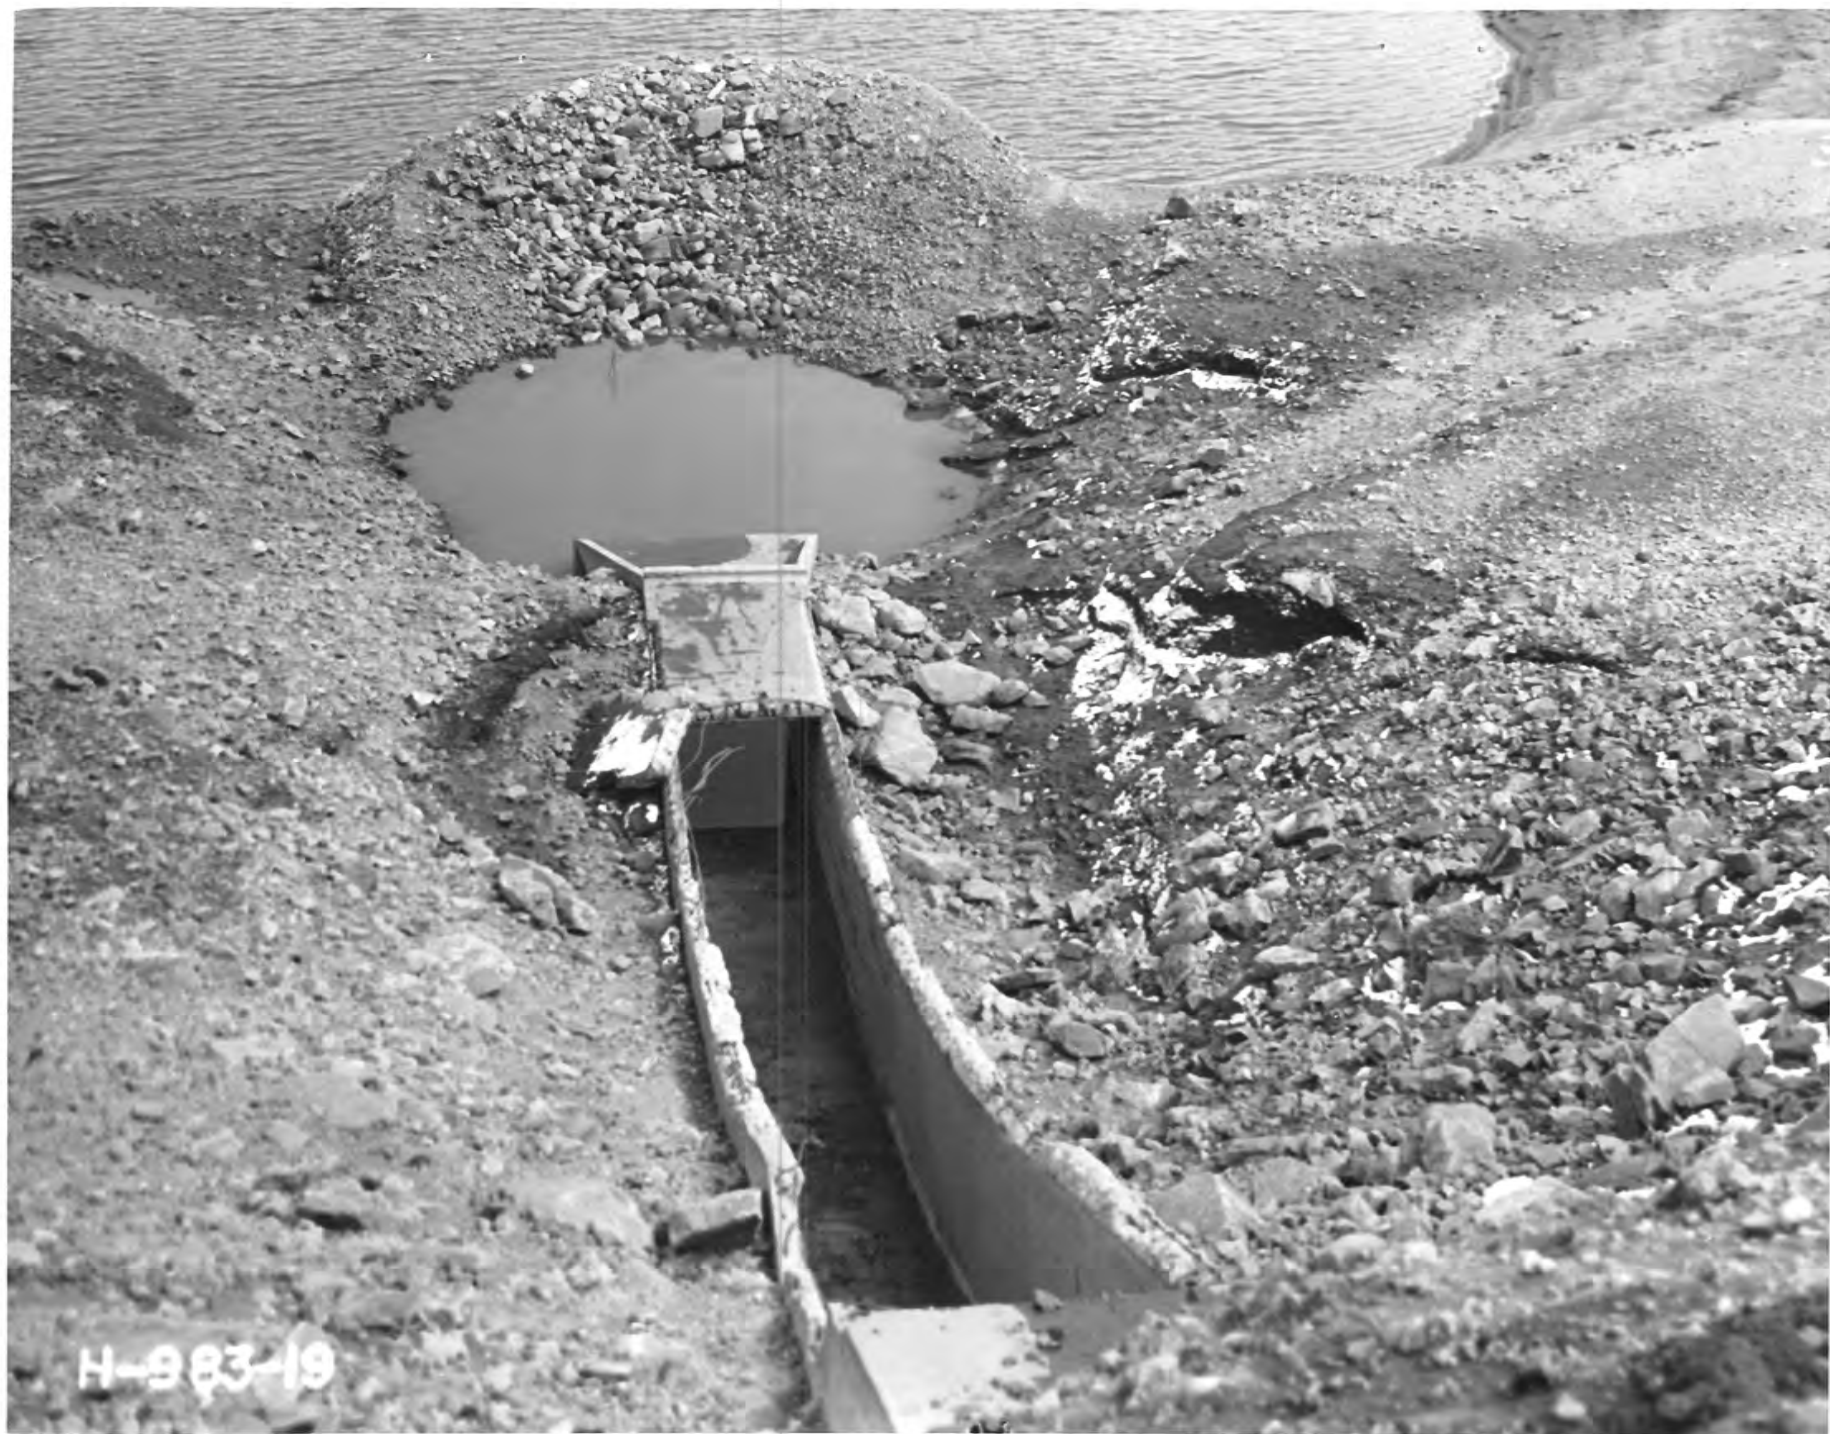
H-983-19. Looking down at the breakage in the chute from left side.

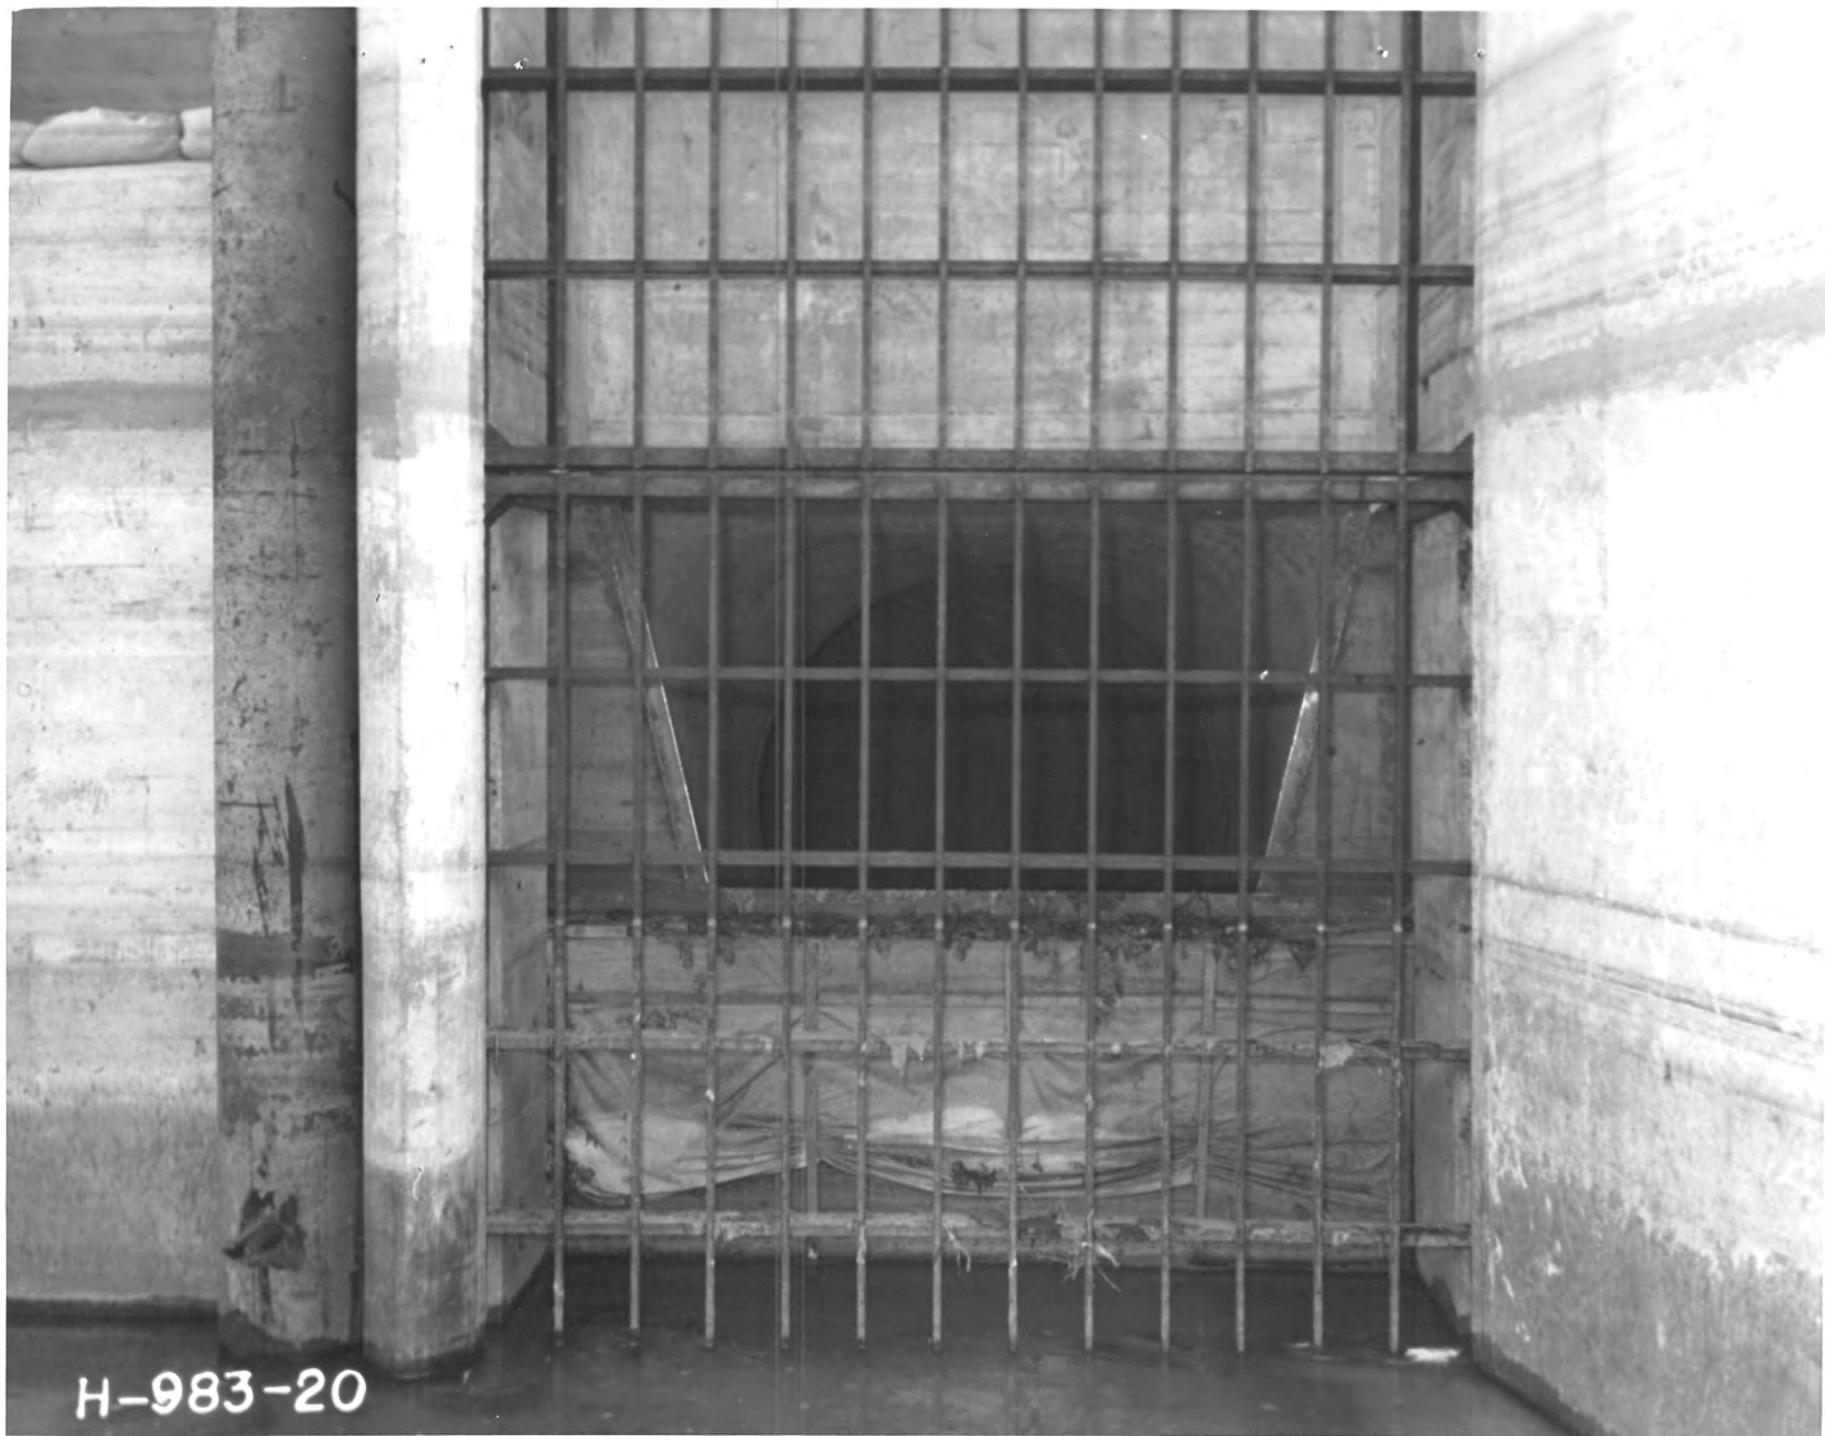
H-983-20

8. From Marys Lake, I drove to the East Portal of Adams Tunnel and made an inspection of the weir in the stop-log slot at the entrance to Aspen Creek siphon. This is a trapezoidal weir with a 7-foot crest length and a height of 5 feet. The side slopes are  $1\frac{1}{4}:1$  as prescribed for a Cipolletti weir. The blade is made of  $1\frac{1}{8}$ -inch steel, has been welded and dressed down, and appeared to be in good shape. The most serious defect in this weir is that it has been placed at the downstream edge of the stop-log slot, and the stop logs extend upstream from the weir a distance of approximately 8 inches. Heavy timbers were used for the bulkhead, and the crest of the weir was placed approximately 6 feet above the bottom of the structure and 6 inches above the top of the stop logs. Canvas had been placed over the bulkhead to assist in making it watertight. It was not possible to get to the weir through the trashrack to check the level or make a close examination of the blade. All inspection was made through the trashrack from a point approximately 4 feet upstream from the weir blade. A hand level was used to sight on the weir crest and, apparently, it was level. The weir blade was probably plumb because it was wedged against the downstream side of the stop-log slot. These stop-log slots are usually carefully plumbed to avoid binding of the stop logs. Had it not been for the fact that the weir blade was placed on the downstream side of the stop logs, this installation looked fairly good; see attached photographs. A stilling-well

H-983-20. The 7-foot trapezoidal weir in the stoplog slots at the entrance to Aspen Creek Siphon. This weir is between the trash-racks and the transition entrance to the siphon proper. The gage well is shown just to the left of the pier that separates the siphon entrance from the spillway section.
