BUREAU OF RECLAMATION  
HYDRAULIC LABORATORY

Memorandum

April 3, 1951

Operating characteristics of some of the hydraulic structures on Colorado-Big Thompson Project east of the Continental Divide

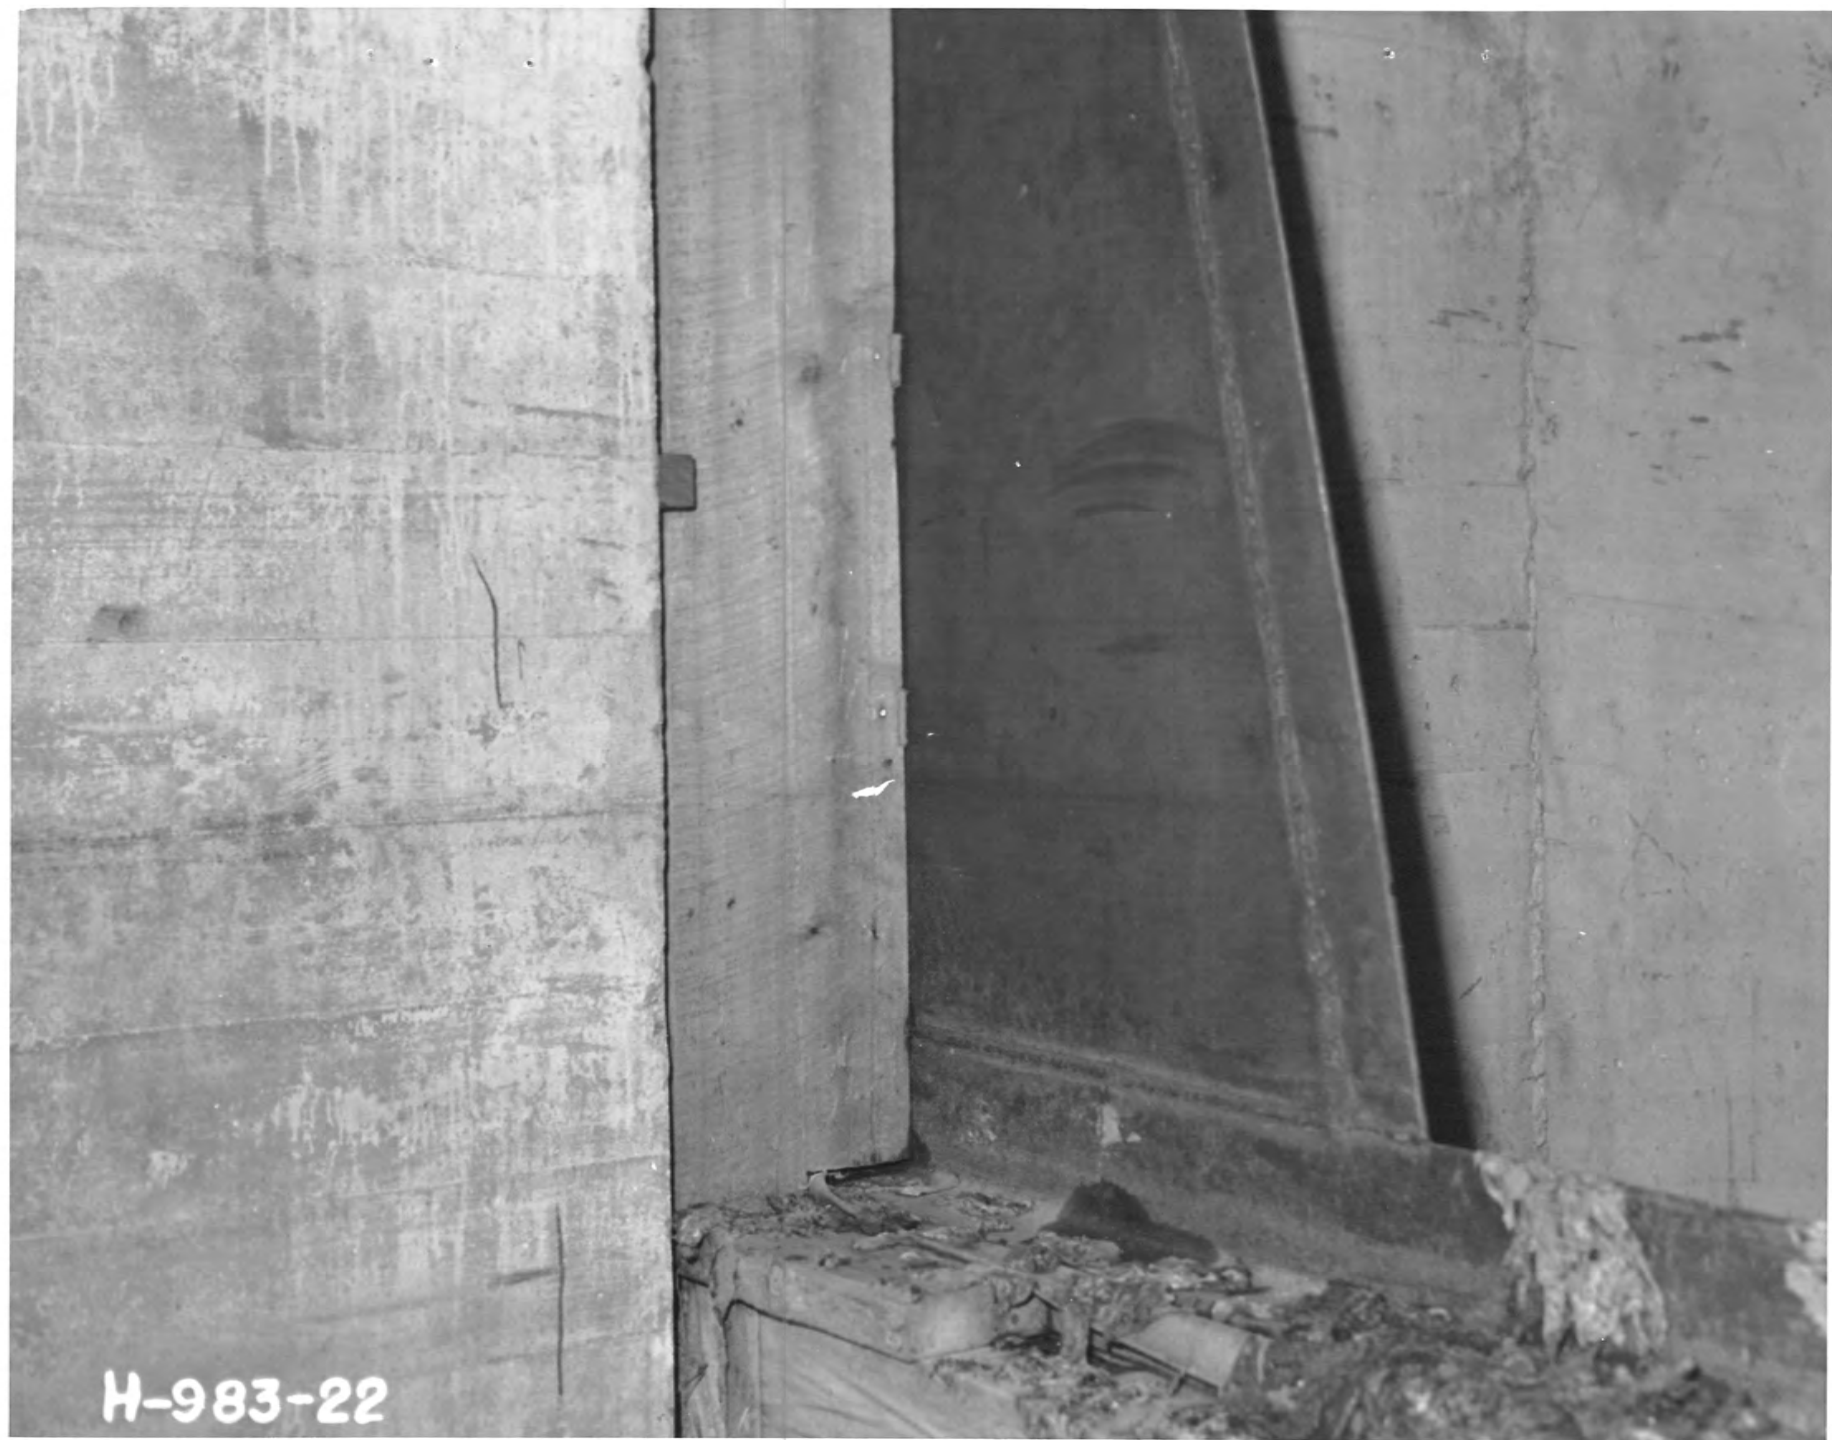
H-983-22

8. From Marys Lake, I drove to the East Portal of Adams Tunnel and made an inspection of the weir in the stop-log slot at the entrance to Aspen Creek siphon. This is a trapezoidal weir with a 7-foot crest length and a height of 5 feet. The side slopes are  $1\frac{1}{4}:1$  as prescribed for a Cipolletti weir. The blade is made of  $1\frac{1}{8}$ -inch steel, has been welded and dressed down, and appeared to be in good shape. The most serious defect in this weir is that it has been placed at the downstream edge of the stop-log slot, and the stop logs extend upstream from the weir a distance of approximately 8 inches. Heavy timbers were used for the bulkhead, and the crest of the weir was placed approximately 6 feet above the bottom of the structure and 6 inches above the top of the stop logs. Canvas had been placed over the bulkhead to assist in making it watertight. It was not possible to get to the weir through the trashrack to check the level or make a close examination of the blade. All inspection was made through the trashrack from a point approximately 4 feet upstream from the weir blade. A hand level was used to sight on the weir crest and, apparently, it was level. The weir blade was probably plumb because it was wedged against the downstream side of the stop-log slot. These stop-log slots are usually carefully plumbed to avoid binding of the stop logs. Had it not been for the fact that the weir blade was placed on the downstream side of the stop logs, this installation looked fairly good; see attached photographs. A stilling-well

H-983-22. A close-up of the left edge of the weir showing the 8-inch stoplogs projecting upstream from the weir blade.

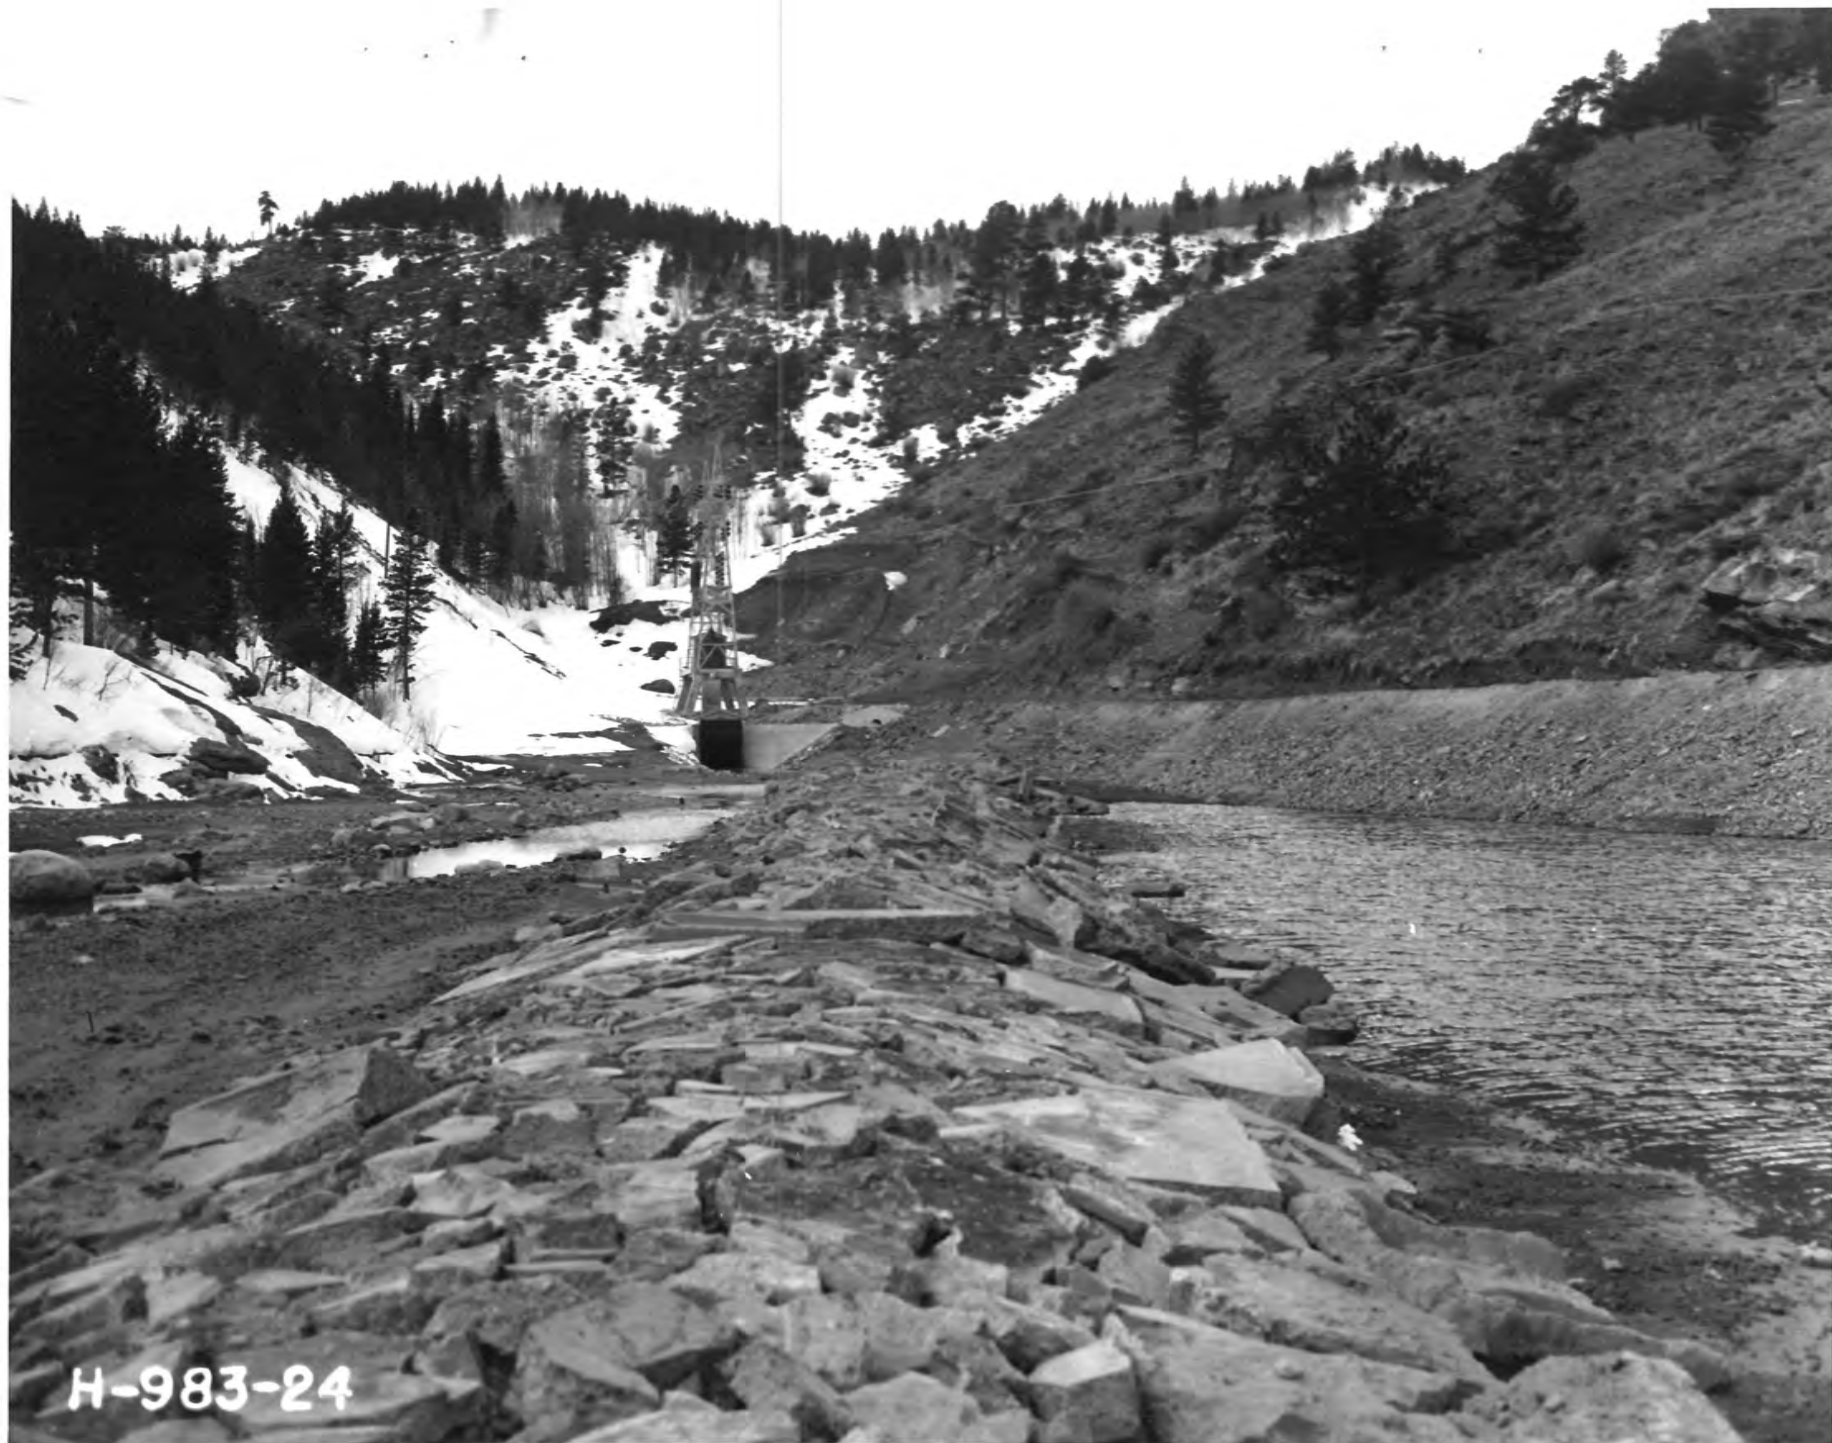
H-983-24

10. The 30-inch concrete conduit to carry the natural flow of Wind River through East Portal Reservoir is well protected as shown in the enclosed photograph.

H-983-24. The east portal of Adams Tunnel--Looking across the reservoir between the tunnel portal and the entrance to Aspen Creek Siphon. Protective cover over 30-inch reinforced concrete tube to pass natural flow of Wind River through the reservoir extends through center of photograph.

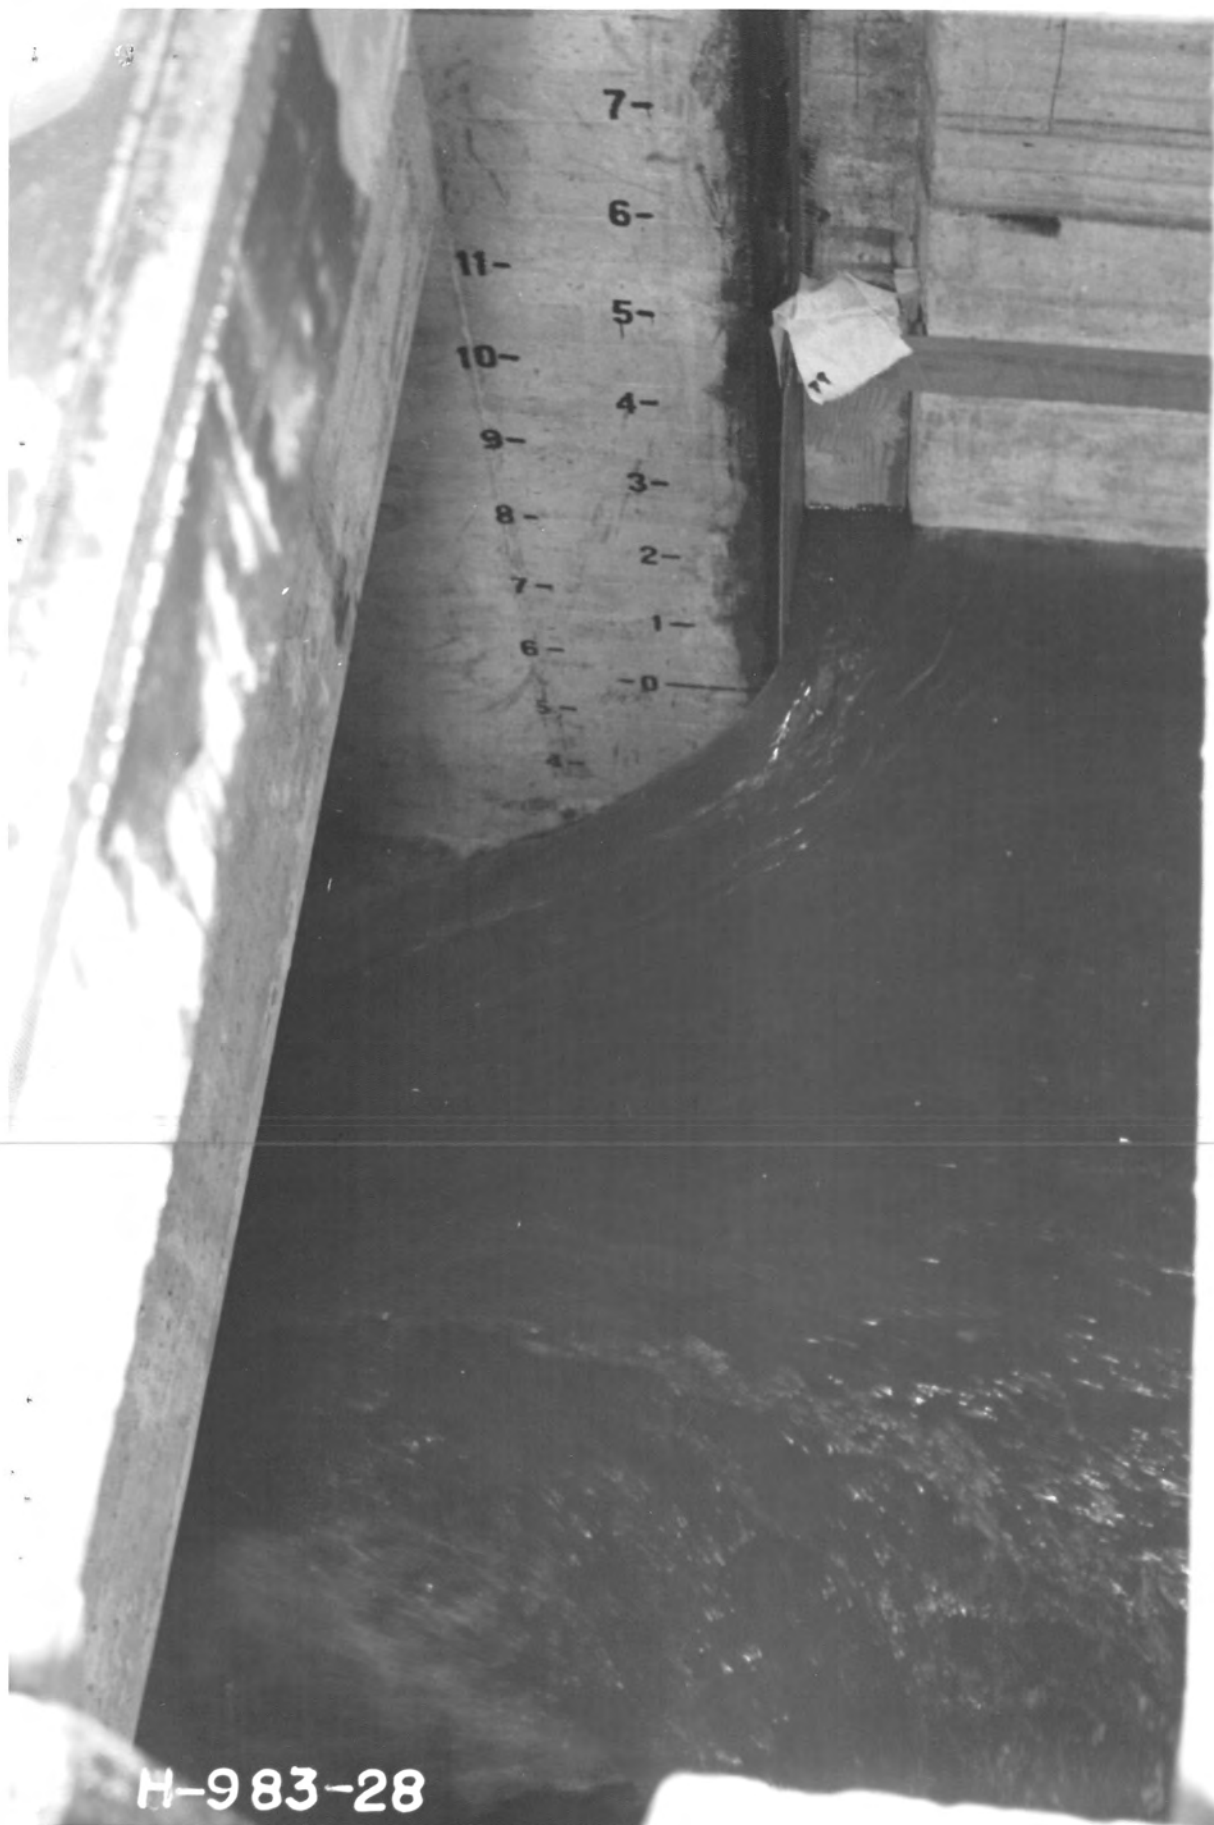
H-983-28

11. The water arrived at East Portal of the Adams Tunnel about 1:30 p.m., and within an hour the pool had been filled and the flow stabilized so that flow conditions on the weir could be observed. The approach conditions are not good. The water approached the combination spillway and entrance to Aspen Creek siphon structure and flows around the center pier into the siphon entrance where the weir is located. The flow around this pier causes a whirl which is carried through the trashrack and through the weir, causing very unstable conditions on the left side. This turbulence affected approximately half the length of the weir. The turbulence in the water may be seen in the lower portion of the enclosed photograph. At 2:45 p.m., the flow was apparently stable, and there was a 3.94-foot head on the weir. According to the discharge table for the weir, this head would correspond to a flow of 208 cfs. The A-35 recorder was set, and the paper started on the chart.

H-983-28. Flow conditions on the weir with approximately 3 feet of head on the weir crest.

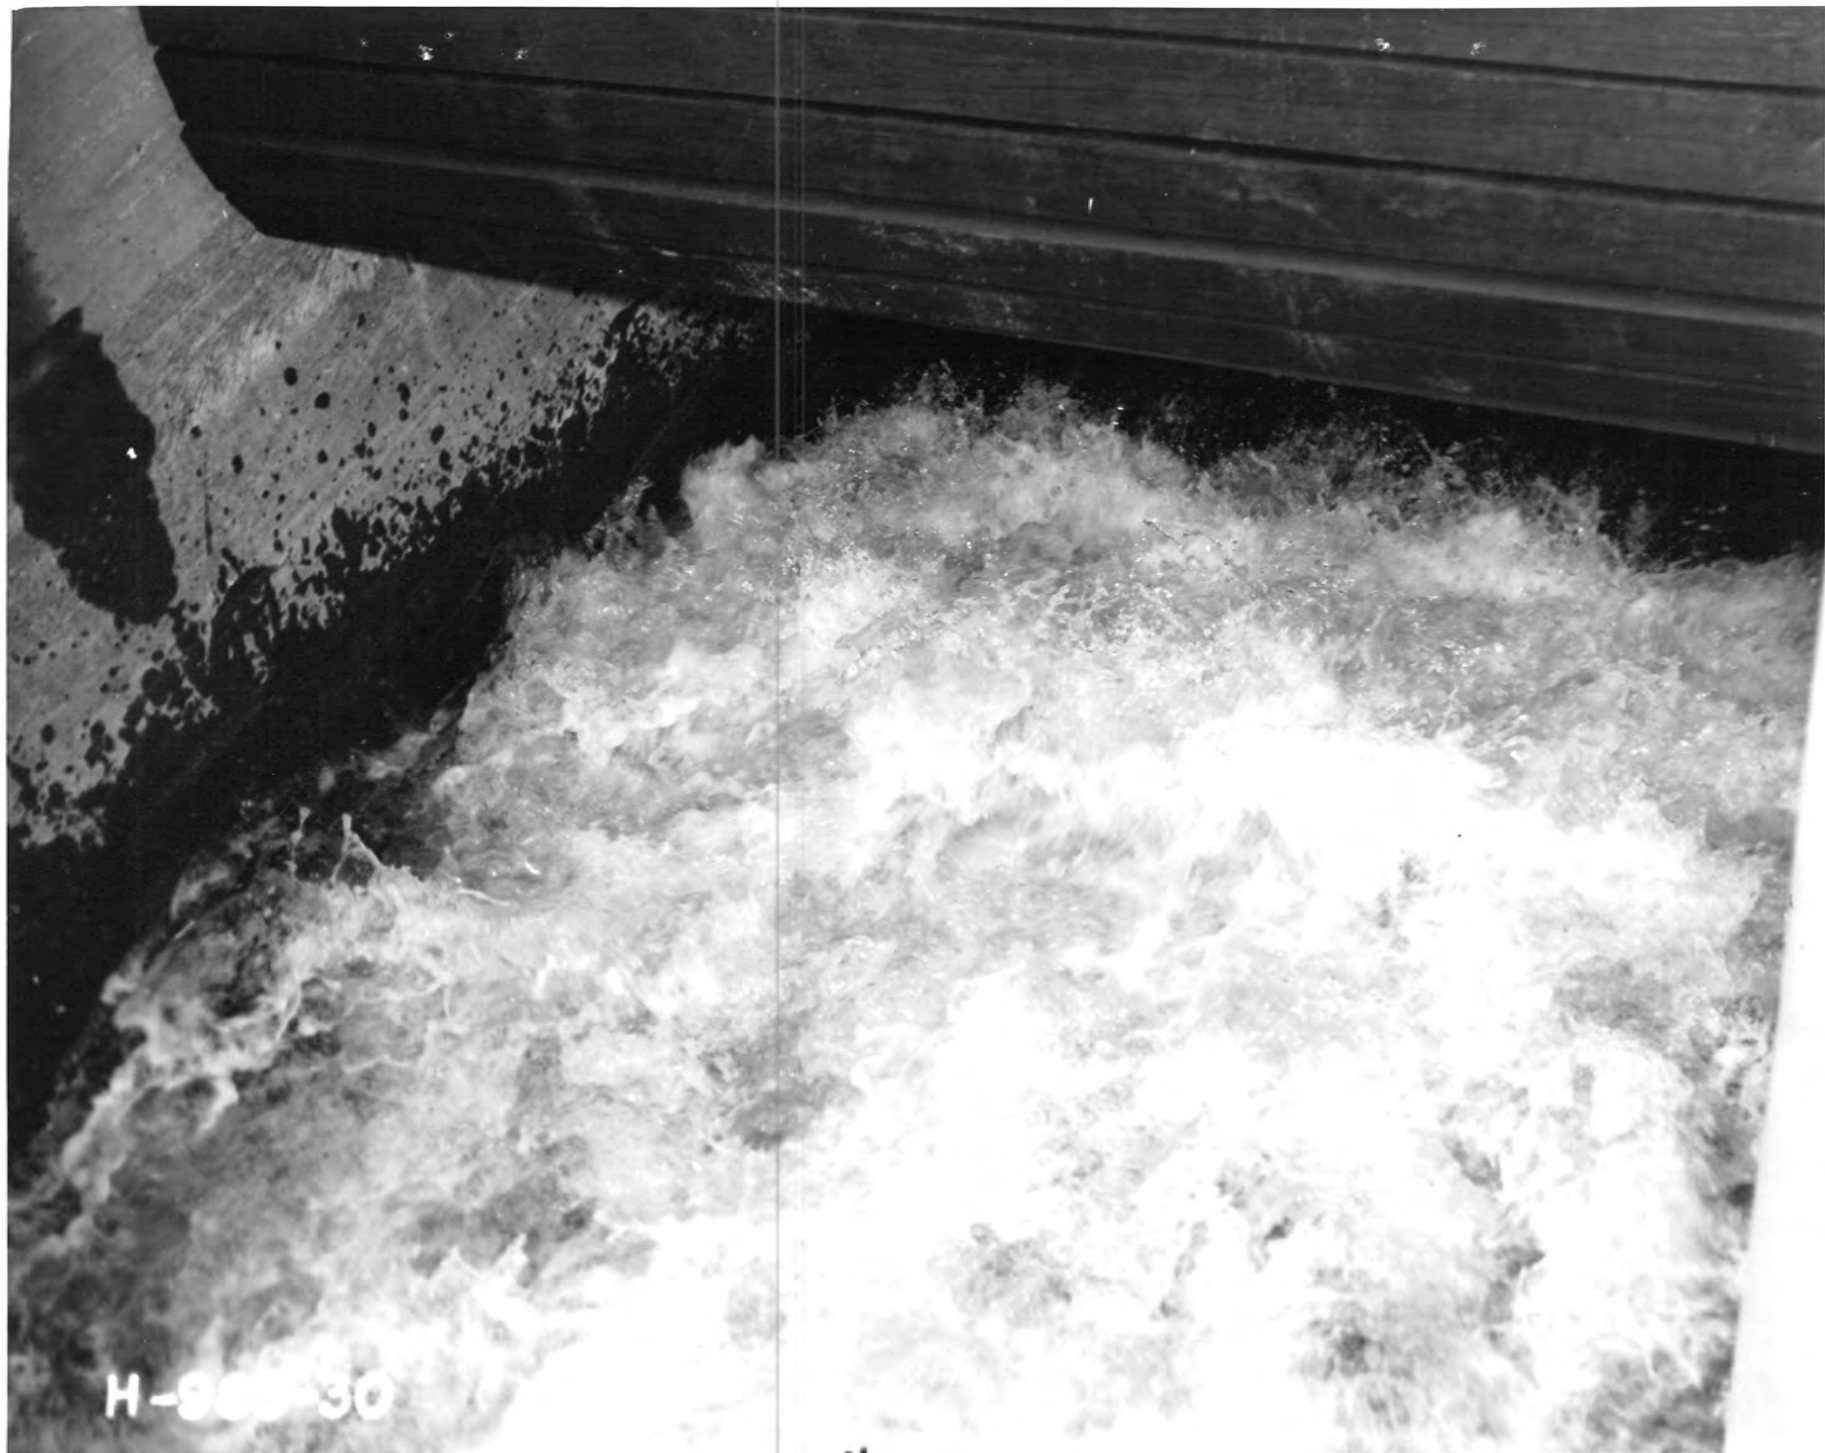
H-900-30

12. The flow from the tunnel into the small reservoir at the East Portal is satisfactory. The water emerges from the tunnel below critical depth and a hydraulic jump forms just at the portal of the tunnel (enclosed photographs), and the water enters the lake very smoothly.

H-983-30. Flow conditions at the outlet end of Adams Tunnel--Discharge approximately 210 second feet, note that the hydraulic jump forms just at the protective curtain at the portal of the tunnel.

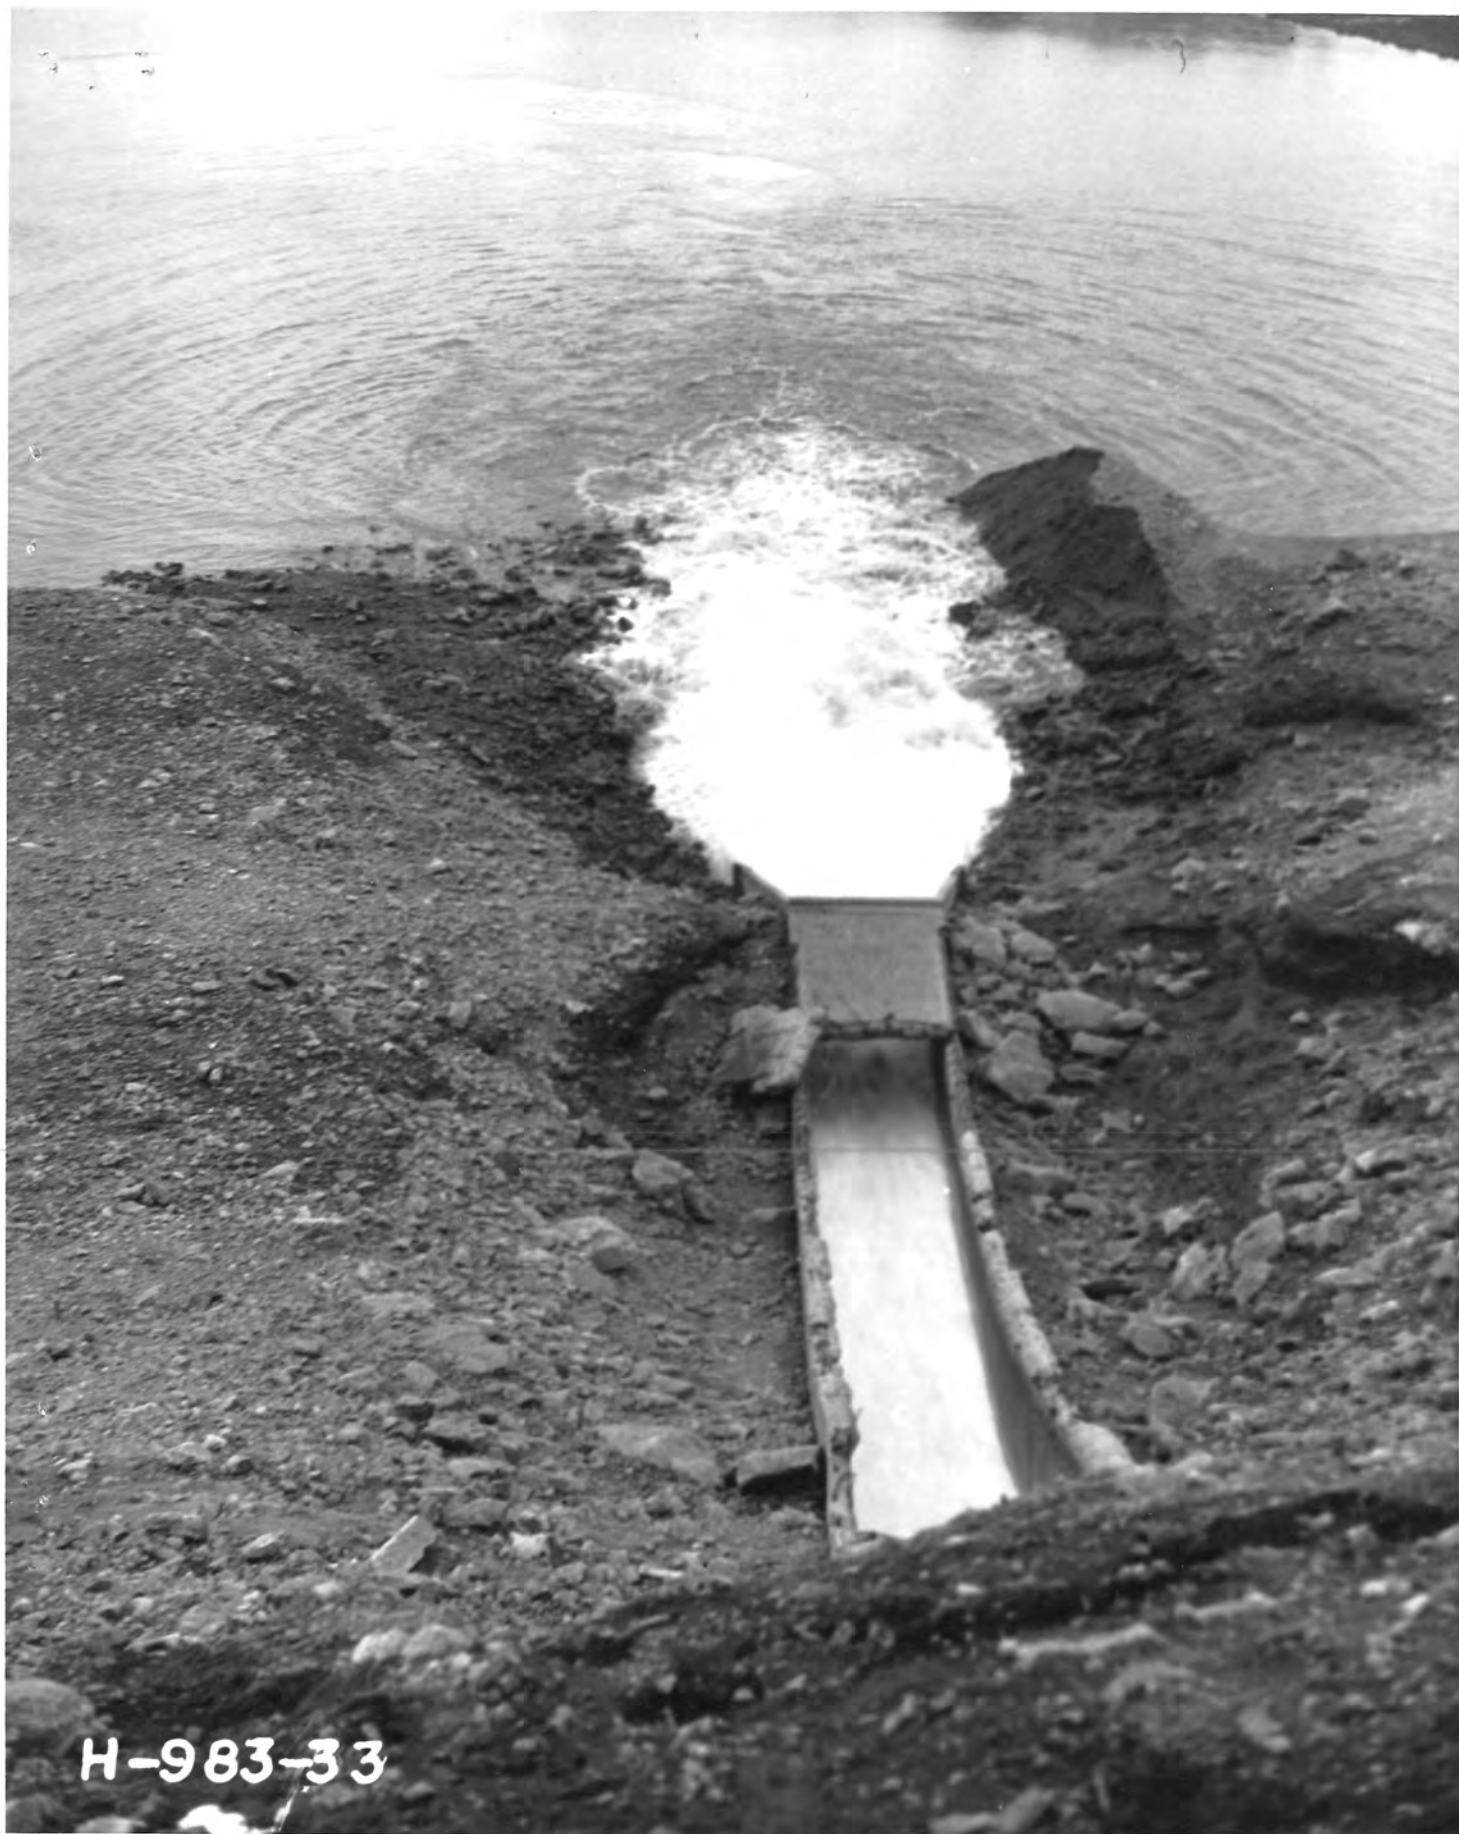
H-983-33

13. When I arrived at the chute at Marys Lake Power Plant, the flow apparently had leveled out, and a steady flow condition prevailed down the chute. No unusual conditions were observed in this flow. The velocity was quite high, since the chute is very steep. The spread of the sidewalls at the lower end of the chute was not effective and the major portion of the flow was following down the center of the chute, not spreading into the full area as intended. (See enclosed photographs.)

H-983-33. Flow conditions in the by-pass chute at Marys Lake Power Plant with a flow of approximately 210 second feet--Looking downstream from the hill above the chute.

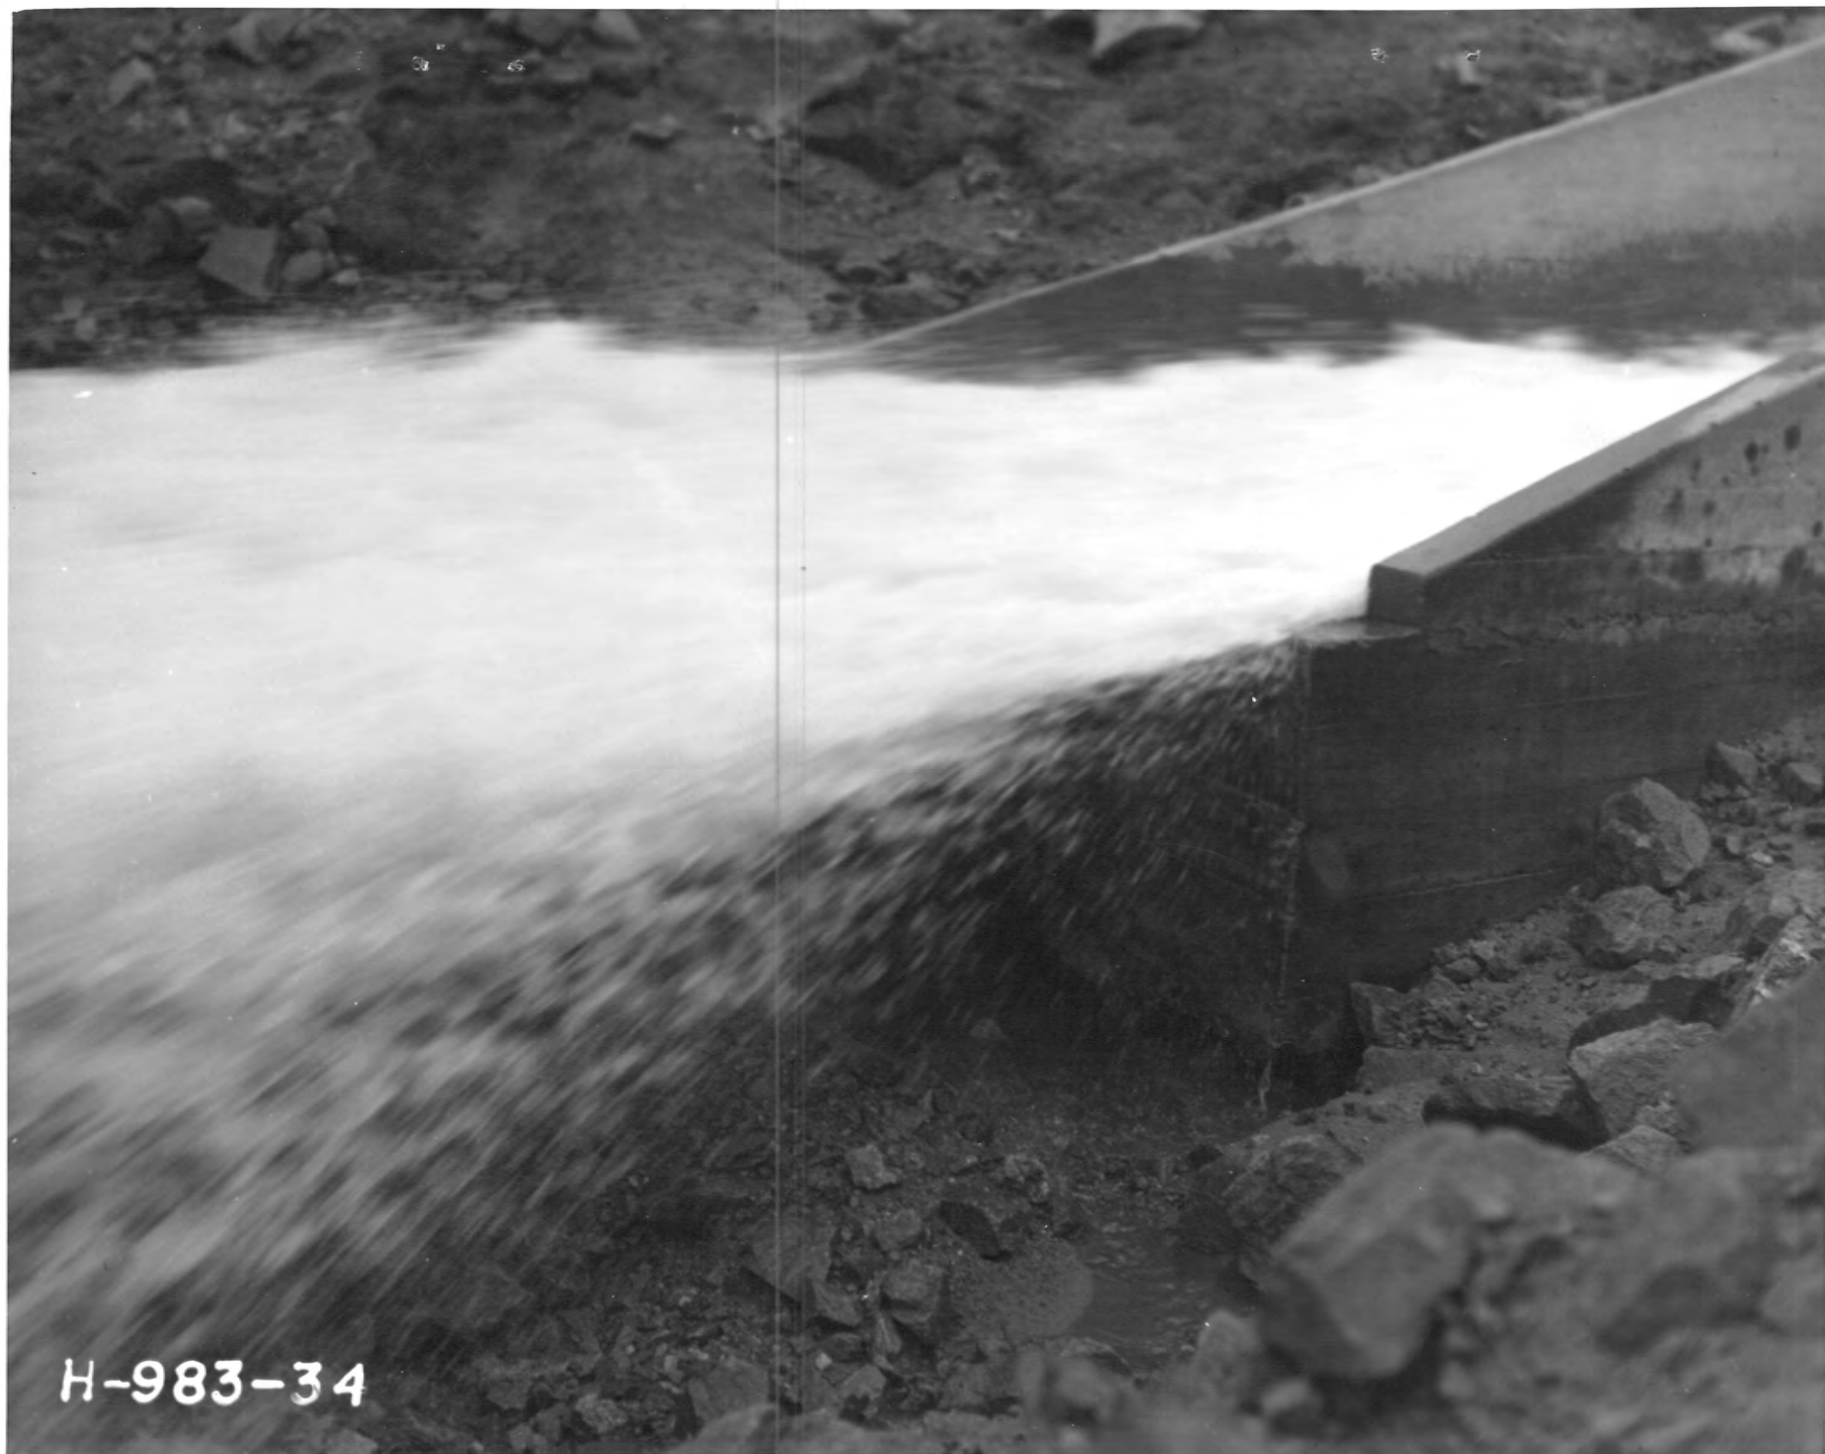
H-983-34

H-983-34. A close-up of the water leaving the chute and discharging into the lake. The lake had been drained so that the water jumped free of the structure into the lake bed.

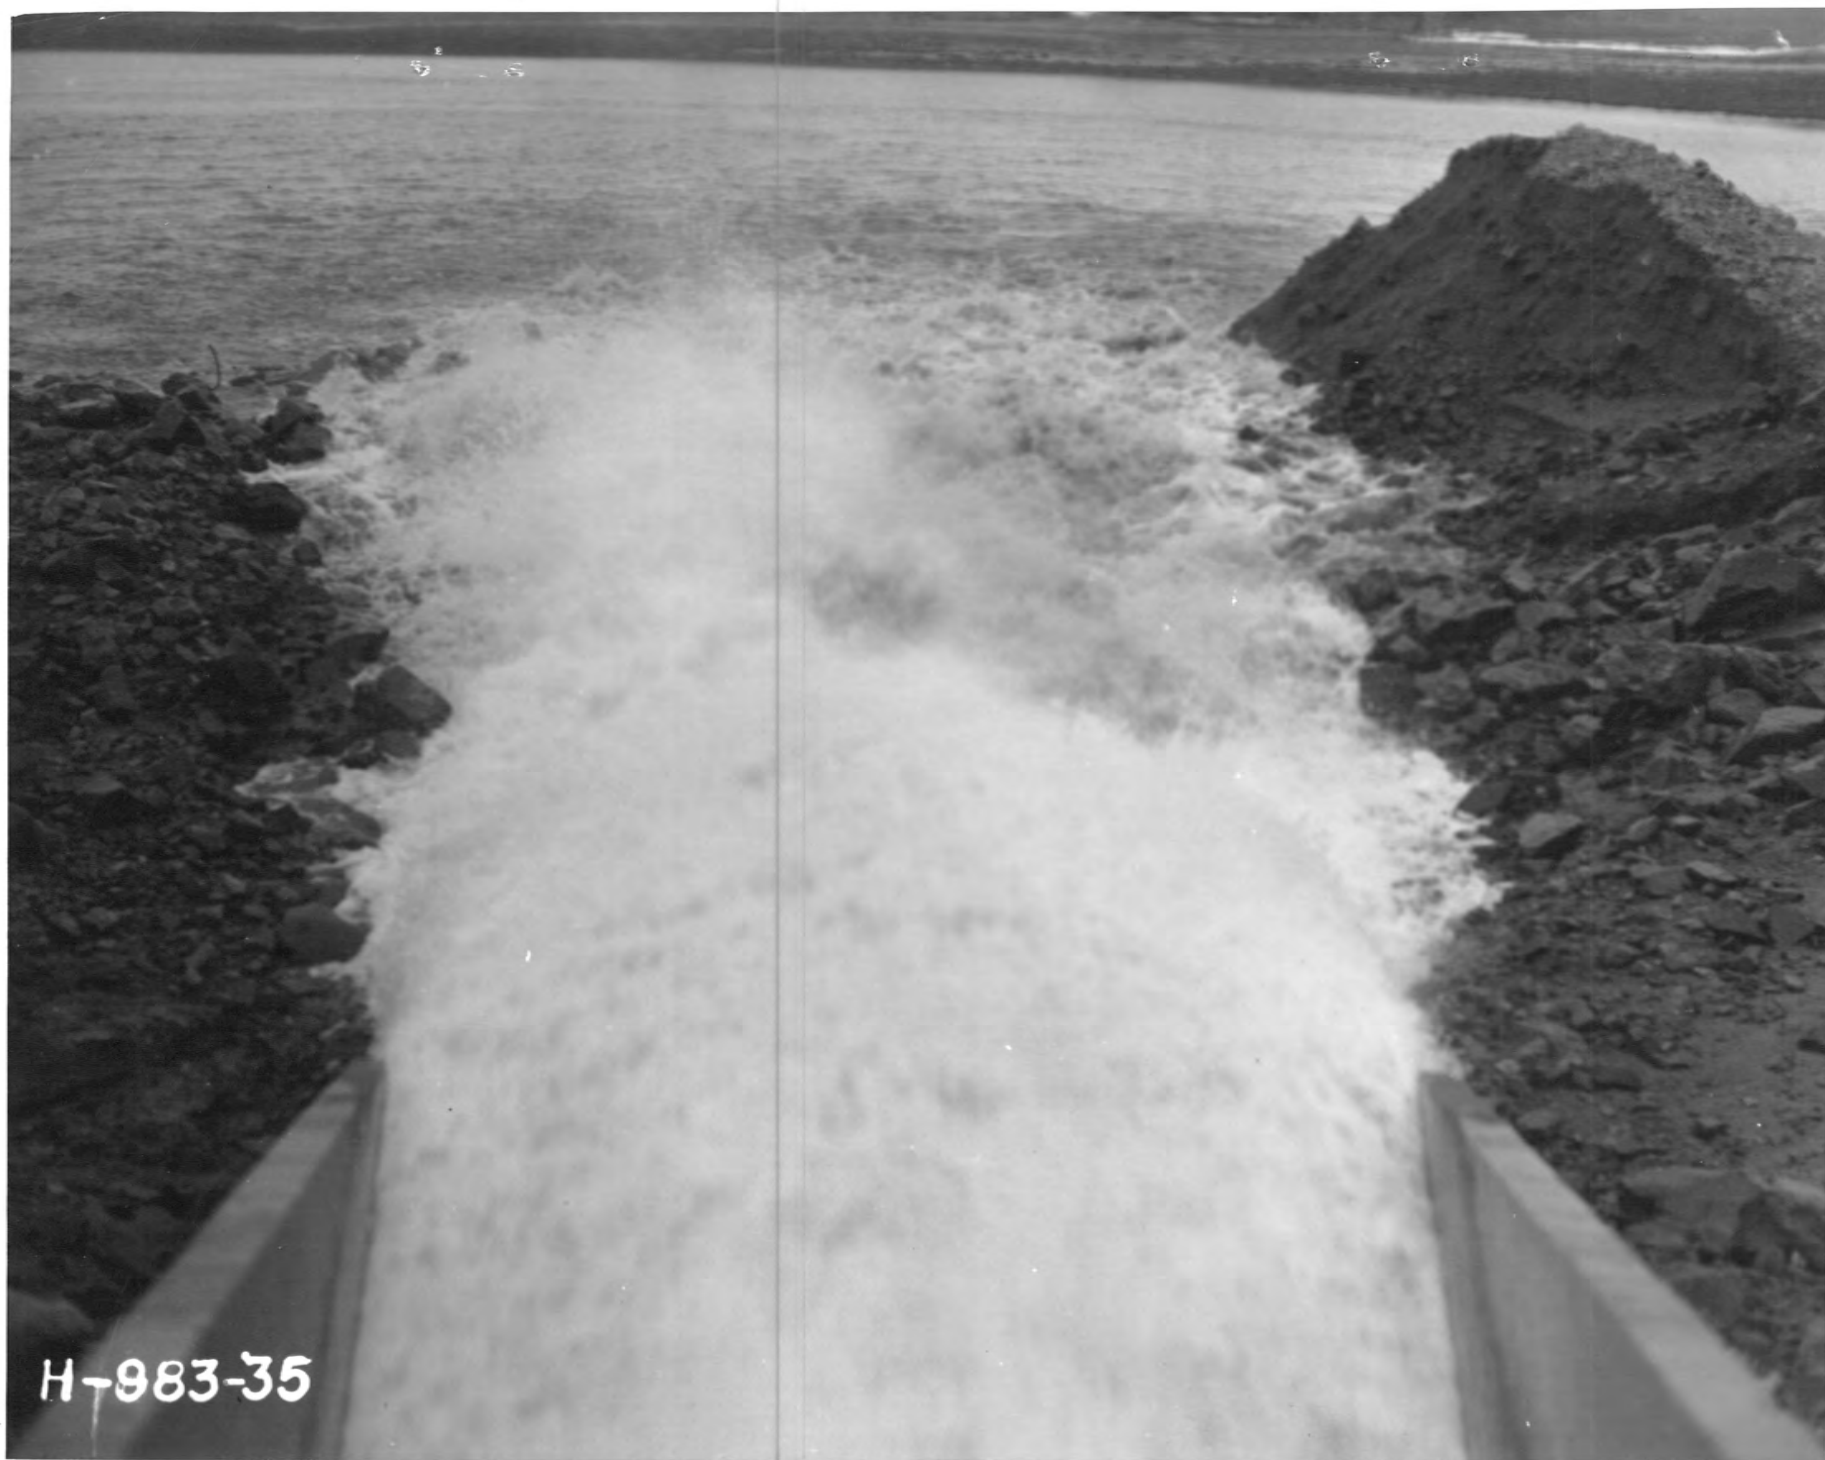
H-983-35

H-983-35. Looking downstream at the flow conditions from the slab over the chute--Discharge approximately 210 second feet.
