Correction to memorandum of April 10, 1951--Operating characteristics of hydraulic structures on the Colorado-Big Thompson Project east of the Continental Divide

Operating characteristics of hydraulic structures on the Colorado-Big Thompson Project east of the Continental Divide

CAPTIONS FOR PICTURES OF HYDRAULIC STRUCTURES ON
COLORADO-BIG THOMPSON PROJECT
EAST OF CONTINENTAL DIVIDE

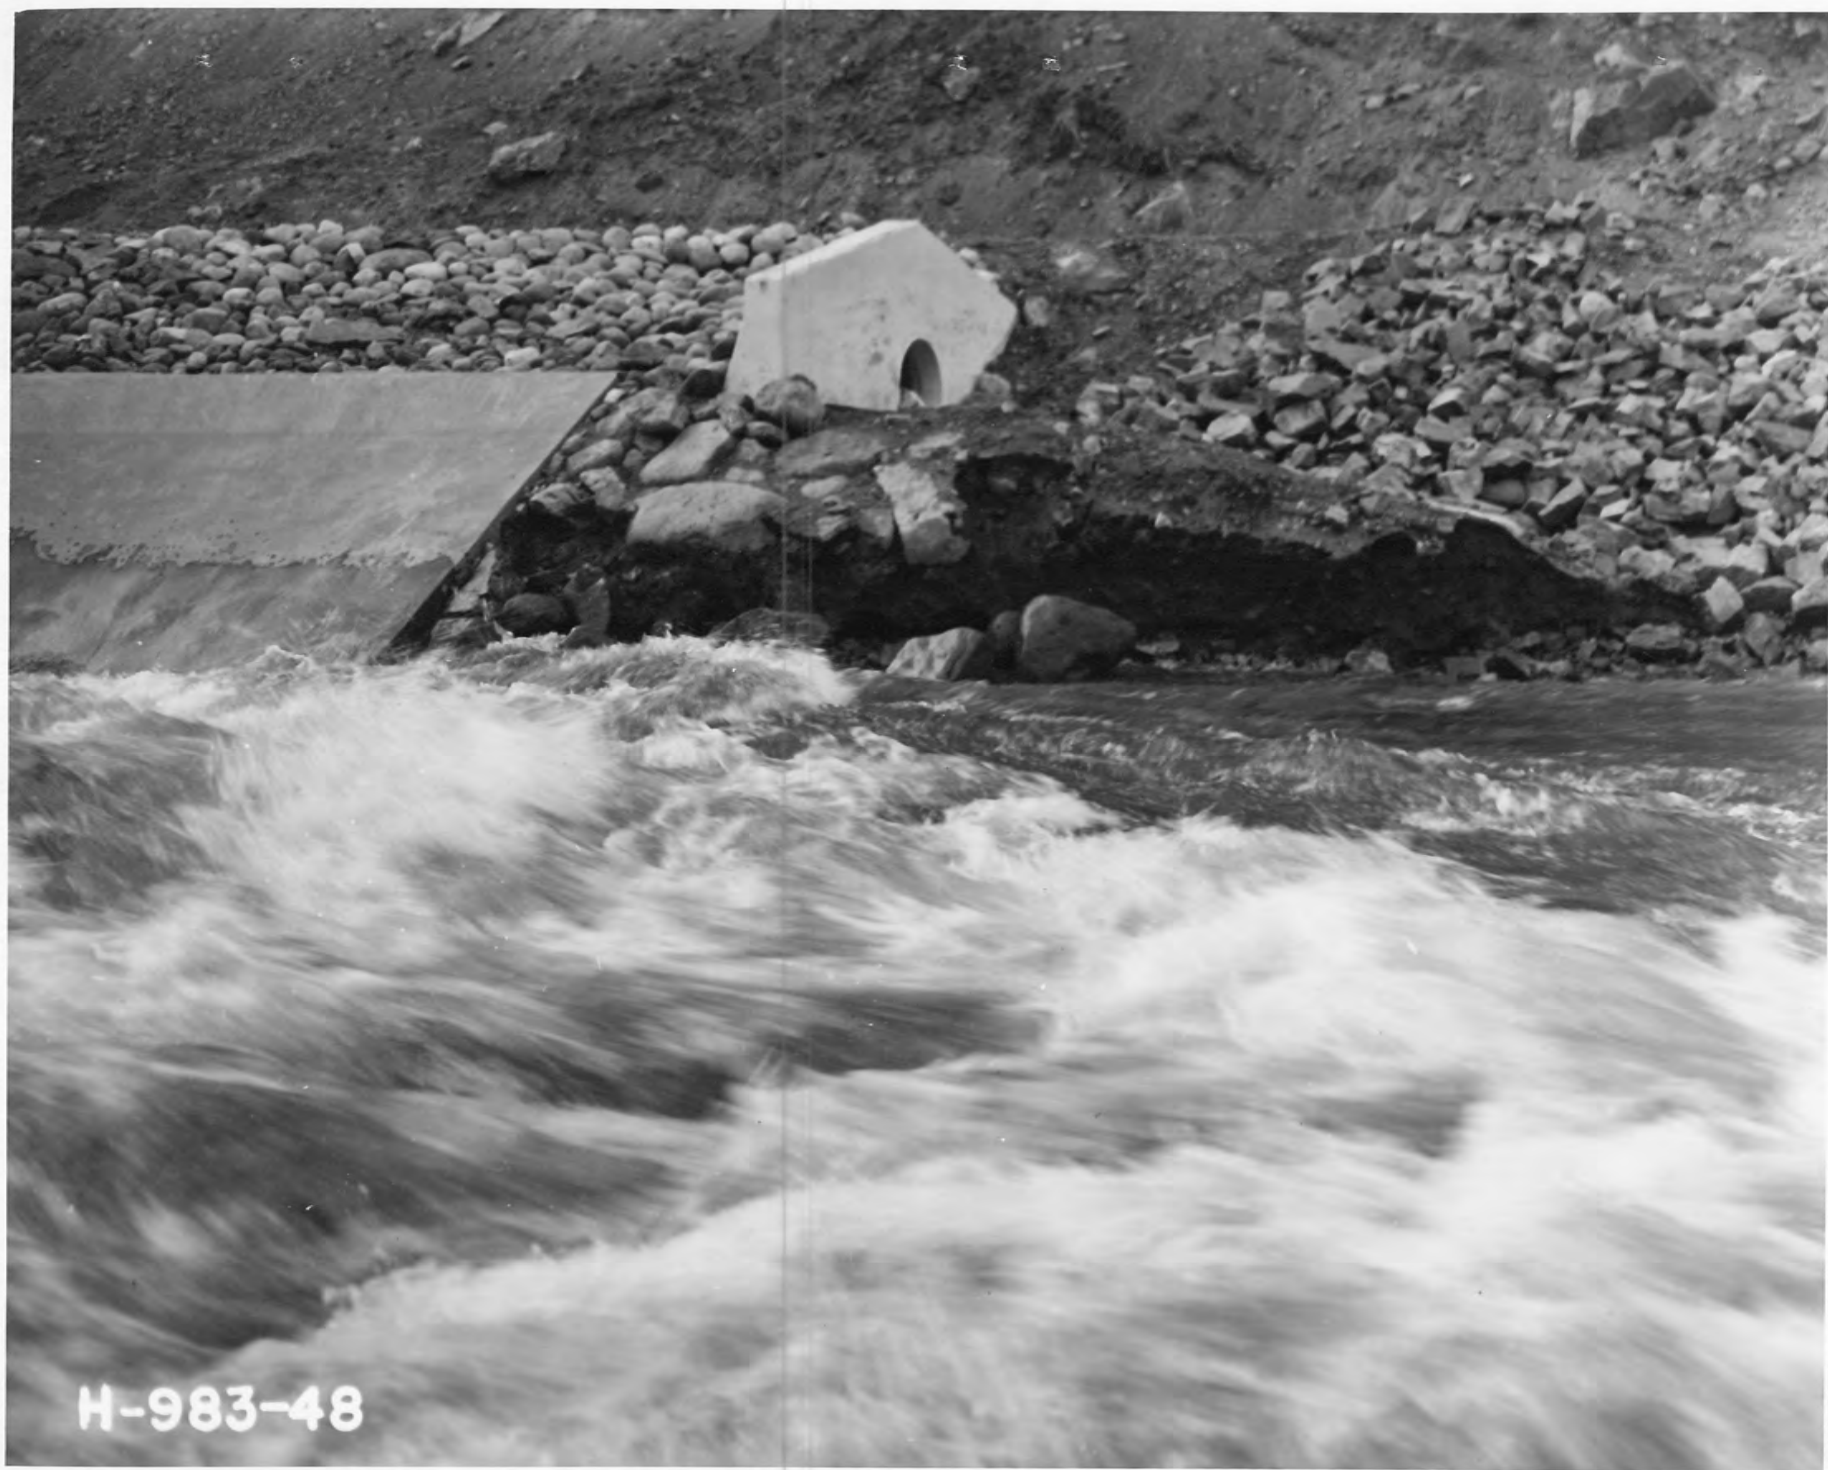
H-983-48

5. For some time after the flow reached the portal, a hydraulic jump formed beyond the concrete transition section and caused rapid erosion of the banks and bottom of the earth section of the reservoir. As the reservoir filled, the jump moved upstream into the concrete-lined transition but at no time came closer than approximately 25 feet from the tunnel portal. This position of the jump was maintained after the flow had stabilized and had been running for 3 or 4 hours, see attached photographs. Erosion on the banks and bottom continued after the full flow was reached and the reservoir was stabilized (photograph attached).

H-983-48. East Portal of Adams Tunnel--Discharge 575 second feet--Showing erosion at downstream end of left wall of transition section.

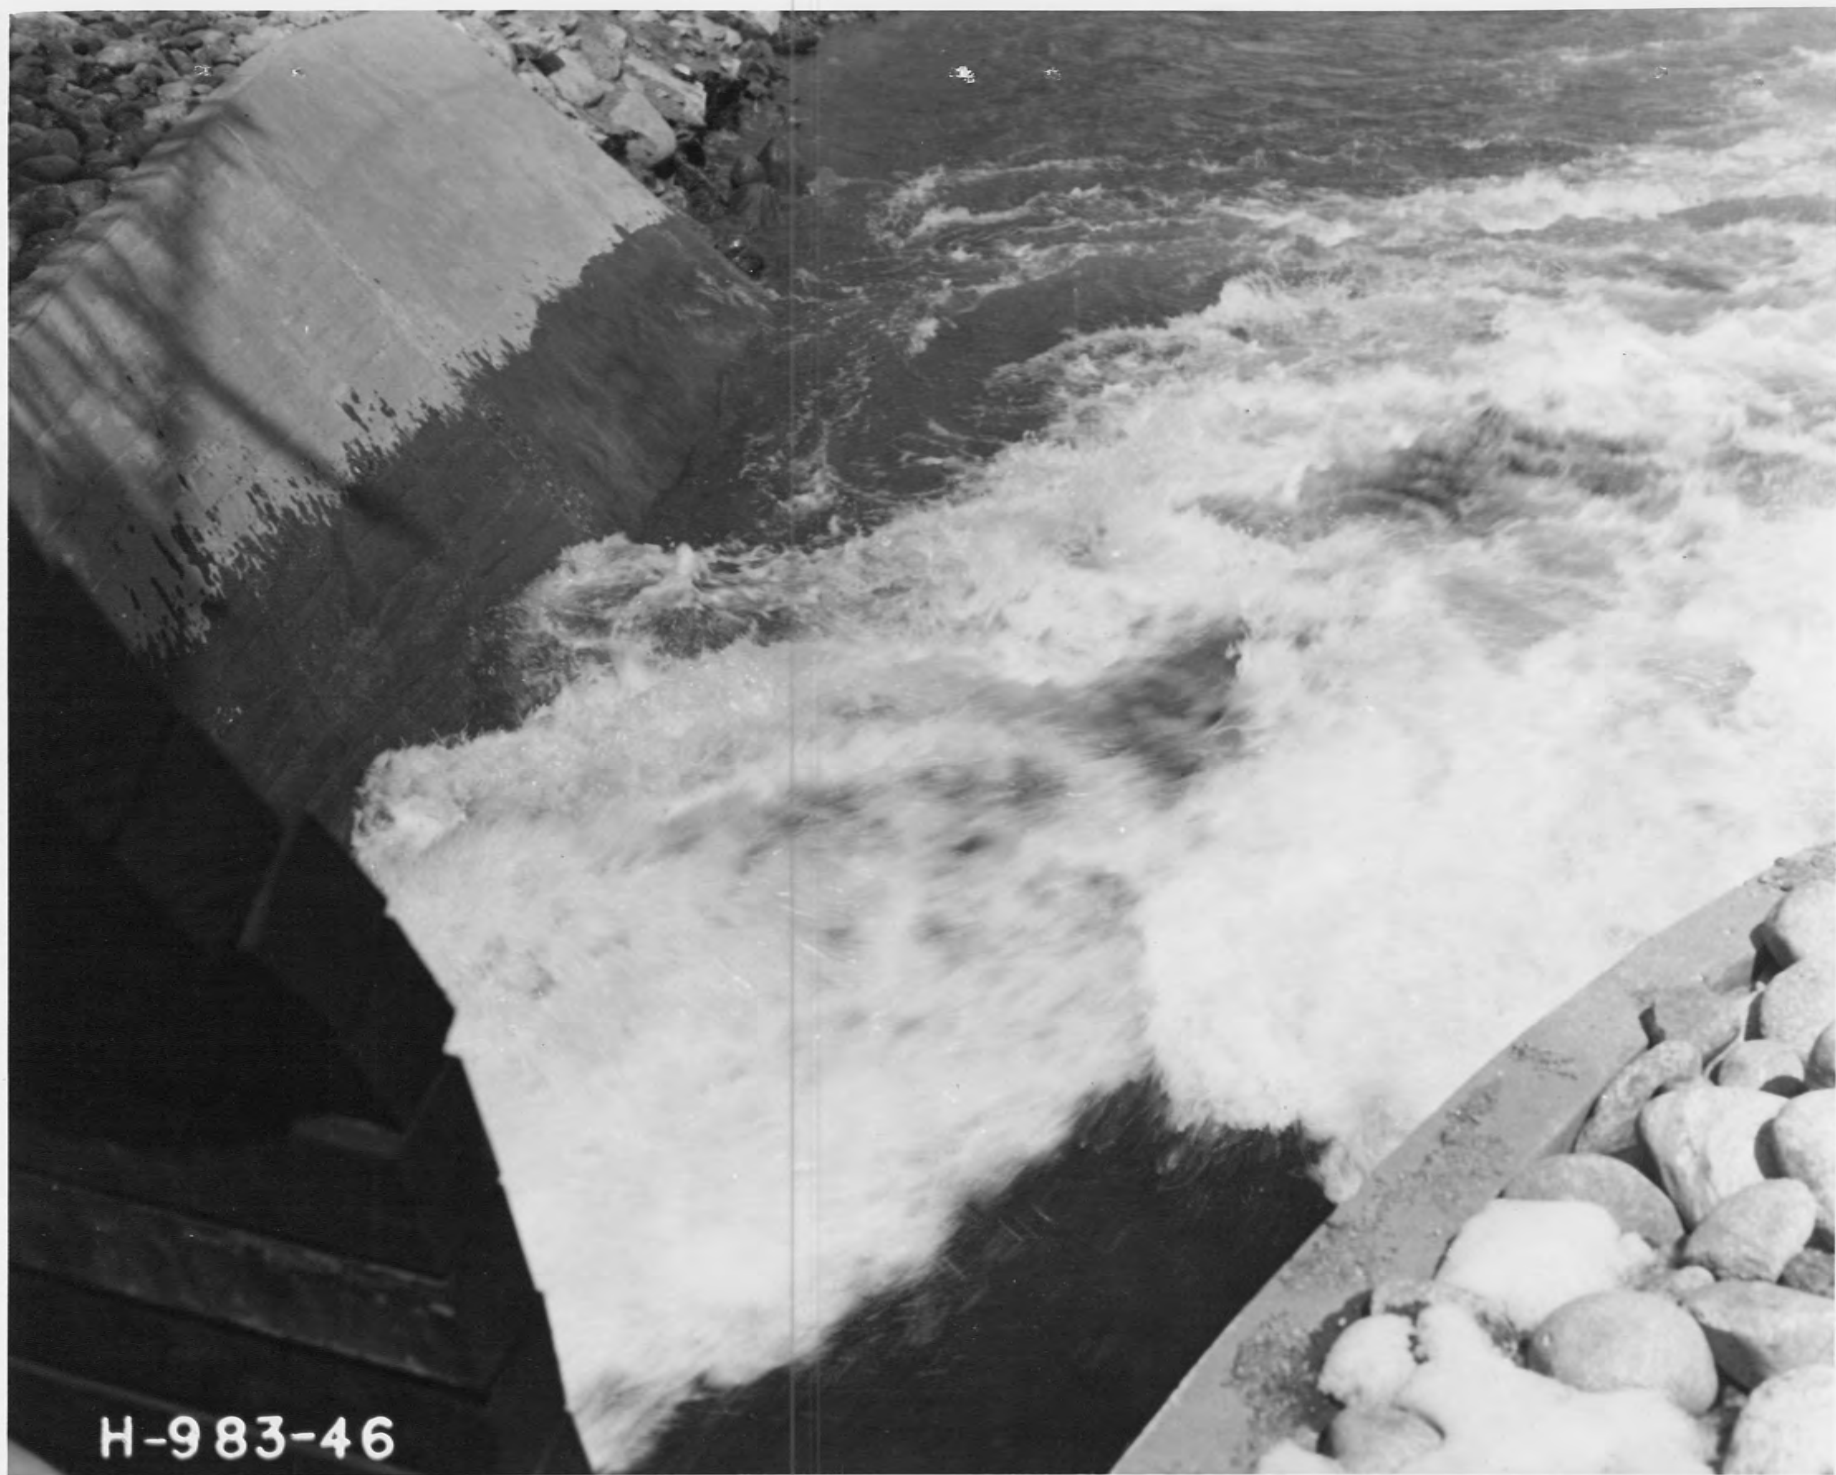
H-983-46

6. After the flow had stabilized (about 3 hours after arrival of the water) a number of observations was made. At maximum discharge, the water emerged from the tunnel at a measured depth of 3.1 feet, formed an irregular jump and a whirl to the left in the reservoir (see attached photographs). Velocity disturbances extended well into the reservoir area. The flow continued through the reservoir and into the Aspen Creek Siphon entrance structure. The entrance losses at this structure were rather high. The flow approached the dual spillway, siphon entrance structure and flowed to the right causing considerable draw-down around the center pier. There was also some disturbance around the right guide wall. If this wall were swung to the right at the upstream end, conditions would be improved. These flow conditions may be seen in the attached photographs.

H-983-46. Discharge of 575 second feet flowing from Adams Tunnel--Taken from right side looking downstream. The depth of flow in the foreground is 3.1 feet.

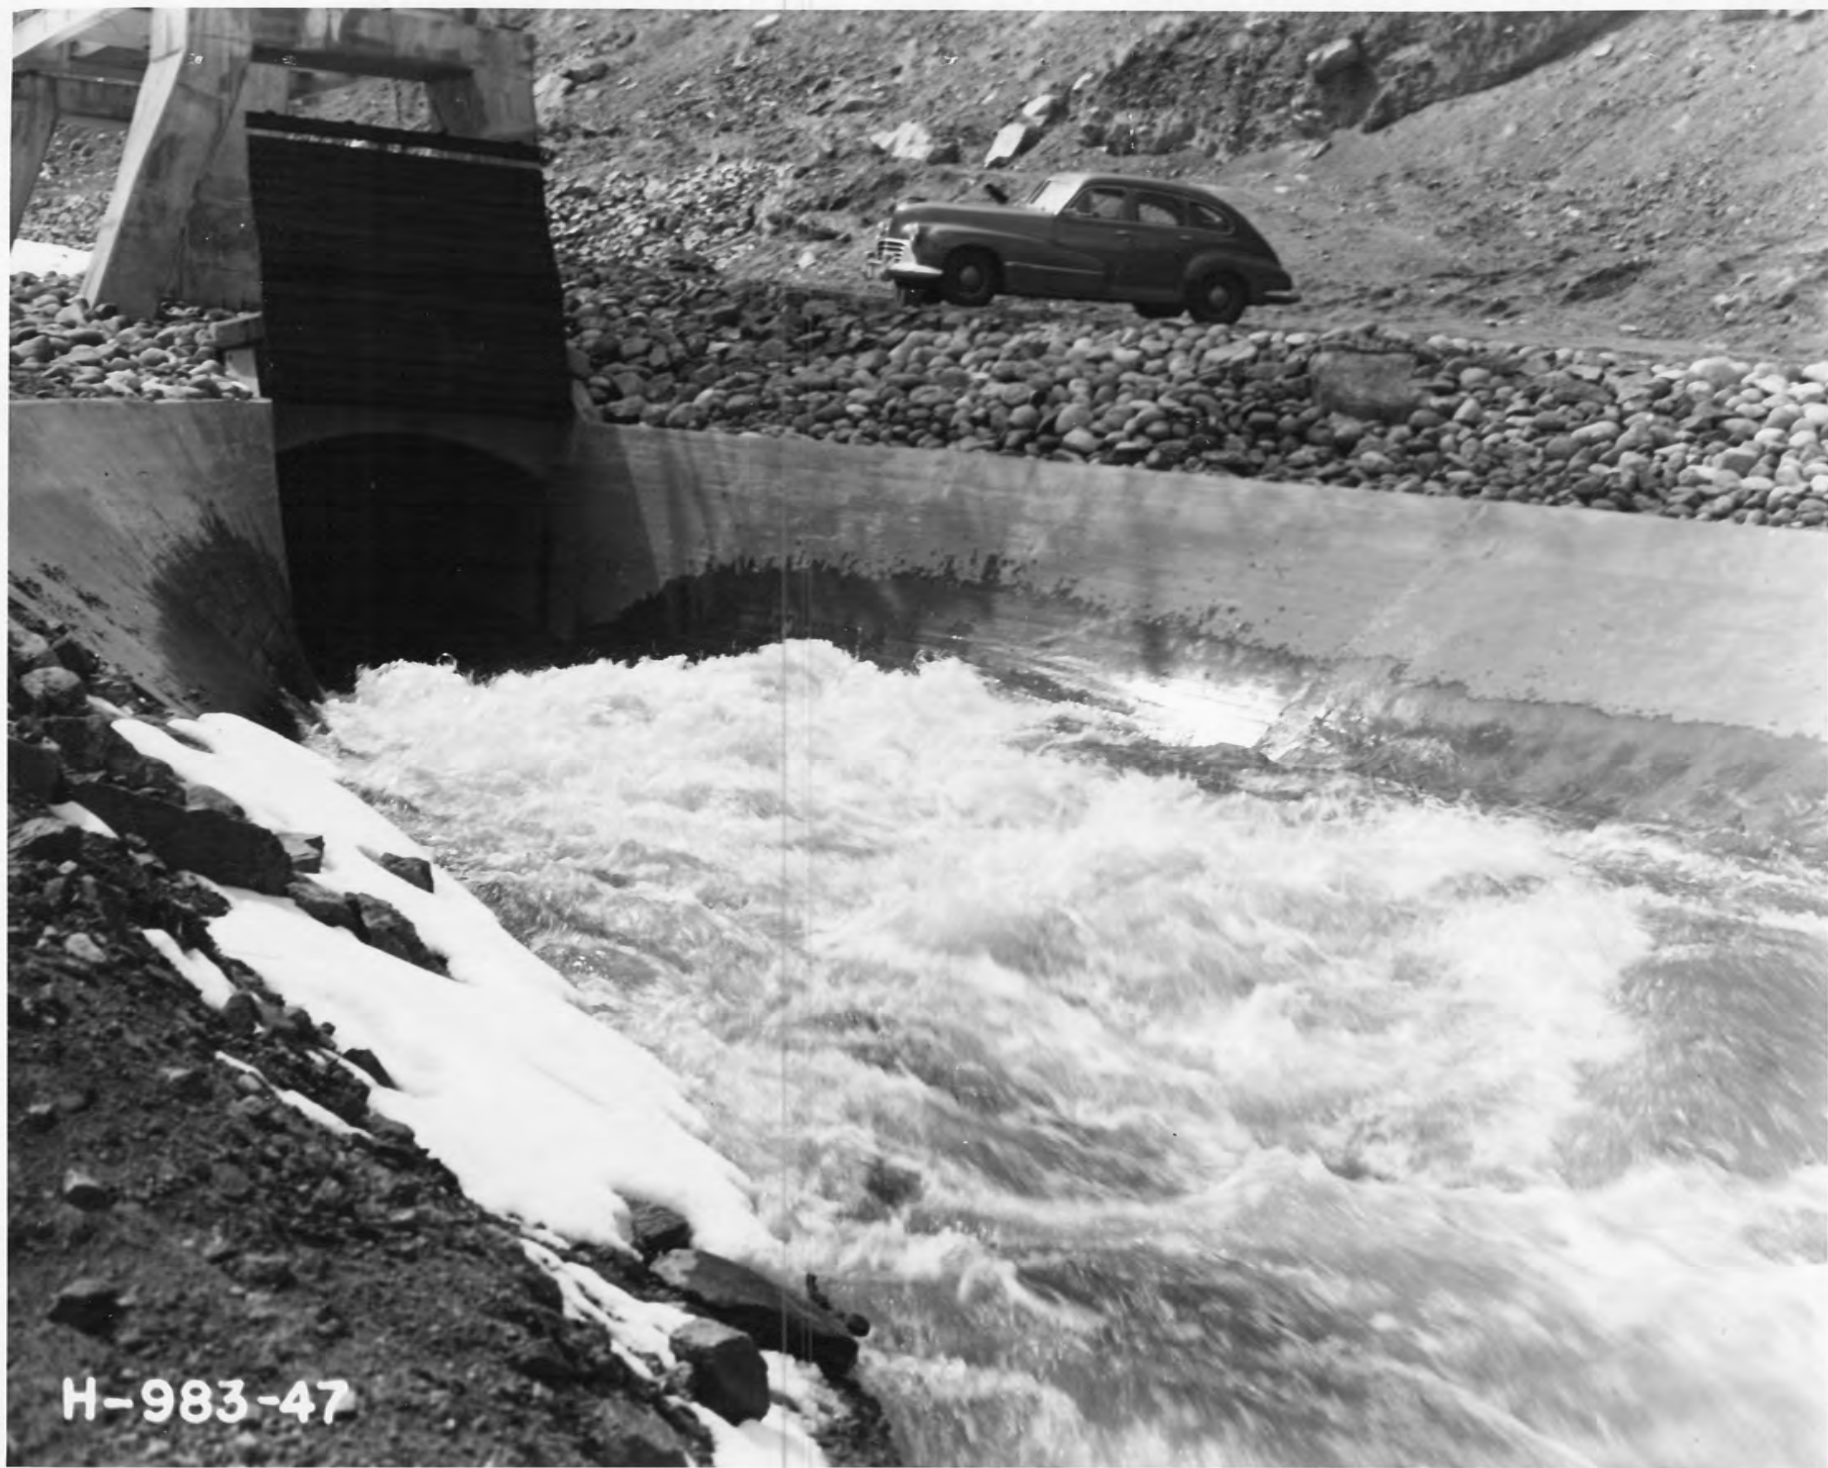
H-983-47

H-983-47. Discharge of 575 second feet emerging from the east portal of Adams Tunnel--Taken from right bank looking upstream.

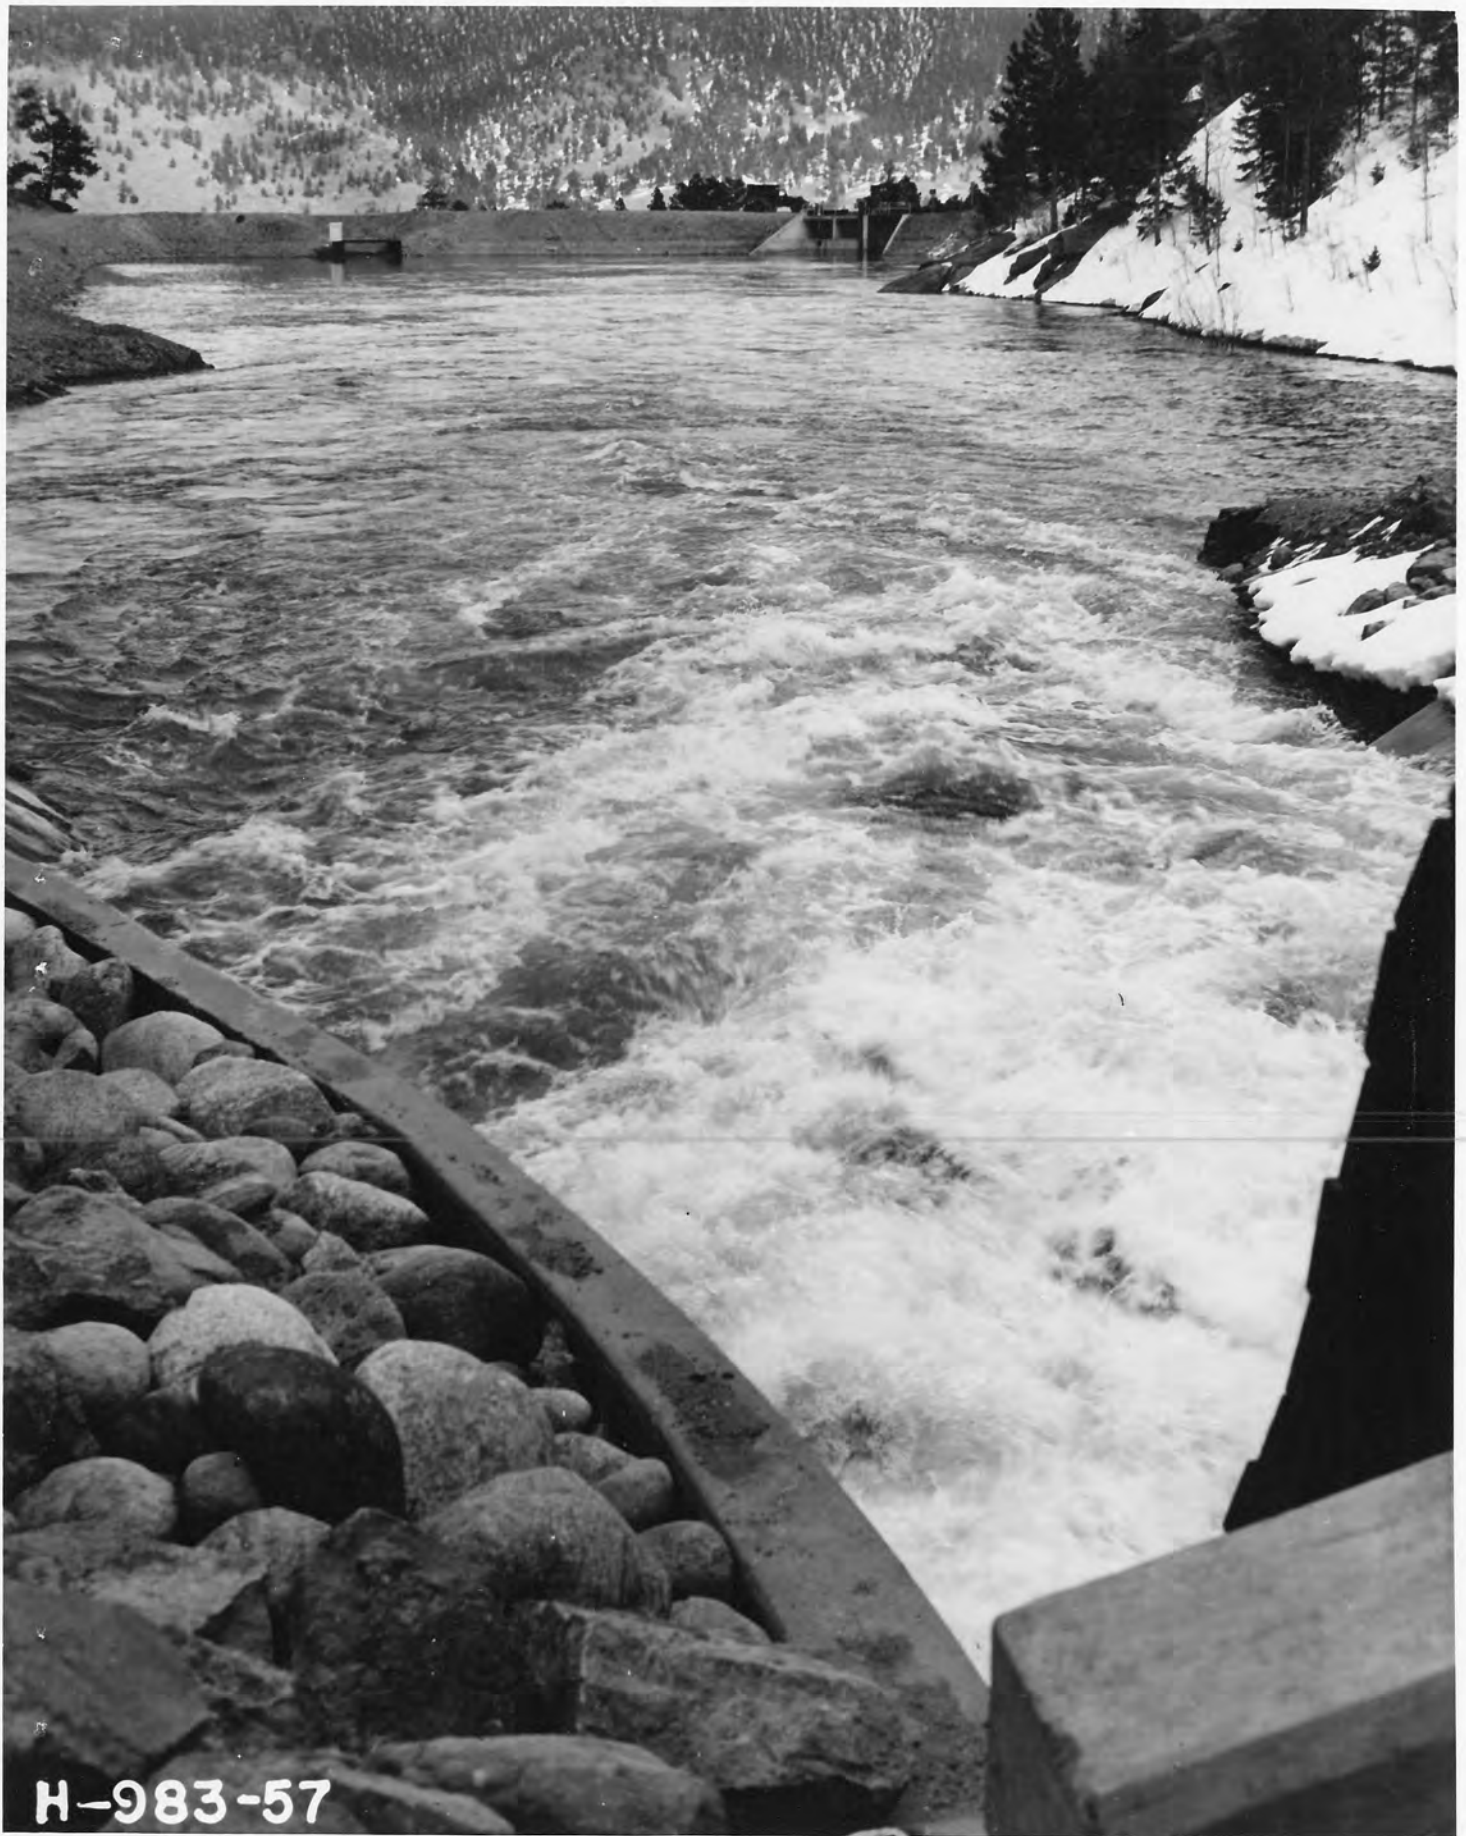
H-983-57

4. After leaving the powerhouse, I went to the East Portal of the Adams Tunnel. The flow emerged from the East Portal of the tunnel at 10:25 a.m. and began filling the East Portal Reservoir rapidly. Velocity through the reservoir was high and until the portion of the reservoir on the left side of the 30-inch concrete Wind River bypass was filled, velocity waves could be seen to extend almost the entire length of the reservoir.

H-983-57. Discharge of 575 second feet entering East Portal Reservoir from Adams Tunnel--Entrance to Aspen Creek Siphon in the right background. Surface velocity waves carried well into the reservoir.

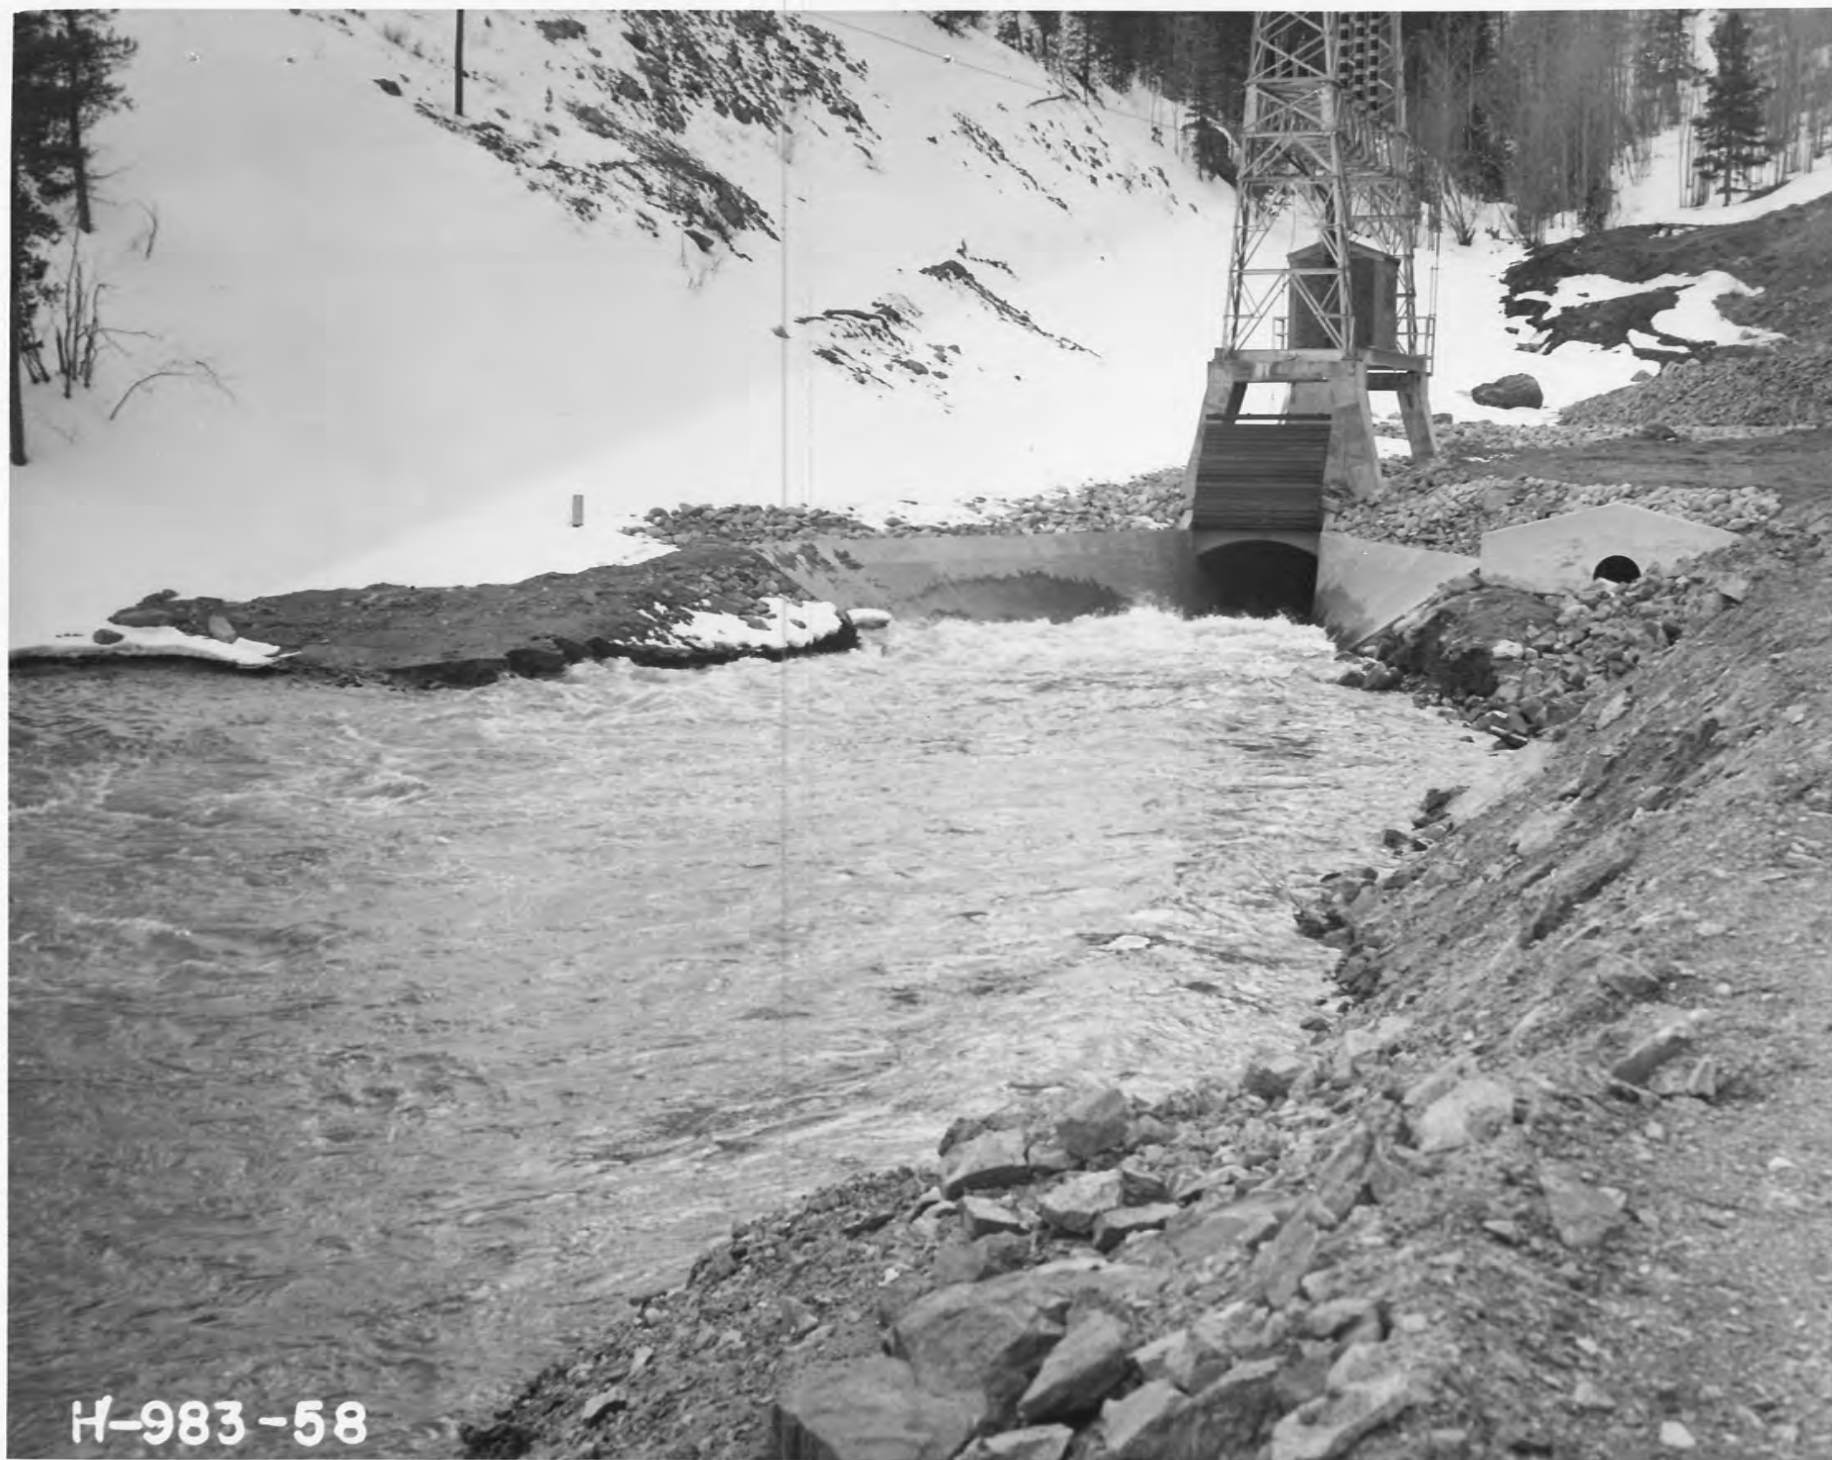
H-983-58

H-983-58. Discharge of 575 second feet flowing from Adams Tunnel--Taken from left bank of East Portal Reservoir looking upstream. Note bank cutting downstream from transition section.

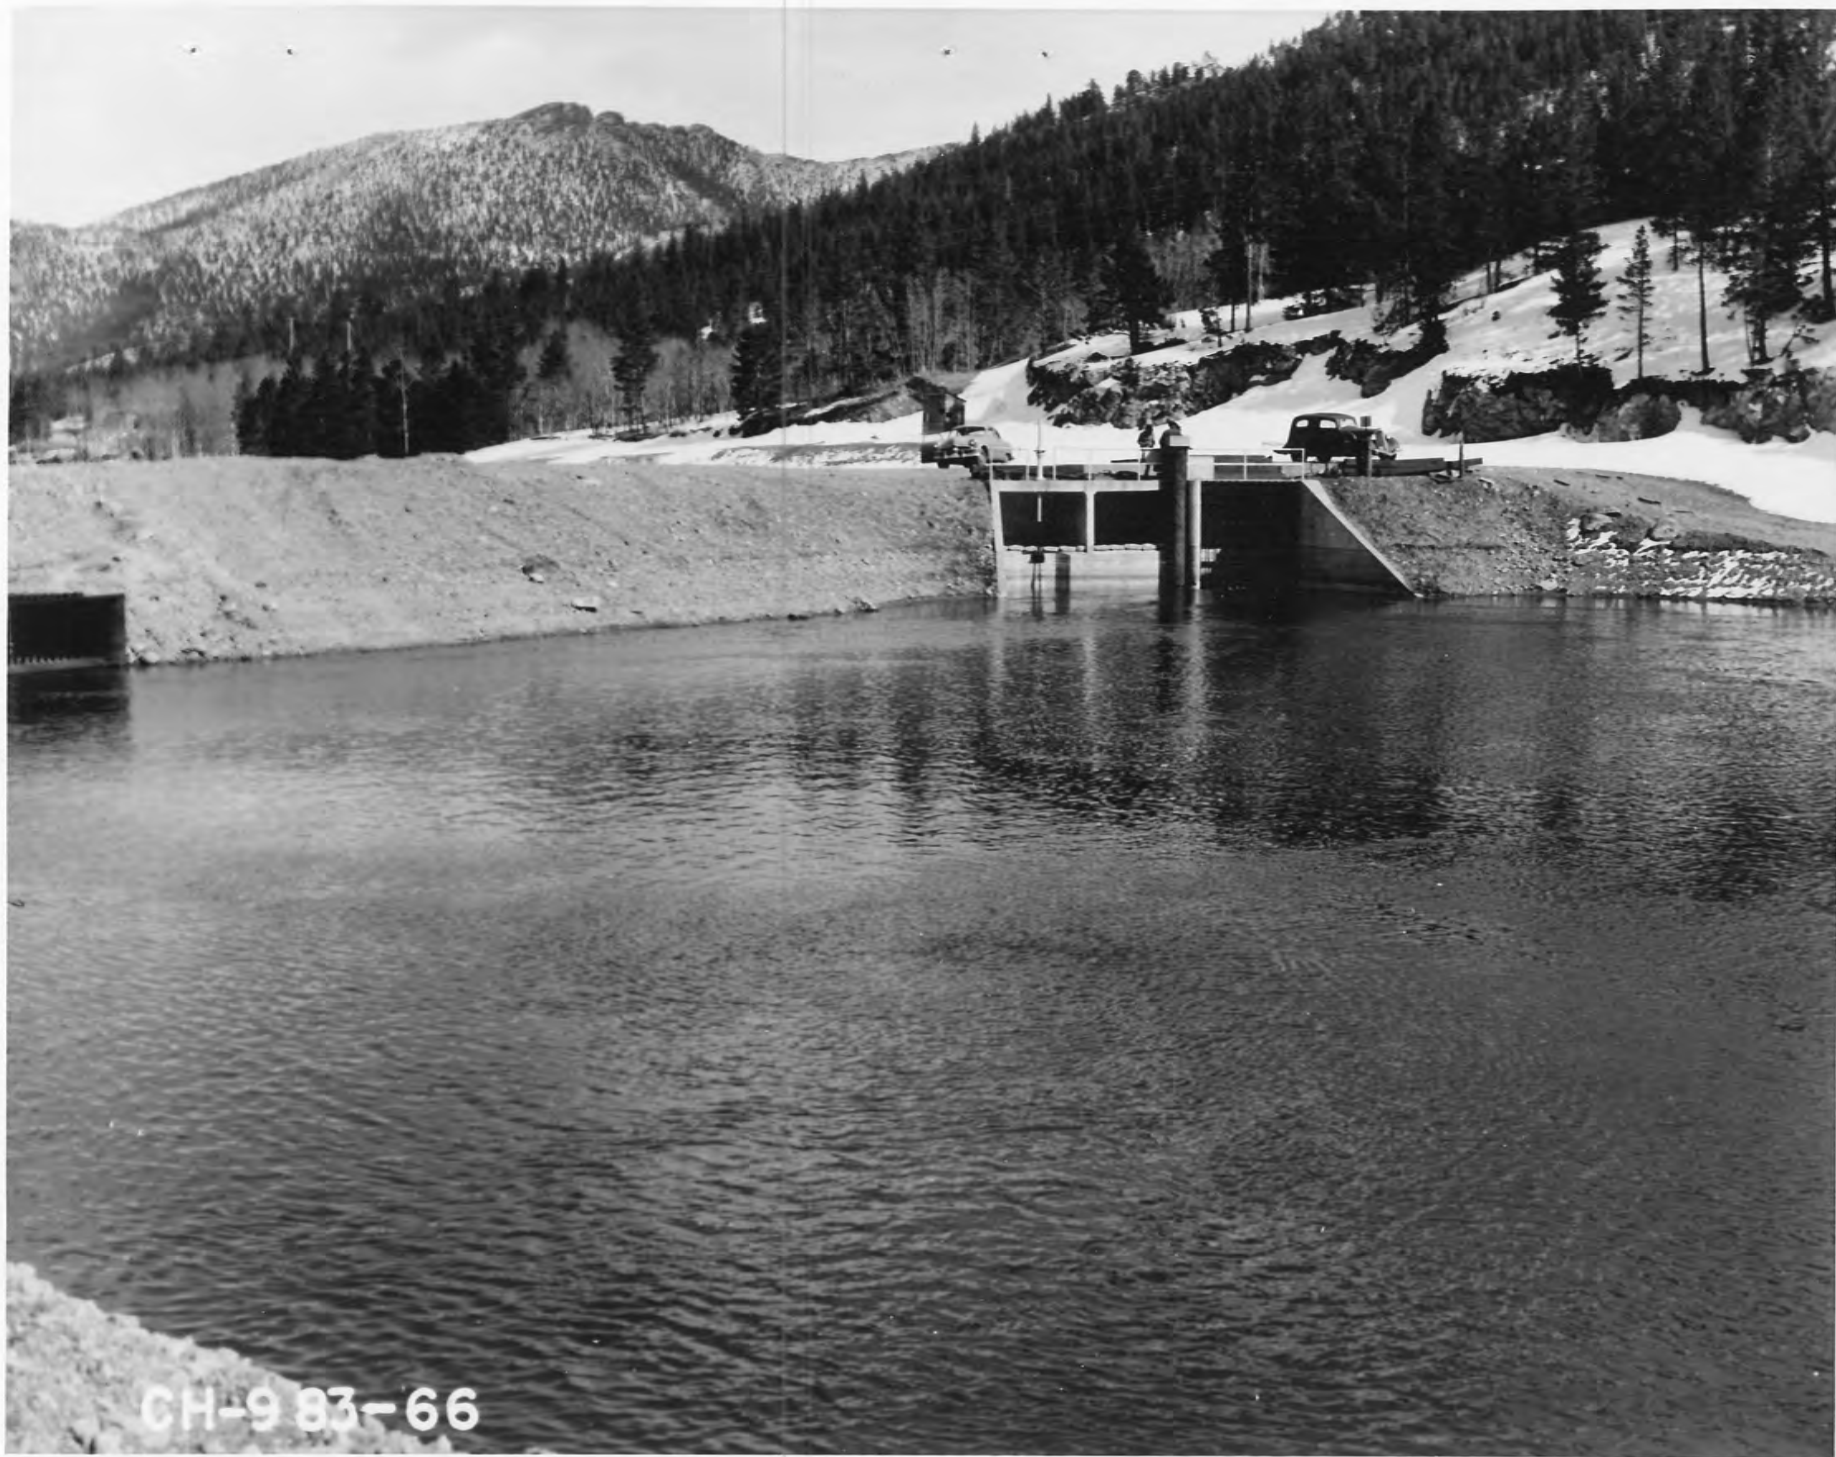
CH-9 83-66

CH-983-66. Discharge of 575 second feet entering Aspen Creek Siphon--Taken from left bank of East Portal Reservoir looking downstream.

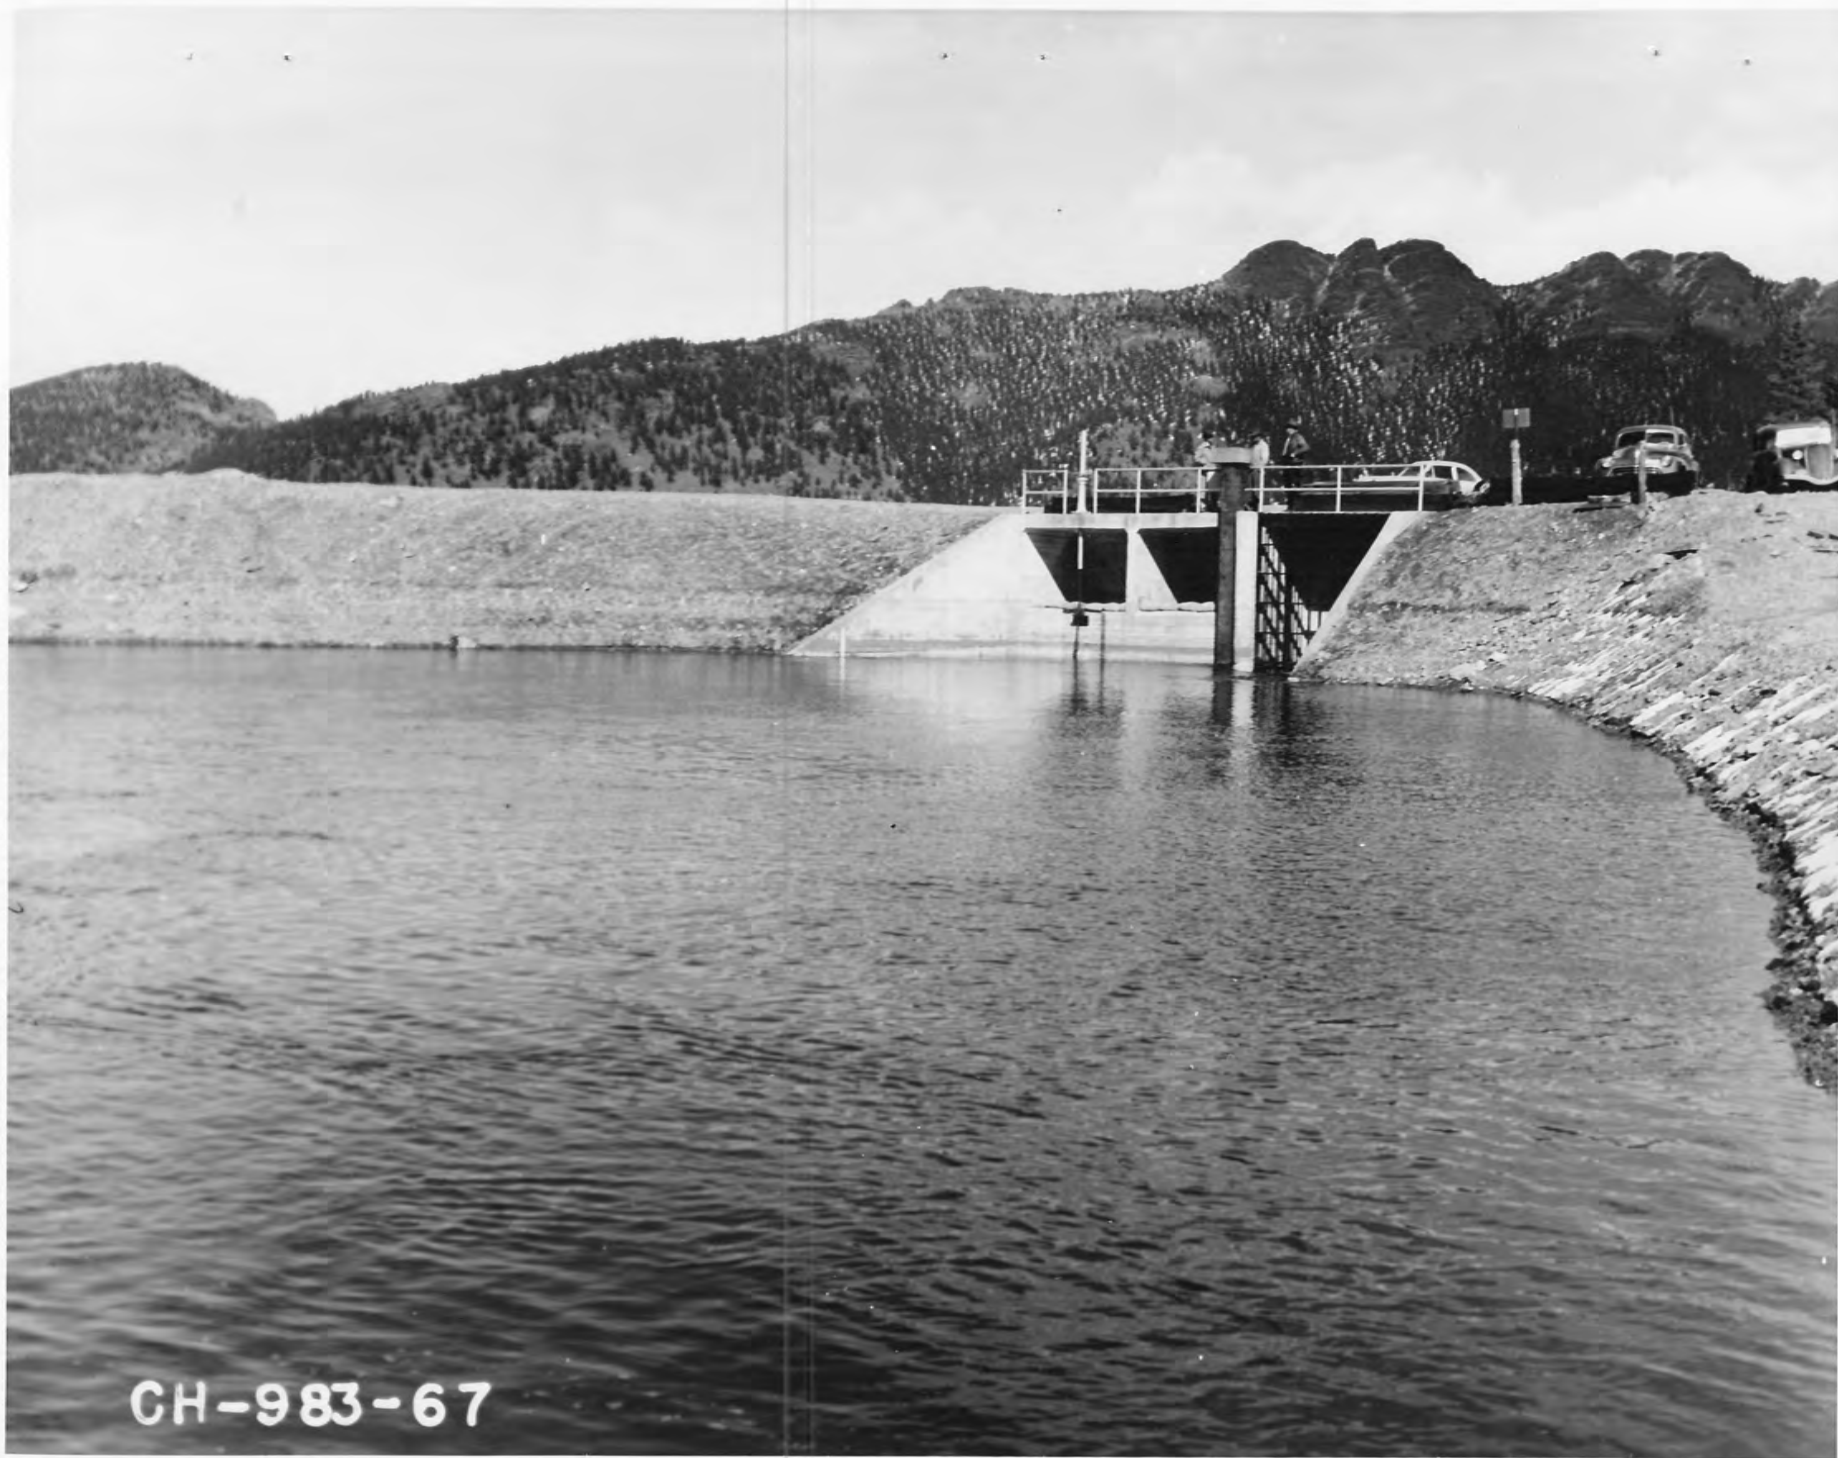
CH-983-67

CH-983-67. Discharge of 575 second feet entering Aspen Creek Siphon--Taken from right bank of East Portal Reservoir looking downstream.

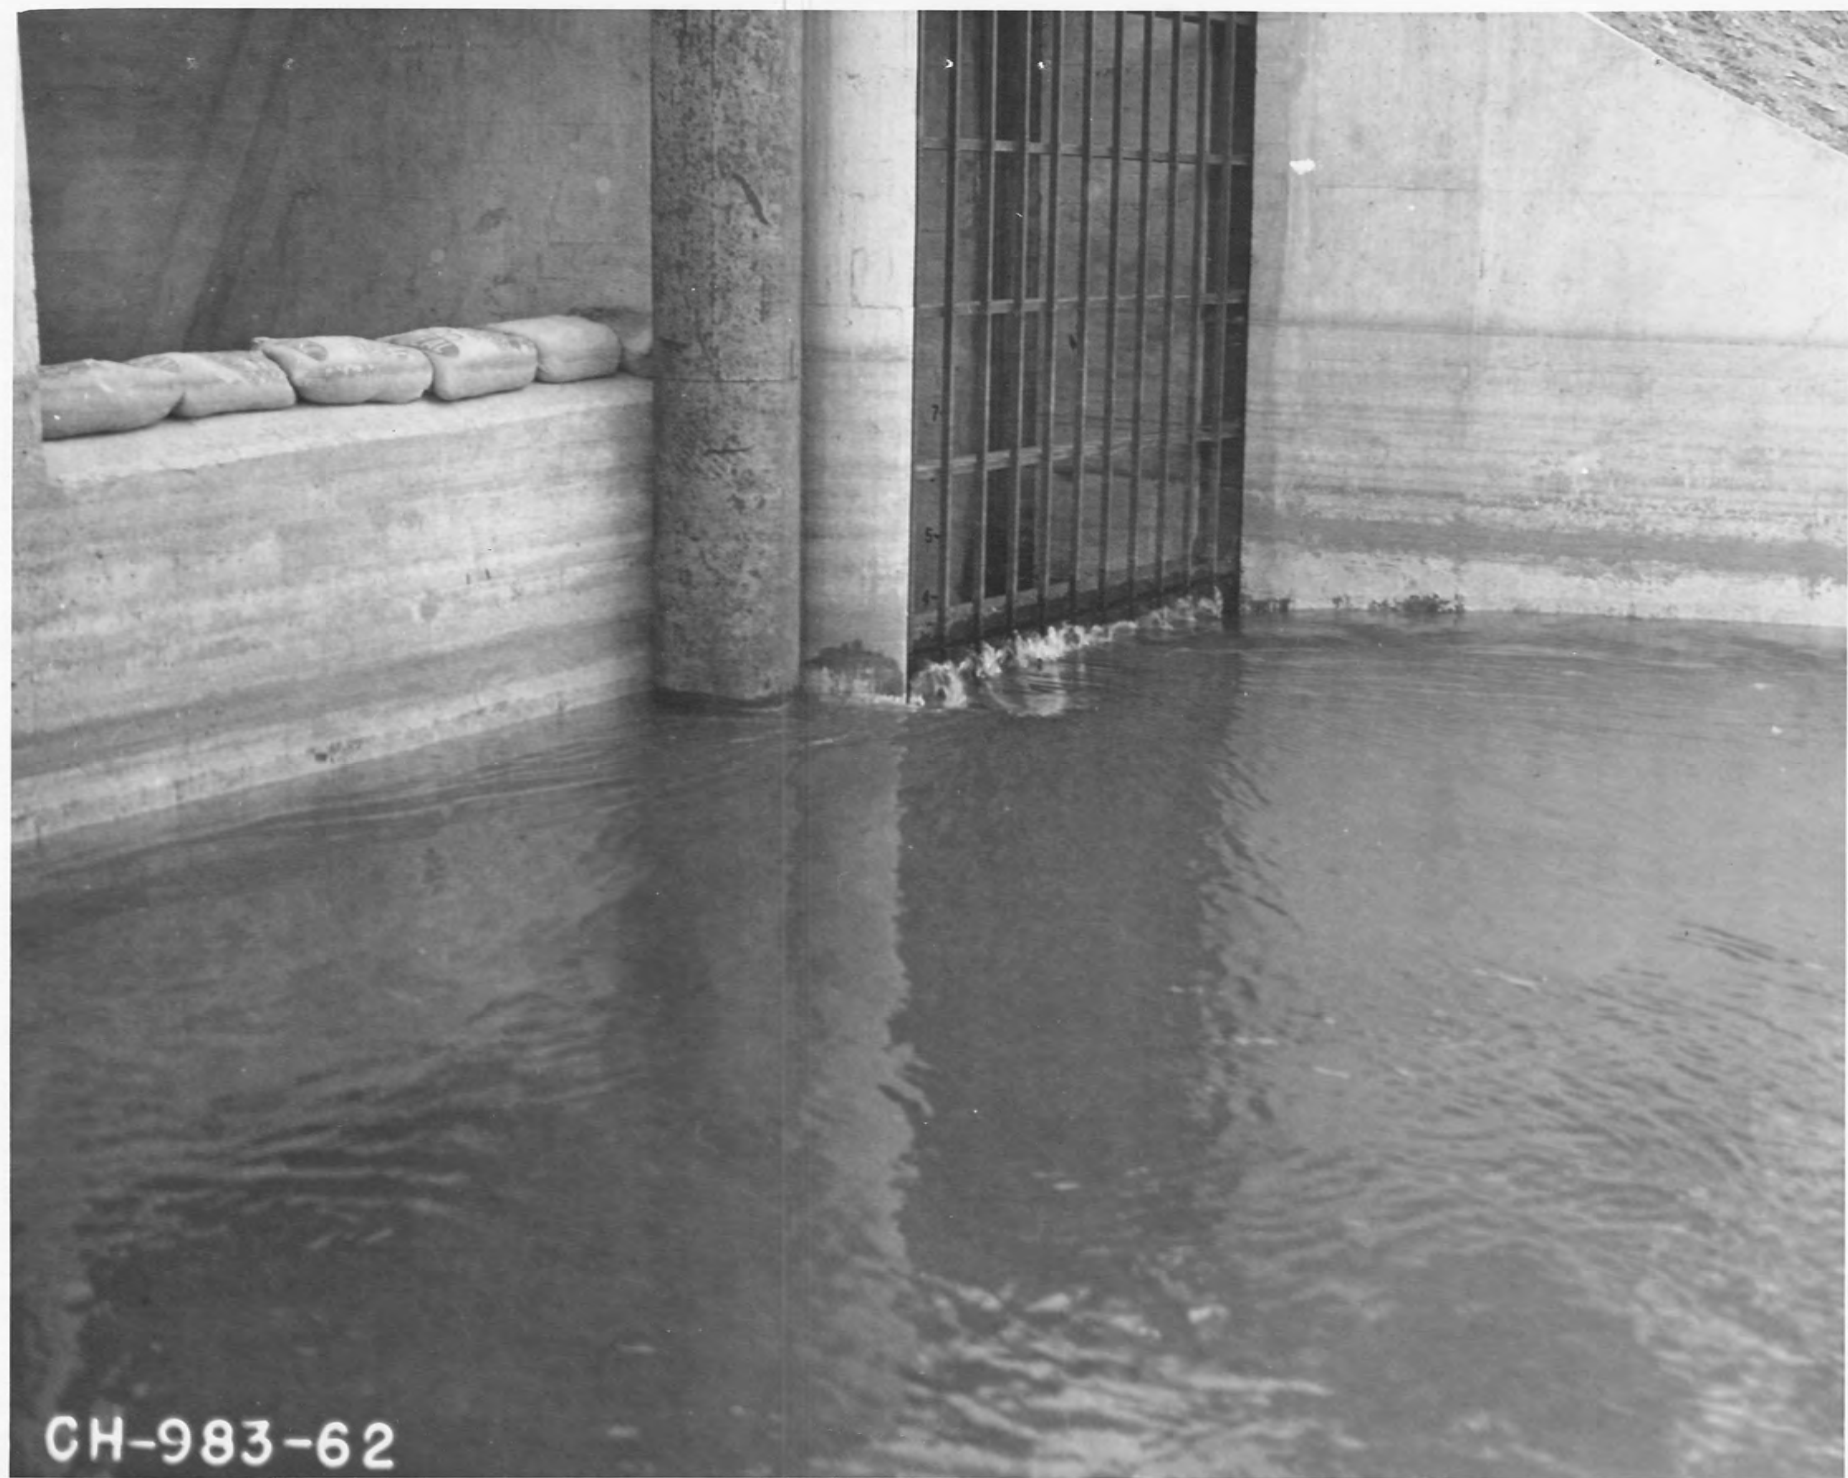
CH-983-62

9. Probable elevation of the lake in front of the spillway structure was 8254.8. Across the front of the siphon entrance approximately 6 inches upstream from the upstream-side^{of the} trashrack, the following elevations were measured: at right side, elevation 8254.25; 2 feet from right side, 8254.10; 4 feet from right side, 8254.10; 6 feet from right side, 8254.12; 8 feet from right side, 8253.85; 10 feet from right side, 8253.15; at the left side of the structure elevation 8252.95. The slope in water surface across the front of the structure may be seen in the attached photographs.

CH-983-62. Discharge of 575 second feet entering Aspen Creek Siphon--Taken from left side of structure showing drawdown to entrance and disturbance at trashrack.
