Correction to memorandum of April 10, 1951--Operating characteristics of hydraulic structures on the Colorado-Big Thompson Project east of the Continental Divide

Operating characteristics of hydraulic structures on the Colorado-Big Thompson Project east of the Continental Divide

CAPTIONS FOR PICTURES OF HYDRAULIC STRUCTURES ON
COLORADO-BIG THOMPSON PROJECT
EAST OF CONTINENTAL DIVIDE

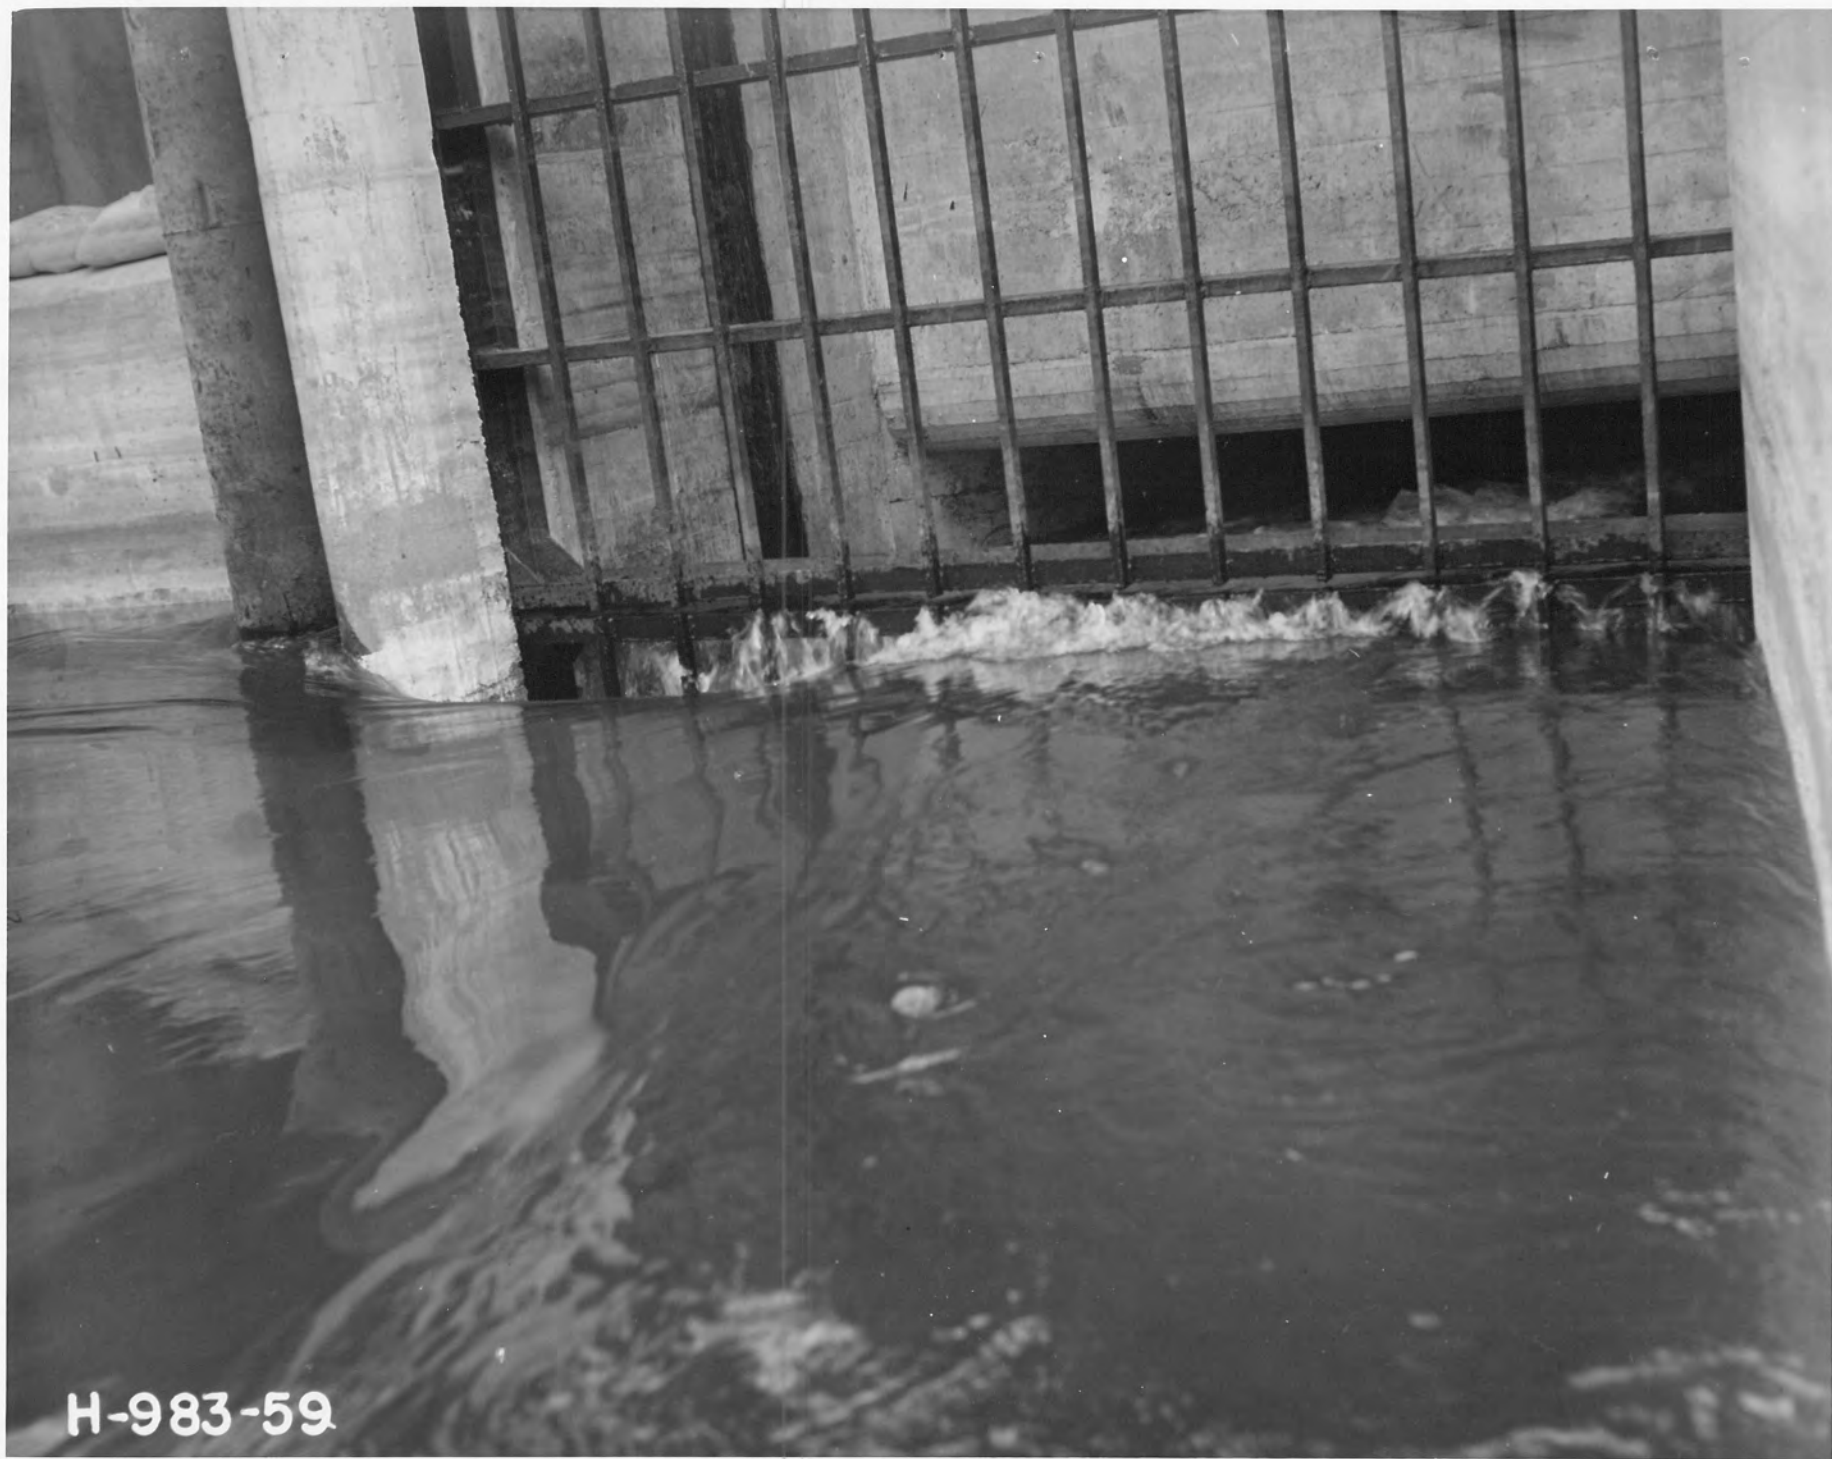
H-983-59

H-983-59. Discharge of 575 second feet entering Aspen Creek Siphon--Taken from right side of structure--Showing drawdown around pier and disturbance at trashrack.

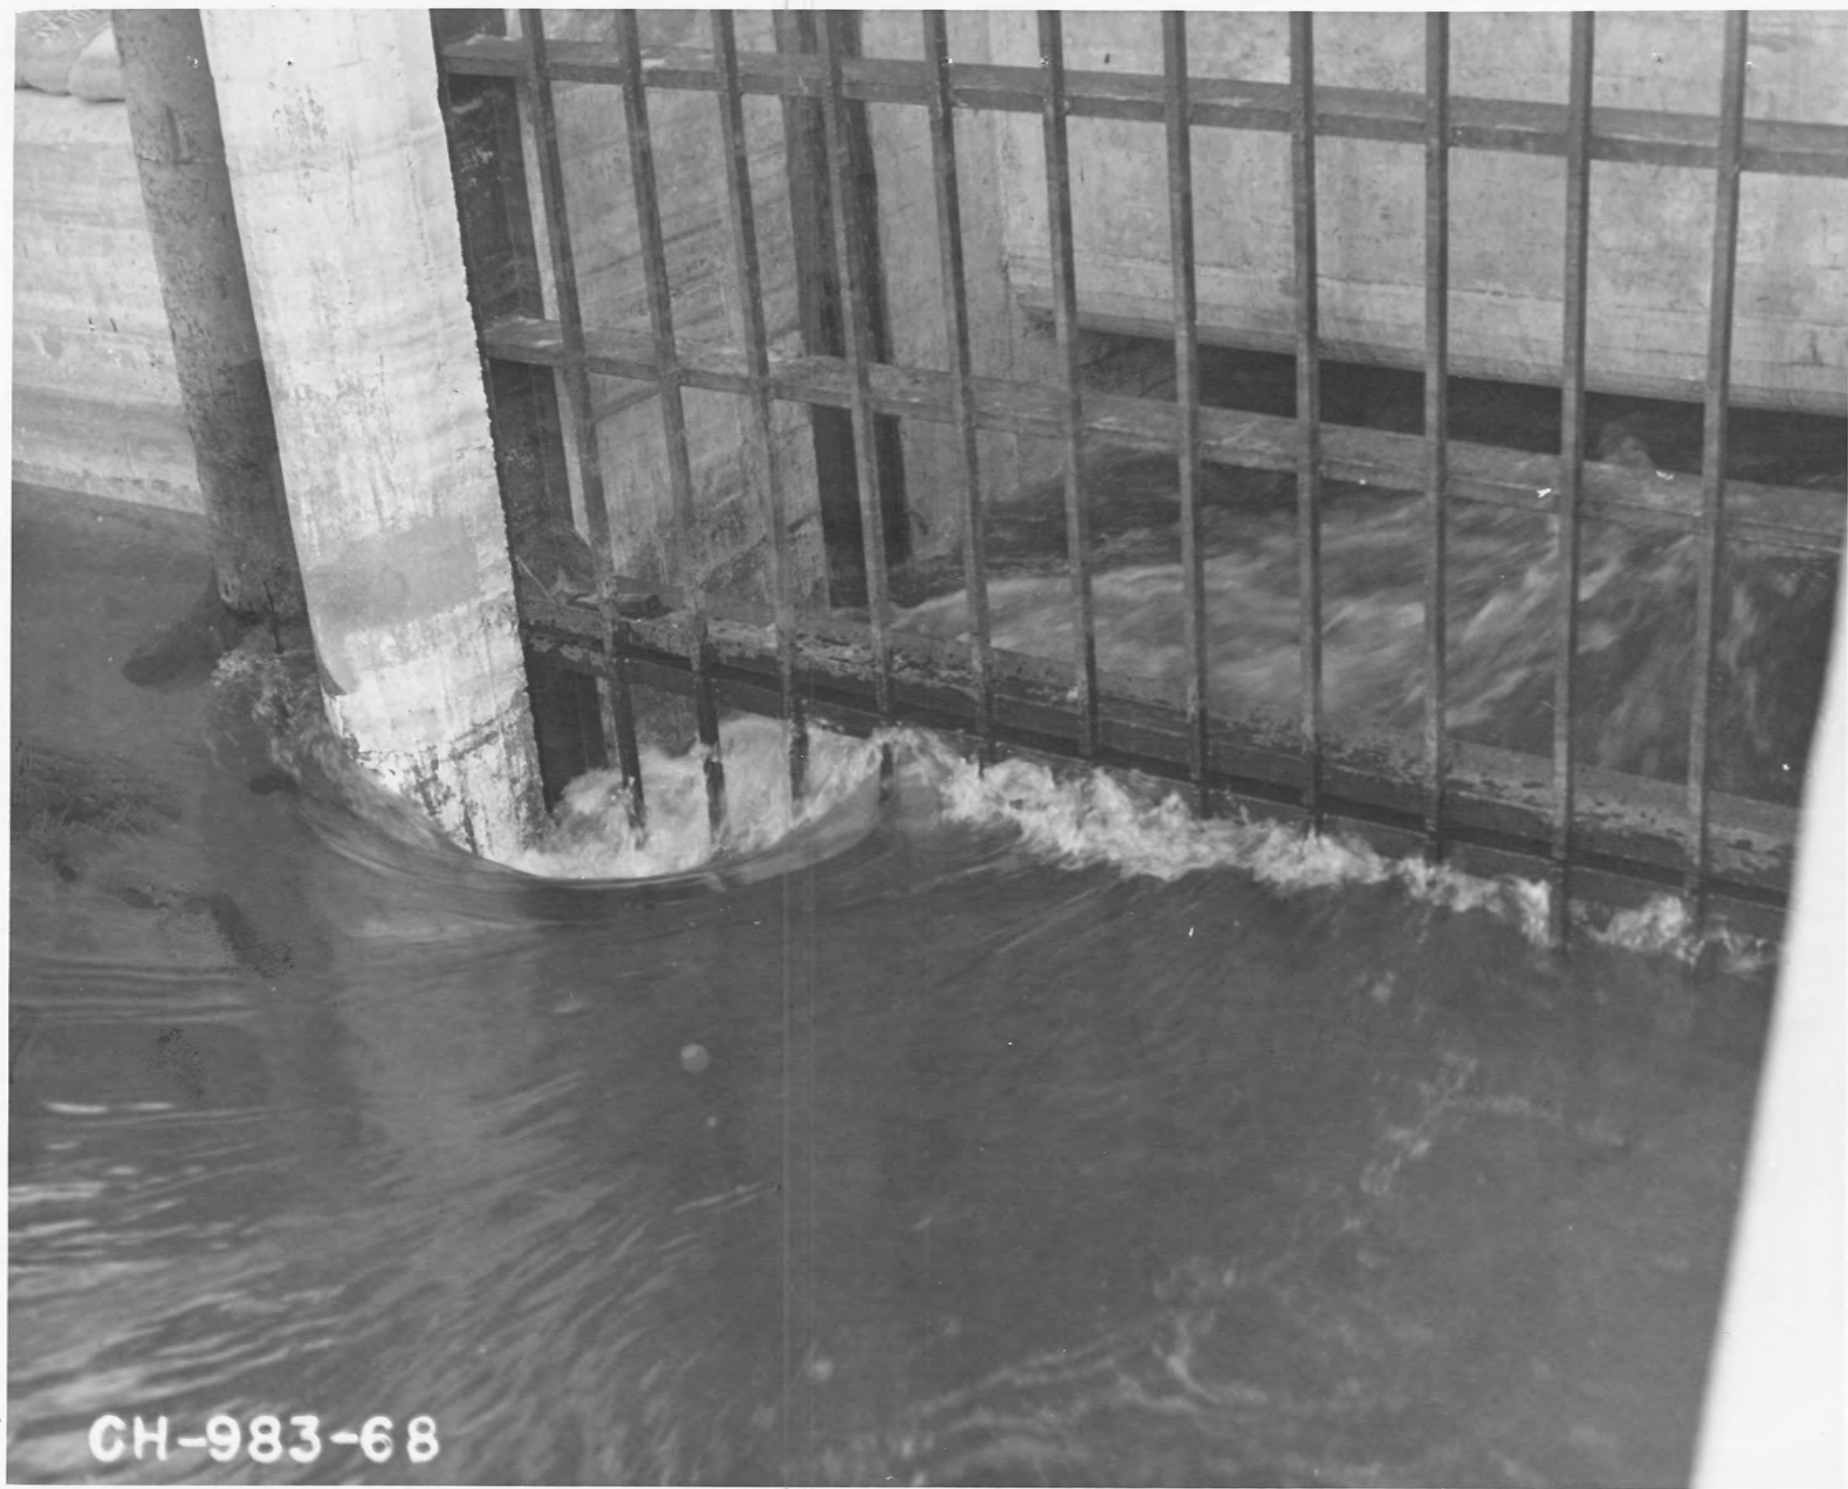
CH-983-68. Discharge of 575 second feet entering Aspen Creek Siphon--Showing drawdown around pier and flow into siphon entrance transition.

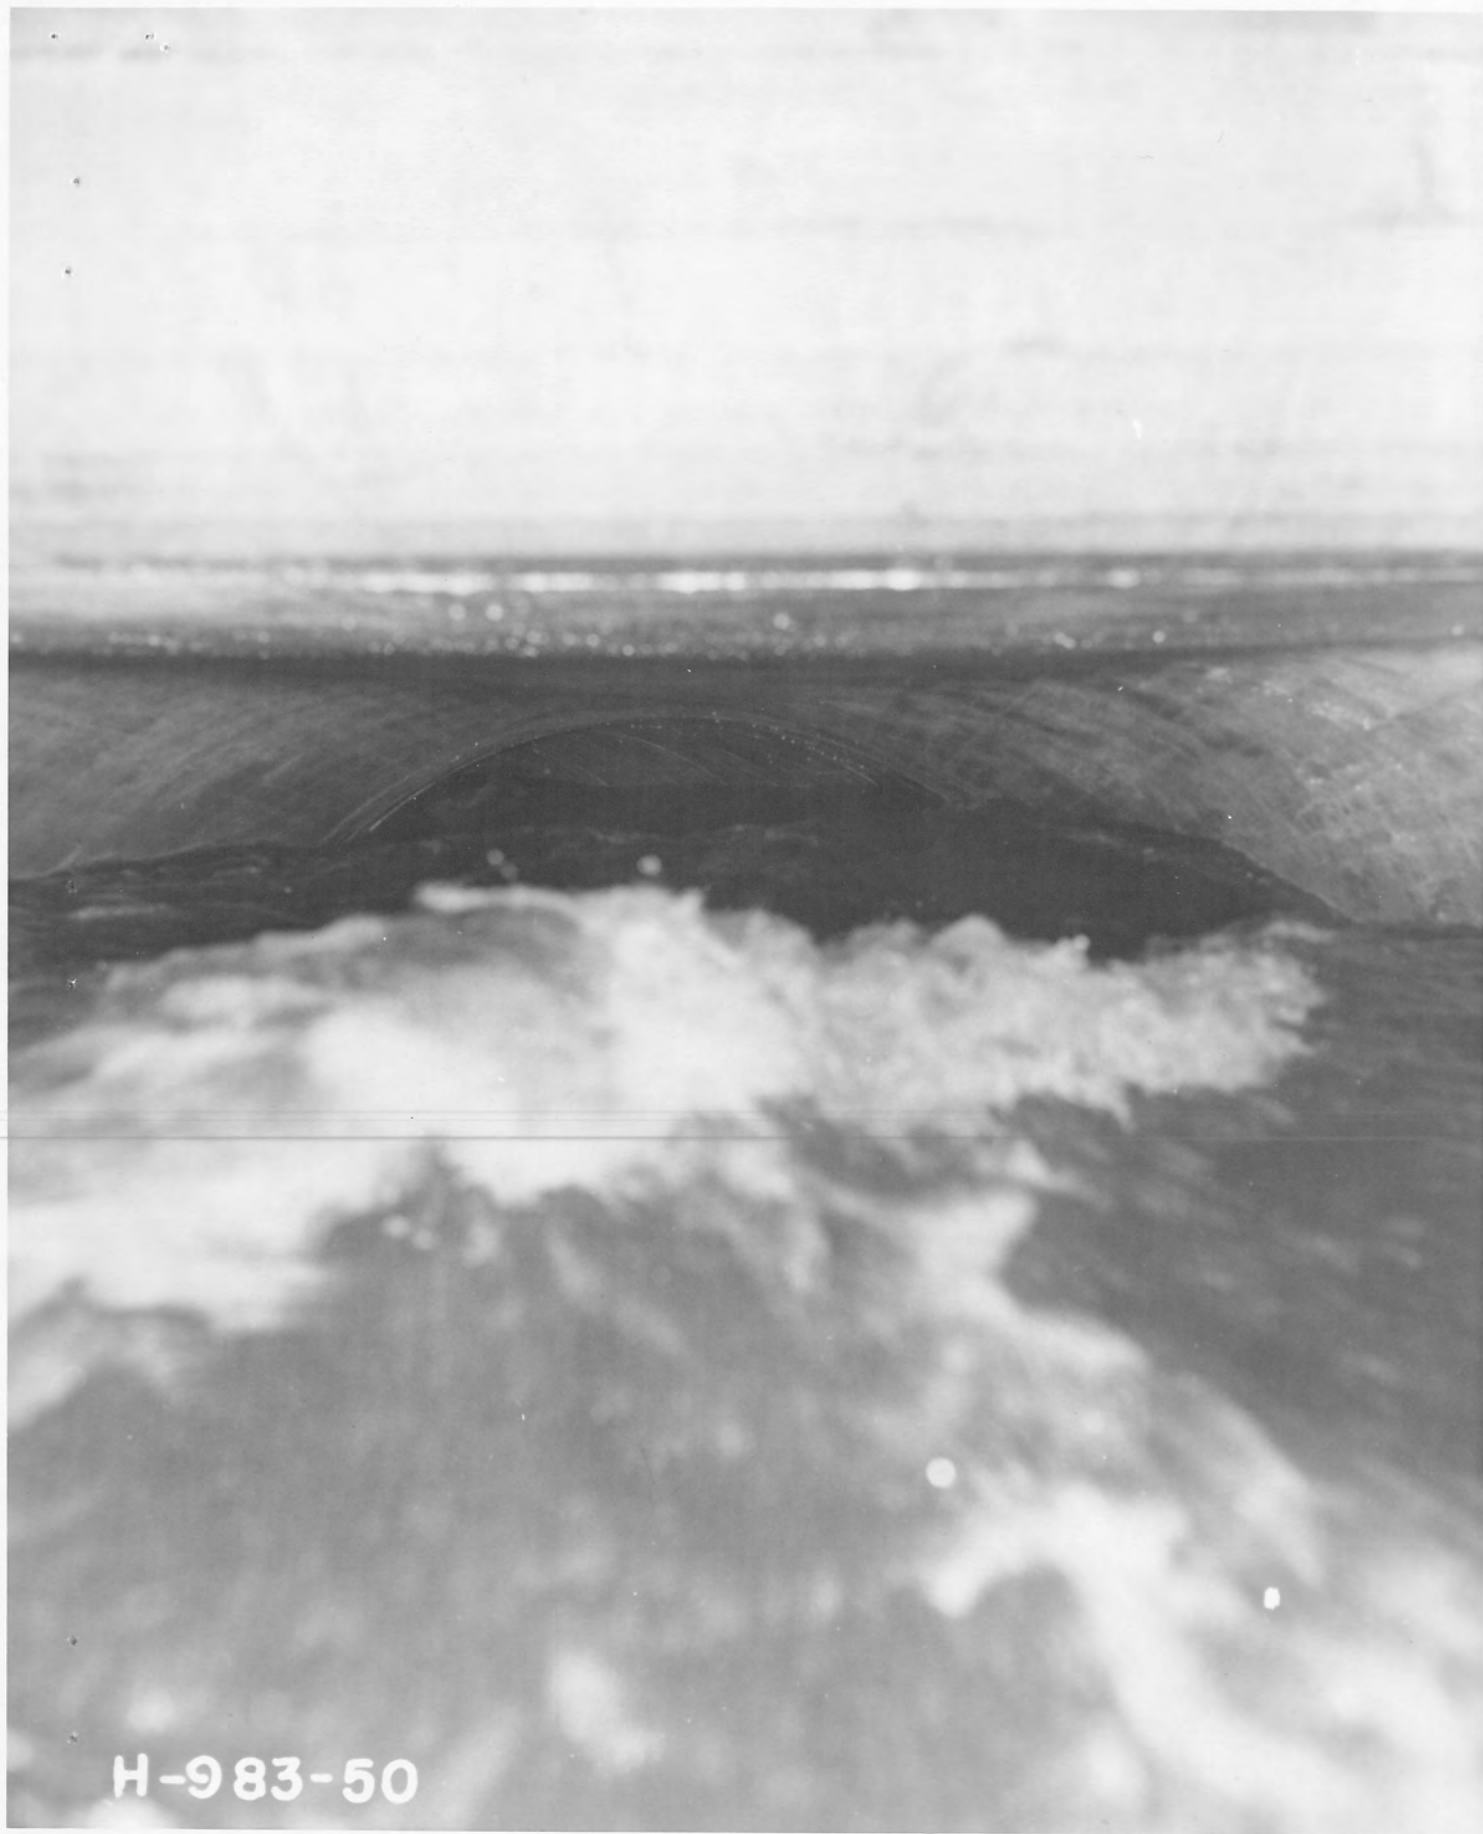
H-983-50

7. The head loss from the reservoir to the siphon transition inside the trashrack was measured and found to be approximately 1 foot. The siphon did not fill and waves on the water surface, estimated to be 5/10 of a foot high, could be seen as far as the bend in the tube downstream (see attached photograph). It was estimated that the tops of the waves were approximately 1.25 to 1.5 feet below the crown of the siphon at the entrance. Air could be heard popping in the siphon barrel, but it was impossible to estimate the distance downstream to where the tube filled. Rocks could also be heard rolling through the siphon entrance structure and striking the trashrack.

H-983-50. 575 second feet flowing into Aspen Creek Siphon. The flow disappears around the horizontal bend without filling the tube. The standing waves were estimated to be from 0.6 to 0.8 foot high.

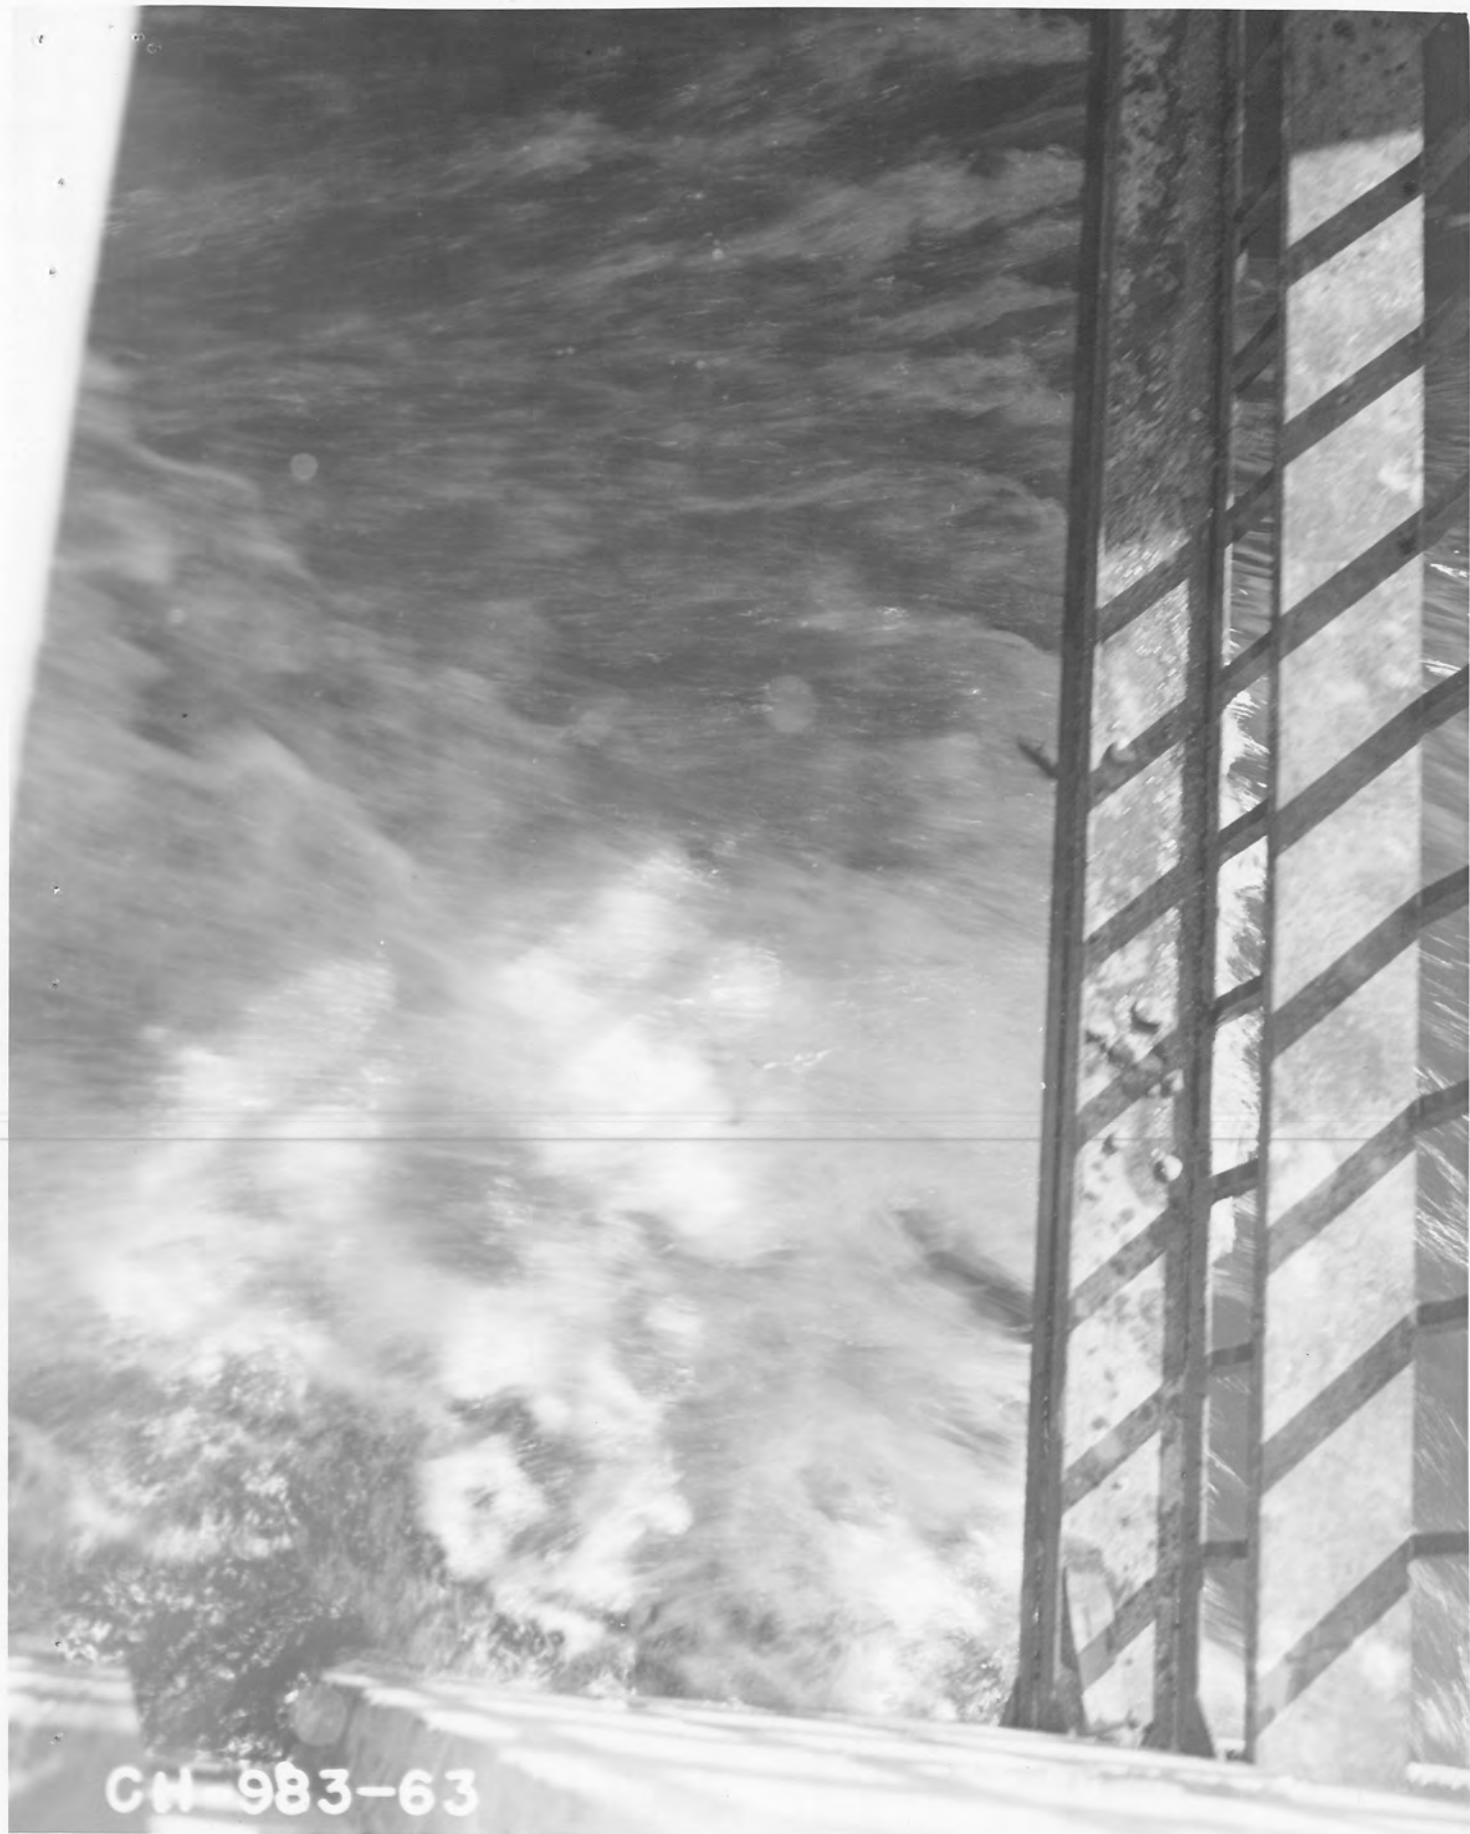
CH 983-63

10. The water surface inside the trashrack was very rough (see attached photographs), but an average of several readings indicated an elevation of 8253.10.

CH-983-63. Looking down on a flow of 575 second feet entering Aspen Creek Siphon just downstream from the trashrack--Note air in flow in foreground. The effect of the 1.4 foot high stop log is not noticeable.

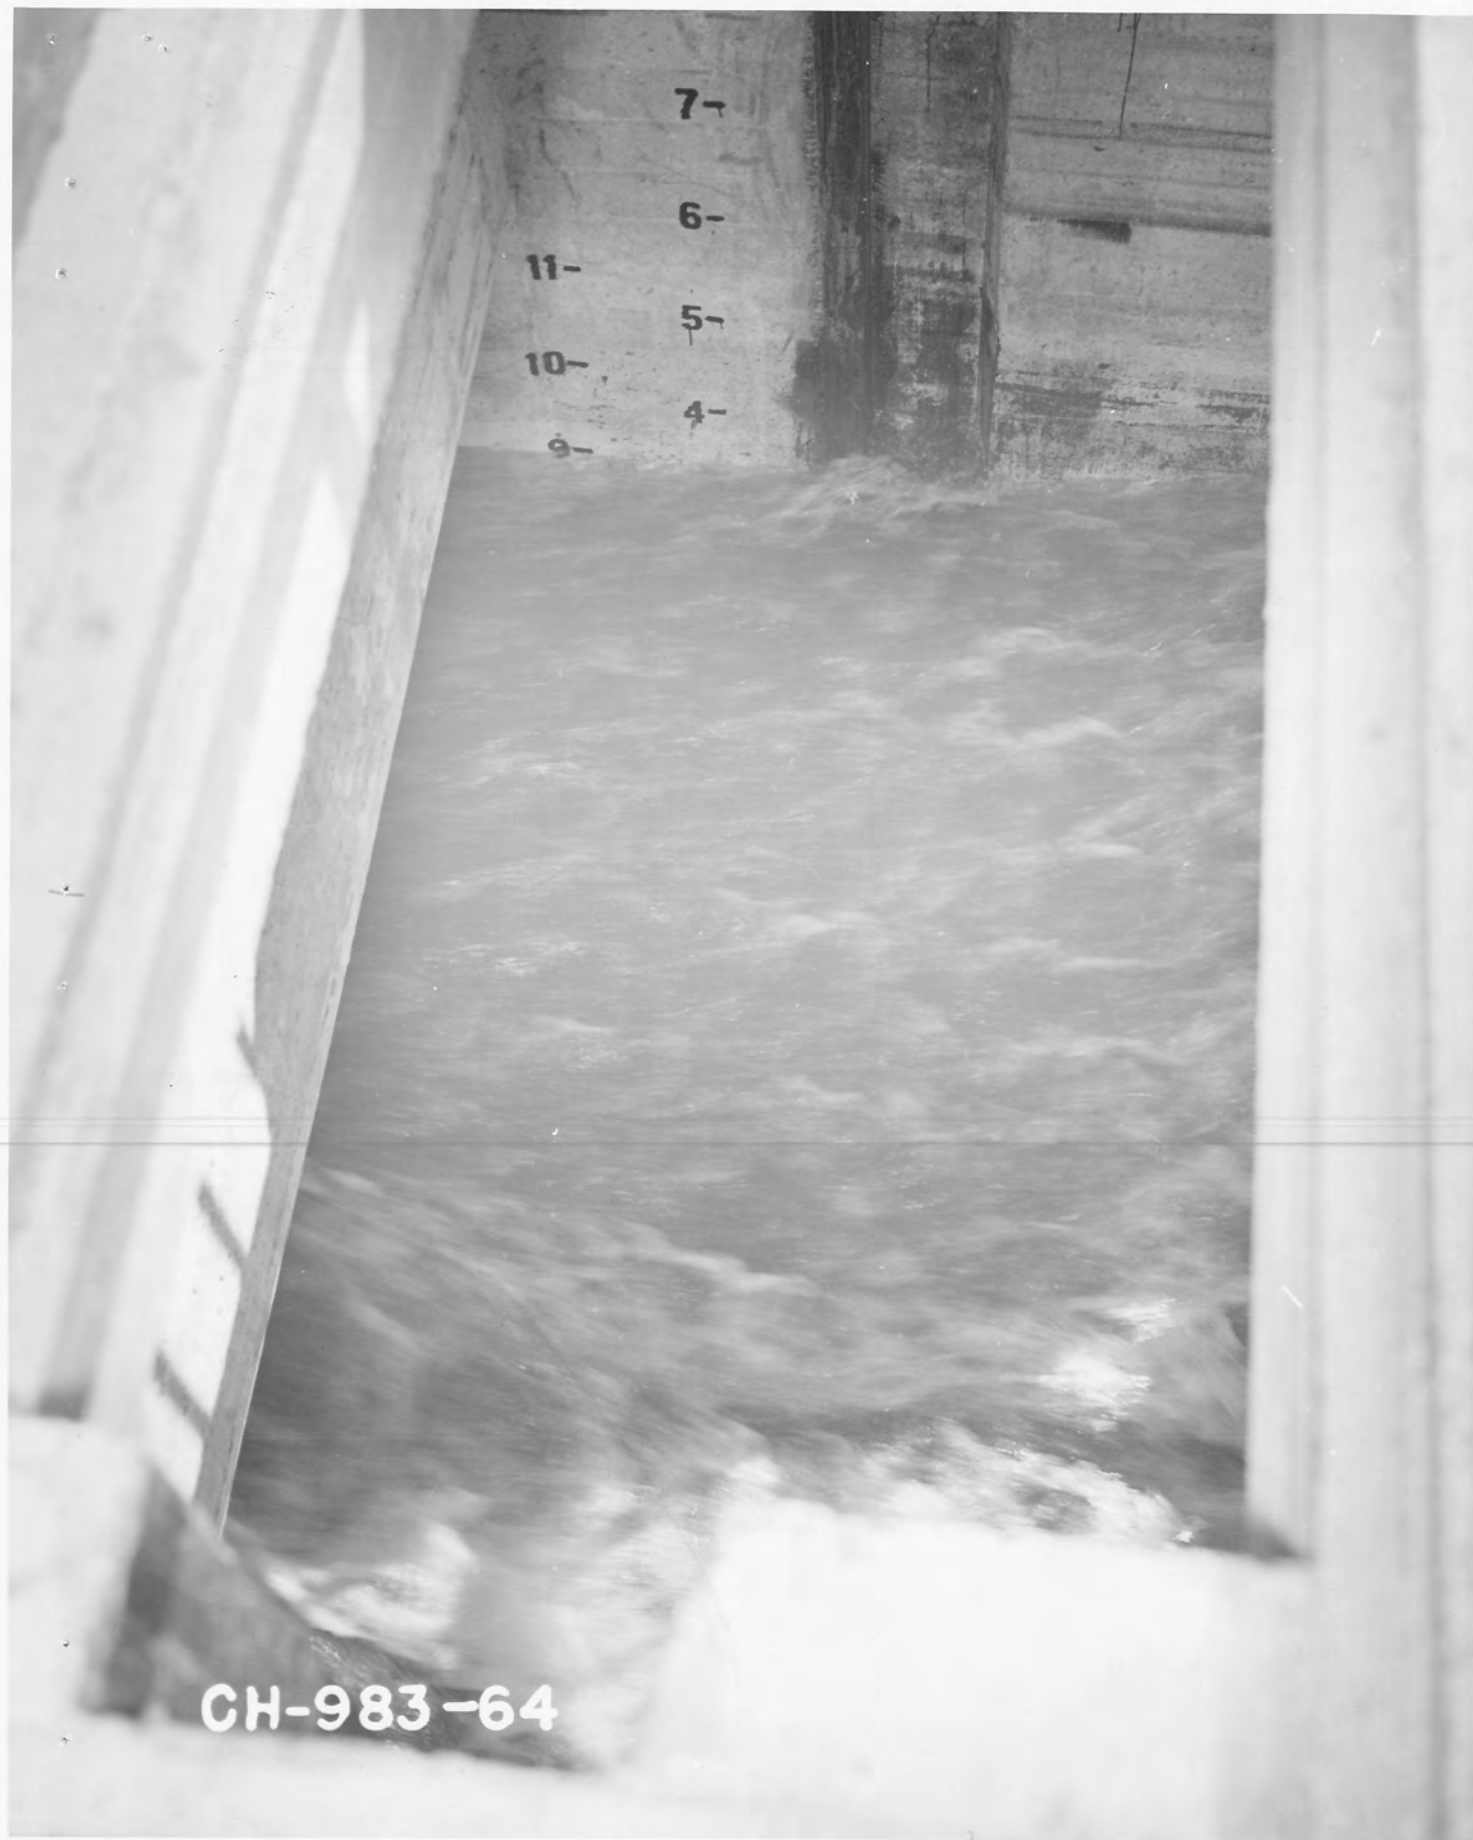
CH-983-64

CH-983-64. Looking down on a flow of 575 second feet entering Aspen Creek Siphon just downstream from the trashrack--The depth of water is 9 feet and the transition structure has a clear opening of 10.75 feet.

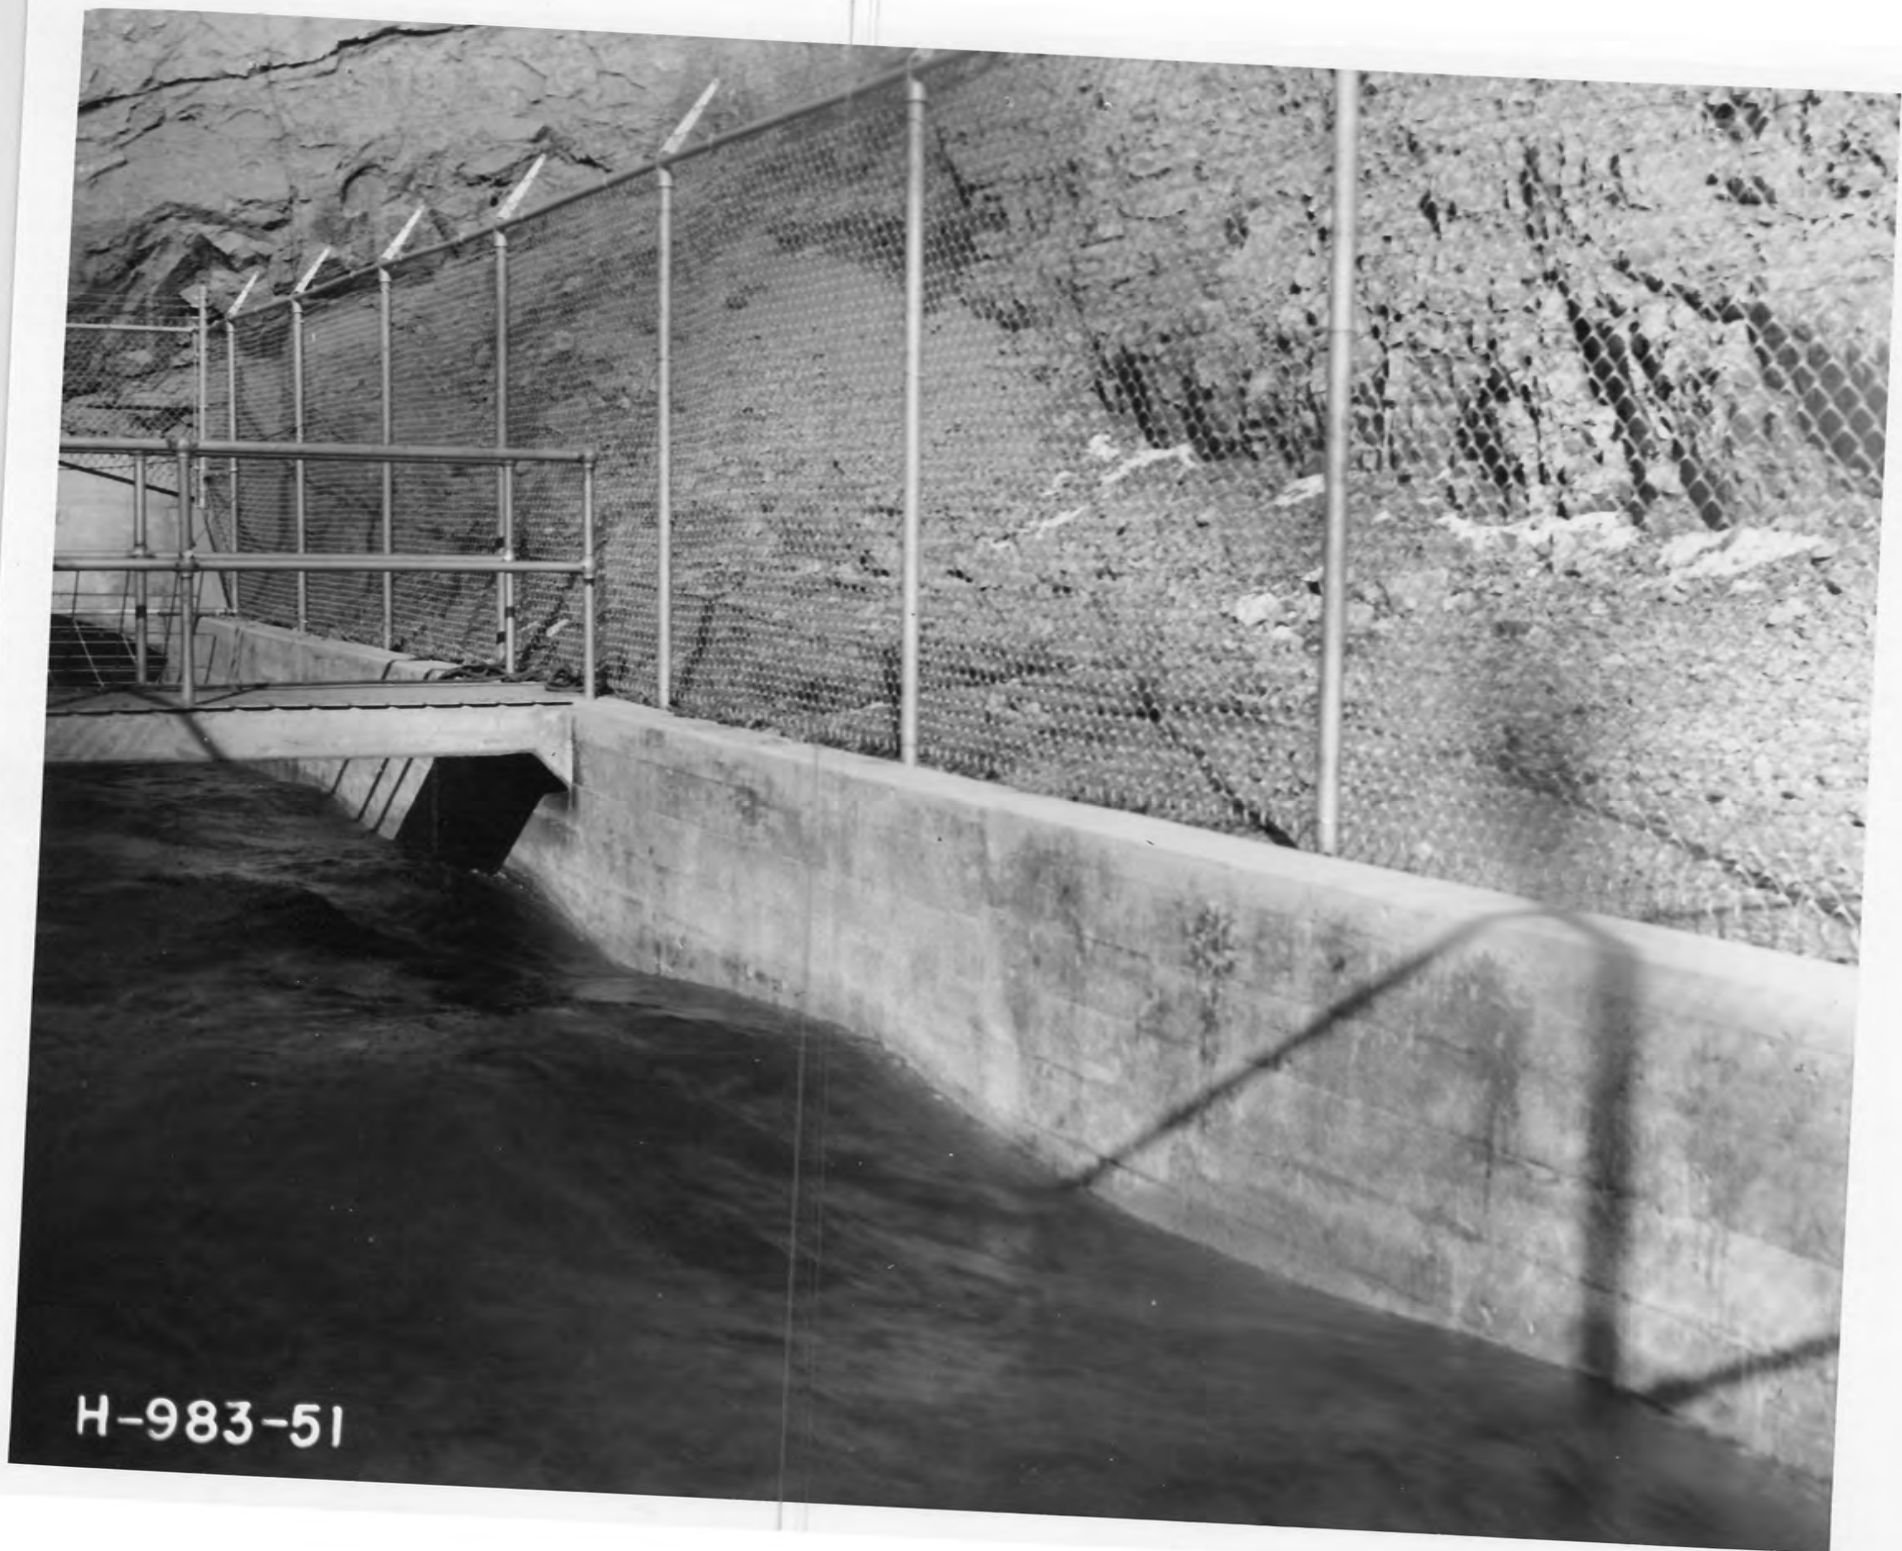
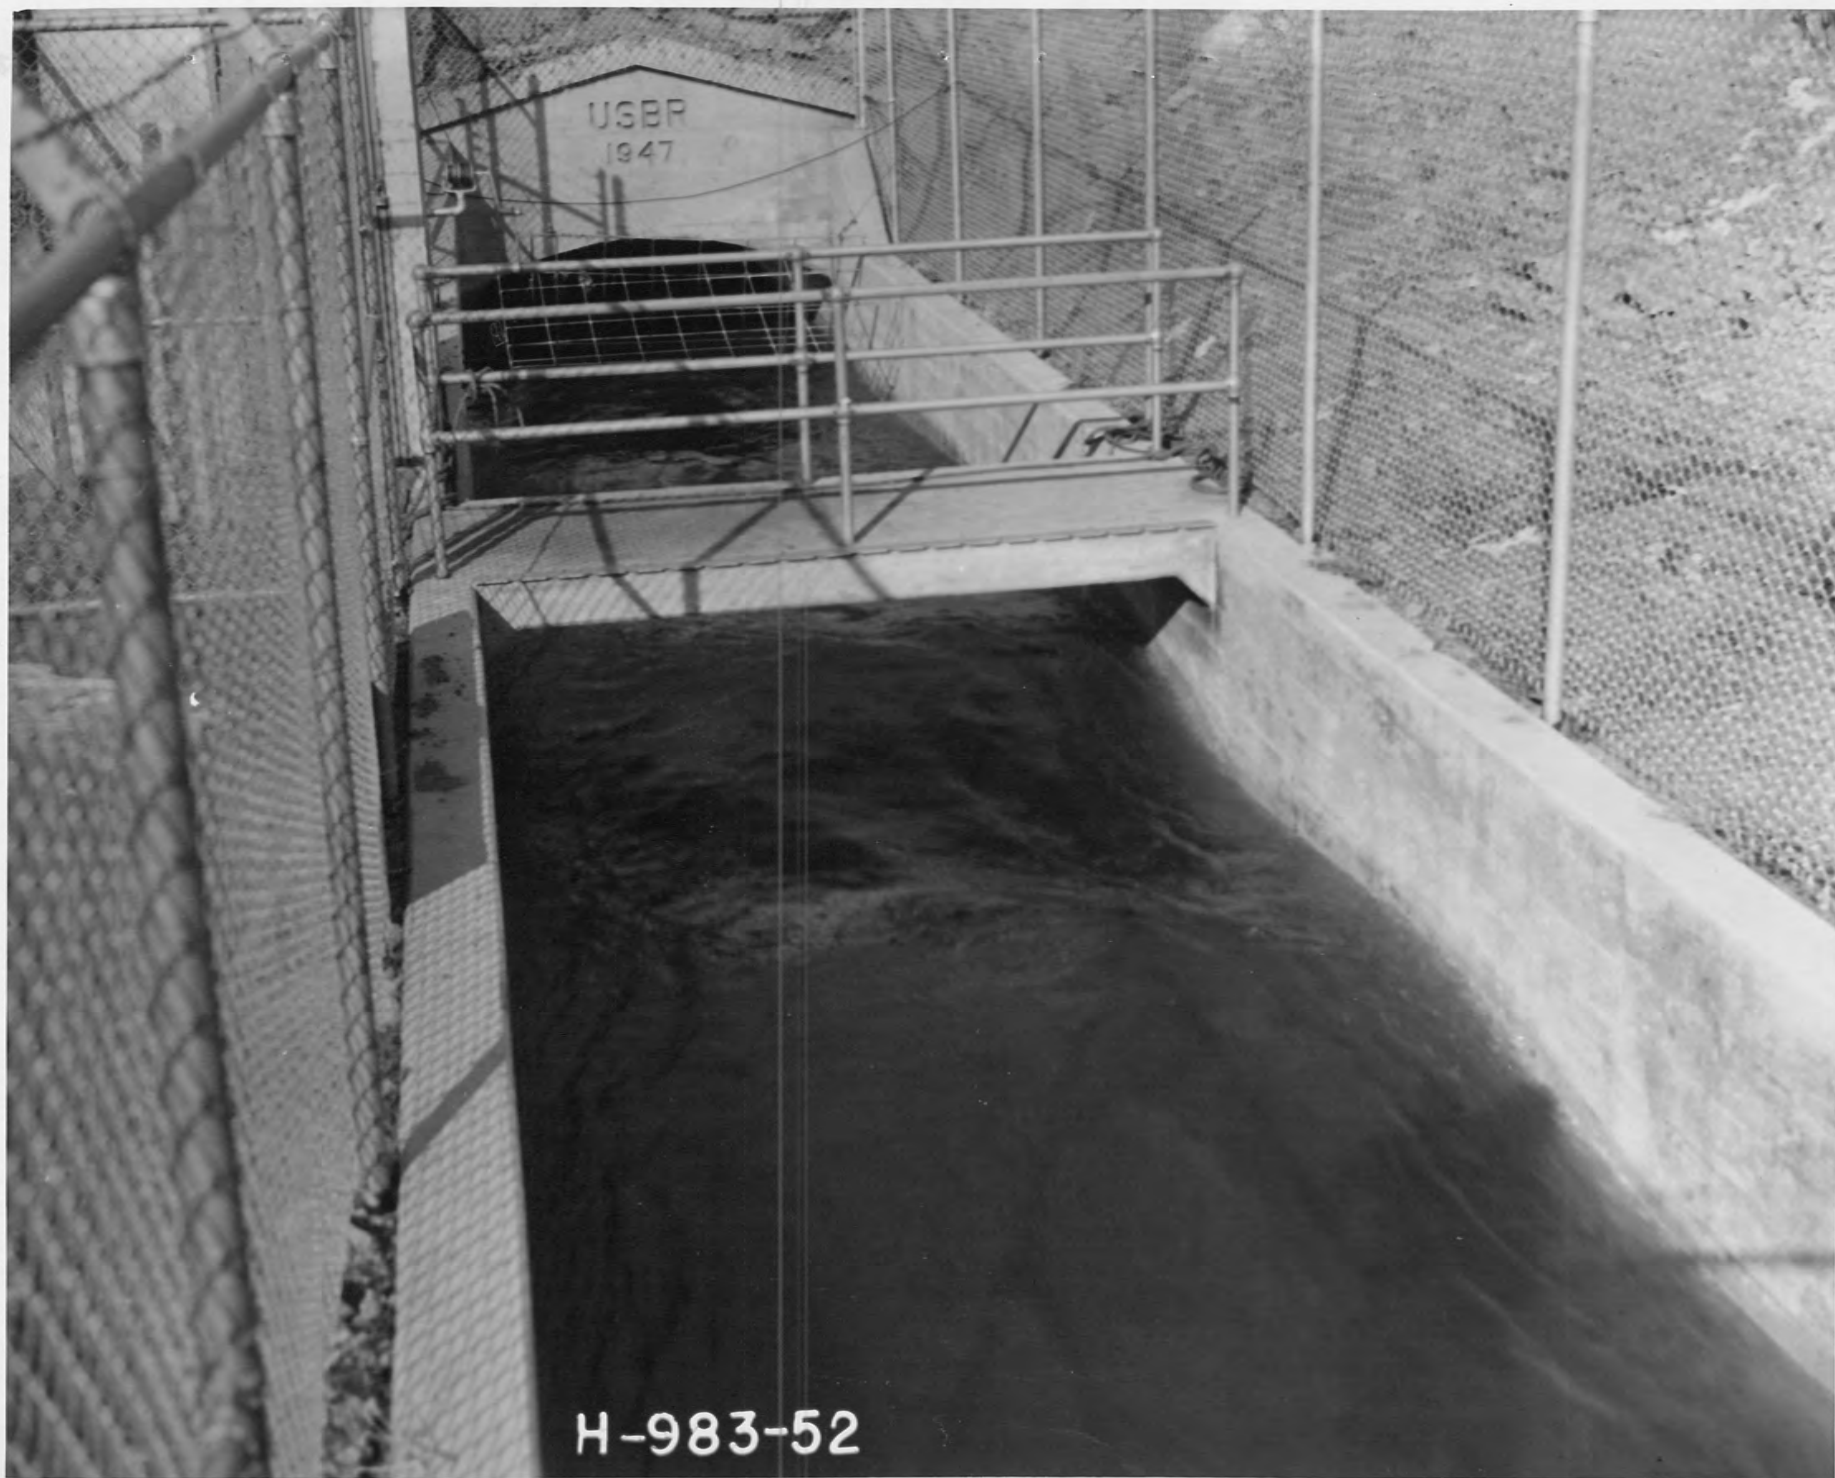
14. An inspection of the rating station at the downstream end of the Aspen Creek Siphon showed high velocities. Mr. Burgess stated that the water surface was steady for the maximum flow. I observed a number of standing waves between the end of the siphon and the entrance to Rams Horn Tunnel. These standing waves were approximately 15 feet apart and were from 6 to 8/10 of a foot in height. This is not a desirable condition to have in a gaging station (see attached photographs).

H-983-51 and 52. Flow conditions in the Aspen Creek gaging station--Looking downstream toward west portal of Rams Horn Tunnel. The standing waves were estimated to be about 15 feet apart and from 0.6 to 0.8 foot high. Discharge less than 575 second feet.

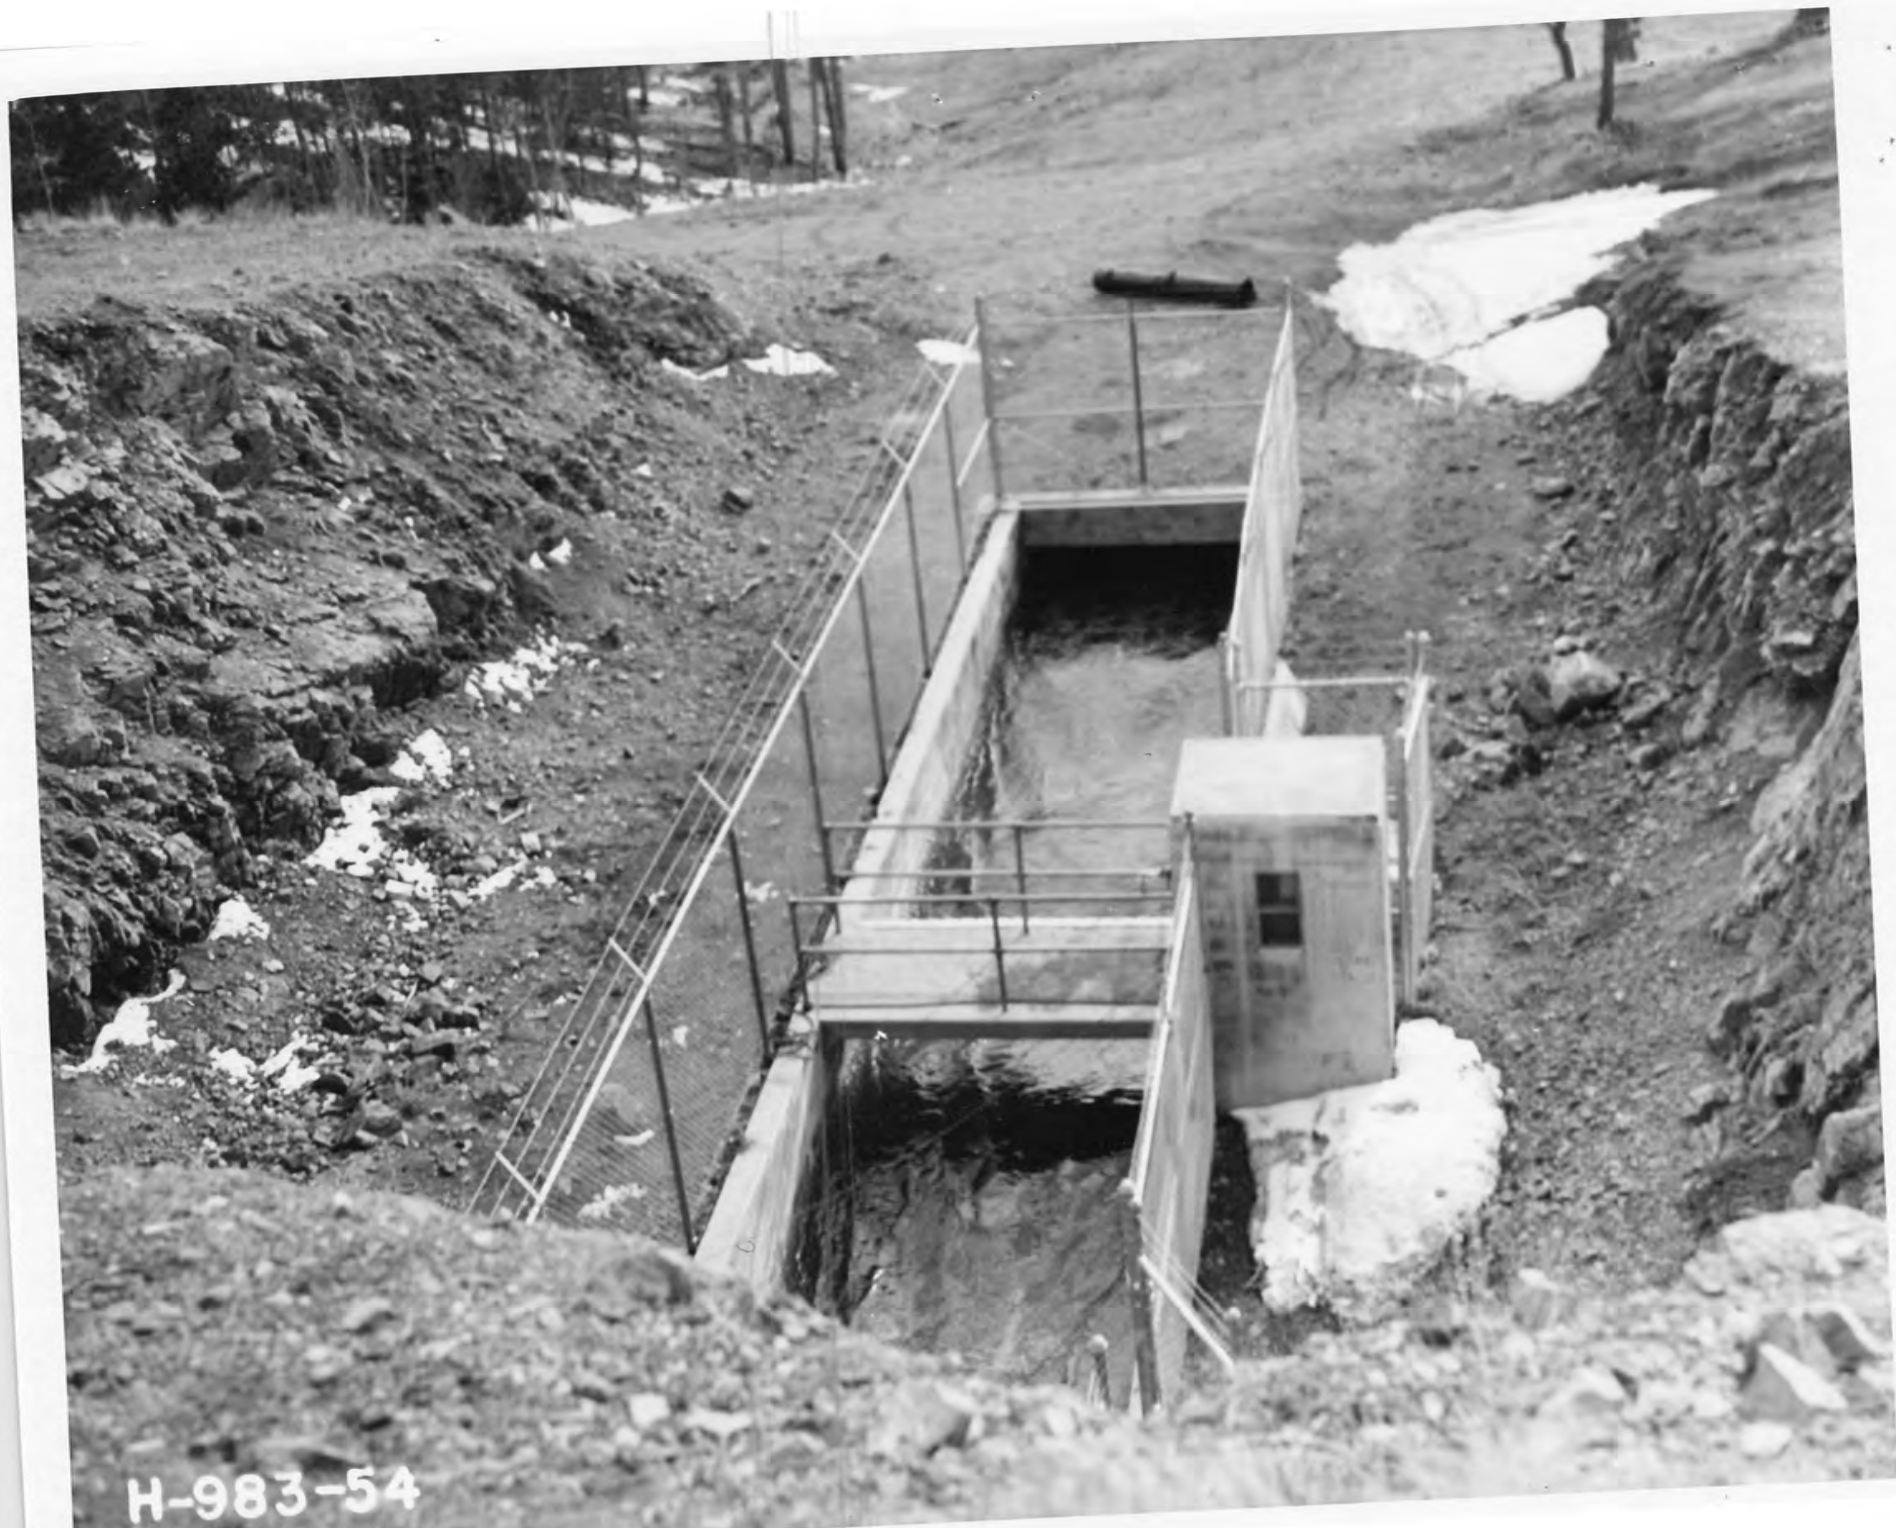
H-983-54

H-983-54. The Aspen Creek gaging station between the siphon and Rams Horn Tunnel. Taken from above west portal of tunnel looking upstream toward exit of siphon. Discharge less than 575 second feet.
