Correction to memorandum of April 10, 1951--Operating characteristics of hydraulic structures on the Colorado-Big Thompson Project east of the Continental Divide

Operating characteristics of hydraulic structures on the Colorado-Big Thompson Project east of the Continental Divide

CAPTIONS FOR PICTURES OF HYDRAULIC STRUCTURES ON
COLORADO-BIG THOMPSON PROJECT
EAST OF CONTINENTAL DIVIDE

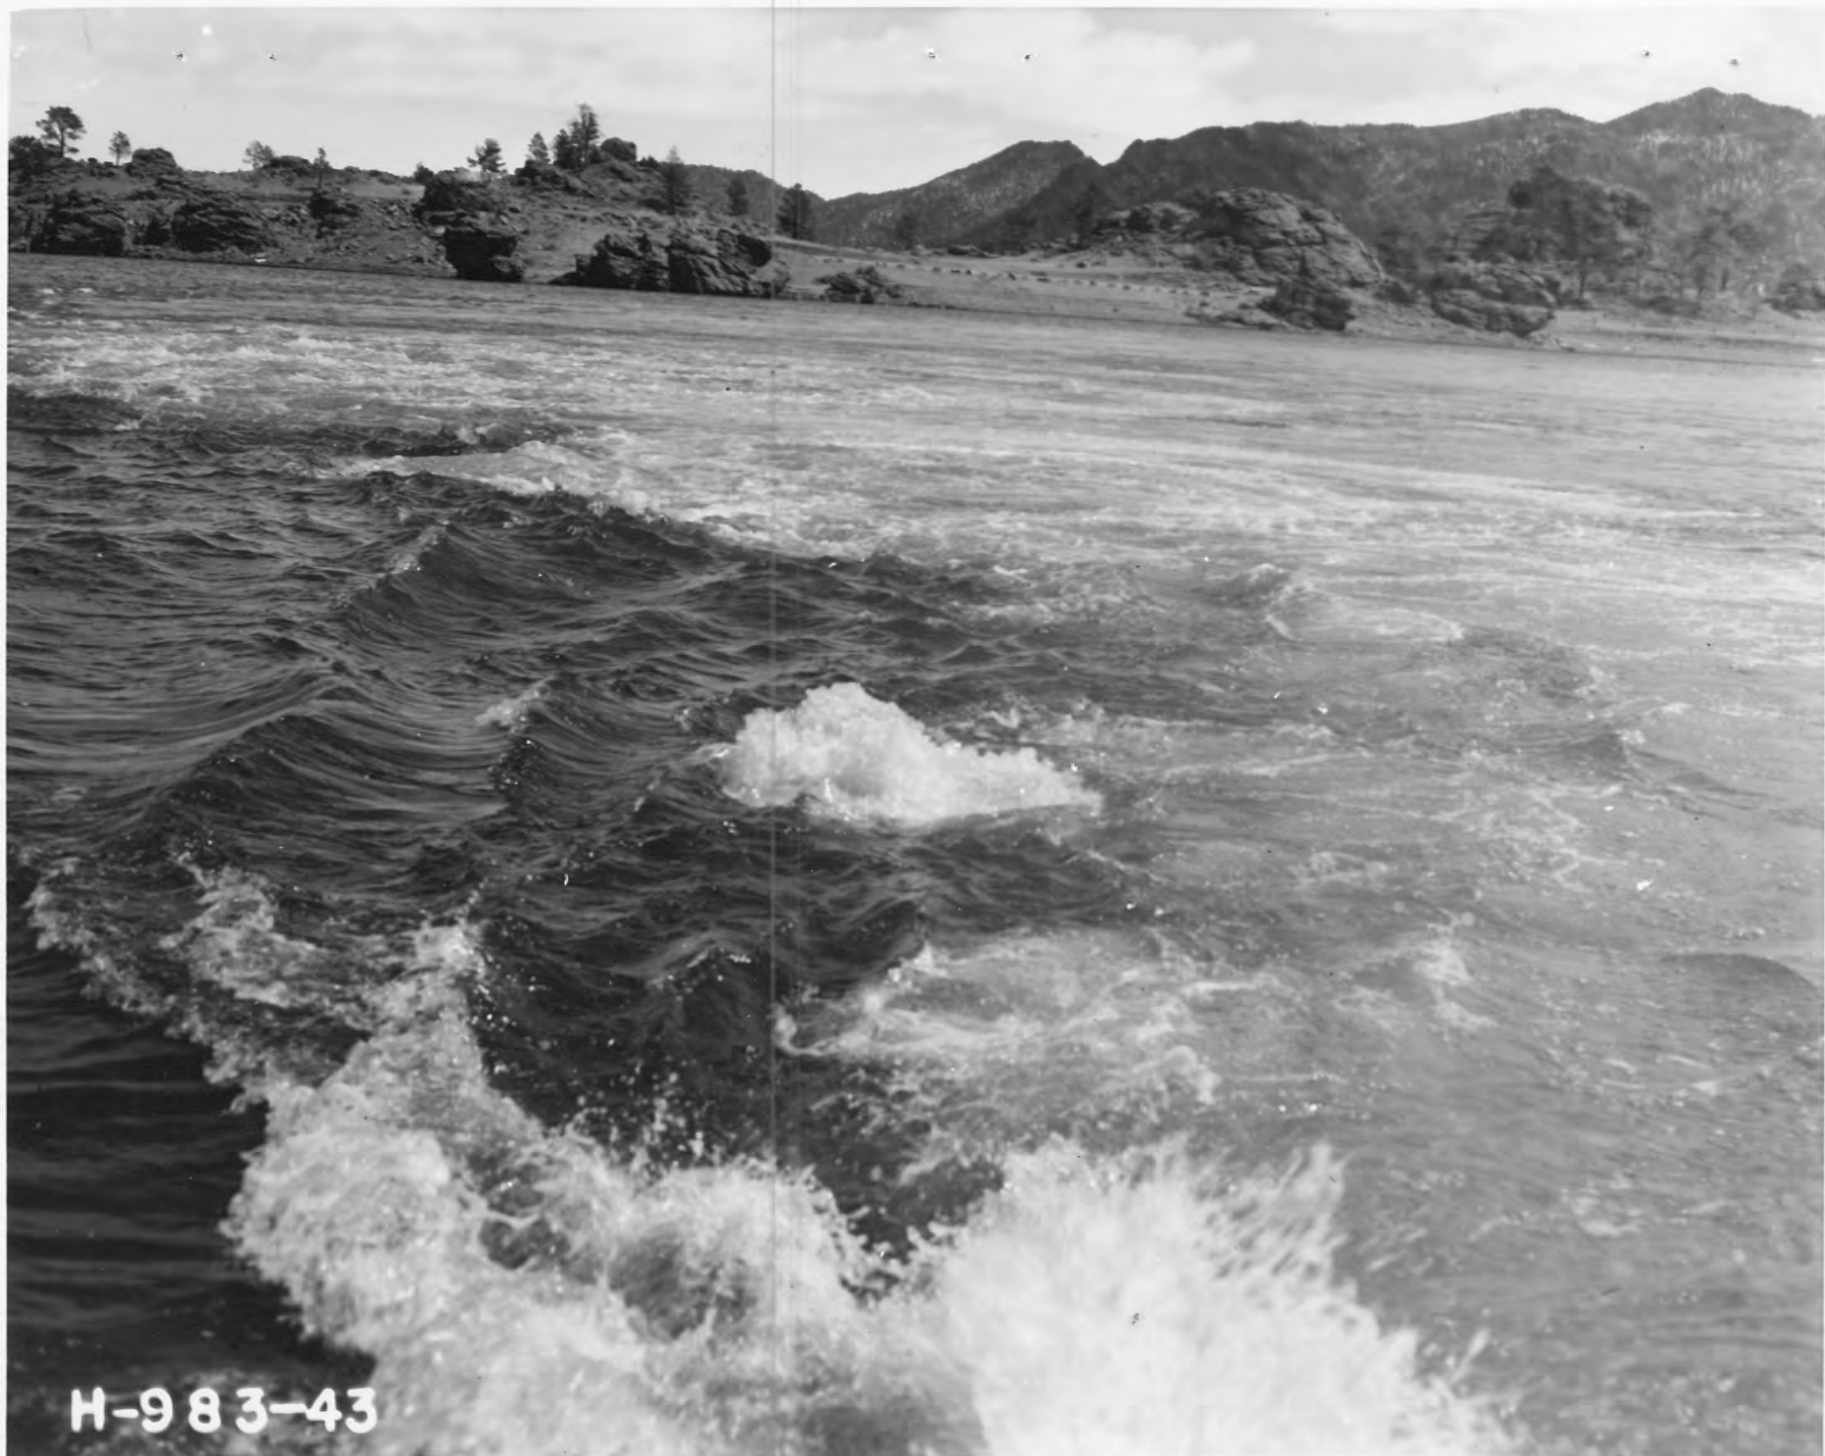
H-983-43

16. Since the water was flowing through the bypass chute at the rate of approximately 550 cubic feet per second, I took a few pictures of the flow conditions at this chute. The entire structure appeared to be vibrating considerably, and the vibration could be felt on the ground around the concrete structure.

H-983-43. Flow of 575 second feet entering Marys Lake from bypass chute around Marys Lake Power Plant--Note turbulence in lake especially the boil at the end of the damaged chute.

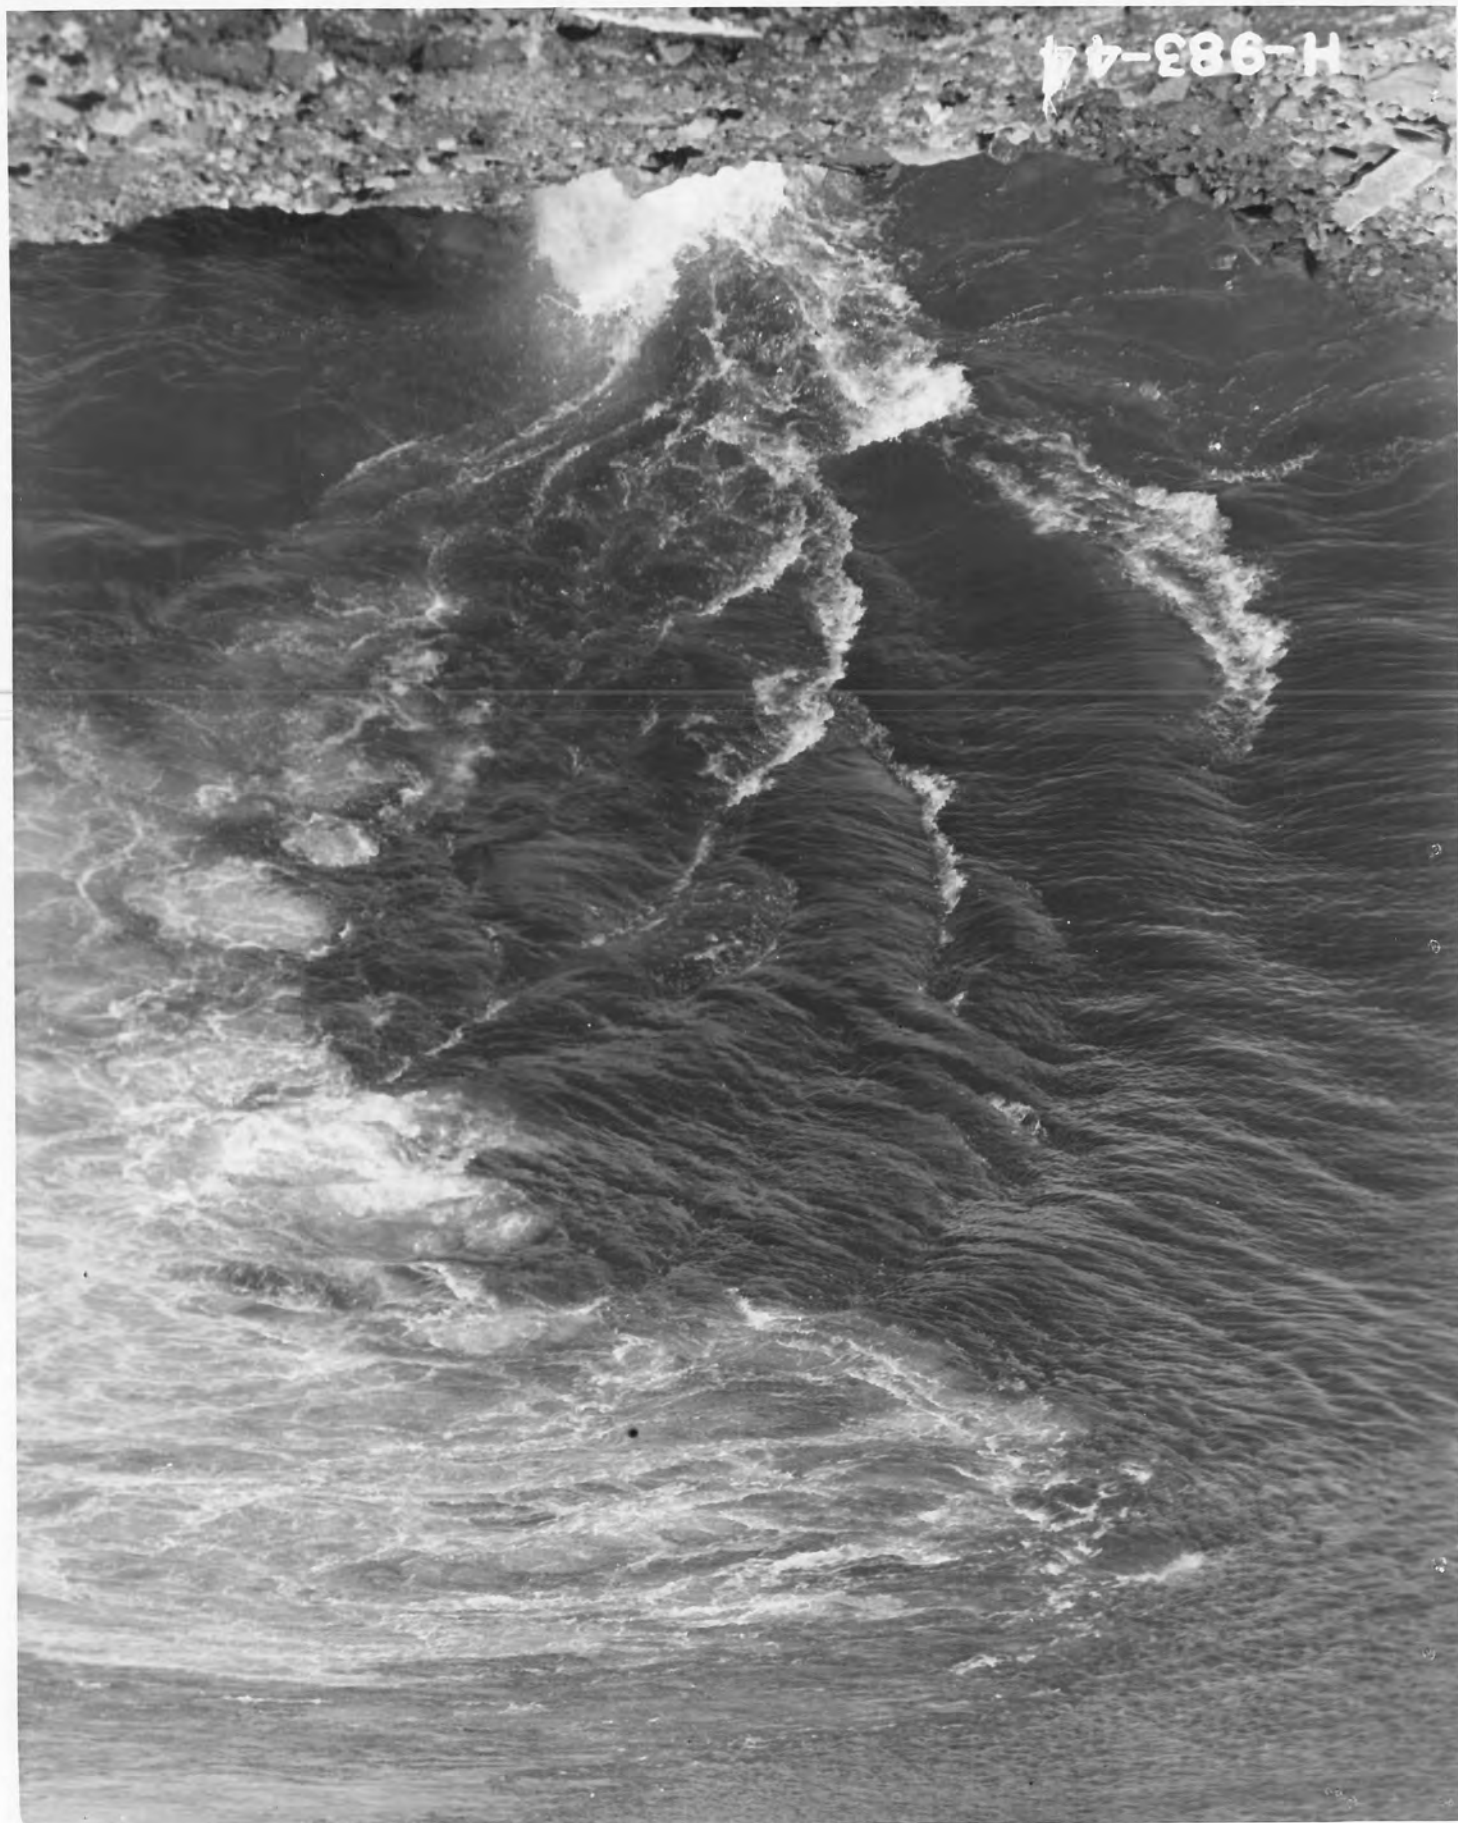
H-983-44. 575 second feet entering Marys Lake from bypass chute--Taken from above the exit of the damaged structure.

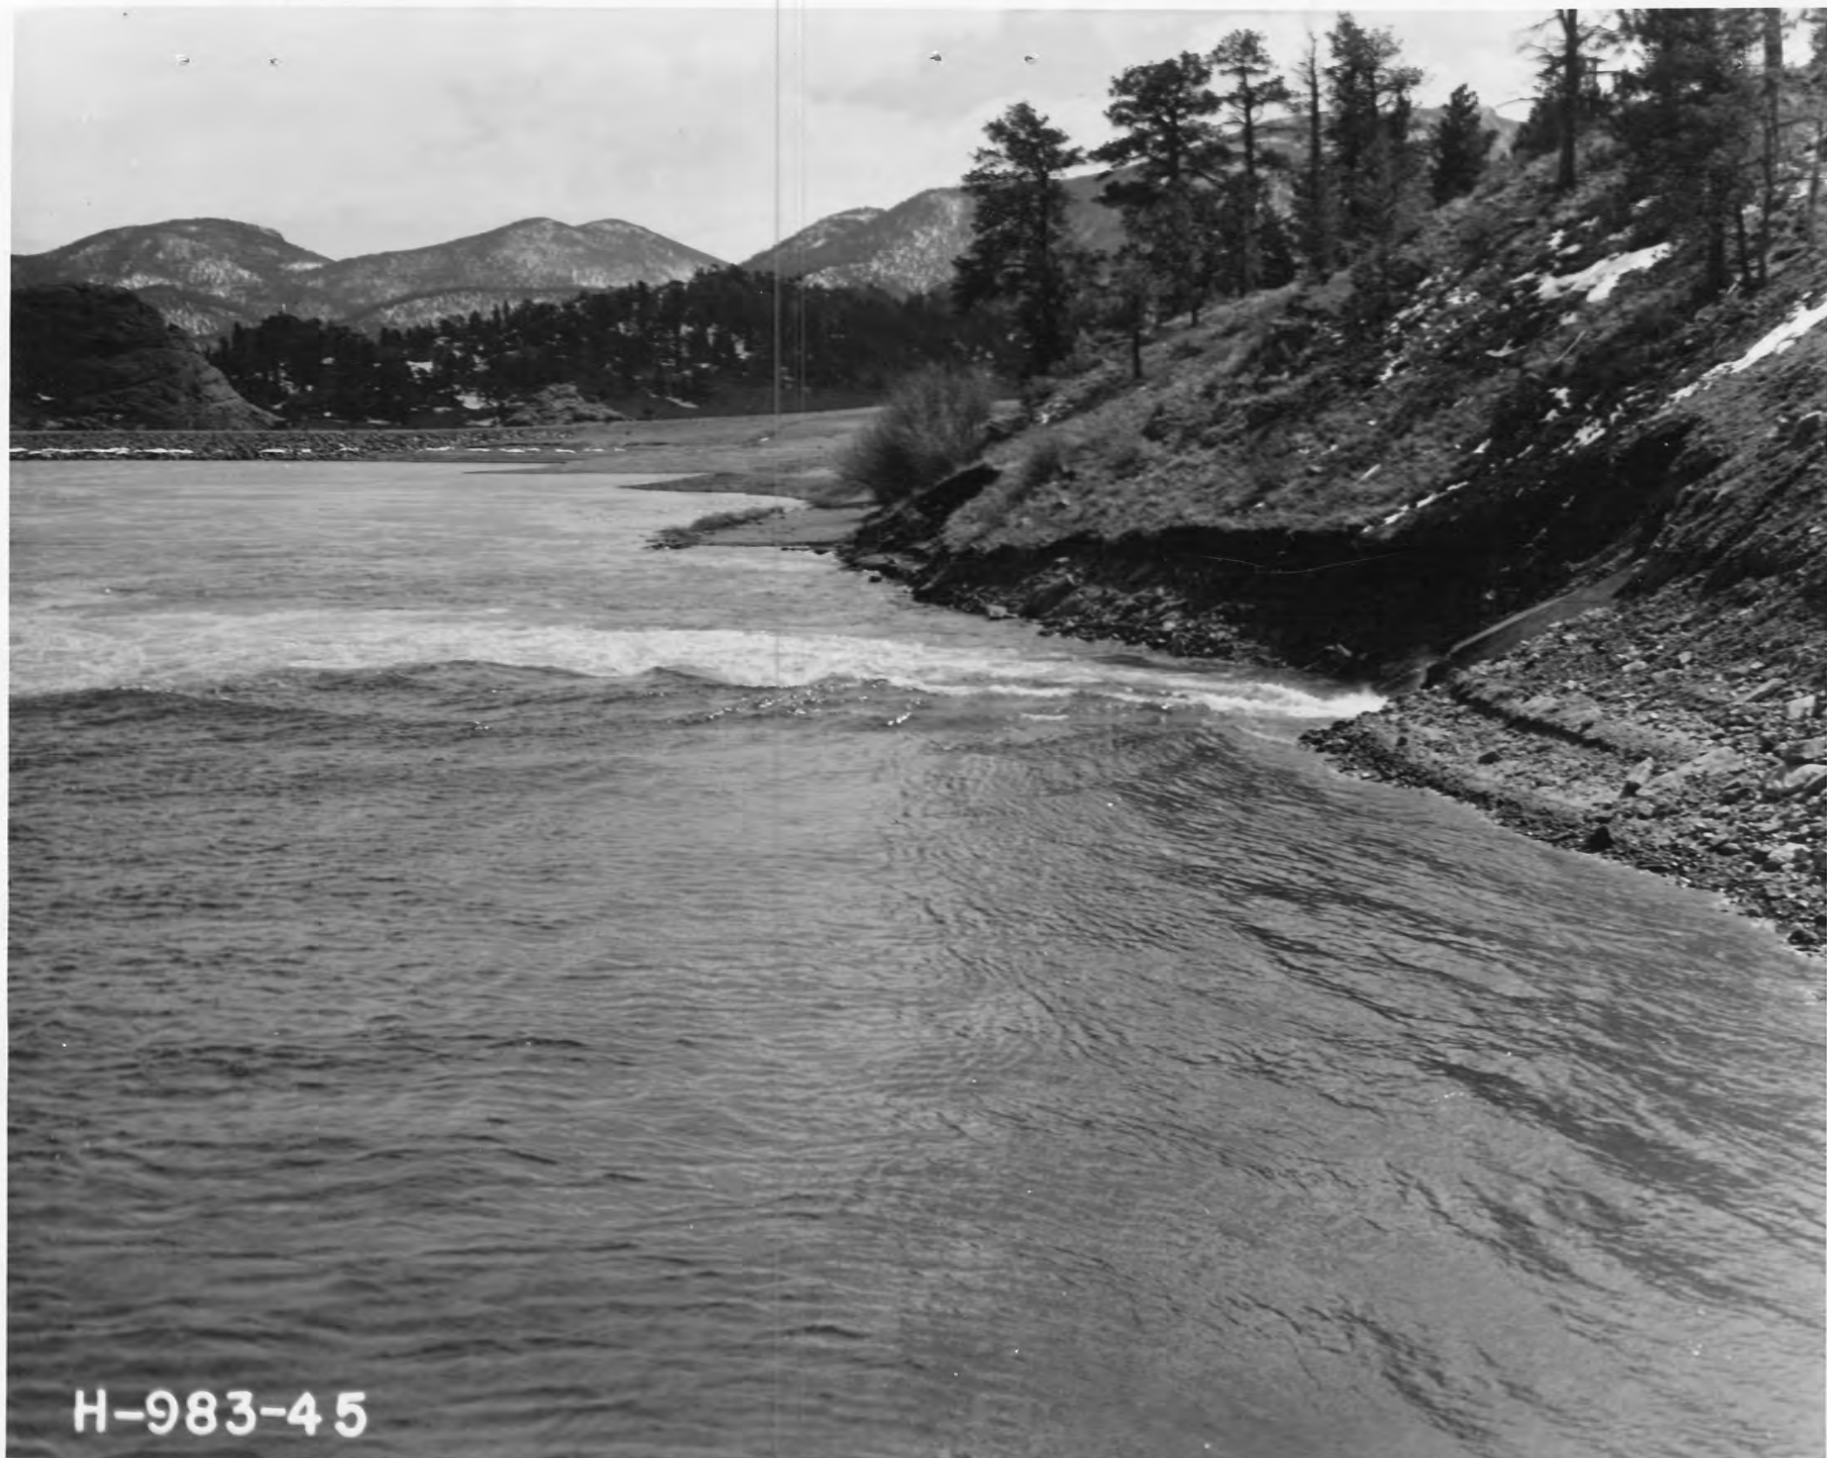
H-983-45

H-983-45. 575 second feet entering Marys Lake from bypass chute--Taken from right downstream corner of Marys Lake Power House.
