PROTOTYPE BEHAVIOR OF MORNING-GLORY SHAFT SPILLWAYS

J. N. Bradley

Engineer, Bureau of Reclamation  
Design and Construction Division  
Denver, Colorado

A paper for the  
Summer Convention, ASCE,  
Denver, Colorado, June 1952

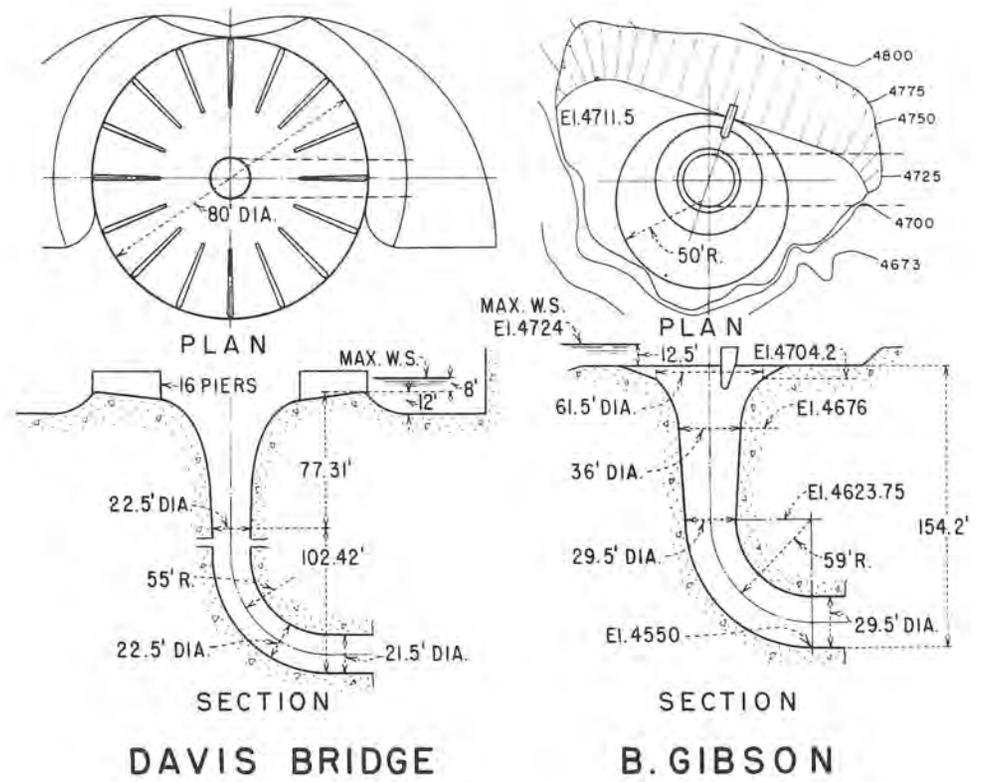
Figure 2

Davis Bridge spillway on the Deerfield River near Whitingham, Vermont, was completed about 1925. This spillway (Figure 2) was designed for a maximum discharge of 27,000 cfs, a drop of 180 feet, and a head on the crest of 8 feet. Reports indicate that this structure has discharged a number of times for short periods. The maximum discharge occurred in the September hurricane flood of 1938 when the water reached an elevation of 6 feet on the crest. The computed discharge at that time was about 19,000 second feet, or 72 percent of capacity. The spill during this flood exceeded 10,000 second feet, for about 15 hours' duration. Inspection after the flood showed no appreciable erosion of the concrete in the horizontal part of the tunnel. Several small erosion pockets were apparent at the vertical bend, but it was not certain whether this was caused by erosion due to velocity or spalling due to freezing and thawing of the concrete surfaces. In any event, the repairs were of a minor nature. The report goes on to say that all ice and debris which passed over the crest between the piers has readily gone through the spillway. Logs and trees 50 to 60 feet long have passed through the spillway at times. The spillway makes some noise when it is in operation, but this can be heard only a short distance from the dam, and vibration appears to be no problem.

The Gibson spillway on the North Fork of the Sun River in Montana, a Bureau of Reclamation dam, was completed about 1926. This structure (Figure 2) was designed for 50,000 cfs, a drop of 160 feet, with 20 feet of head over the crest. Later the crest portion was altered and six radial gates were installed. The report states that during the month of May 1938, a total of 435,000 acre feet of water flowed through the spillway. The peak of this flow amounted to 13,000 second feet, or 26 percent of capacity. Upon inspection of the tunnel in 1948, two spots about 5 feet in greatest dimension, oval in shape, and about 2 inches deep, prominently displayed erosion in the vertical bend. Water passing through the spillway in the 1948 season caused them to show additional erosion. From the irregular and misaligned nature of the vertical bend, it would be unfair to tie down the responsibility for this erosion to any one cause. The report goes on to state that no ice has passed through the spillway, but large trees have passed through it during flood season with no apparent damage. Noise was reported to have been considerable, increasing as the discharge, but this was not particularly objectionable. Vibration was considered normal, and in no way detrimental. With radial gates, vortex action is no problem.

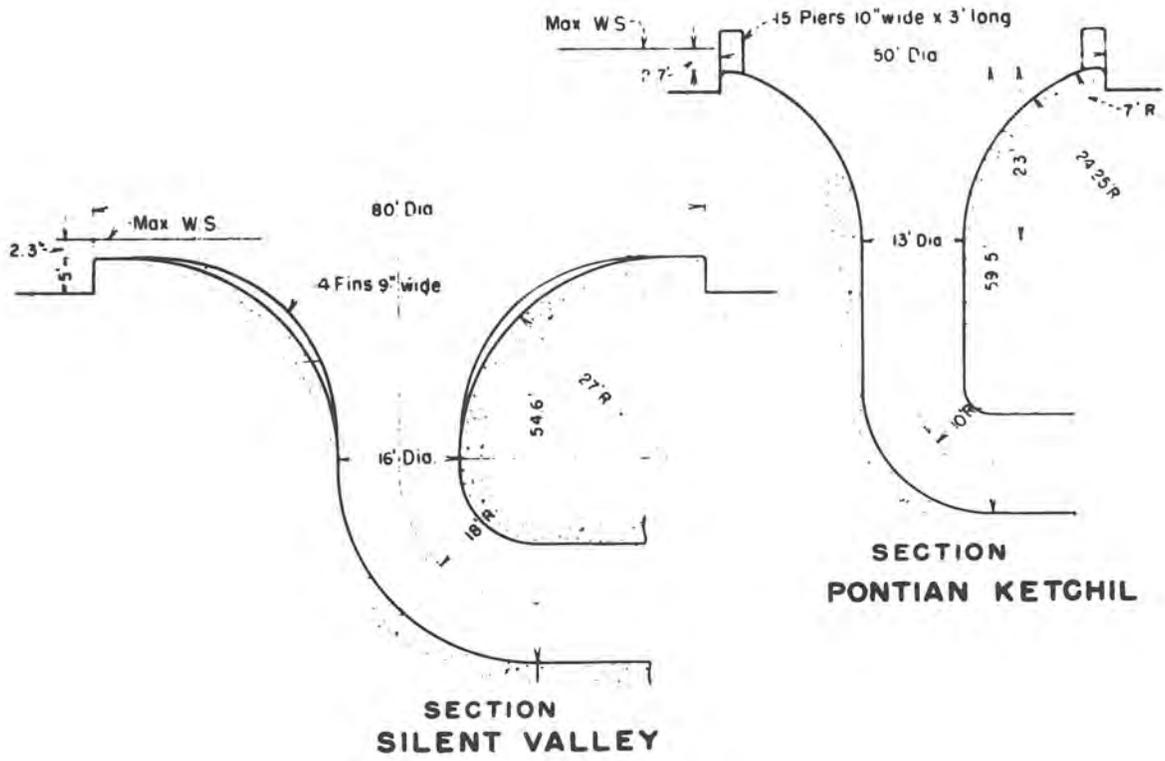
Figure 3

Two British conservatively designed morning-glory spillways were completed in 1926 and 1927, the Silent Valley in Ireland and the Pontian Ketchil in Singapore (Figure 3). The Silent Valley spillway was designed for a capacity of 2,600 cfs, a 55-foot fall and 2.3 feet of head on the crest. The Pontian Ketchil spillway was designed for a discharge of 2,700 cfs, a fall of 60 feet, and a head of 2.7 feet on the crest. Mr. Binnie informs us that the Silent Valley and Pontian Ketchil spillways have operated as expected without appreciable erosion of any kind and without unusual repairs. Apprehension that erosion might occur caused the designers of the Silent Valley spillway to line the vertical bend with cast iron. The Pontian Ketchil spillway is situated in the Malayan forest where cyclonic storms occur of such intensity as to uproot large trees and carry them for considerable distances. Many of

these have passed through the spillway without damage. Antivortex devices consist of four fins on the Silent Valley spillway and 15 piers on the Pontian Ketchil spillway.

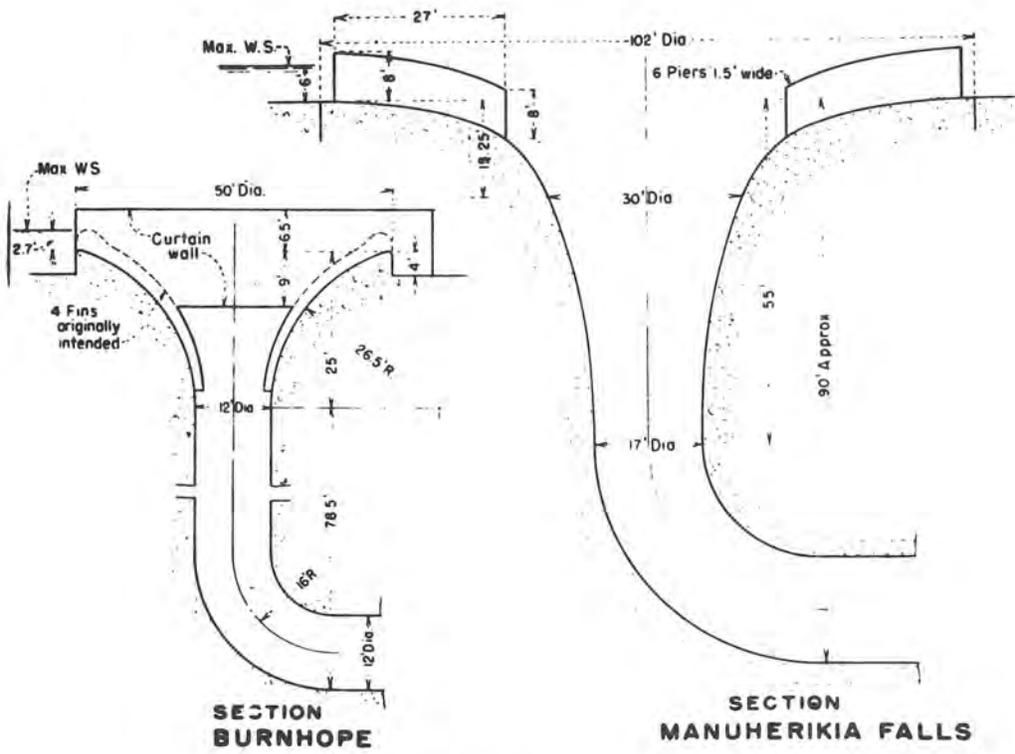
Figure 4

The capacity of another English spillway, the Burnhope (Figure 4) in Durham County, is 2,600 cfs, 2.7 feet of head on the crest, and approximately 100 feet of drop. The vertical bend in the Burnhope spillway was purposely lined with cast iron to prevent erosion. One moderate flood of 1,500 cfs, or 55-percent capacity, has been recorded with no undesirable operating conditions or damage. In this design a curtain wall extends across the center of the spillway parallel to the horizontal tunnel.

The Manuherikia Falls spillway in New Zealand (Figure 4) is designed for 15,000 cfs, a drop of 90 feet and a head of 6 feet on the crest. This spillway has passed several small floods since 1935, aggregating about 2 feet of head on the crest, besides a moderately large one in November 1948. In 1948, the spillway passed a maximum flow of 5,000 cfs, representing one-third of capacity for a depth of 3 feet over the crest. The report states that there are signs of wear at the circumferential construction joints in the morning-glory proper to about 25 feet below crest level. Some of the concrete has been eroded to a depth of about 3 inches at these joints. Frost action may have caused some of the erosion, as there is seepage through the rock surrounding the spillway. The remainder of the vertical shaft is in good condition. The vertical curve, however, shows erosion at construction joints, amounting to about 3 inches. The floor in the horizontal section of the tunnel shows general wearing of the concrete surface of approximately 1 inch. Some of this occurred when the tunnel was used for stream diversion. Very little debris or ice has passed through this spillway, and no objectionable noises have been noted. Six piers serve to counteract vortex action.

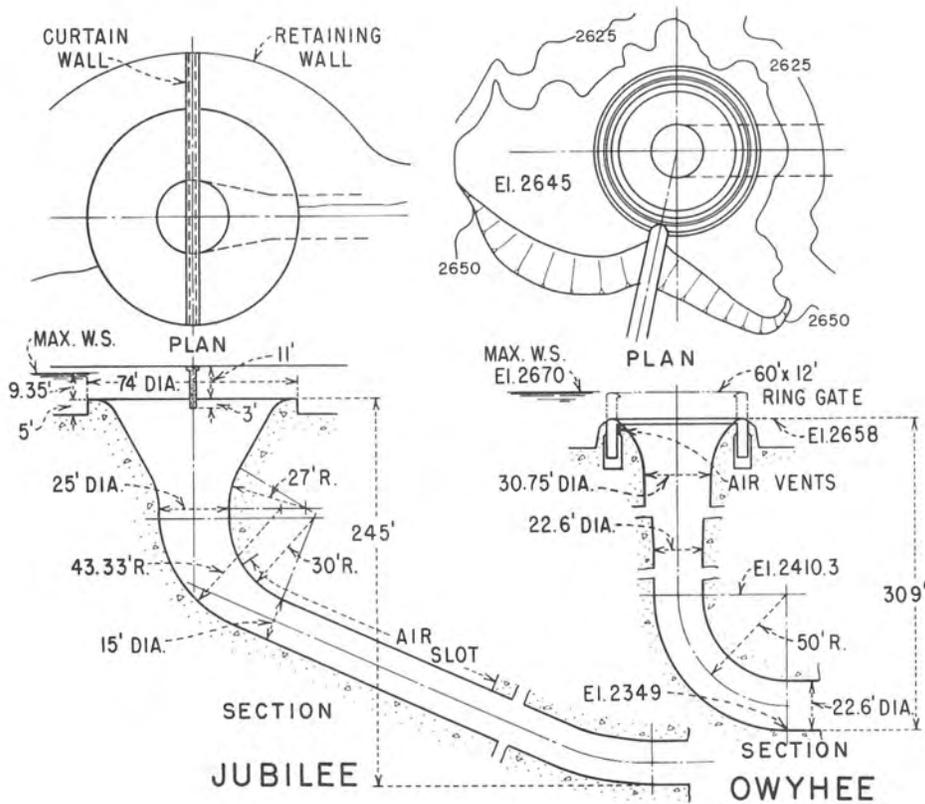
Figure 5

The Jubilee spillway (Figure 5), the largest English spillway up to this time, has a capacity of 17,000 cfs, a drop of 245 feet, and a head of 9.4 feet on the crest. There was evidently some concern as to the advisability of dropping the water 245 feet into a vertical shaft (100 feet greater than in any former spillway), which is evidenced by the inclined shaft. The only information on Jubilee spillway states that it has operated as expected. Discharges have been small or moderate, and no erosion is reported. This is the first spillway in which special air venting has been employed. A curtain of water tends to seal the tunnel at the entrance to the inclined shaft for the higher discharges. An air duct was, therefore, provided downstream from the curtain of water in the inclined portion of the tunnel. It is interesting to note that the curtain wall on this spillway is normal to the one on Burnhope.

The Owyhee spillway in Idaho (Figure 5), constructed in the early thirties by the Bureau of Reclamation, was a daring design at the time, with a capacity of 30,000 cfs, dropping 300 feet through a vertical shaft. The spillway was designed for a maximum head of 12 feet on the crest. A floating ring gate was incorporated in the crest portion. The ring gate operates on the same principle as the drum gate used on straight overfall spillways. It is raised by admitting water to the chamber beneath and lowered by draining

water from the chamber. All reports from the Owyhee spillway (on which we have kept special watch) are favorable. A large flow occurred through the spillway during a 3-month period in the spring of 1936, when approximately 300,000 acre feet of water was passed. The maximum discharge recorded was 15,000 second feet, or one-half capacity. Since then smaller discharges have passed through the spillway frequently. The spillway operated at 18,000 cfs or 60 percent of capacity in 1952. Inspection of the vertical shaft, elbow, and horizontal tunnel downstream has disclosed no indication of erosion of any kind. These inspections have been conducted frequently since the spillway first operated in 1936. No evidence of vibration has been apparent in the spillway and the jet does not flutter even with the gate in a raised position. Incidentally a single pier serves as an anti-vortex device and also houses the ring-gate operating equipment.

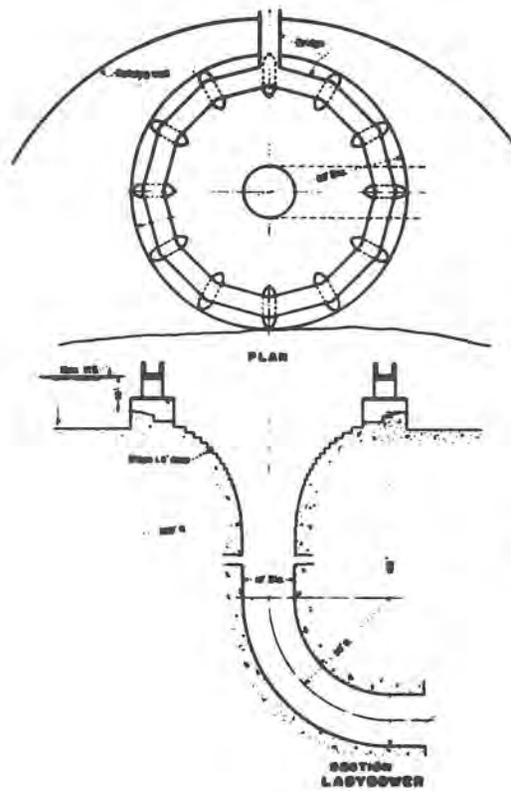
Figure 7

The Lady Bower (Figure 7) is the latest in English morning-glory spillways. Constructed in the middle 1930's it was designed to operate at a maximum of 10 feet of head on the crest with 122 feet of drop. The report states that the spillway has operated several times with no objectionable features. No erosion of the concrete has so far been experienced, either in the tunnel or at the vertical bend. The internal step form of design was arrived at by model studies. The report states that the step design is cheaper to construct but is less efficient than the smooth morning-glory shape. The crest is surmounted with 12 piers.

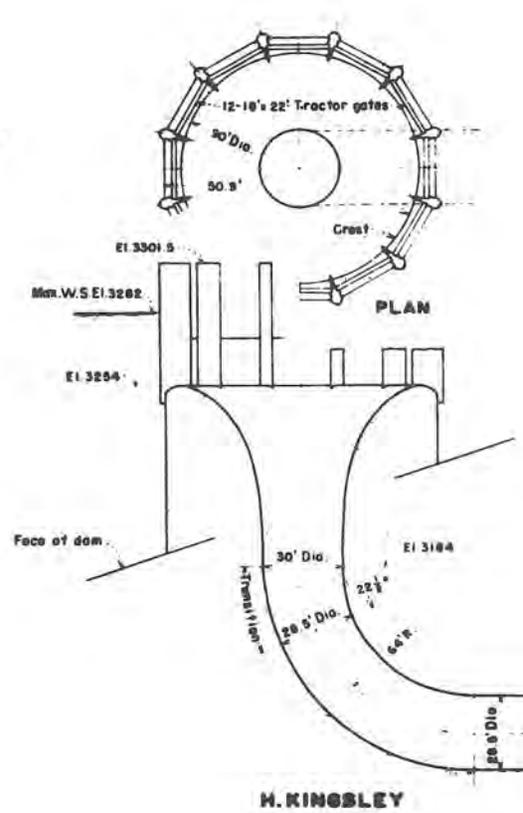
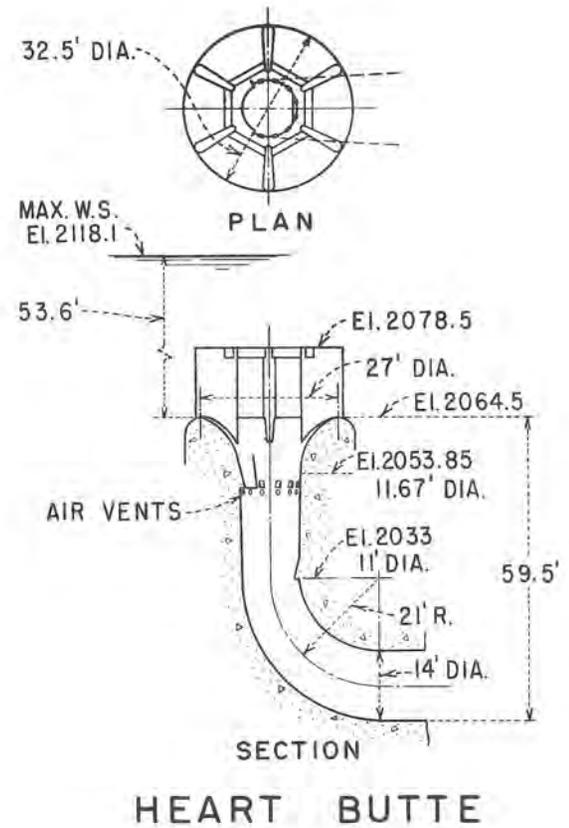
Figure 8

The spillway for the Heart Butte (Figure 8), recently constructed by the Bureau of Reclamation, is unique in that it is designed to operate principally submerged. Both operate in conjunction with retention reservoirs. The Heart Butte Dam spillway is located in North Dakota. It was designed

for a capacity of 5,600 cfs, with a drop from headwater to tail water of 106 feet, and operates submerged at a maximum head of 54 feet on the crest. Free flow occurs for heads up to 6 feet. Submerged flow occurs for heads above 6 feet. A large vortex forms for heads from 6 to 20 feet. For heads from 20 to 54 feet, vortices are either small or nonexistent. The six piers on the crest serve to break up the large vortex into a number of smaller ones reducing fluctuations in discharge and resulting in improved flow conditions. This dam was completed in 1949, and in the Spring of 1950 passed a major flood. The spillway operated for approximately 1 month and passed 148,000 acre feet of water. The maximum flow into the reservoir during the flood was 24,000 cfs, while the maximum discharge released through the spillway amounted to 3,800 cfs. An inspection after this flood showed erosion at two points in the vertical bend. In each case the eroded areas were about 8 inches in diameter and a maximum of 1 inch deep. This spillway again went into operation in 1951 and 52.
