February 3, 1955

Memorandum

Subject: Hydraulic Laboratory tests pertaining to vibration in the Y-branch of the Mexican Outlet Works--Falcon Dam

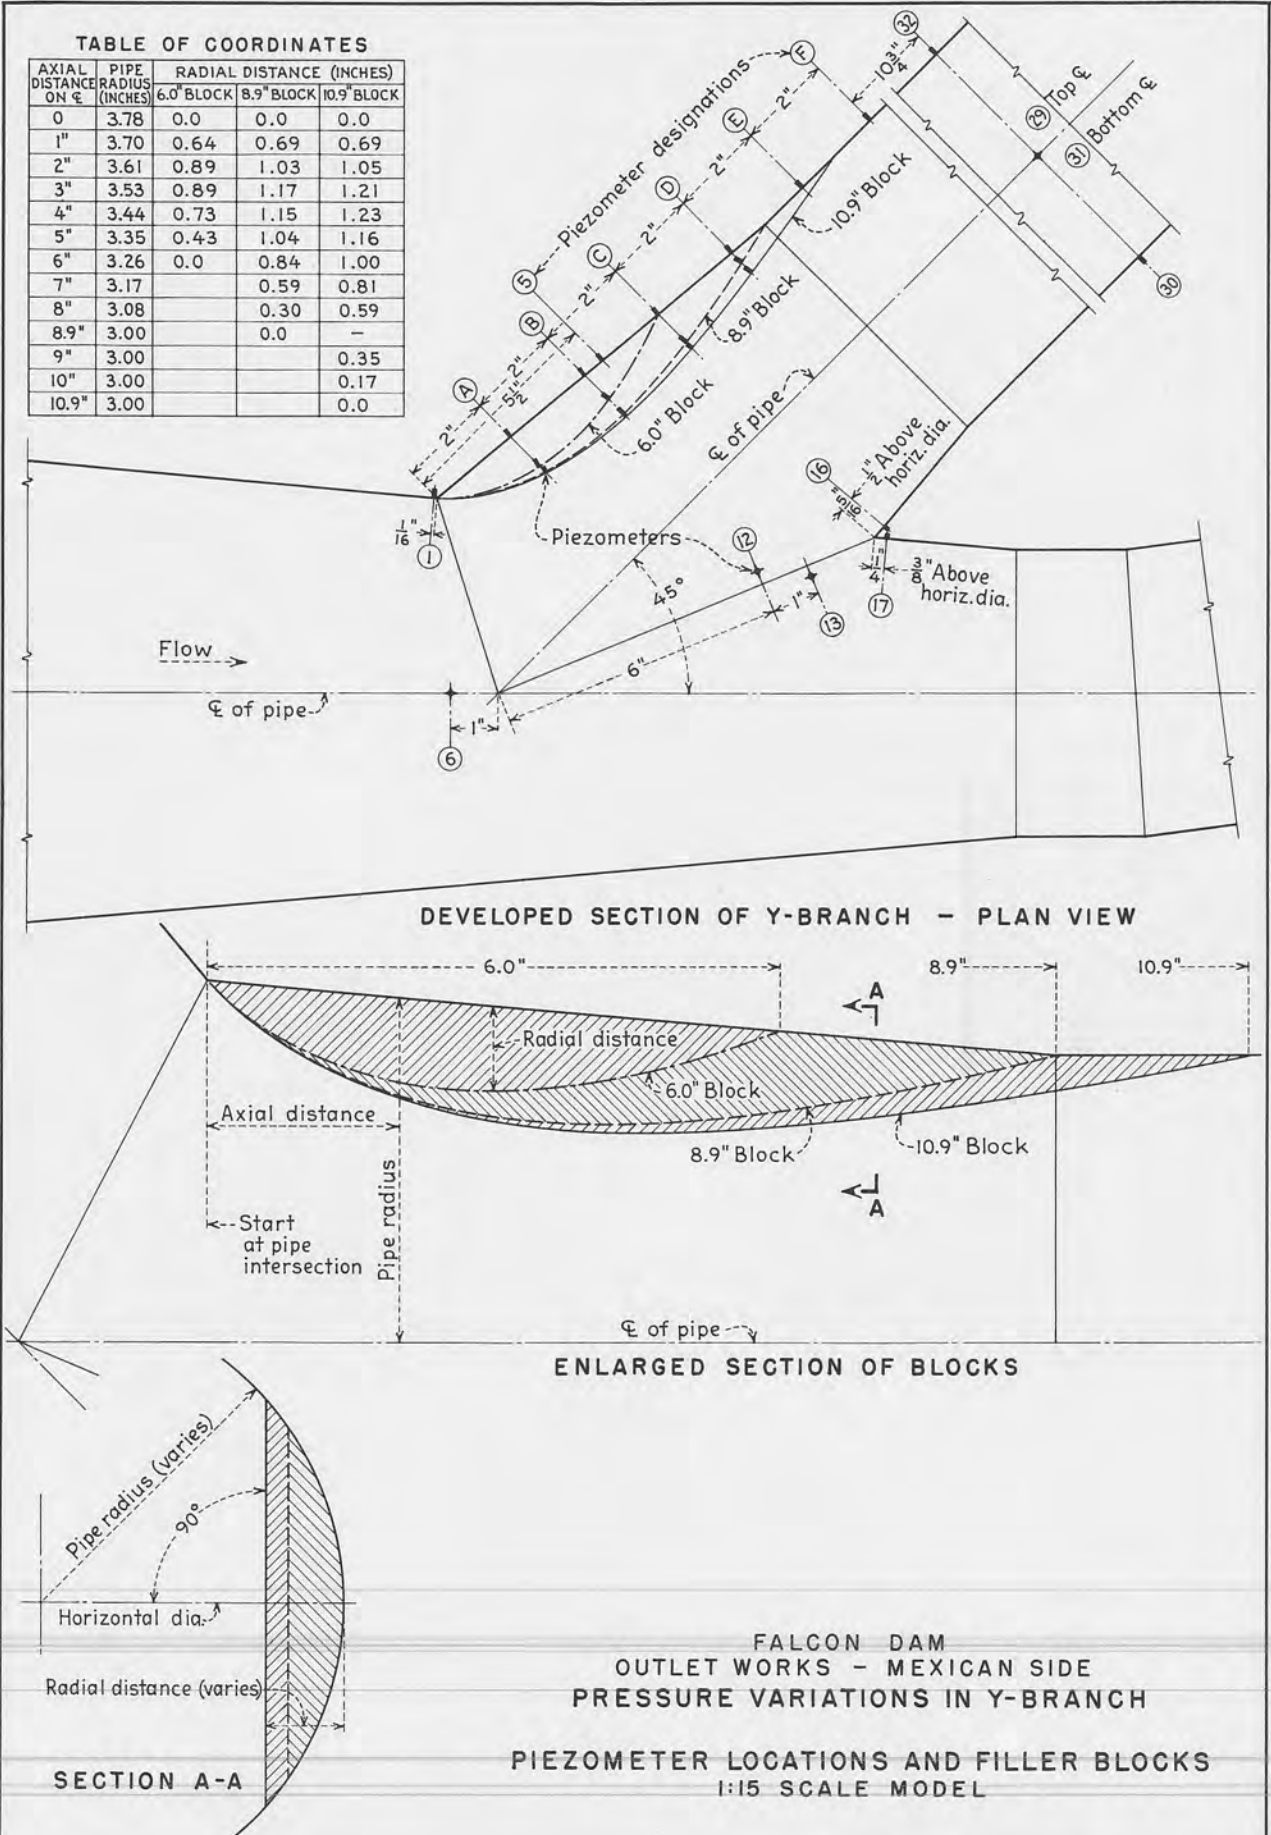
The surges at the left valve were most pronounced on the invert and left side and appeared to be the result of a zone of turbulence along the upstream left side of the left branch. The frayed condition of the jet from an orifice placed at the No. 2 butterfly valve position during the calibration tests showed that turbulence from the Y-branch extends downstream to the butterfly valve. The maximum pressure variation recorded in the initial tests, 48 feet of water prototype and the minimum instantaneous pressure, -16.5 feet of water prototype, were measured in this zone (Piez. No. 5). Such pressure variations undoubtedly exist in the prototype and are responsible for the vibration in the structure and for the forces which tended to close the left butterfly leaf. It is possible that more severe subatmospheric pressures than measured exist momentarily and that these low pressures may reach vapor pressure causing a cavitation-like action. There was indication that this was the case when tests were made later with the addition of piezometers A, B, C, D, E, and F (Figures 1 and 2).

An examination of the oscillograph records disclosed that an extensive reduction in pressure fluctuations had been accomplished by installing the filler block (Figure 2). There seemed also to be a decided reduction in the noise and vibration of the model. The fluctuation in pressure at the No. 2 butterfly valve location was reduced considerably (Piez. 32, Figure 2). Because of the pronounced effectiveness of the filler block in reducing the pressure fluctuations and vibration it seemed desirable to determine if a smaller filler block would accomplish as much. A similar, but smaller, filler block was installed (Figure 1). A comparison of the oscillograph records for this filler block showed it to be much less effective.

After a study of the records for conditions with and without the blocks, it was believed that improvement could be obtained in the region of piezometers B, C, D, and E by using a block that was longer and thicker than the 8.9 inch one. The 10.9 inch long block was therefore installed. Pressure fluctuations along the block were still somewhat larger than those at the branch entrance, or those at the butterfly valve, and further improvement might be accomplished by a still longer block. The added length was not considered justified in this case since the maximum fluctuation was 19.5 feet

Because of the effectiveness of the two long filler blocks in reducing the vibration and pressure fluctuations in the model, it is recommended that consideration be given to installing a similar shape in the Y-branch of the Mexican outlet works. The shape could be formed of flat plate stock bent to shape and welded to the pipe walls. The length should be at least that of the 8.9 inch block (13.4 feet proto) and preferably should be longer. The space between the plate and pipe walls might be filled with concrete. We feel certain that the vibration described in the report of the Mexican engineers will be reduced to an acceptable amount by the installation of the filler block.
