TEST OF PROTECTIVE COATINGS FOR NAVY

BUREAU OF RECLAMATION  
HYDRAULIC LABORATORY

Tests of Protective Coatings  
CONE CAVITATION APPARATUS

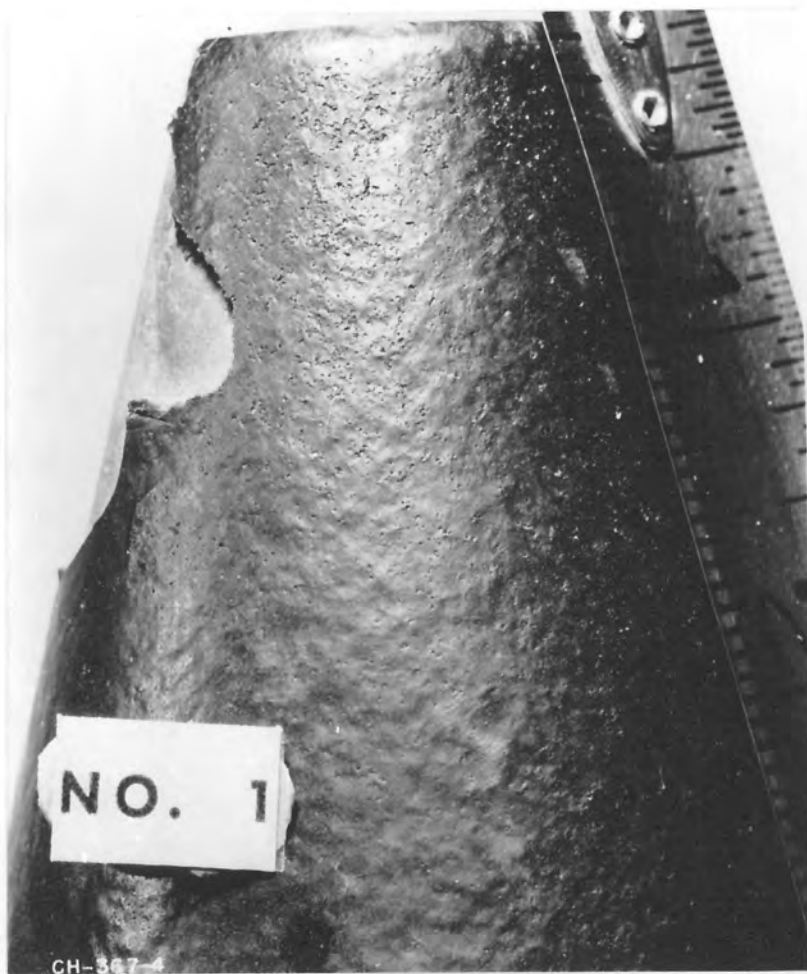
The coating of Specimen 1 was removed from a small area near the tip of the cone (Figure 3B) in 11-1/4 hours of operation. It appears that the coating in this area was pitted and loosened by cavitation and that pressures under the loosened coating and velocities past it caused a rupture and tearing away of a portion of the material (Figure 4A and B). There was some pitting of the coating material at the periphery of the cone base, but no metal was exposed in this region (Figure 5).

A. PITTED COATING

Tests of Protective Coatings  
Tip of SPECIMEN 1 AFTER  $11\frac{1}{4}$  HRS at 71.2 FT/SEC

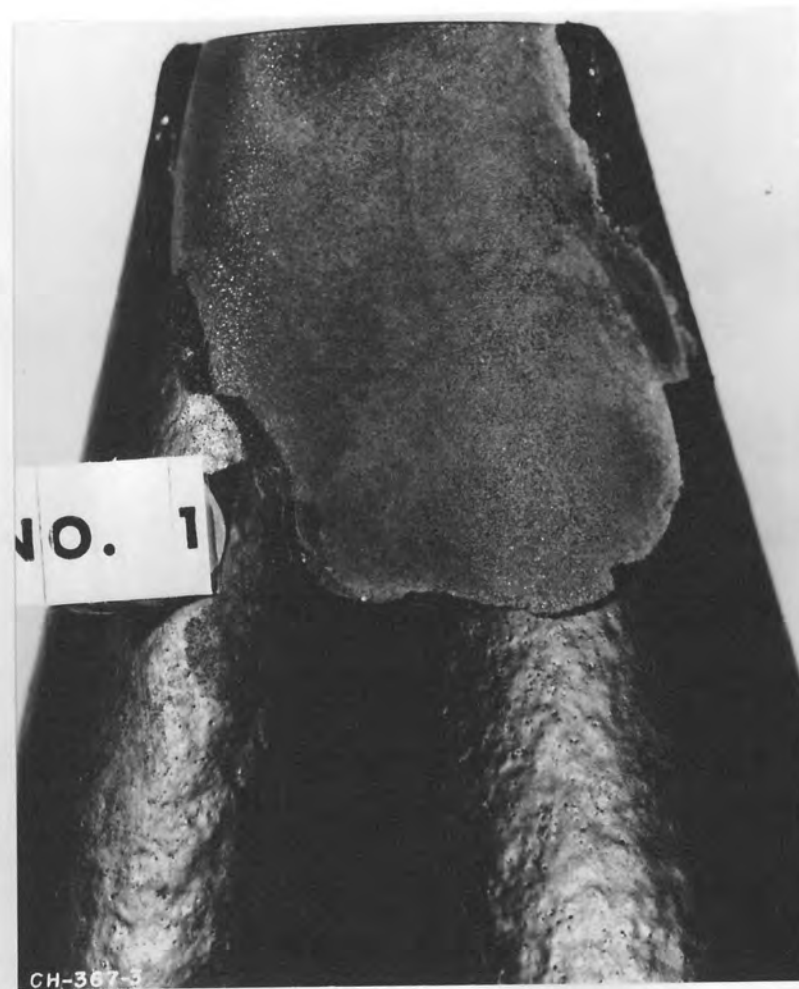
Damage near the cone tip was of two kinds, cavitation-erosion penetrating the coating and a tearing away of a portion of the coating after loosening by cavitation action. Specimens 1, 5, and 6 are good examples of the cavitation-erosion near the tip (Figures 4, 15, and 17), while Specimens 1, 7, and 8 are examples of the loosened coating being torn away (Figures 4, 18, and 21).

B. Exposed Metal at Cone Tip.

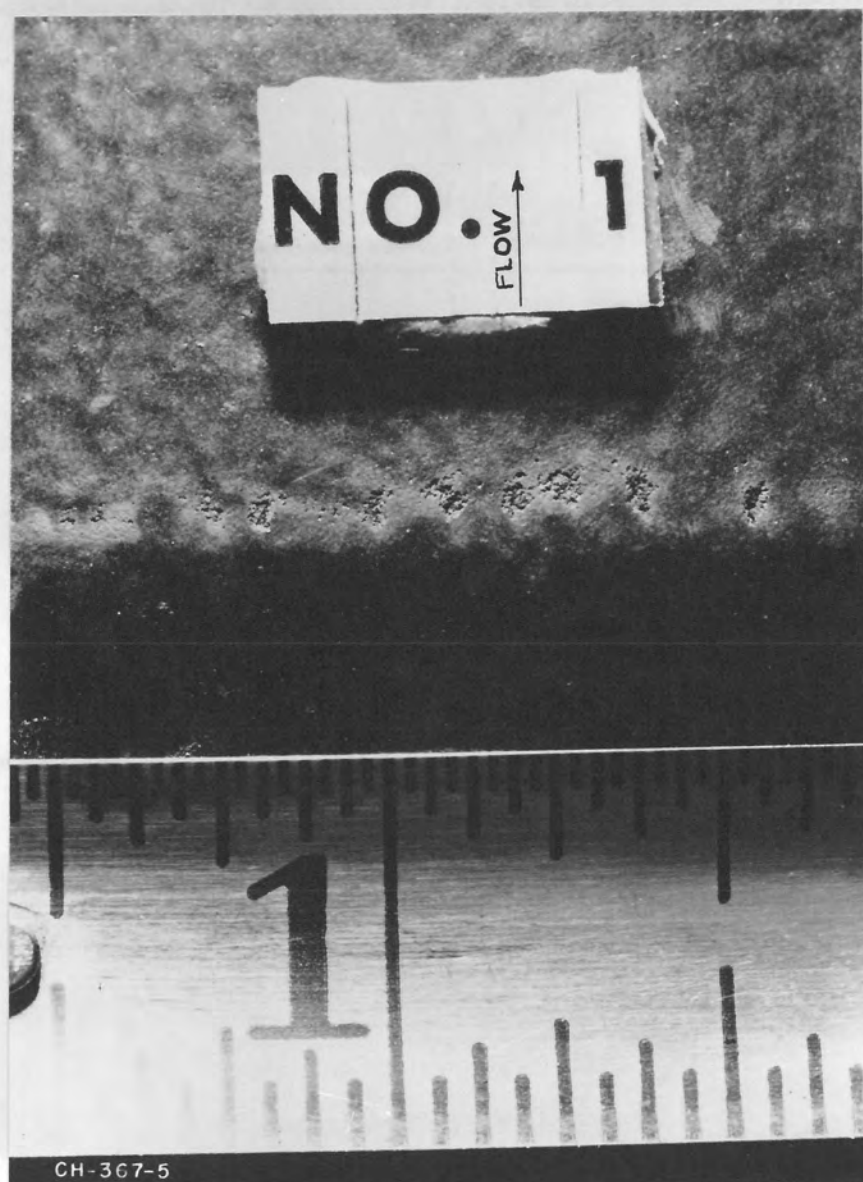
Figure 5

cone bases of the various specimens. For example, the damage at the cone bases of Specimens 1 and 2 was only slight in 11-1/4 hours of operation (Figure 5), the damage at the cone bases of Specimens 3 and 4 was slight in 11-1/4 hours and not noticeably increased in 40 hours (Figure 11), the damage at the cone bases of Specimens 5 and 6 was to bare metal in about 1 hour of operation with considerable bare metal exposed in 1-3/4 hours and much more in 5-3/4 hours (Figures 13 and 15), the damage at the cone bases of Specimens 7 and 8 was to bare metal in about 3-1/2 hours with considerable increase in area of exposed metal in 8-1/2 hours (Figures 19 and 21). The damage at the bases of the cones of Specimens 9 and 10 was negligible in 1-1/2 hours of operation. The material at the junction of the cone base and cylindrical throat section appeared to be rounded compared with the other specimens. This may account at least in part for the negligible damage at the cone bases of these specimens (Figures 22 and 24). The possibility that there were different degrees of rounding at the junction for the different coatings may make comparative results questionable.

PITTED COATING AT CONE BASE

Tests of Protective Coatings  
CONE BASE of SPECIMEN 1 after  $11\frac{1}{4}$  HRS at 71.2 FT/SEC.

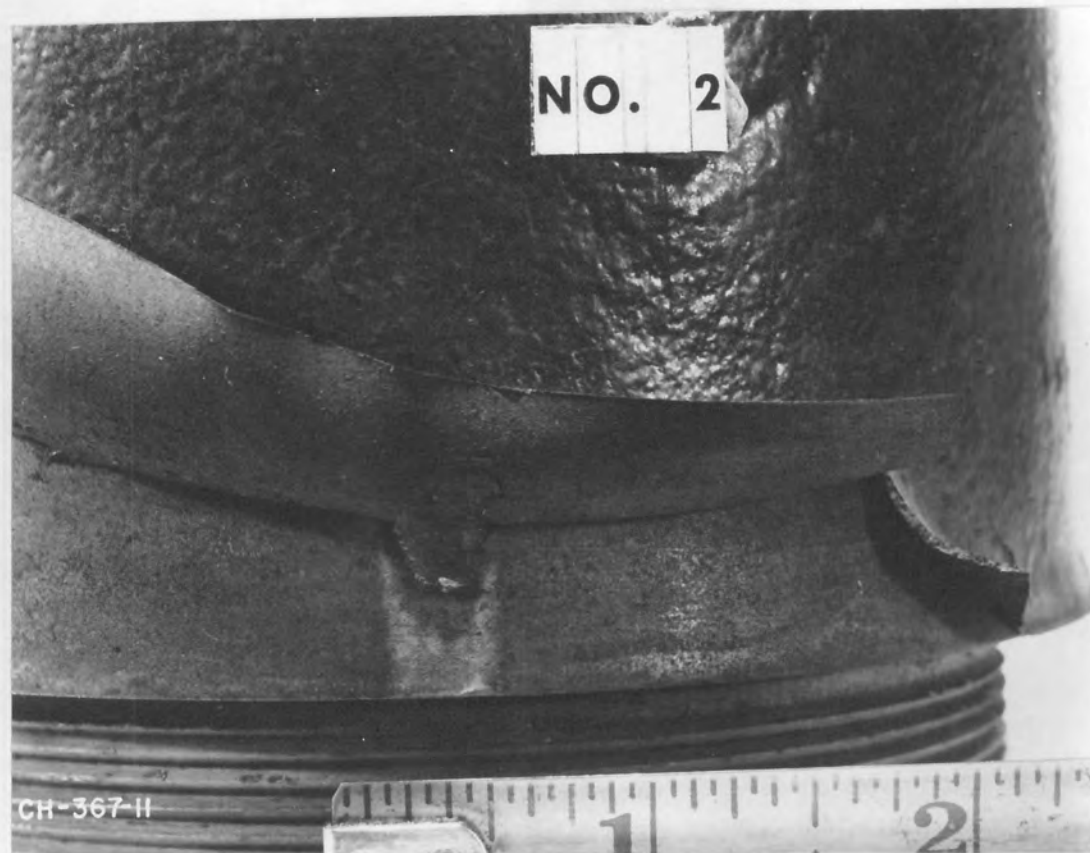
The coating of the second specimen (Number 2) became loosened and torn at the upstream edge of the coating in the throat section in 10-1/2 hours (Figure 6). The loosening and tearing of the coating at this location prevented continuing the test under controlled conditions, and the test was discontinued. There was cavitation-erosion at the base of the cone as in the case of Specimen 1, but a portion of the coating seemed to have been removed as a layer (Figure 7A). This damage seemed to be a result of cavitation and velocity on a thin layer of the coating.

B. TEAR IN UPSTREAM EDGE OF COATING CAUSED BY  
PRESSURE AND VELOCITY.

Tests of Protective Coatings  
SPECIMEN 2 After 10 1/2 HRS at 71.2 FT/SEC.

The tests prove that some special treatment of the coating at both upstream and downstream edges of the coating materials should be considered in future test programs. This treatment should be of a nature to prevent velocity and pressure acting on loosened edges of the coating to tear them and upset the test conditions. A special undercutting or extension of the specimen at both ends might do much to solve the problem. Some degree of success was obtained by slight alterations to the cone in some of our most recent tests (Figure 1).

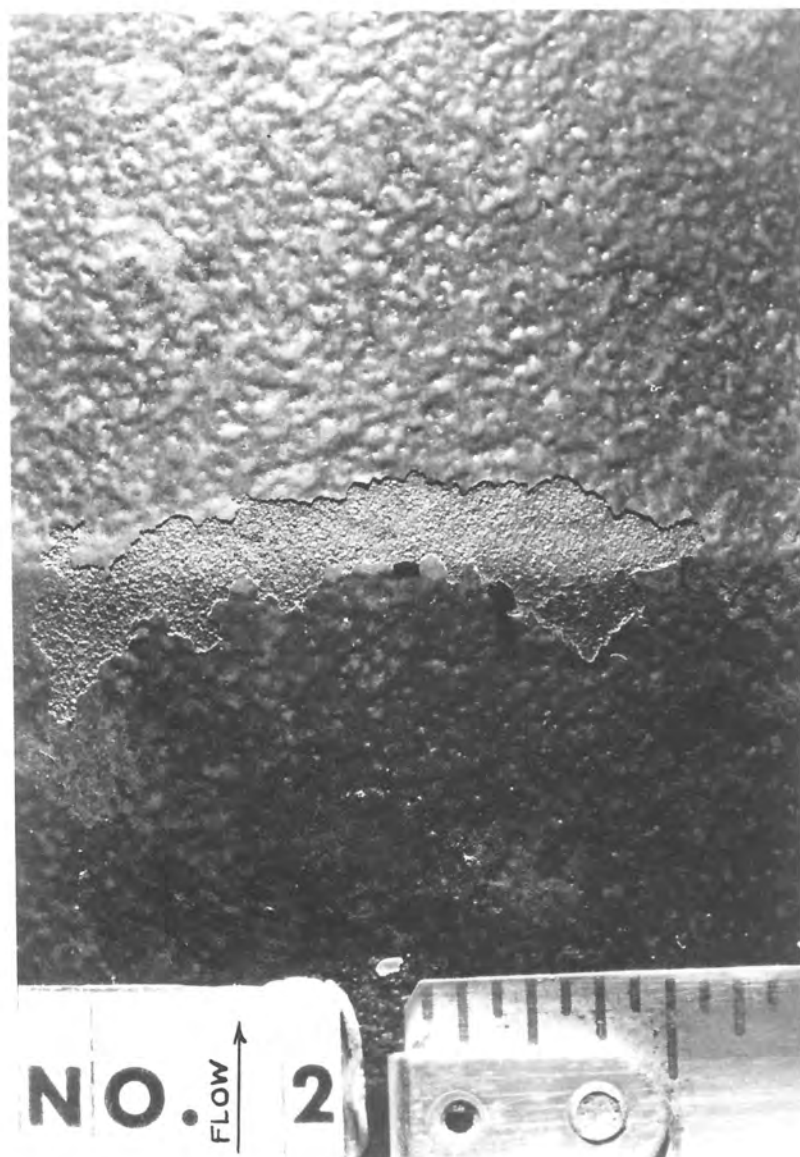
A. CONE BASE EROSION

Tests of Protective Coatings  
SPECIMEN 2 CONE TIP and Base After  $10\frac{1}{2}$  HRS at 71.2 FT/SEC.

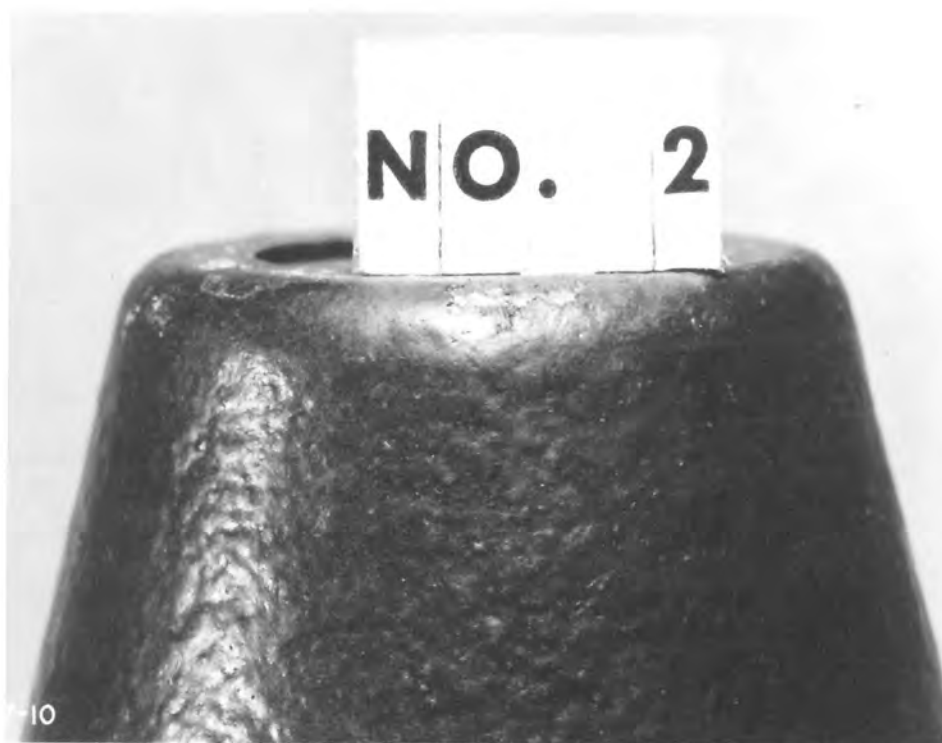
B. CONE TIP

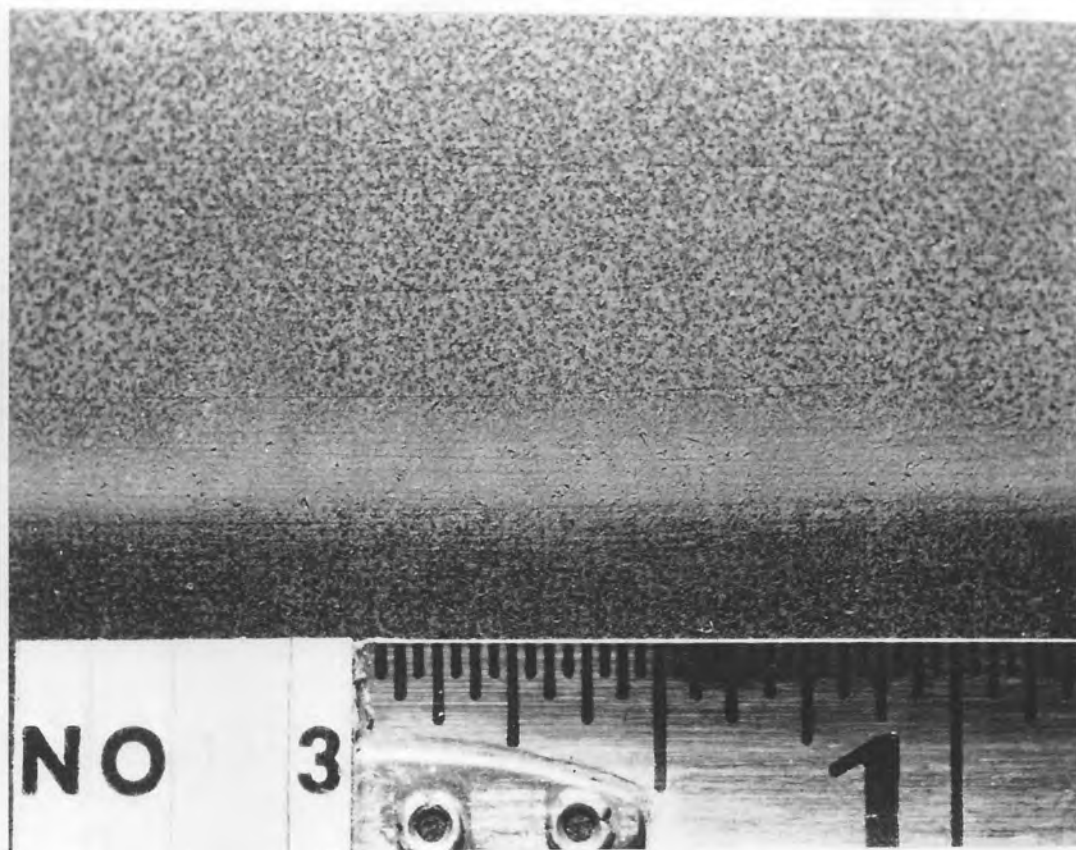
The two metal specimens (Numbers 3 and 4) were tested for different periods. Specimen 3 was tested for a period comparable to that for Specimen 1 (11-1/4 hours) while Specimen 4 was subjected to 40 hours' testing. The test on this specimen was continued in order to obtain sufficient damage for comparison with that obtained for the other coatings. The test was made after the tests on all other coatings were completed. A slight erosion at the base of the cone, characterized by a silvery appearance of the metal, was noted on Specimen 3 (Figure 9). No other damage could be detected. After 40 hours' testing of Specimen 4, there still seemed to be no damage other than that of the periphery at the cone base where the erosion was greater than that after 11-1/4 hours' testing of Specimen 3 (Figure 10). Photomicrographs of areas in the throat of the apparatus, at the base of the cone section, midway between the cone base and tip, and near the cone tip were taken at the end of the 40-hour test on Specimen 4. While erosion at the base of the cone is shown distinctly by the photomicrographs, there is no apparent damage in the other areas (Figure 11).

B. SLIGHT PITTING NEAR CONE BASE - DARK SPOTS  
CAUSED BY RUSTING

Tests of Protective Coatings  
SPECIMEN 3 AFTER 11 1/4 HRS at 72.09 FT/SEC.

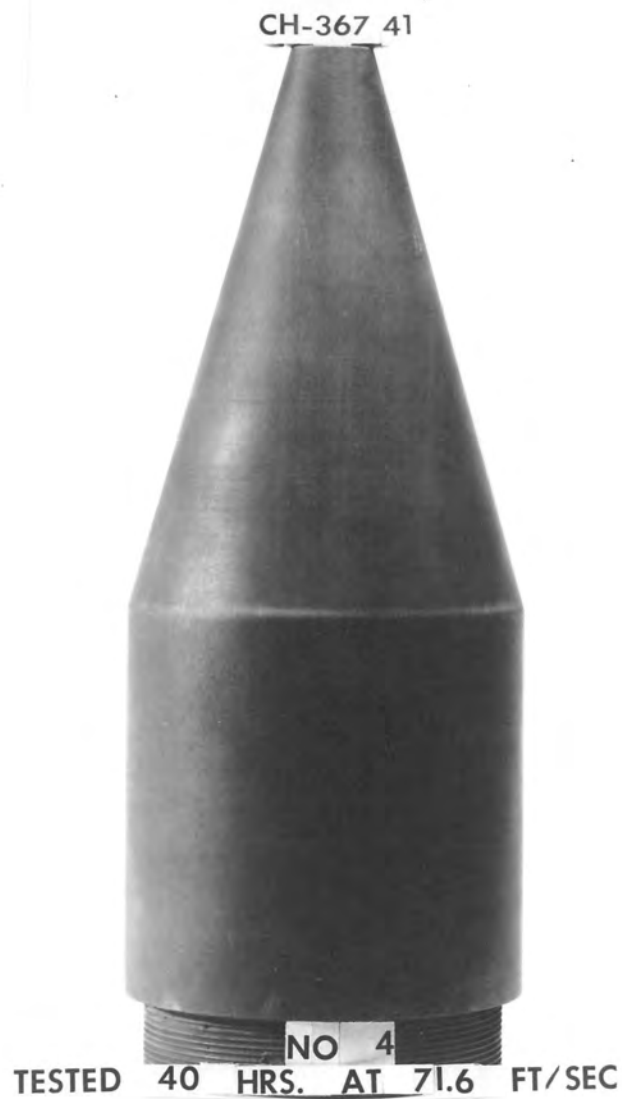
Figure 10

Damage near the base of the cone section of the specimens was by cavitation-erosion. This damage was noticeable on all except Specimens 9 and 10 (Figures 5, 7, 10, 15, 16, 19, and 21). This damage occurred at the upstream end of the cavitation envelop--an unusual location. It is believed that slight pressure surges at the cone base where the pressure gradient (throat pressure to vapor tension pressure) is practically vertical caused a collapse of some of the cavities almost as soon as they formed. This resulted in erosion of the surface at that location. This condition was not prevalent in our previous tests where the corner at the cone base was rounded as shown on Figure 1.

Tests of Protective Coatings  
SPECIMEN 4 AFTER 40 HRS At 71.6 FT /SEC.

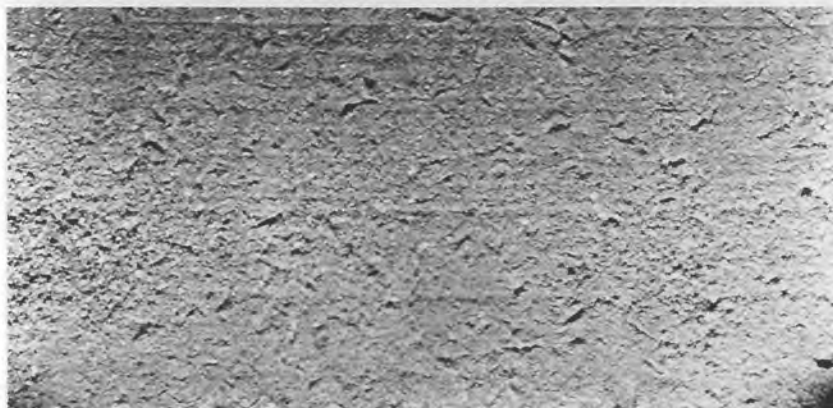
C. PITTING AT CONE  
BASE - NOTE REMOVAL  
OF MACHINE MARKS

Tests of Protective Coatings  
PHOTO-MICROGRAPHS - MAGNIFICATION 12X  
SPECIMEN 4 AFTER 40 HRS At 71.6 FT/SEC.

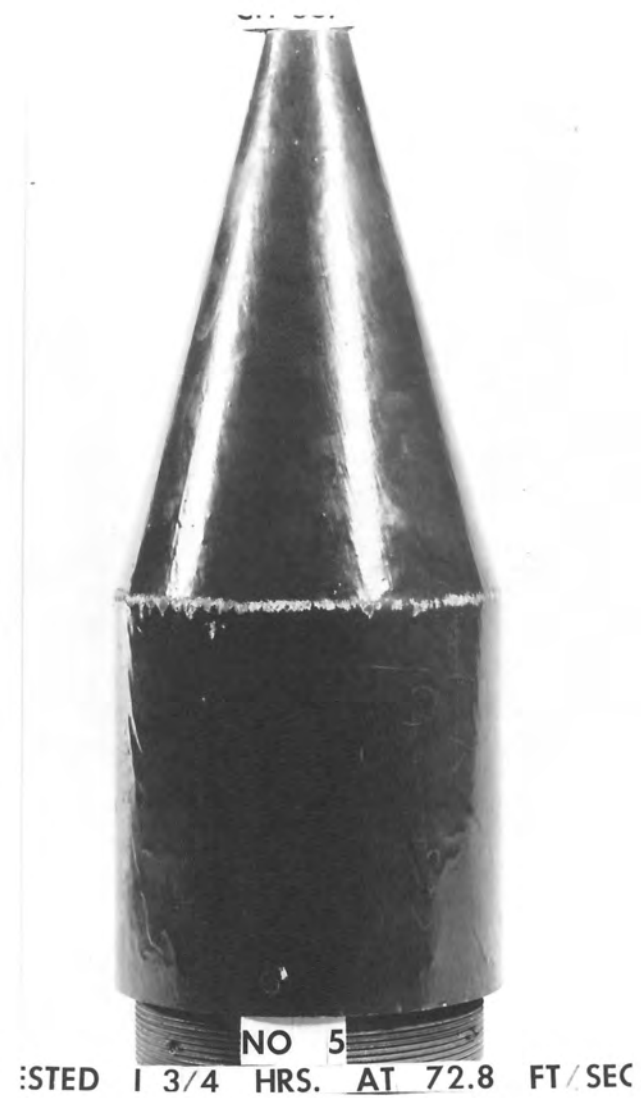
B. PITTING AT CONE BASE

Tests of Protective Coatings  
SPECIMEN 5 BEFORE AND AFTER TEST.

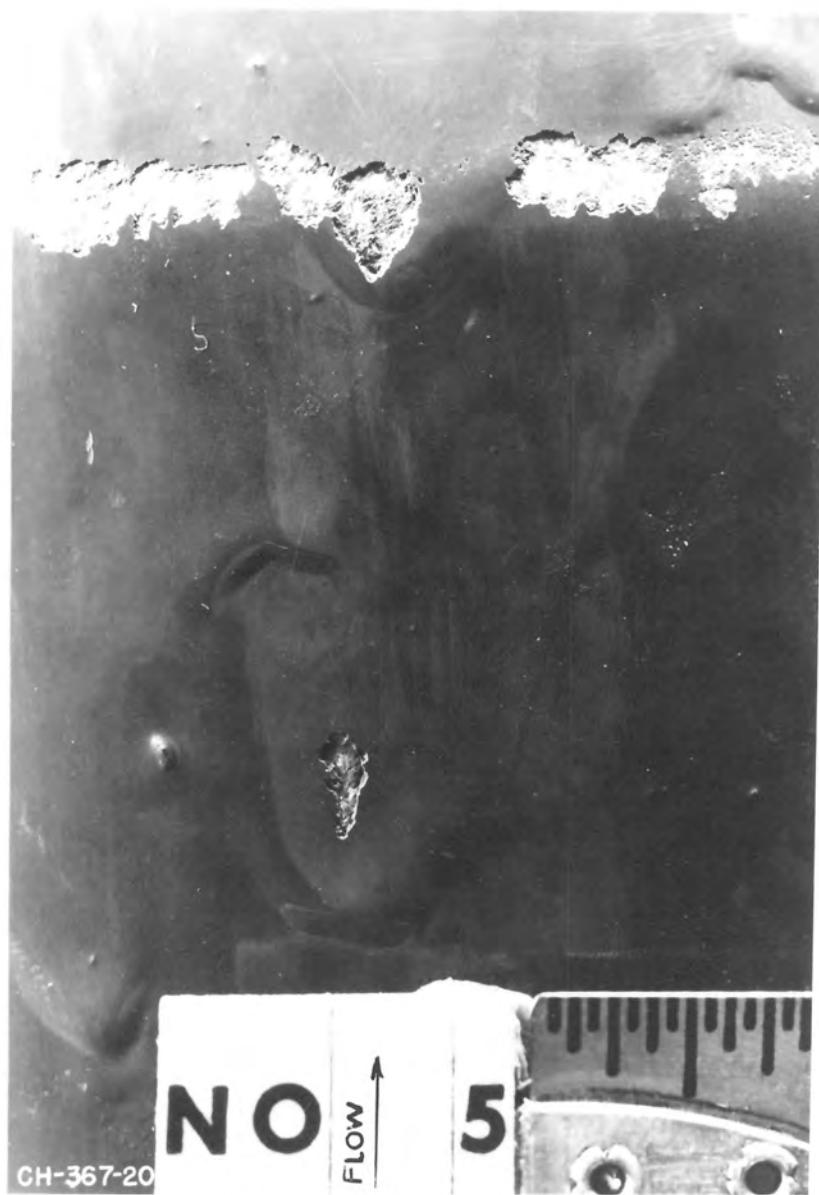
The coating of Specimen 5 had been under test for 1-3/4 hours when metal became exposed at the base of the cone and considerable pitting occurred near the cone tip (Figures 12 and 13). Additional testing of 5-3/4 hours exposed metal near the tip and increased the exposed areas near the cone base (Figures 14 and 15). A change was made in the test conditions for the latter test period in order to contain more of the cavity collapses on the specimen. The back pressure was increased to about 47 feet of water to give a cavitation envelop or "vapor pocket" 4 inches long. In 1 hour of testing, cavitation-erosion exposed metal near the cone base of Specimen 6. In 4 hours, cavitation-erosion had exposed metal at numerous spots near the cone tip (Figures 16 and 17).

A. PITTING DOWNSTREAM OF COATING SAG IN  
STRAIGHT PART OF CONE SPECIMEN AND AT CONE  
BASE

Tests of Protective Coatings  
SPECIMEN 5 AFTER 1-3/4 HRS At 72.8 FT/SEC

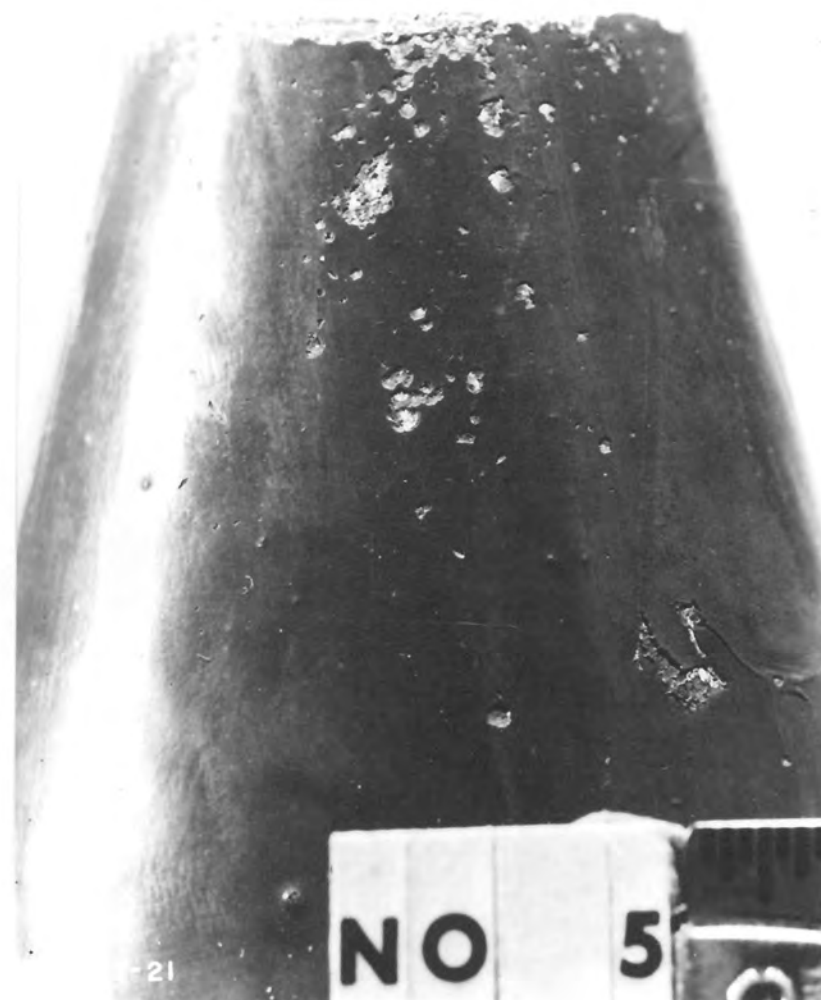
B. PITTING AT TIP

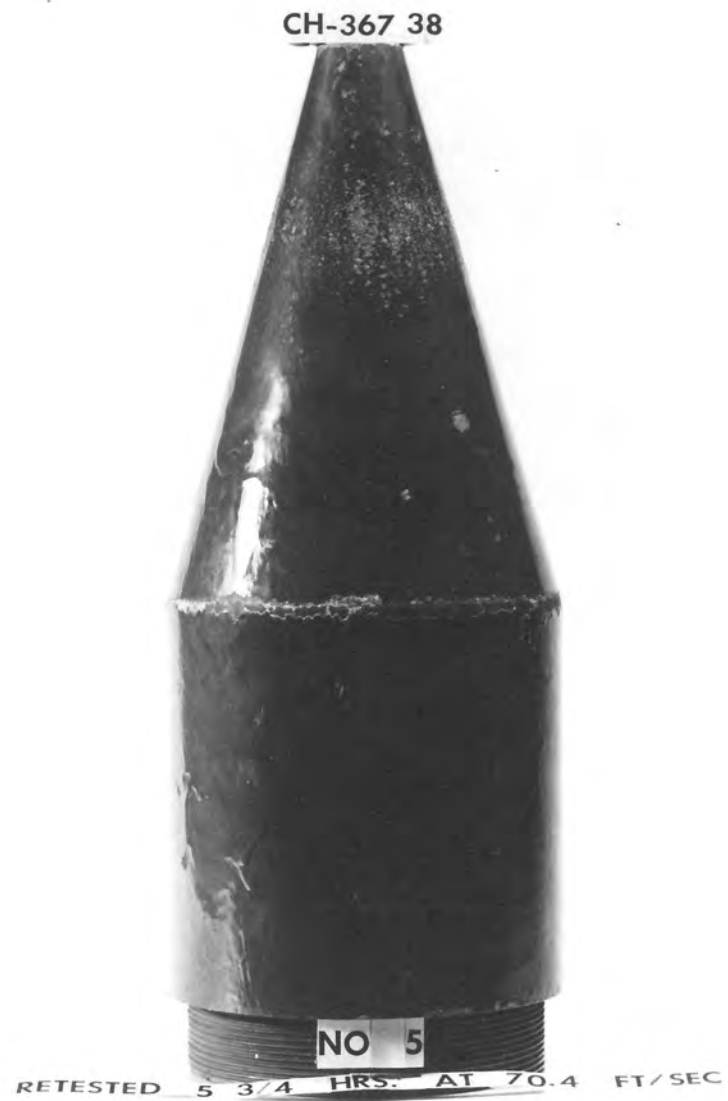
PITTING at Cone Tip and BASE

Tests of Protective Coatings  
SPECIMEN 5 AFTER RETEST  
WITH SHORTENED VAPOR POCKET

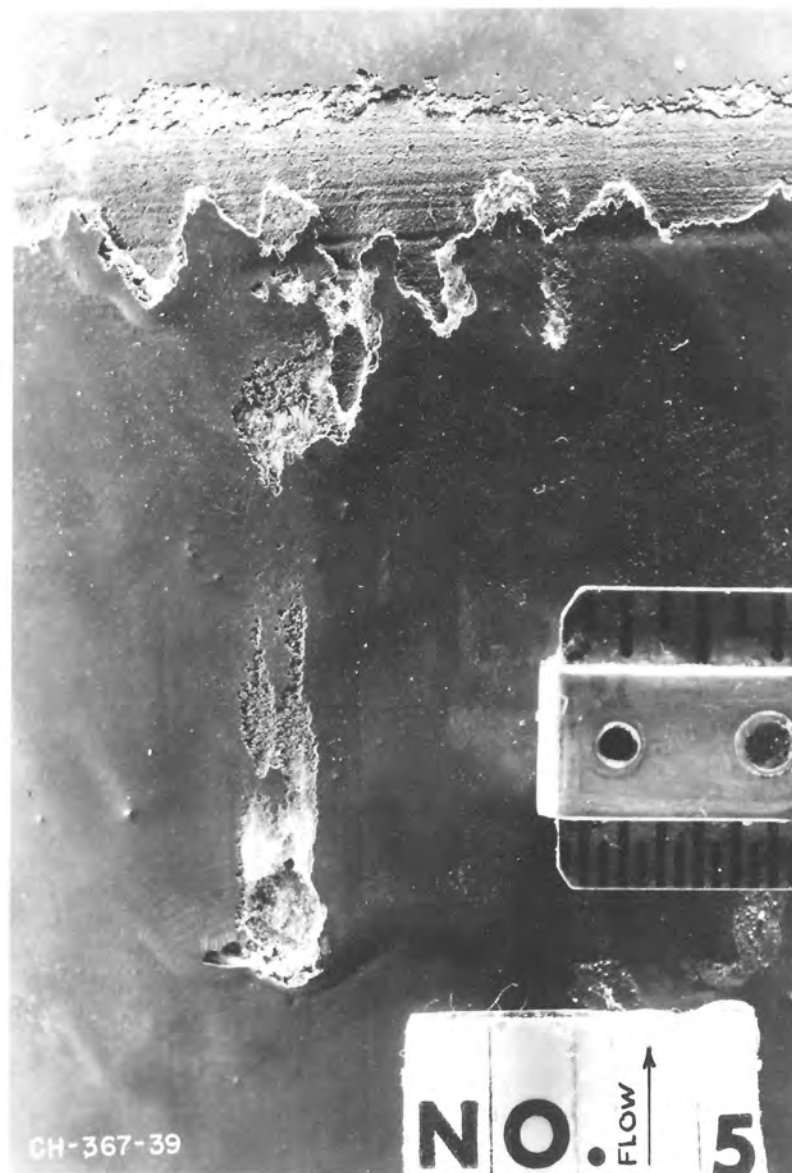
A. PITTING AT CONE BASE AND COATING SAG

Tests of Protective Coatings  
SPECIMEN 5 RETEST 5-3/4 HRS At 70.4 FT/SEC SHORTENED VAPOR POCKET

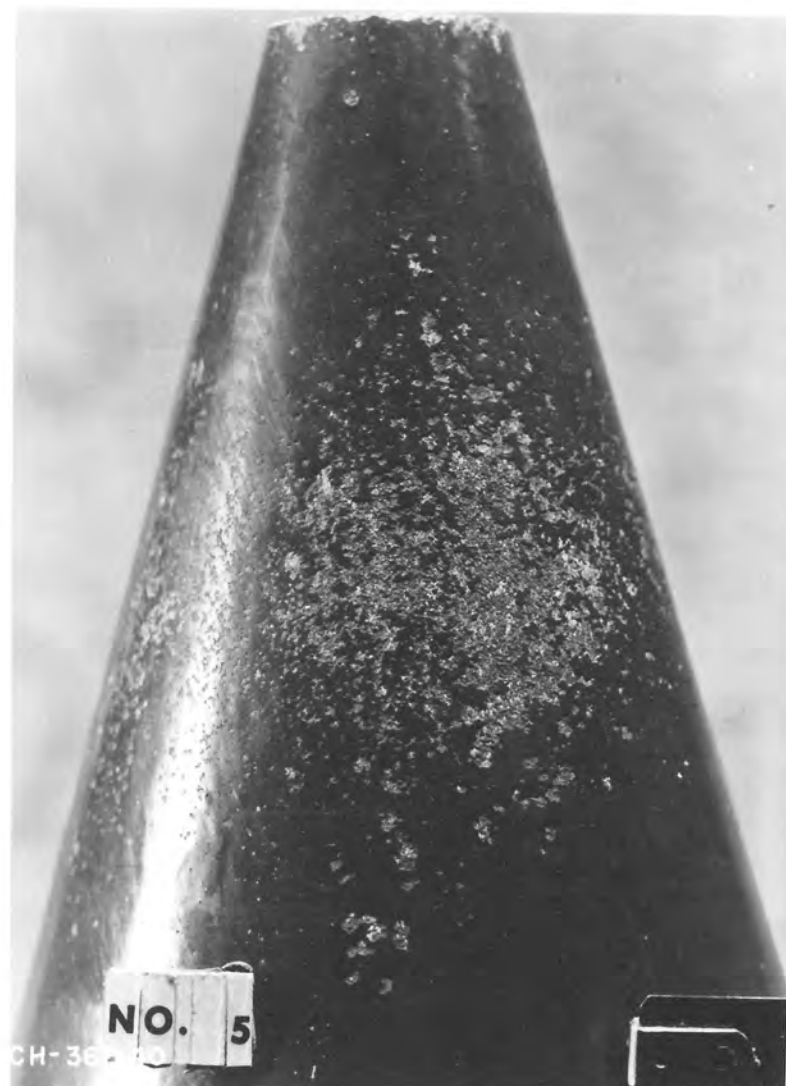
B. Pitting on Cone Tip

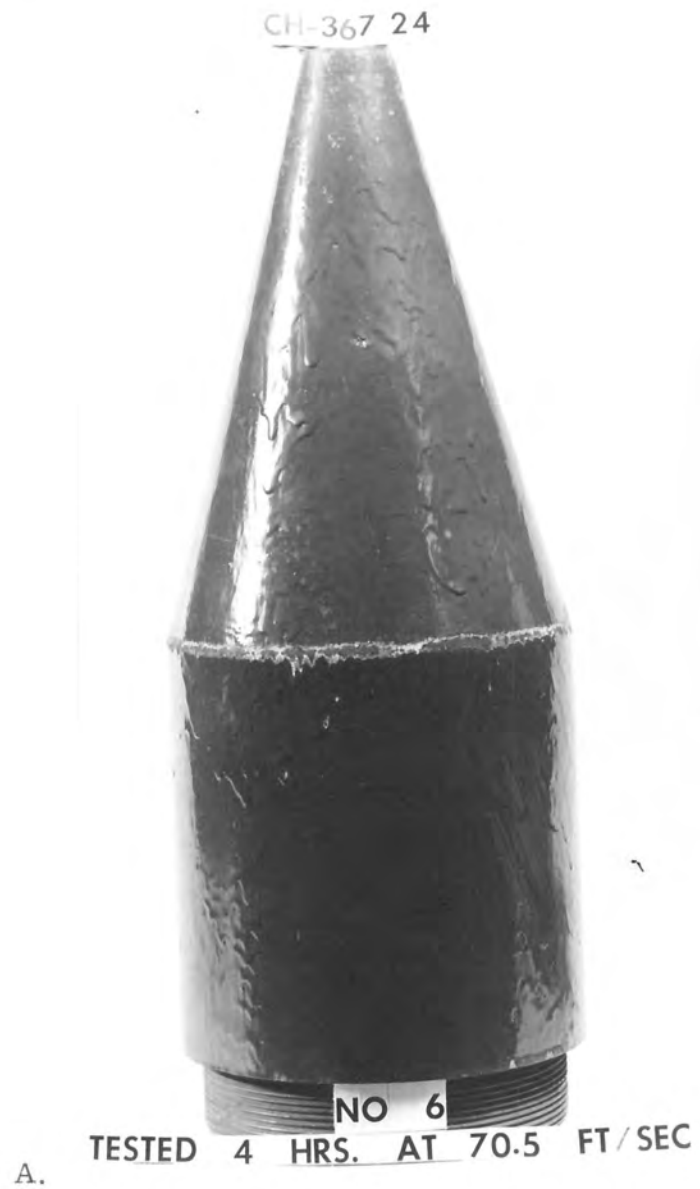
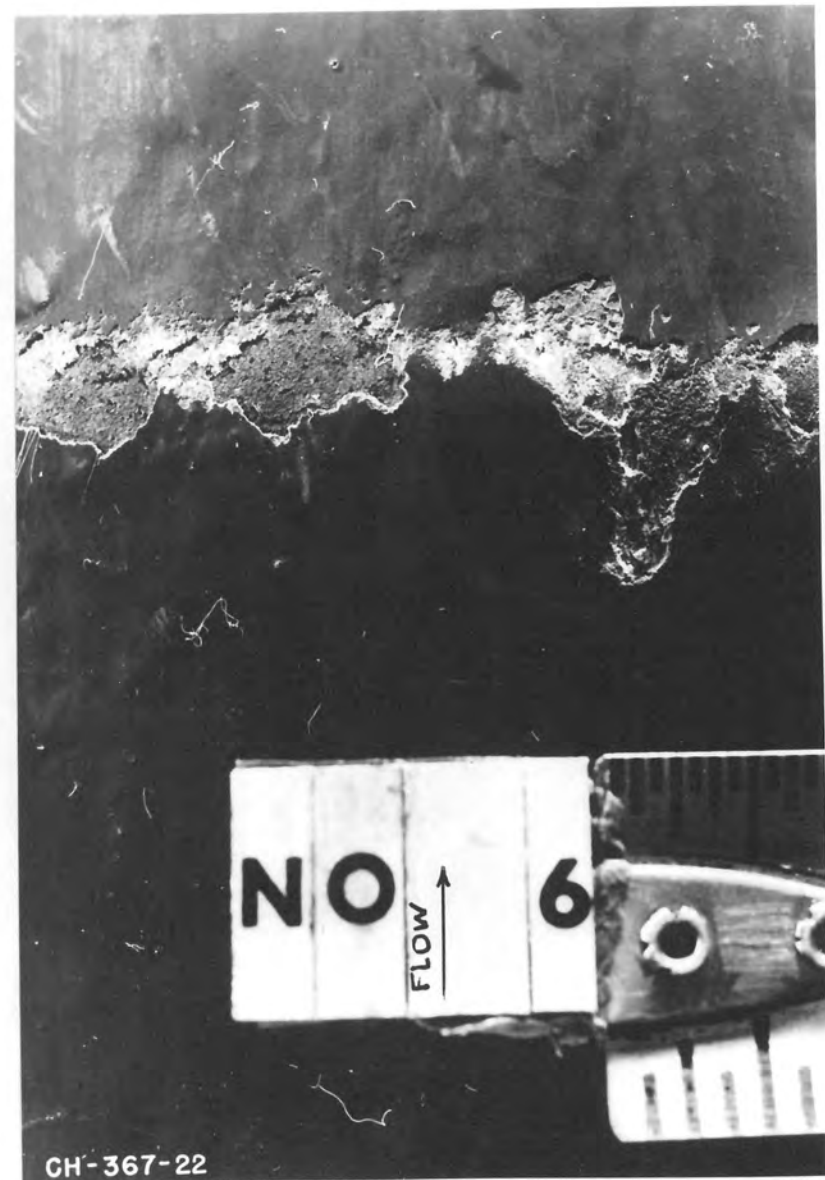
Tests of Protective Coatings  
SPECIMEN 6 AFTER 4 HRS At 70.5 FT/SEC.

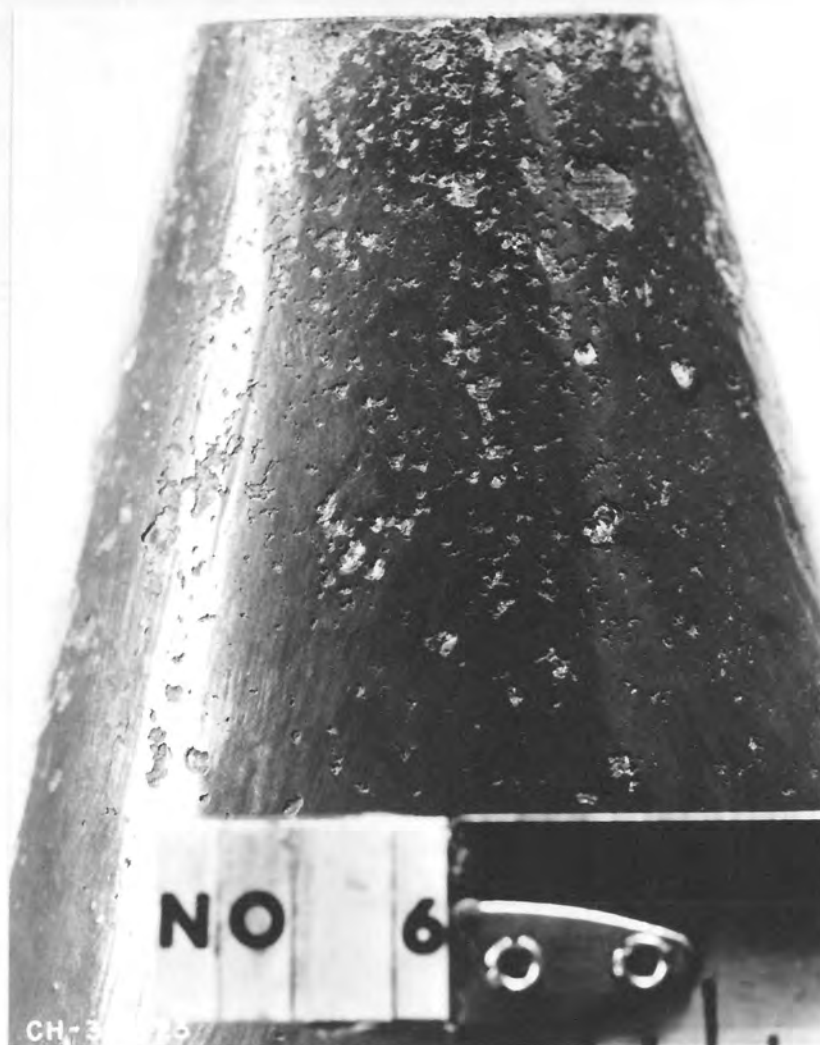
Figure 17

PITTING AT TIP

Tests of Protective Coatings  
Tip of SPECIMEN 6 AFTER 4 HRS  
At 70.5 FT/SEC.

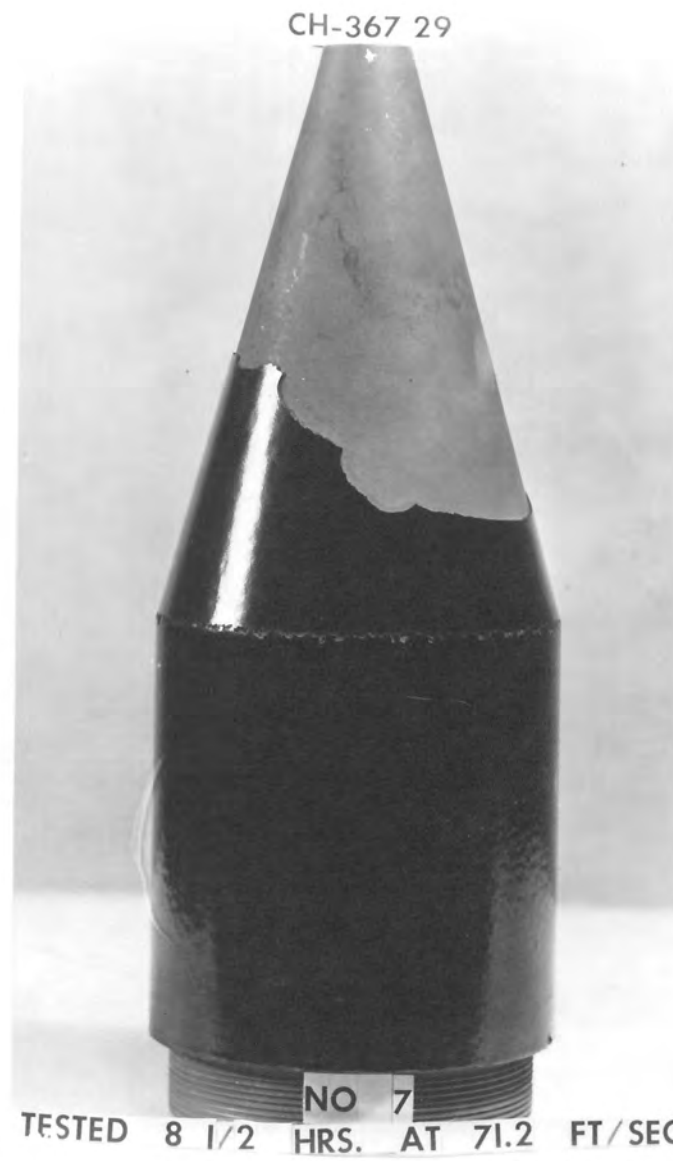
Metal was exposed near the cone base of Specimen 7 in 2-1/2 hours of testing. The coating on the upper half of the cone was loosened by cavitation and torn away in 8-1/2 hours (Figures 18 and 19). Failure similar to that on Specimen 7 was noted on Specimen 8 after 3-1/2 hours' testing. Bare metal exposed by cavitation-erosion was noted at the cone base in about 2 hours (Figures 20 and 21).

B. PITTING AT BASE - TEARING AT TIP RESULTING FROM LOOSENING BY CAVITATION

Test of Protective Coatings  
SPECIMEN 7 BEFORE and AFTER TEST

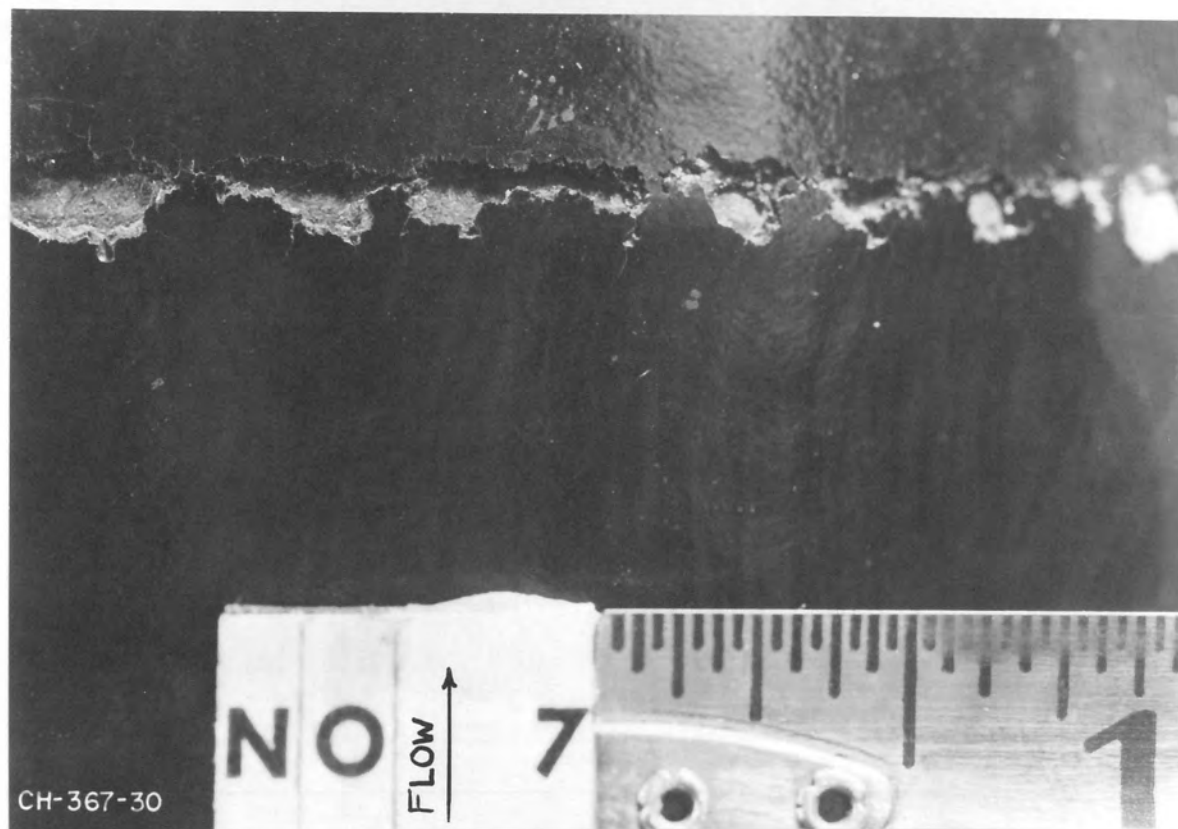
PITTING AT CONE BASE

Tests of Protective Coatings  
CONE BASE of SPECIMEN 7  
After  $8\frac{1}{2}$  HRS At 71.2 FT/SEC

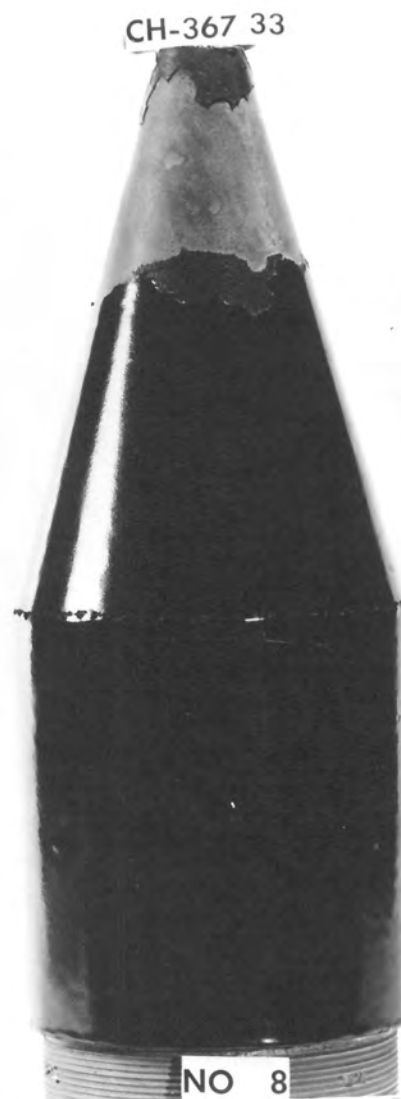
B. PITTING AT BASE AND TEAR AT TIP

Tests of Protective Coatings  
SPECIMEN 8 BEFORE AND AFTER TEST

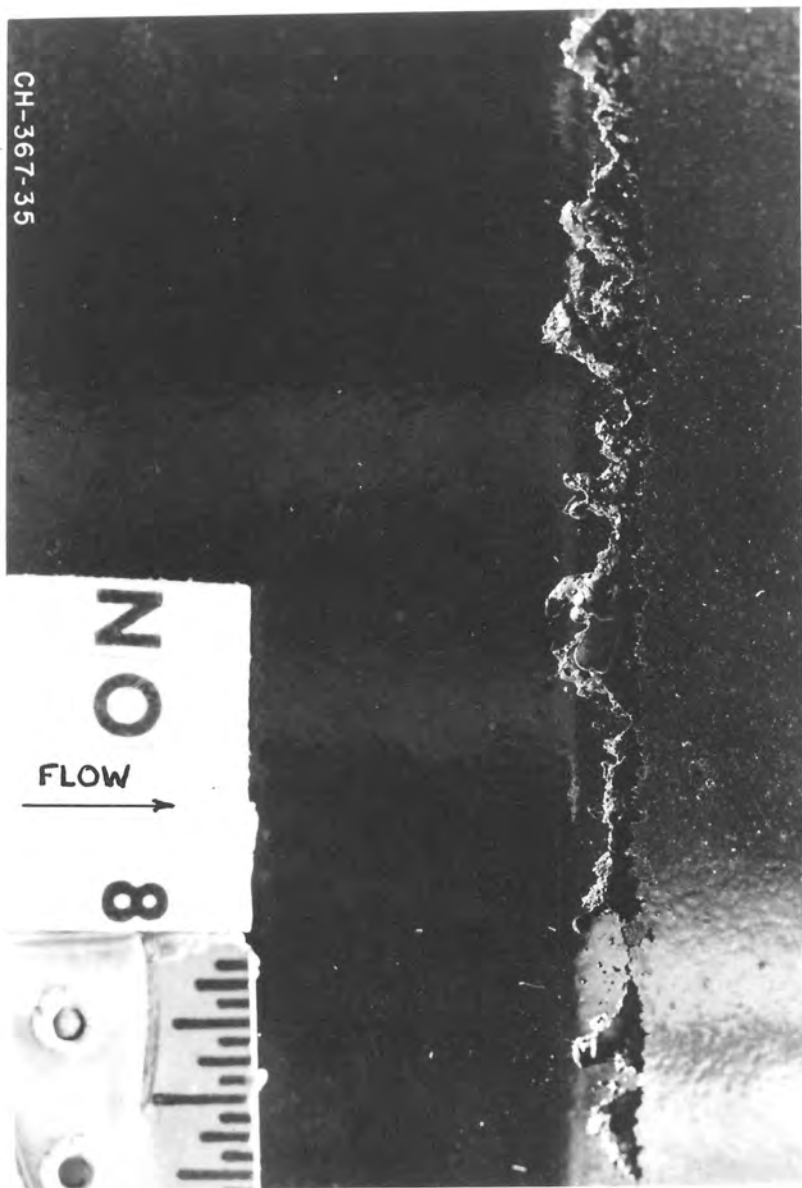
A. PITTING AT BASE

Tests of Protective Coatings  
SPECIMEN 8 AFTER 3½ HRS At 70 FT/SEC

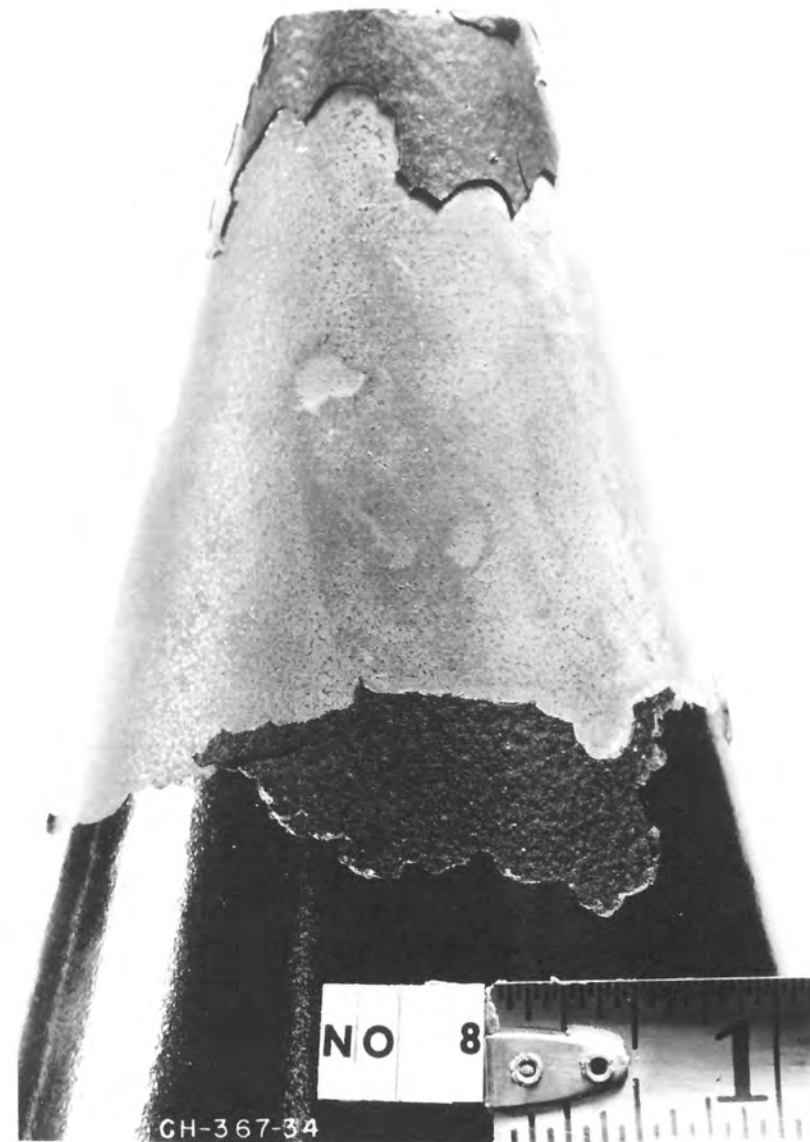
B. TEAR AT TIP

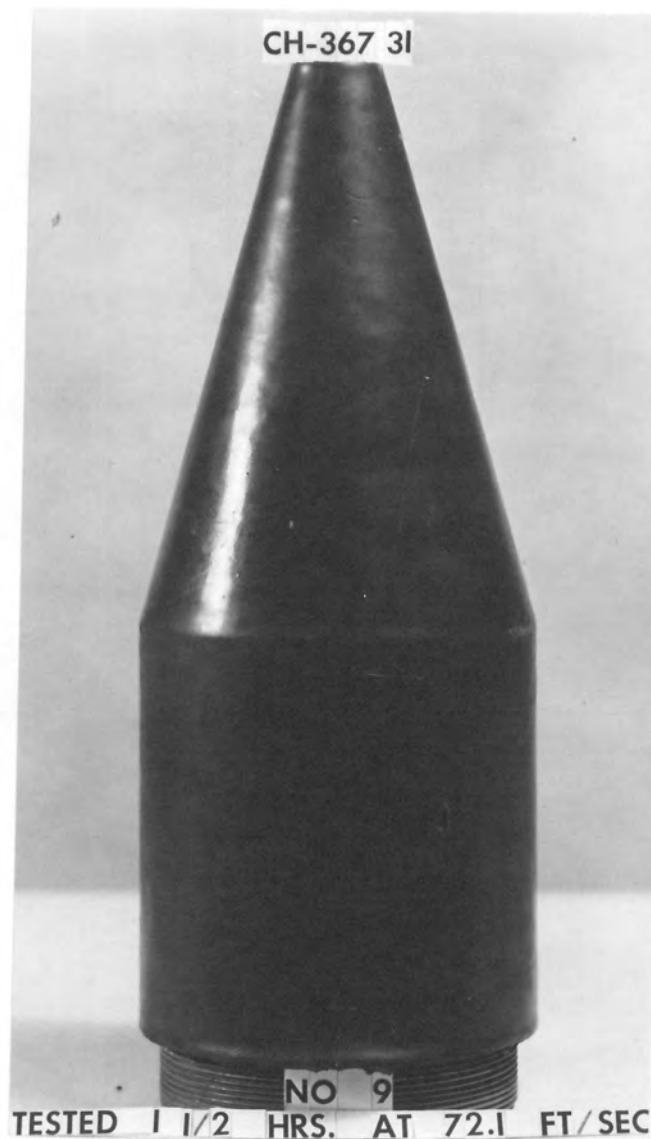
The coatings of both Specimens 9 and 10 became loosened and torn at the upstream edge of the coating in the throat section. The time in which this took place on both specimens was so short that no comparison as to cavitation-erosion resistance was possible (Figures 22 through 24). This gave further indication that a revision should be made to prevent pressure and velocity conditions damaging the coatings in this area so as to prevent further controlled cavitation studies.

Loosened coating at upstream edge.

Tests of Protective Coatings  
SPECIMEN 9 BEFORE AND AFTER TEST
