TEST OF PROTECTIVE COATINGS FOR NAVY

BUREAU OF RECLAMATION  
HYDRAULIC LABORATORY

Tests of Protective Coatings  
CONE CAVITATION APPARATUS

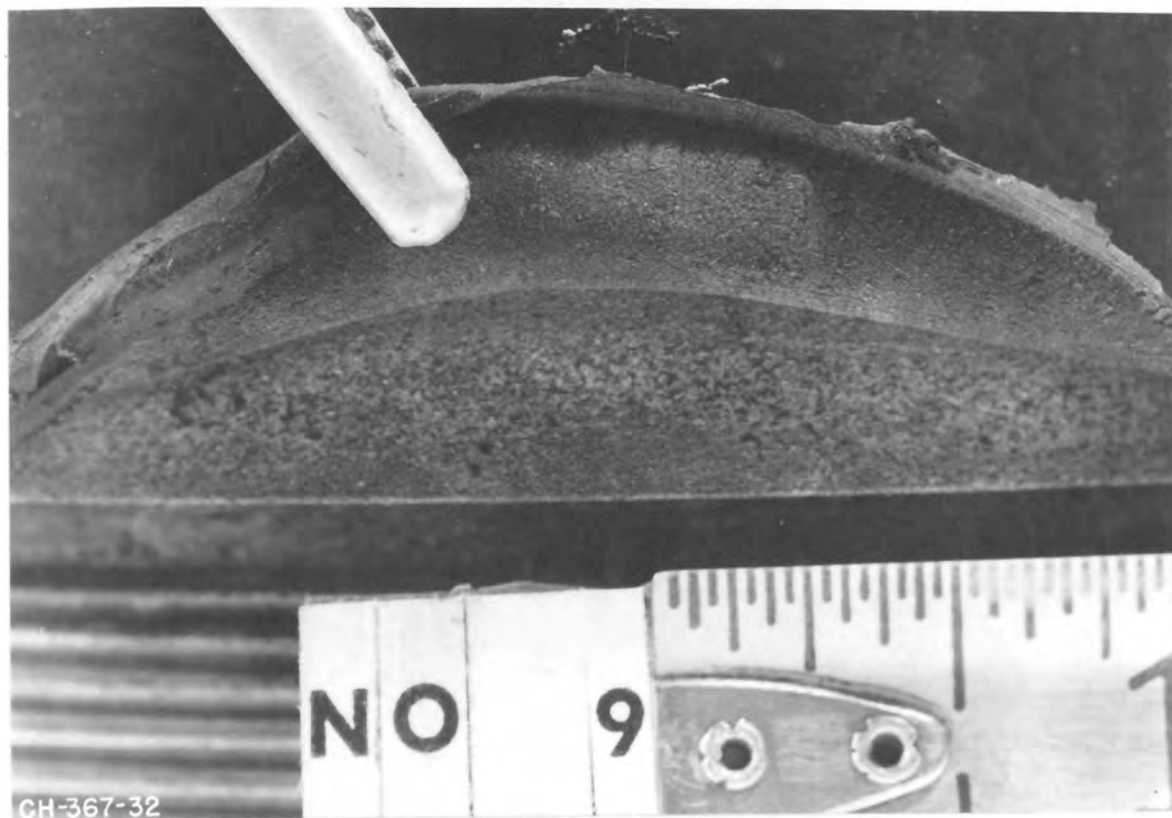
The coatings of both Specimens 9 and 10 became loosened and torn at the upstream edge of the coating in the throat section. The time in which this took place on both specimens was so short that no comparison as to cavitation-erosion resistance was possible (Figures 22 through 24). This gave further indication that a revision should be made to prevent pressure and velocity conditions damaging the coatings in this area so as to prevent further controlled cavitation studies.

TEAR AT UPSTREAM EDGE OF COATING

Tests of Protective Coatings  
UPSTREAM Edge of SPECIMEN 9  
AFTER  $1\frac{1}{2}$  HRS At 72.1 FT/SEC

The tests prove that some special treatment of the coating at both upstream and downstream edges of the coating materials should be considered in future test programs. This treatment should be of a nature to prevent velocity and pressure acting on loosened edges of the coating to tear them and upset the test conditions. A special undercutting or extension of the specimen at both ends might do much to solve the problem. Some degree of success was obtained by slight alterations to the cone in some of our most recent tests (Figure 1).

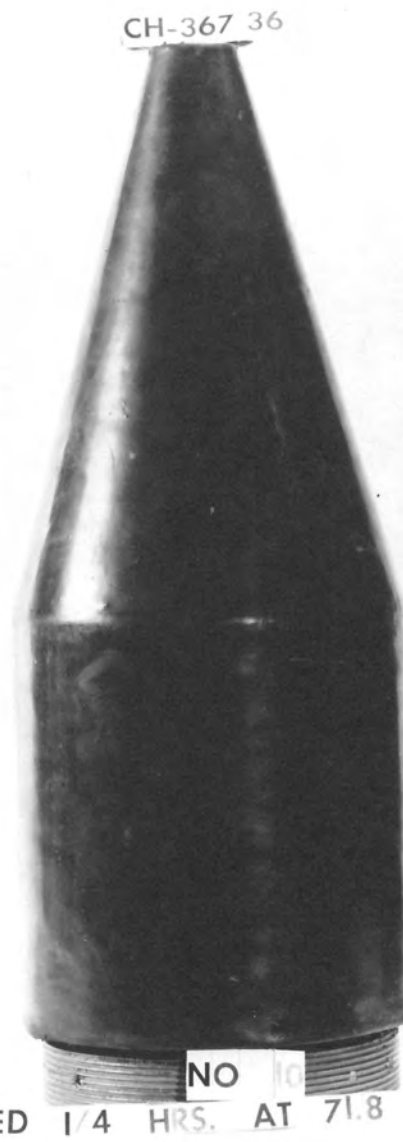
Loosened Coating at upstream edge

Tests of Protective Coatings  
SPECIMEN 10 BEFORE AND AFTER TEST

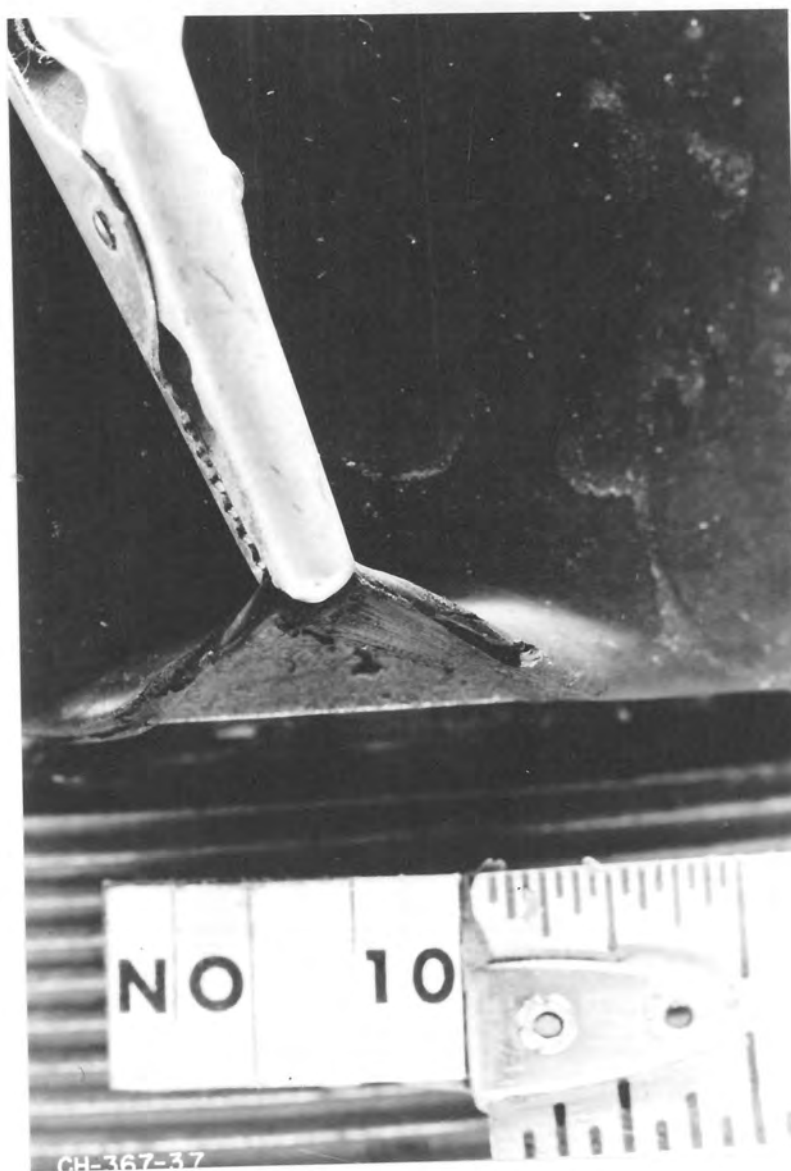
LOOSENED COATING

Tests of Protective Coatings  
UPSTREAM EDGE OF SPECIMEN 10  
AFTER  $\frac{1}{4}$  HR At 71.8 FT/SEC.
