CAVITATION DAMAGE OF ROUGHENED CONCRETE SURFACES

by Donald Colgate

A paper prepared for presentation
at the 1956 Annual Convention,
American Society of Civil
Engineers, October 15-19, 1956,
Pittsburgh, Pennsylvania.

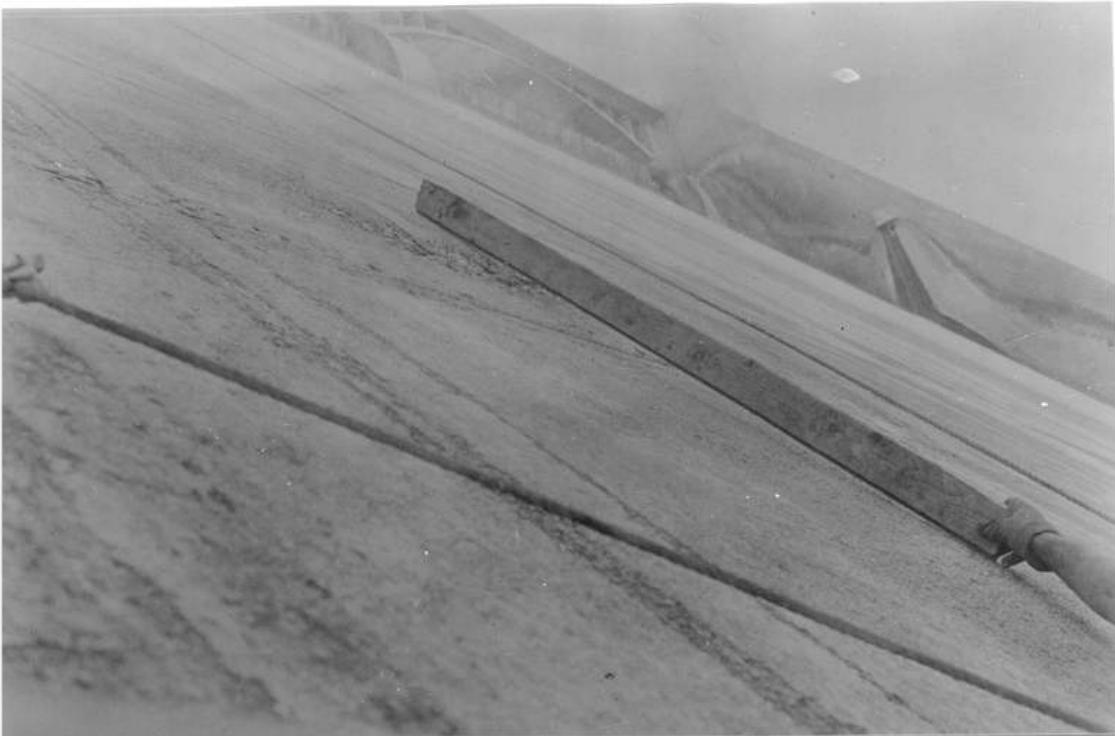
At Grand Coulee Dam the forms on the spillway face bulged outward permitting the concrete to "hump" about 3 inches in at least one of the 5-foot lifts. An examination of the spillway face after about 9 seasons of

operation disclosed that the concrete downstream from this hump had been damaged by cavitation (Figure 1). In this instance the designers had specified that the spillway section conform in all respects to the "lines, grades, and dimensions" shown on the drawings. In practice, some deviation from true lines is to be expected, but the permissible limits of such deviation to prevent damaging cavitation have not been accurately determined.

Figure 1. Spillway, Grand Coulee Dam, showing "humped" concrete surface and cavitation erosion.

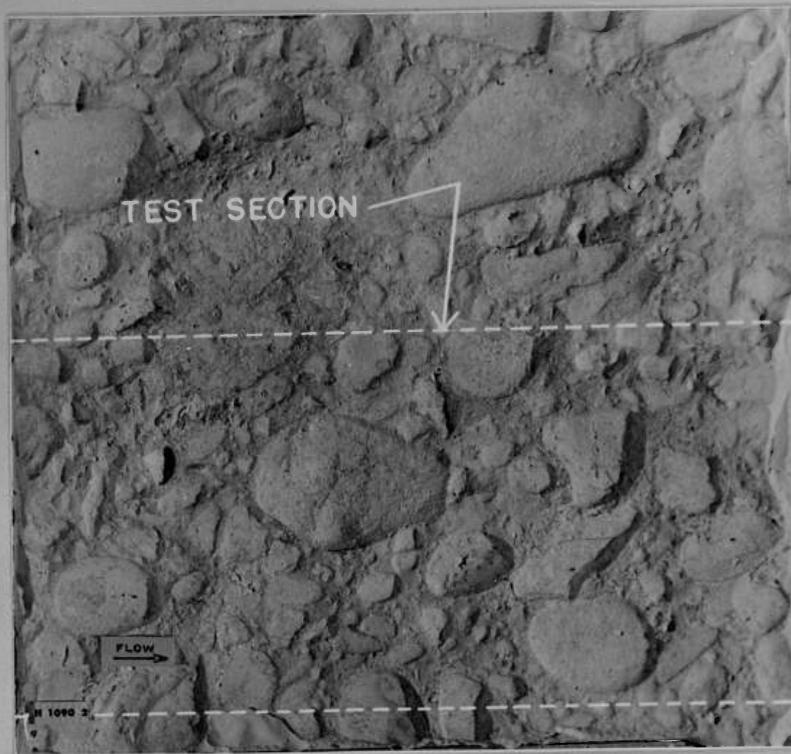
During the building of Davis Dam on the Colorado River, discharges were made into the side of the spillway bucket. Debris of varied origin was washed about until quite an area was scoured, some places to a depth of 3 inches or more below the finished surface (Figures 2 and 3). When the bucket was dewatered and the scoured area inspected, the question arose as to whether or not these roughened surfaces would induce cavitation. The answer was not readily apparent, and since spillway releases were imminent, the repair of the scoured area to the original contours was authorized and performed.

Figure 2. 1-foot-square plaster mold of eroded surface at Davis Dam (Specimen No. 2).

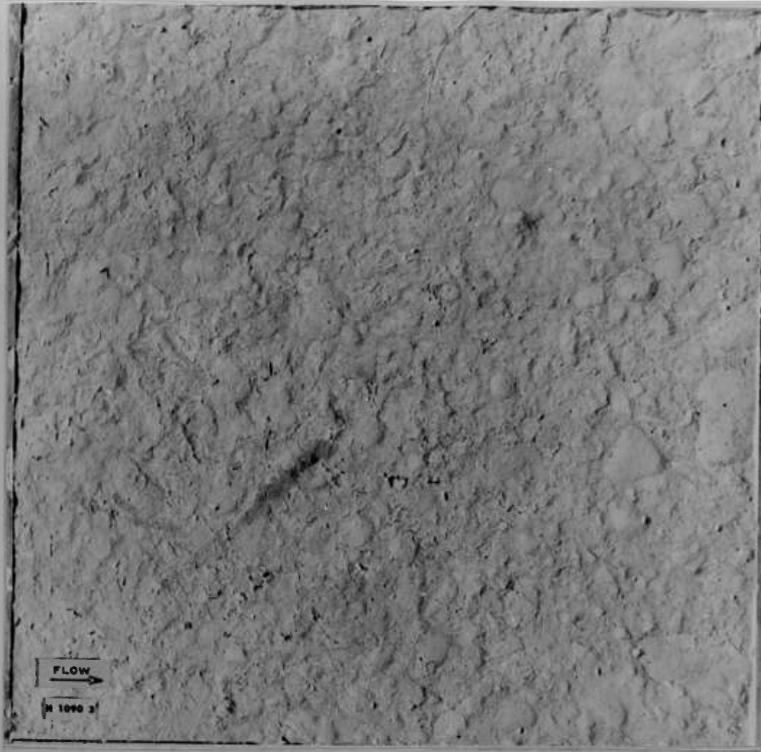
Figure 3. 1-foot-square plaster mold of eroded surface at Davis Dam (Specimen No. 3).

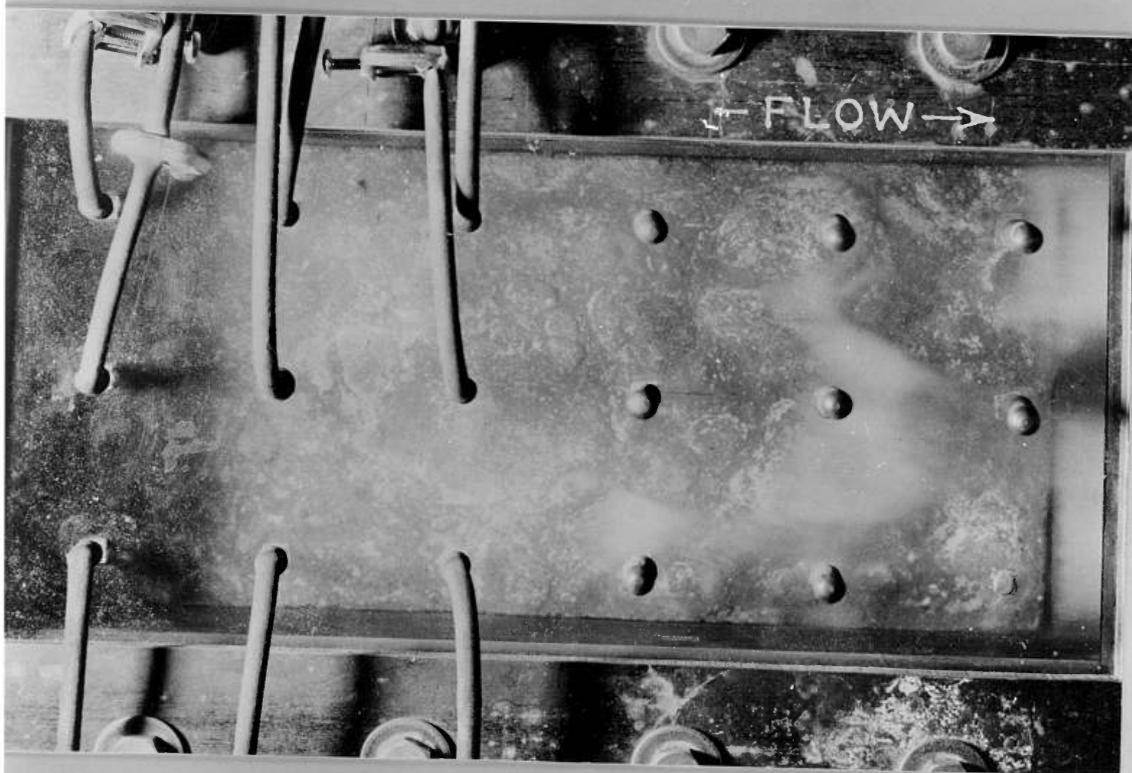
At the onset it was determined that, under certain conditions, cavitation did form on the protruding aggregate (Figure 5). The test apparatus had sufficient range to permit visible cavitation to be formed for stream velocities as small as 25 fps with low back pressure, and up to 97 fps with high back pressure. The only measurements made were (a) the discharge, (b) pressures at various points on the viewing window, and (c) single leg Pitot tube pressures to calculate the velocities at various distances above the specimen.

Figure 6. Visible cavitation cloud on Specimen No. 2. Head on the viewing window = +14', $\sqrt{\frac{T_0}{\rho}} = 5.4$.
