CAVITATION DAMAGE OF ROUGHENED CONCRETE SURFACES

by Donald Colgate

A paper prepared for presentation
at the 1956 Annual Convention,
American Society of Civil
Engineers, October 15-19, 1956,
Pittsburgh, Pennsylvania.

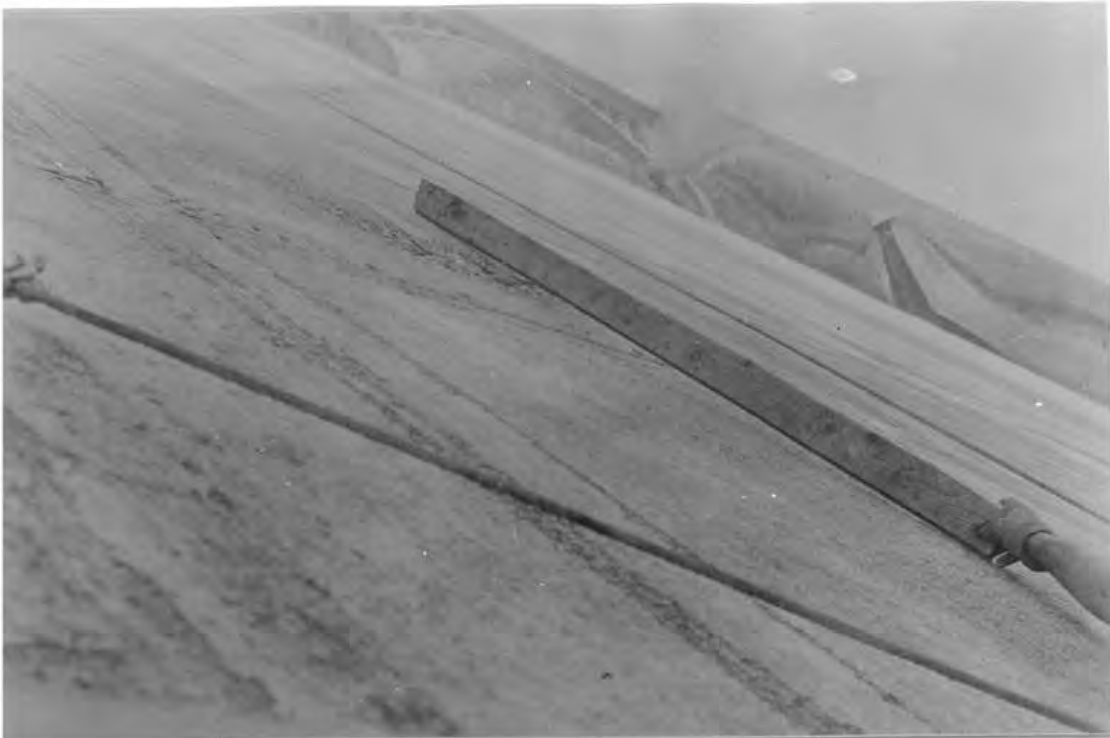
At Grand Coulee Dam the forms on the spillway face bulged outward permitting the concrete to "hump" about 3 inches in at least one of the 5-foot lifts. An examination of the spillway face after about 9 seasons of

operation disclosed that the concrete downstream from this hump had been damaged by cavitation (Figure 1). In this instance the designers had specified that the spillway section conform in all respects to the "lines, grades, and dimensions" shown on the drawings. In practice, some deviation from true lines is to be expected, but the permissible limits of such deviation to prevent damaging cavitation have not been accurately determined.

Figure 1. Spillway, Grand Coulee Dam, showing "humped" concrete surface and cavitation erosion.

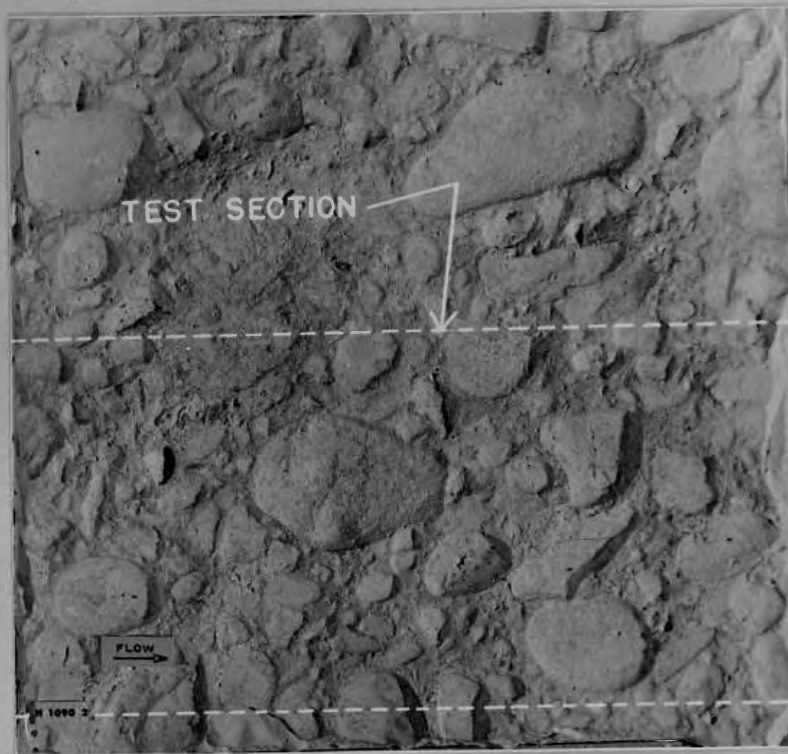
During the building of Davis Dam on the Colorado River, discharges were made into the side of the spillway bucket. Debris of varied origin was washed about until quite an area was scoured, some places to a depth of 3 inches or more below the finished surface (Figures 2 and 3). When the bucket was dewatered and the scoured area inspected, the question arose as to whether or not these roughened surfaces would induce cavitation. The answer was not readily apparent, and since spillway releases were imminent, the repair of the scoured area to the original contours was authorized and performed.

lack of descriptive nomenclature the surfaces have been referred to as Specimen No. 2 and Specimen No. 3. The average exposed aggregate of Specimen No. 2 extended about $3/4$ inch above the lowest point of the roughened surface, and that of No. 3 about $1/4$ inch.

Figure 2. 1-foot-square plaster mold of eroded surface at Davis Dam (Specimen No. 2).

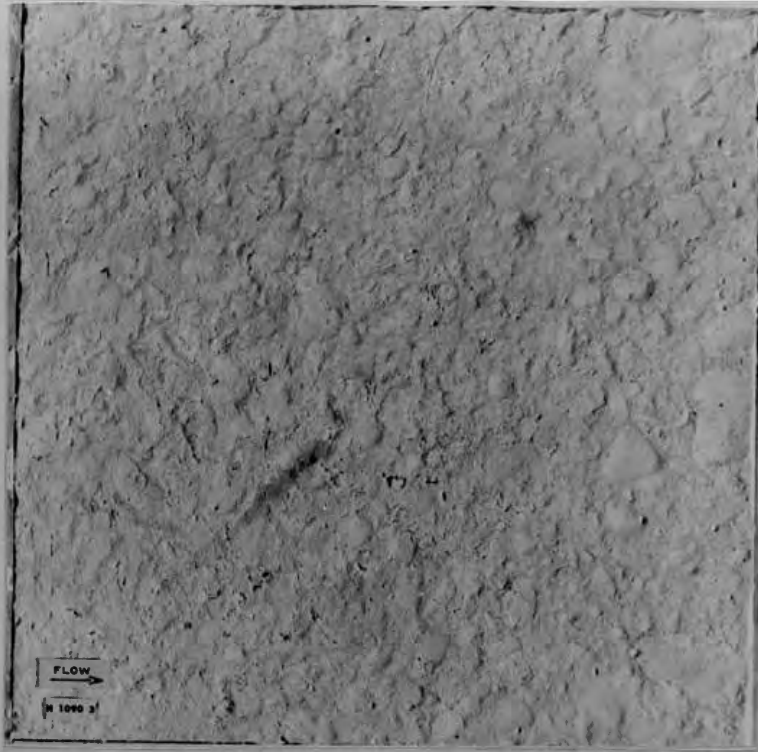
Figure 3. 1-foot-square plaster mold of eroded surface at Davis Dam (Specimen No. 3).

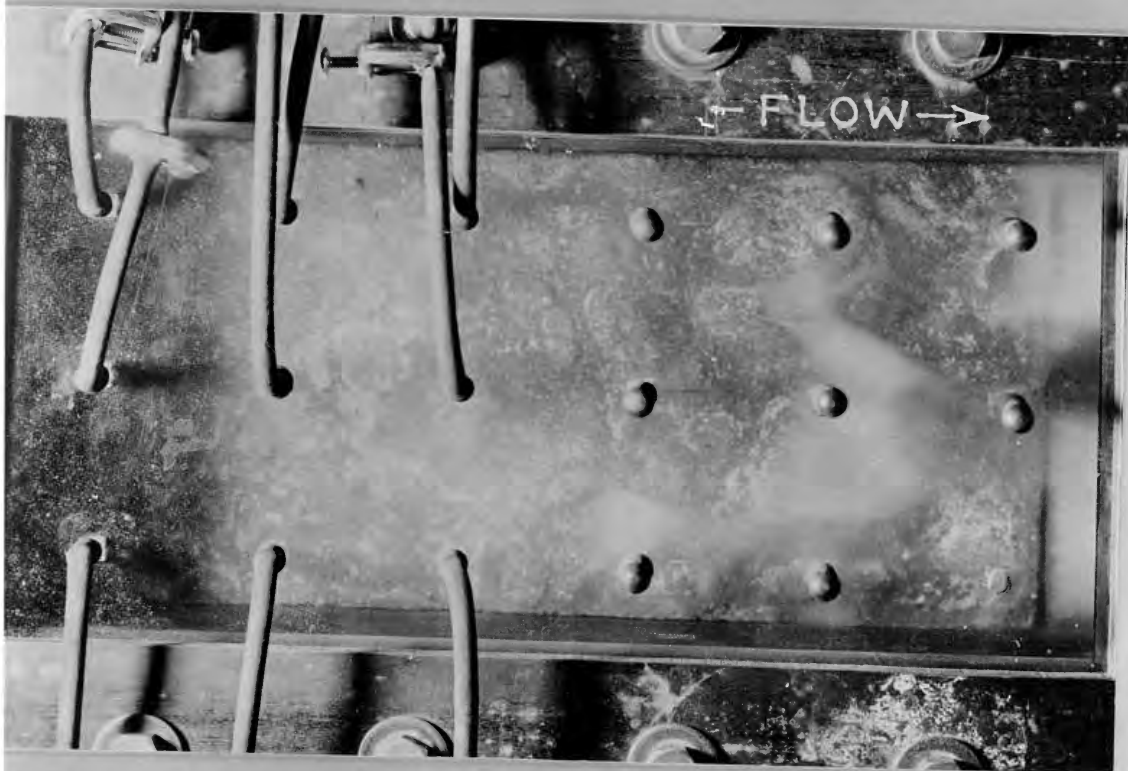
At the onset it was determined that, under certain conditions, cavitation did form on the protruding aggregate (Figure 5). The test apparatus had sufficient range to permit visible cavitation to be formed for stream velocities as small as 25 fps with low back pressure, and up to 97 fps with high back pressure. The only measurements made were (a) the discharge, (b) pressures at various points on the viewing window, and (c) single leg Pitot tube pressures to calculate the velocities at various distances above the specimen.

Figure 6. Visible cavitation cloud on Specimen No. 2. Head on the viewing window = +14', $\sqrt{\frac{T_0}{\rho}} = 5.4$.
