DISCUSSION ON PAPER "USE OF MODEL TO DISCLOSE  
EFFECTS OF CAVITATION IN PENSTOCK WYE-BRANCH"

By  
James W. Ball-<sup>1/</sup>

BUREAU OF RECLAMATION  
HYDRAULIC LABORATORY

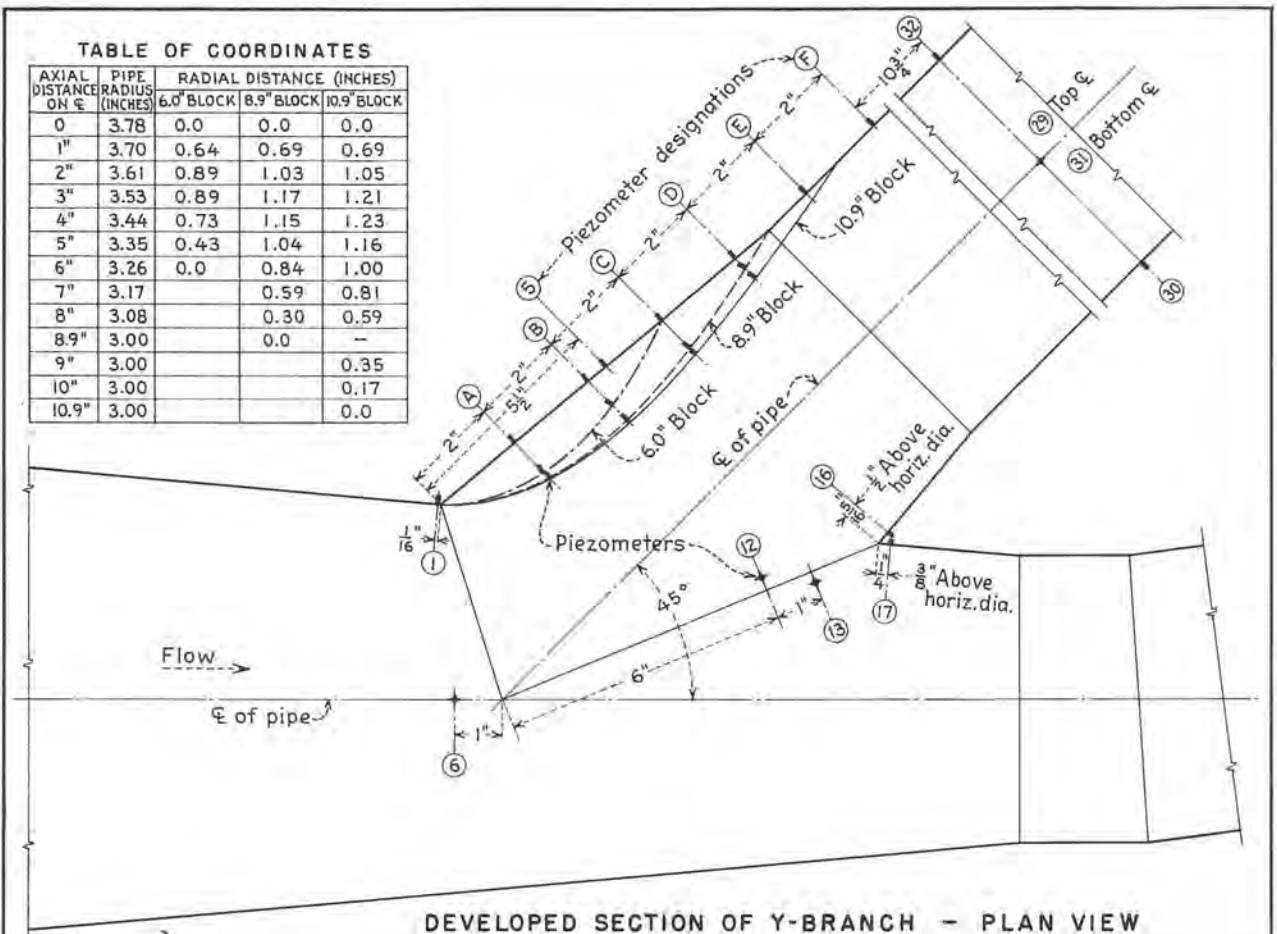
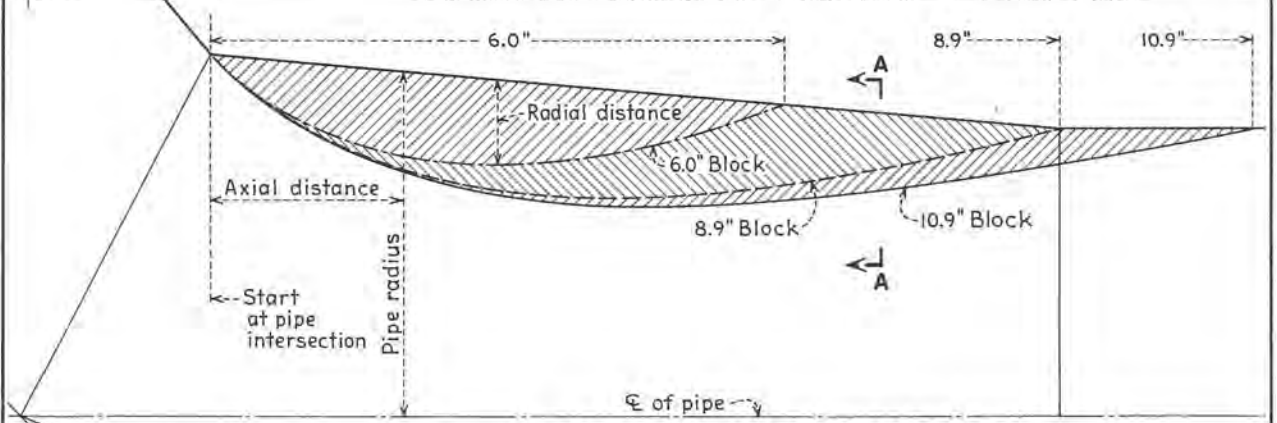
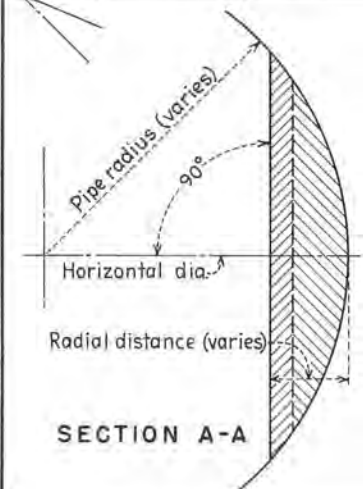
FIGURE 2  
 FALCON DAM  
 OUTLET WORKS - MEXICAN SIDE  
 PRESSURE VARIATIONS IN Y-BRANCH  
 PIEZOMETER LOCATIONS AND FILLER BLOCKS  
 1:15 SCALE MODEL

It was theorized that the vibration and noise resulted from pressure fluctuations which caused intermittent subatmospheric pressures in the zone of separation at the left wall of the left leg of the Y-branch where it connected to the truncated conical section of the main conduit. The vibration tendency was noted when similar flow conditions were represented in a 1:15 scale model of the branch and control valves (Figure 1). Because the vibration and noise were associated with highly fluctuating pressures within the branch, numerous piezometers were installed and measurements made of transient pressures with pressure cells and an oscillograph. The <sup>s</sup> shape of the Y-branch, including piezometer locations, <sup>15</sup> are shown on Figure 2.

Rapid pressure fluctuations up to 60 feet of water (prototype) were recorded at piezometers D and E (Figure 3). Intermittent subatmospheric pressures of about 17 feet were measured at piezometer 5. From the tests it was concluded that pressures in the separation zone of the prototype momentarily reached vapor pressure and that the vapor cavities thus found <sup>formed</sup> collapsed when subjected to the sudden rises of pressure to cause cavitation with the consequent noise and vibration.

It was reasoned that a solid boundary, shaped roughly to the outer limits of the turbulent separation zone, would do much toward minimizing the pressure fluctuations and thus decrease the cavitation potential of the system. A filler block patterned from previous observations on a transparent model of a similar Y-branch was placed in the zone (Figure 2). This 8.9-inch filler block reduced maximum pressure fluctuations on the left flow surface from 60 to 19 feet of water (prototype). Two additional filler blocks, one larger and the other smaller than the original (10.9" and 6.0"), were tested to ascertain the optimum size. A marked increase in the magnitude of the fluctuations occurred when the block was shortened and only a negligible decrease in the fluctuations occurred with the larger block. It was concluded that the intermediate size gave optimum conditions so the field structure was altered to include this shape. Subsequent observations on the field structure indicated a substantial reduction in pressure fluctuations and the elimination of the rather loud and heavy thumping sounds and vibration in the Y-branch.
