DESIGN CONSIDERATIONS REGARDING CAVITATION IN HYDRAULIC STRUCTURES

Donald Colgate^{1/}
and
Rex Elder^{2/}BUREAU OF RECLAMATION
HYDRAULIC LABORATORYOFFICE
FILE COPY

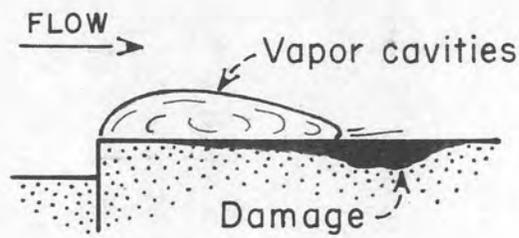
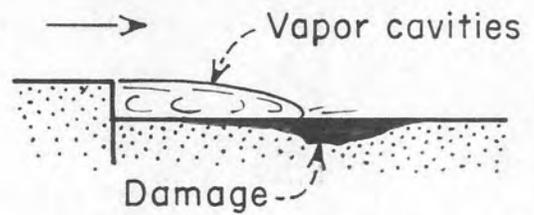
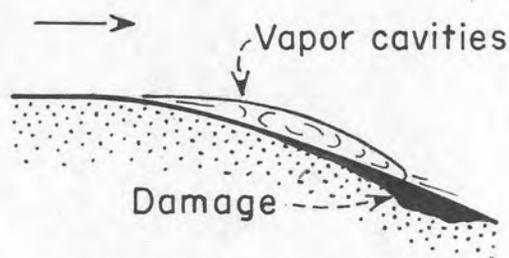
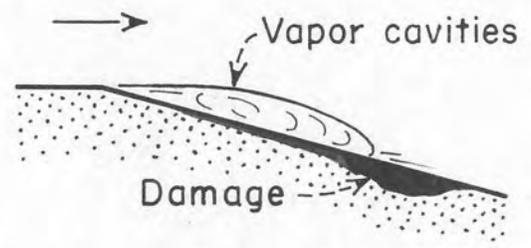
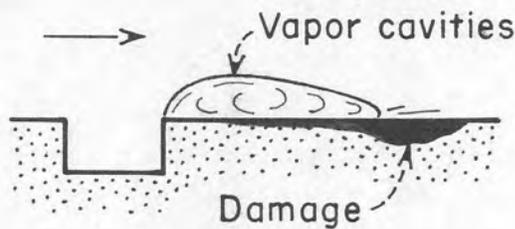
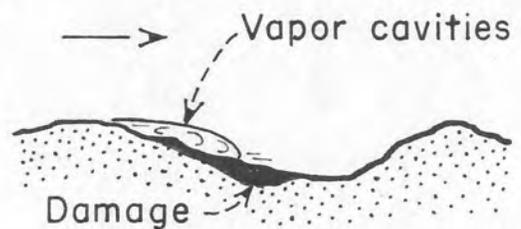
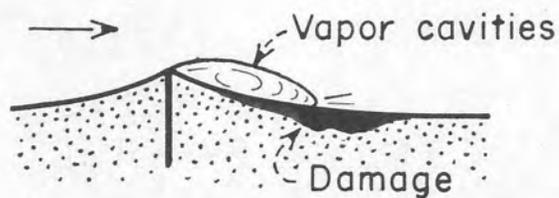
FIGURE 2. POSSIBLE OCCURRENCE OF CAVITATION AT FLOW SURFACE IRREGULARITIES

Damaging cavitation can generally be traced to 1 of 3 major sources: inadequate construction control of the walls of flow passages, improper operating procedures, or improper hydraulic design. Figure 1 shows several types of surface irregularities which can and should be controlled during the construction stage. However, these irregularities are often overlooked and become a source of much trouble during the operating phase.

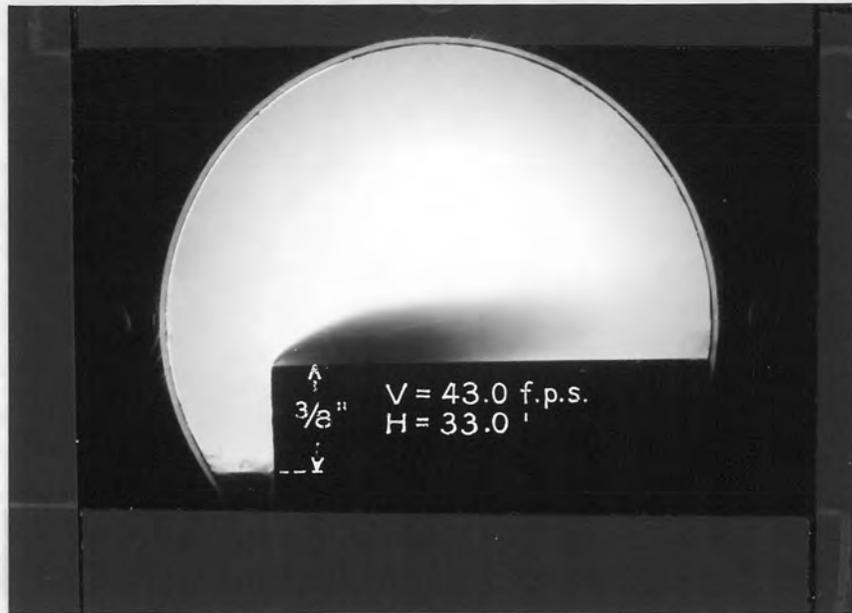
surface irregularities. Figure 2 is a photograph of an operating laboratory apparatus with a 90° offset extending 3/8 inch into the flow, and with a substantial cavitation cloud forming on the sharp corner. Figure 3 shows the cavitation damage resulting from an offset extending 1/4 inch into the flow. This offset was caused by a misalignment between the concrete forms and the steel gate frame in the outlet works at Palisades Dam. The relatively slight preliminary damage may be easily repaired. However, if allowed to continue, the roughened surface caused by the cavitation will be the source of continuing cavitation and extensive damage may result as is graphically illustrated in Figure 4, one of the outlet works conduits at Grand Coulee Dam.

FIGURE 2 -- 90° Offset Into The Flow

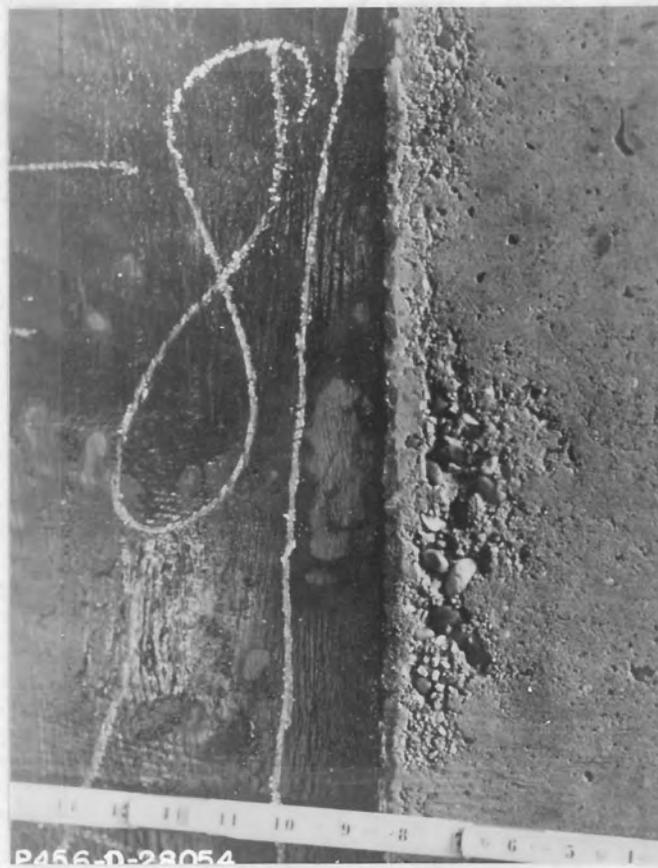
FIGURE 3 -- $\frac{1}{4}$ " Offset Into The Flow, Corner Naturally Rounded

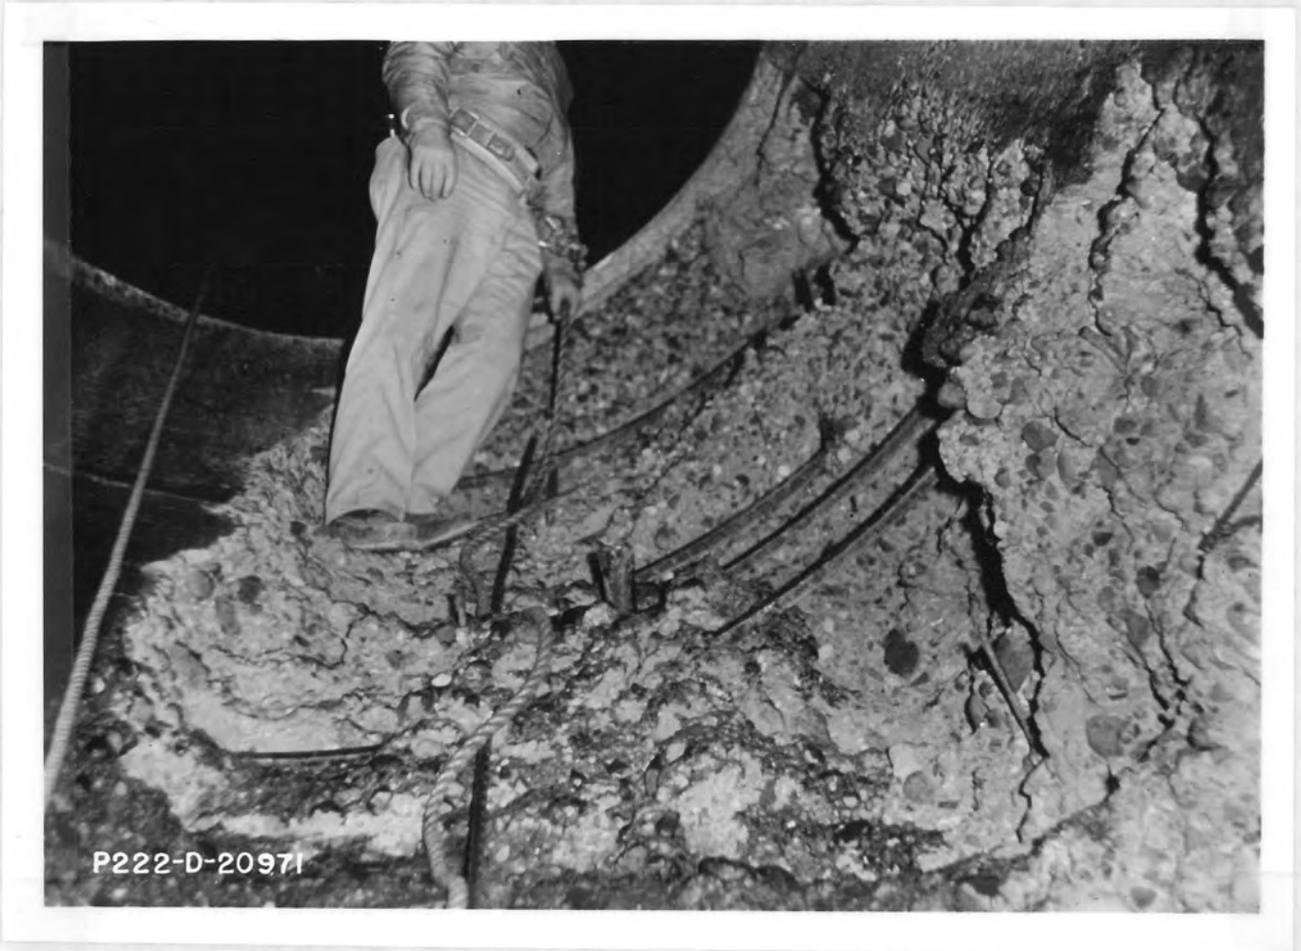
Two adjacent outlets, one repaired with an epoxy mortar patch, and the other corrected with an aeration groove, were operated under about 235 feet of head for 1,800 hours. The one corrected with the groove* showed no damage while the one repaired with a patch suffered damage comparable to that shown in Figure 4. In this instance the admission of air through a properly shaped groove adequately protected the installation from cavitation attack. A resistant repair material was not acceptable as a solution to the problem.

FIGURE 4 -- Extensive Cavitation Damage in an Outlet at
Grand Coulee Dam

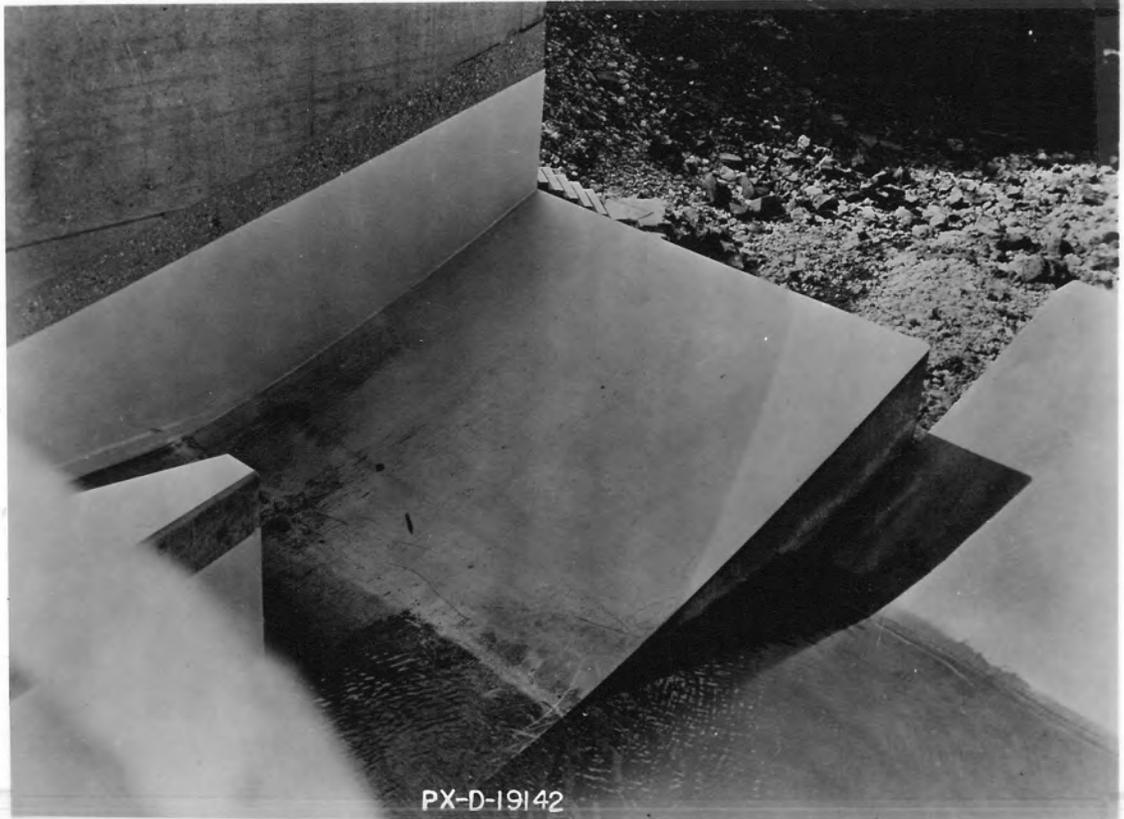
When cavitation damage is found, and the source of the cavitation ascertained, the general procedure is to repair the damaged area and remove or correct the source of the cavitation if possible. In a situation where corrective measures are not feasible, or if there is a question as to the adequacy of the corrective measures taken, a repair material resistant to cavitation attack may be used. At the Army Engineers' Lucky Peak Dam, the source of the damaging cavitation was not readily apparent. The damage pattern indicated that vortices sufficiently violent to produce cavitation pressures started the damage, then the damaged surface induced further cavitation and consequently continuing cavitation damage, until the floor of the outlet structure downstream from the control gate was destroyed. In this instance the damaged area was repaired by forming the flow boundaries of steel plate, Figure 10. This repair method is effective since steel is vastly superior to concrete in resistance to the attack of cavitation. Pressure studies of the Lucky Peak outlet works flow passages indicated that the gates had been operated in a range of openings (6 inches to 1 foot) which tended to produce adverse pressures. A revised operating criteria was issued which prohibited extended operation of the gates at openings smaller than 2 feet. The combination of resistant repair material and revised operating procedures should eliminate the difficulties at Lucky Peak Dam.

FIGURE 10 -- Steel Clad Flow Boundaries,
Lucky Peak Dam

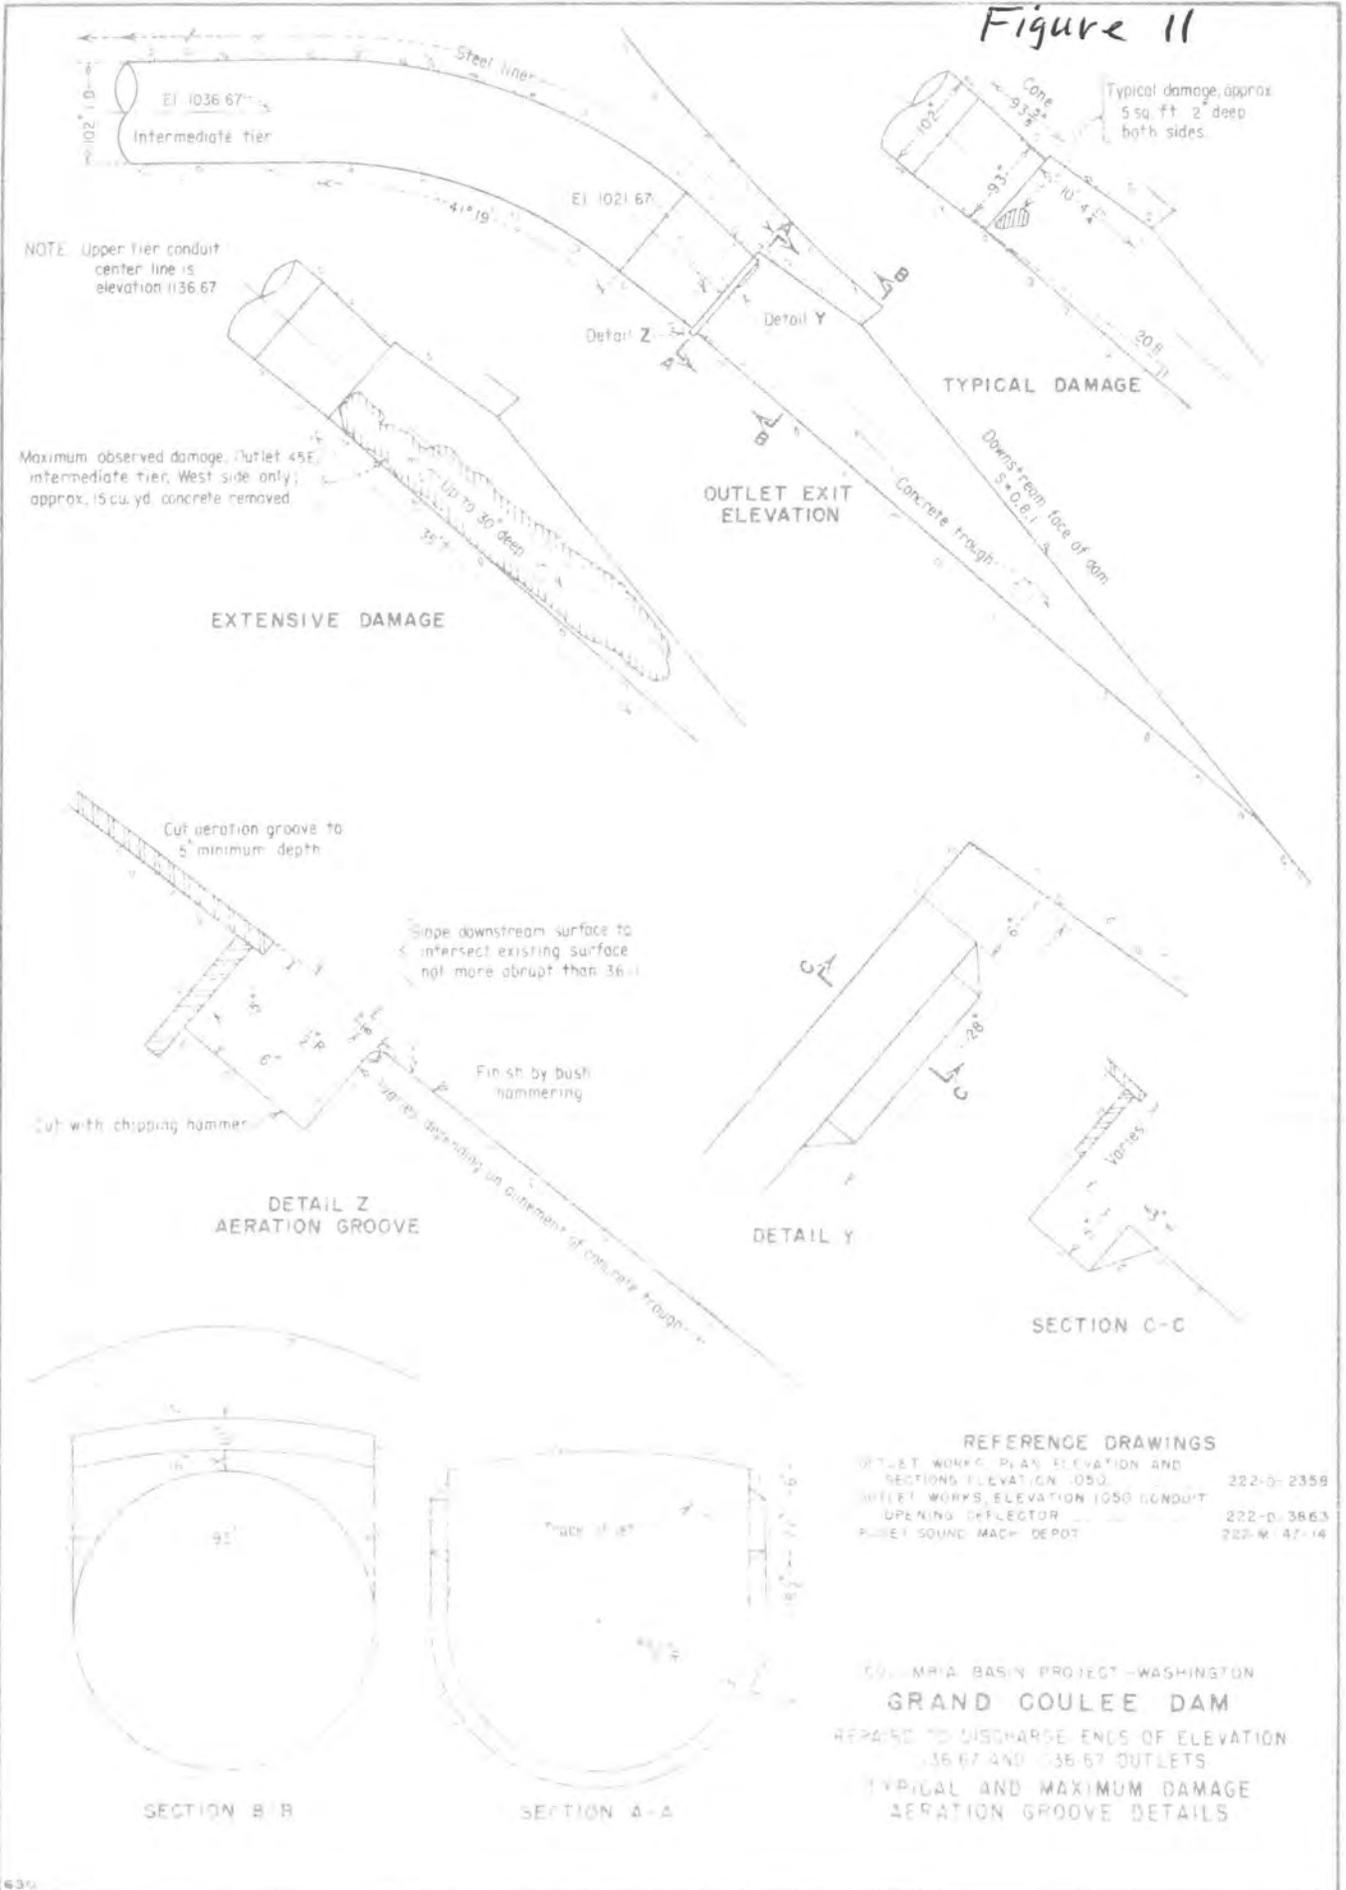
Figure 11

At Grand Coulee Dam, the exit end of the outlet conduits consisted of cones which reduced the tunnel diameter from 102 inches to 93 inches, see Figure 11. These cones were designed to maintain positive pressures in the tunnels and at the control gates during operation. The junction of the steel liner of the cone and the concrete trough downstream formed a break of 20.8:1. With the velocities at Grand Coulee Dam this break in flow surface was sufficient to cause cavitation and the resultant damage as shown in Figures 4 and 12. It is known that admitting air to a low pressure area will reduce the damaging effect of cavitation and since at Coulee Dam the outlets were of such a shape that air could be readily admitted to the downstream end of the cone (Sections A-A and B-B, Figure 11) this method was considered to be one possibility for correcting the difficulty. An aeration groove (Detail Z, Figure 11) was cut into several of the Grand Coulee outlets just downstream from the steel-lined cone. Previous work on gate slots^{5/} was used to determine the proper dimensions of the groove, and the current work on surface irregularities concerning chamfers determined the shape downstream from the aeration groove.

COUMRIA BASIN PROJECT - WASHINGTON
GRAND COULEE DAM
 REPAIR TO DISCHARGE ENDS OF ELEVATION
 1036.67 AND 1036.67 OUTLETS
 TYPICAL AND MAXIMUM DAMAGE
 AERATION GROOVE DETAILS

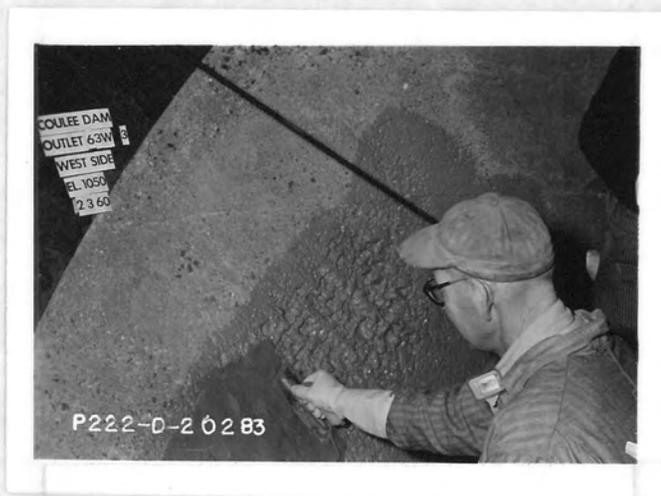
FIGURE 12 -- Epoxy Mortar Patch in an Outlet Tunnel
at Grand Coulee Dam

Some of the outlets showed relatively mild cavitation damage. It was thought that an epoxy mortar patch might be sufficient to resist the damaging effect of the cavitation. Figure 12 shows the application of epoxy mortar to a minor damaged area. The surface is first

sandblasted, then covered with a prime coat of epoxy and filled to grade with an epoxy mortar. Feathered edges may be tolerated with this material.
