**DESIGN AND OPERATING PROBLEMS  
ON THE  
GLENDO DAM HIGH HEAD OUTLET  
WORKS STILLING BASIN**

**M. A. Jabara and W. E. Wagner, Engineers,  
Office of Assistant Commissioner and Chief Engineer  
Bureau of Reclamation  
Denver, Colorado**

**A paper to be presented at the  
1961 Annual Convention,  
American Society of Civil Engineers,  
New York City, October 16-20, 1961**

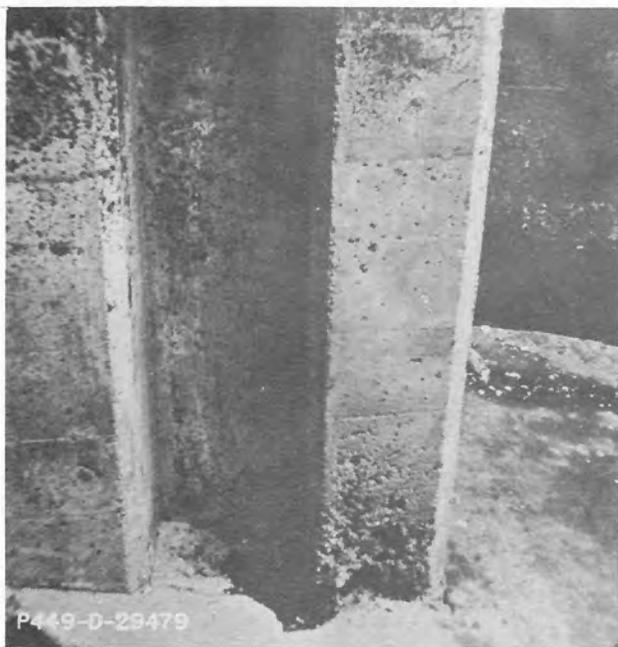
In October, the basin was unwatered in preparation for a comprehensive examination of all flow surfaces. It disclosed an alarmingly extensive cavitation damage to the sides of the center chute block in each outlet bay, in the flared walls, and near the bottom of the stoplog grooves. The whirling action of the water during the time large releases were made simultaneously through only Gates 1 and 2 caused displacement of the riprap in the

A. Stoplog groove on left side of Outlet No. 2.

The stoplog grooves near the end of the flared walls were filled with concrete to form a continuous surface. Metal guides to replace the grooves were placed on the downstream face of the walls.

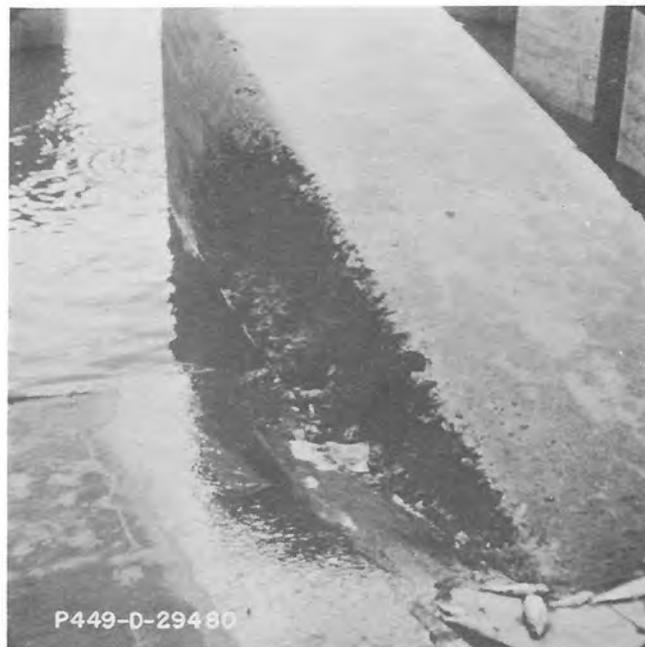
The extensive damage to the chute blocks indicated that they were indefensible against the negative pressures which were produced as the jets impinged on their surfaces. Obviously, the elliptical corners were much too sharp to prevent cavitating pressures on the vertical sides of the blocks. Modification of the stilling basin to insure the presence of relatively high noncavitating pressures on all flow surfaces was imperative.

The model investigation confirmed the earlier conclusion that the cavitation erosion on the original chute blocks resulted from malstreamlining. In general, the tests indicated that the original chute blocks were most effective in stabilizing the hydraulic jump, but produced the lowest pressures on the surfaces. Improved pressures were obtained by increasing the curvature of the elliptical corners. The improvement was short of the desired result. The upward slope was then eliminated, making the maximum height of the block 2 feet 9 inches. These shorter blocks caused large boils of water to form above the baffle piers, requiring a higher tail water to retain the jump within the limits of the basin. Blocks with horizontal top surfaces and with a maximum height of 4 feet 10 inches were then tested. These produced a basin performance quite similar to that with the original blocks. Tests also revealed that blocks with tapered sides which conform with the diverging flow, and the top edges streamlined with an elliptical curve having its major axis, in a direction parallel to the chute floor and five times that of its minor axis presented the most favorable results. The prototype chute blocks were modified accordingly.

B. Left face of center chute block for Outlet No. 2.

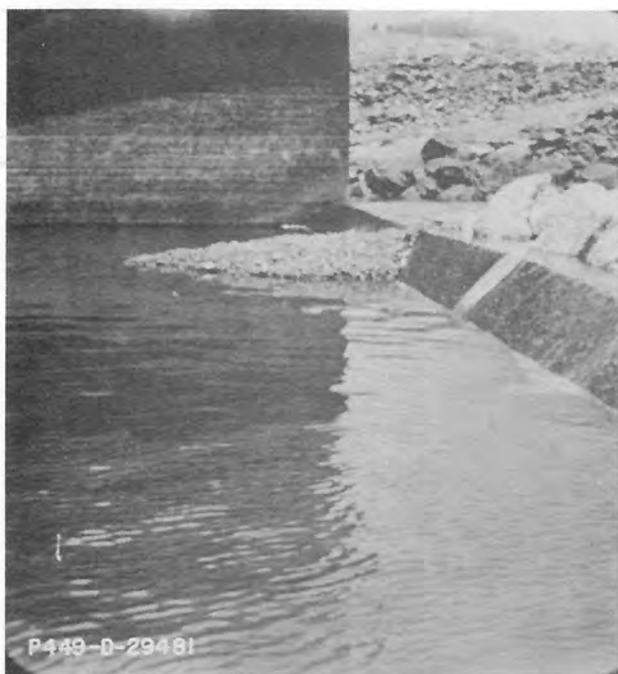
outlet channel. The riprap near the end of the basin, angular when placed, had become rounded due to movement with the turbulent flow. Except for the roughened floor, no cavitation erosion was observed downstream from the chute blocks. The roughened floor is believed to have been caused during the diversion of the river when abrasive materials were carried through the outlet tunnel. Examination of the left stilling basin wall, which had vibrated violently during the operation of the outlet gates, revealed no significant spalling or cracking. Representative photographs depicting the damage are shown in Figure 3.

C. View showing depression left by displaced riprap at downstream end of left stilling basin wall.

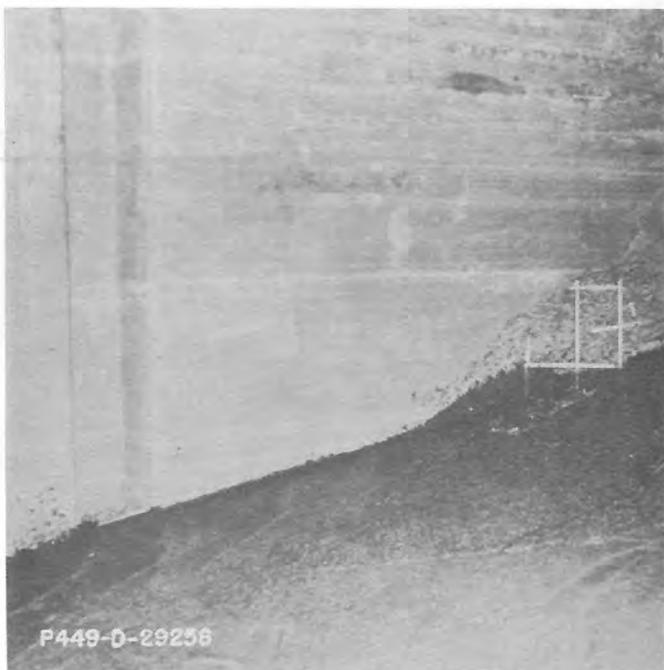
Sharp increase in divergence of training walls immediately downstream from gates producing high-velocity jets will likely result in serious cavitation erosion. This is particularly true if the jet is submerged. Changes

D. Right flared wall of Outlet No. 3.

To eliminate future erosion in the flared walls, 3-1/2-inch structural steel offsets were installed at the upstream end of the flared walls, as shown in Figure 6. Air to the offsets was provided through a 2-1/2-inch by 10-inch opening at the base and seven 2-inch-diameter holes directly above the opening. Again, the model studies confirmed this to be the best solution to the problem.

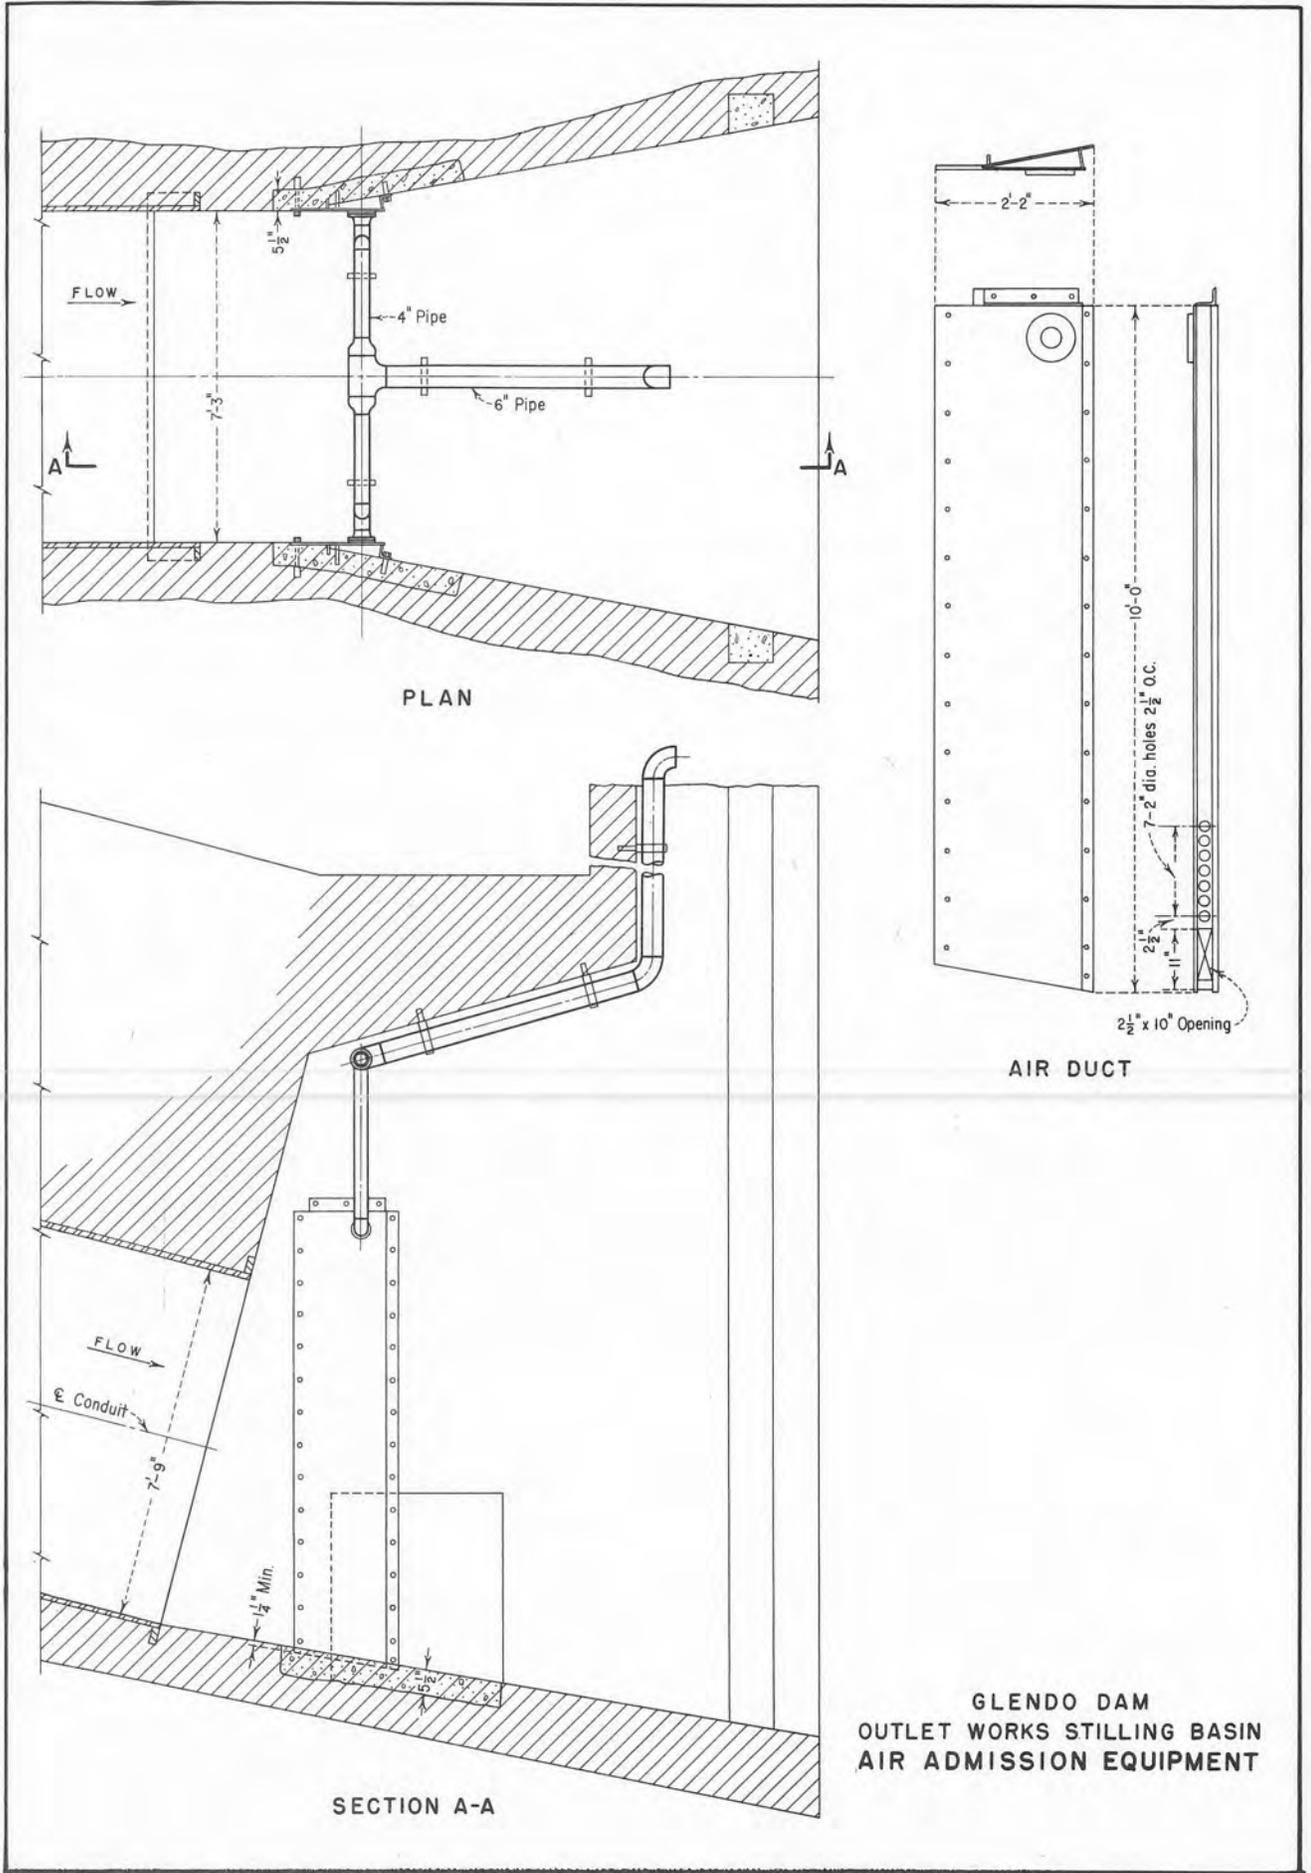
FIGURE 6

GLENDAM  
OUTLET WORKS STILLING BASIN  
AIR ADMISSION EQUIPMENT

in alignment can be accomplished by suitable rounding or by abrupt sizable offsets away from the flow, as shown in Figure 6. The admission of air may be desirable or necessary for offsets, depending upon the size of the offset.
