BUREAU OF RECLAMATION  
HYDRAULIC LABORATORYDenver, Colorado  
DATE: July 11, 1962

FROM : H. T. Falvey

SUBJECT: Cavitation studies--Effect of curing time on dye used as an erosion indicator and a comparison of dye results with erosion obtained on weak concrete

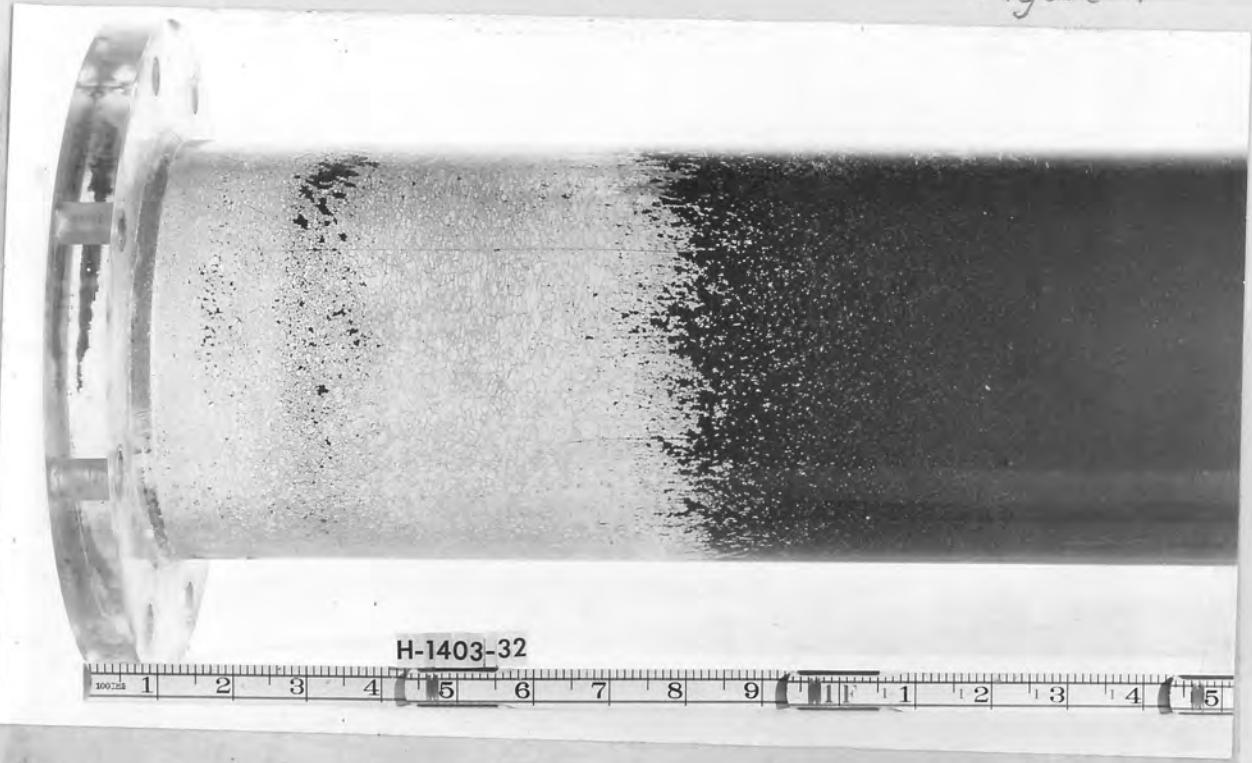
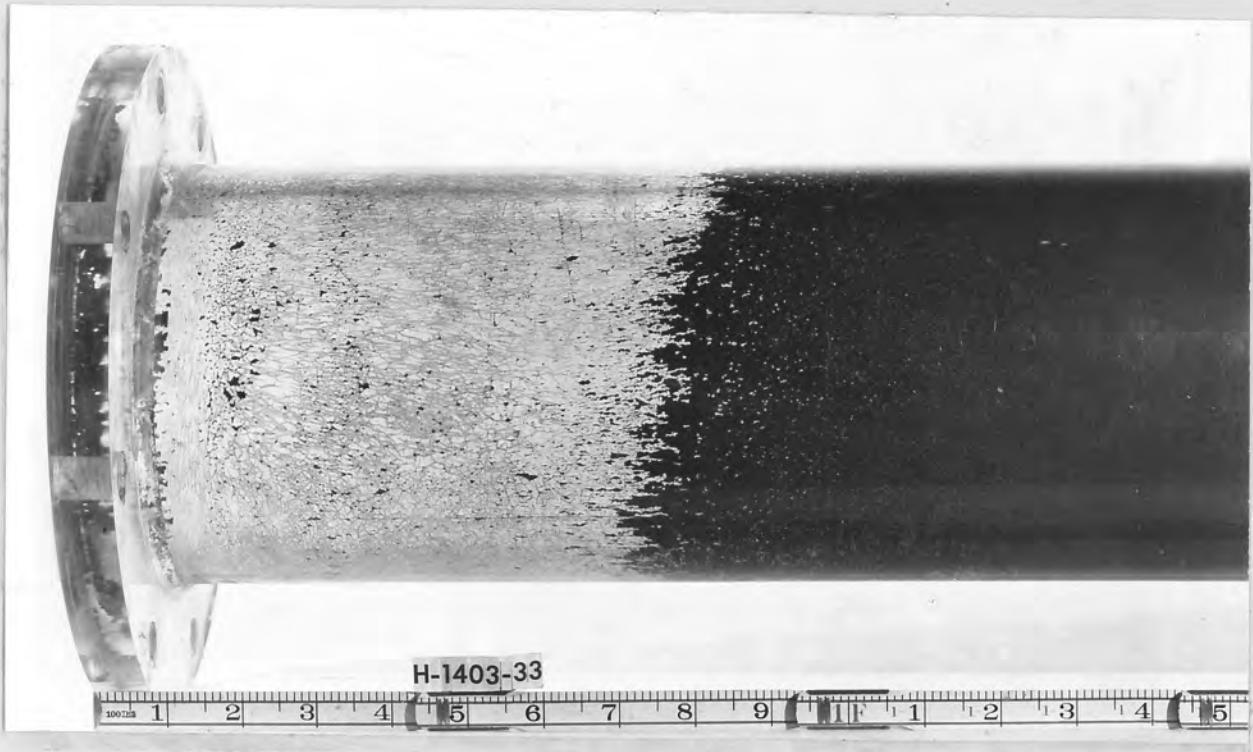
One explanation for these erratic results appeared to be that the curing period of the dye affected the rate of dye removal. Therefore, a series of tests were made holding the cavitation index constant, but varying the curing time of the dye coating. Figure 1 illustrates the extensive degree of dye removal in a 2-hour test period with a curing time of 2 hours at the start of the test. Figure 2 shows relatively small degree of removal for a similar 2-hour test period, but with a curing time of 5 hours. With a curing time of 2 days, no removal of dye occurred for the 2-hour test run. The value of the cavitation index for the dye erosion tests and the concrete erosion tests was 0.33, based on the equation:

Cavitation Index  $K=0.33$ ; Curing time  
for dye - 2 hours; Length of test - 2 hours

These results indicate that the curing time of the dye is an extremely important factor when using dye as an indicator in cavitation erosion studies, especially when the damage is minor. Therefore, if dye is used to estimate areas of probable cavitation damage, every effort should be made to maintain the same curing time for each dye removal test. In general, a minimum dye curing time of 5 hours at room temperature is recommended for consistant results.

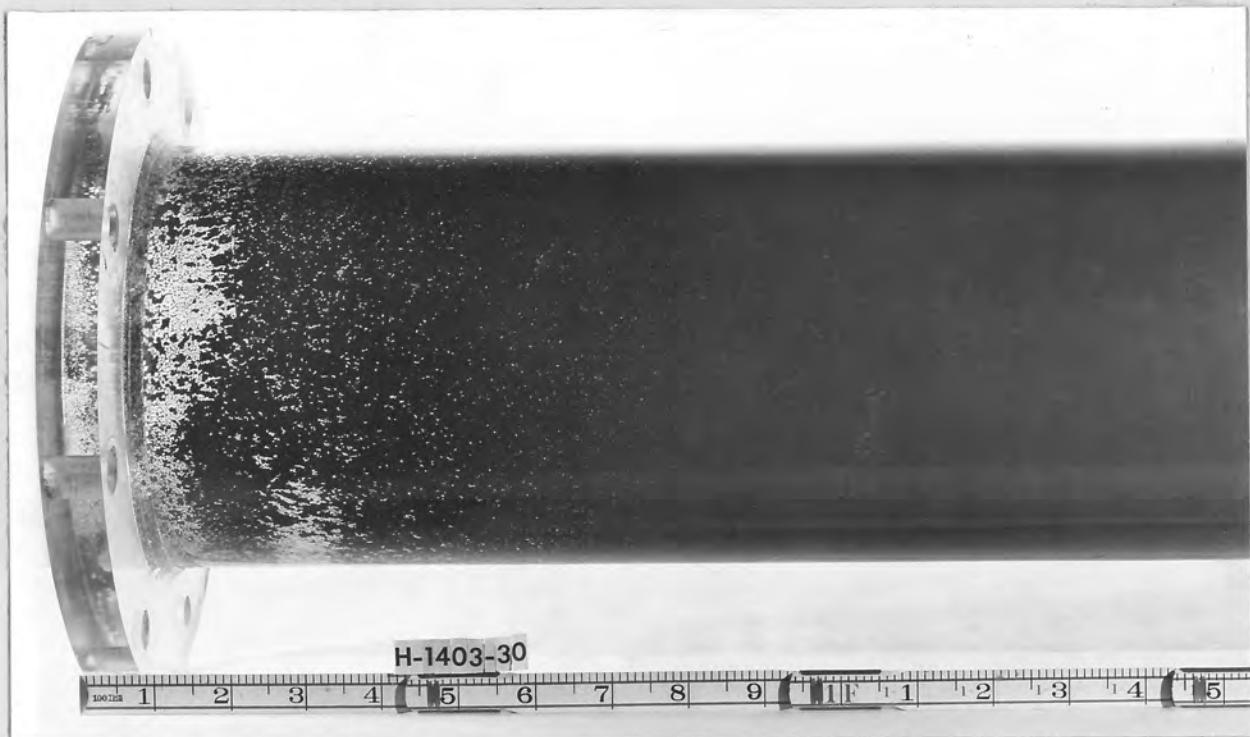
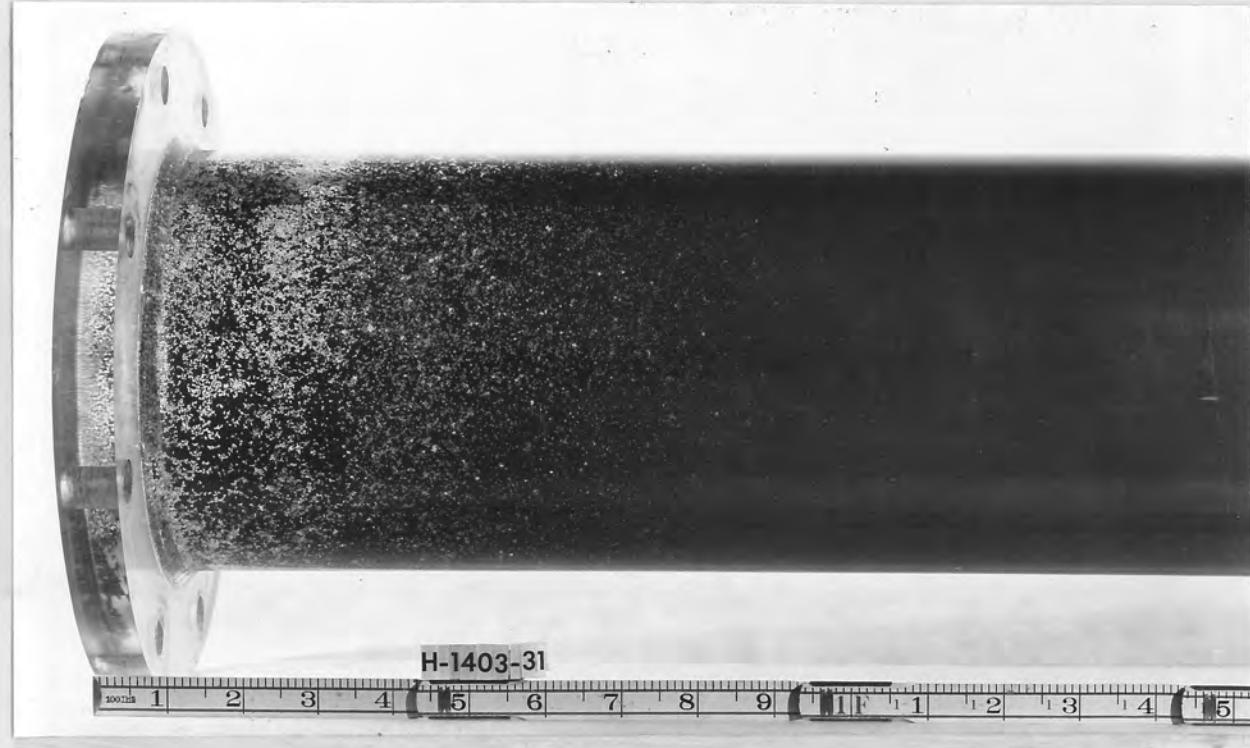
Figure 2

Cavitation Index  $K = 0.34$ ; Curing time  
for dye - 5 hours; Length of test - 2 hours

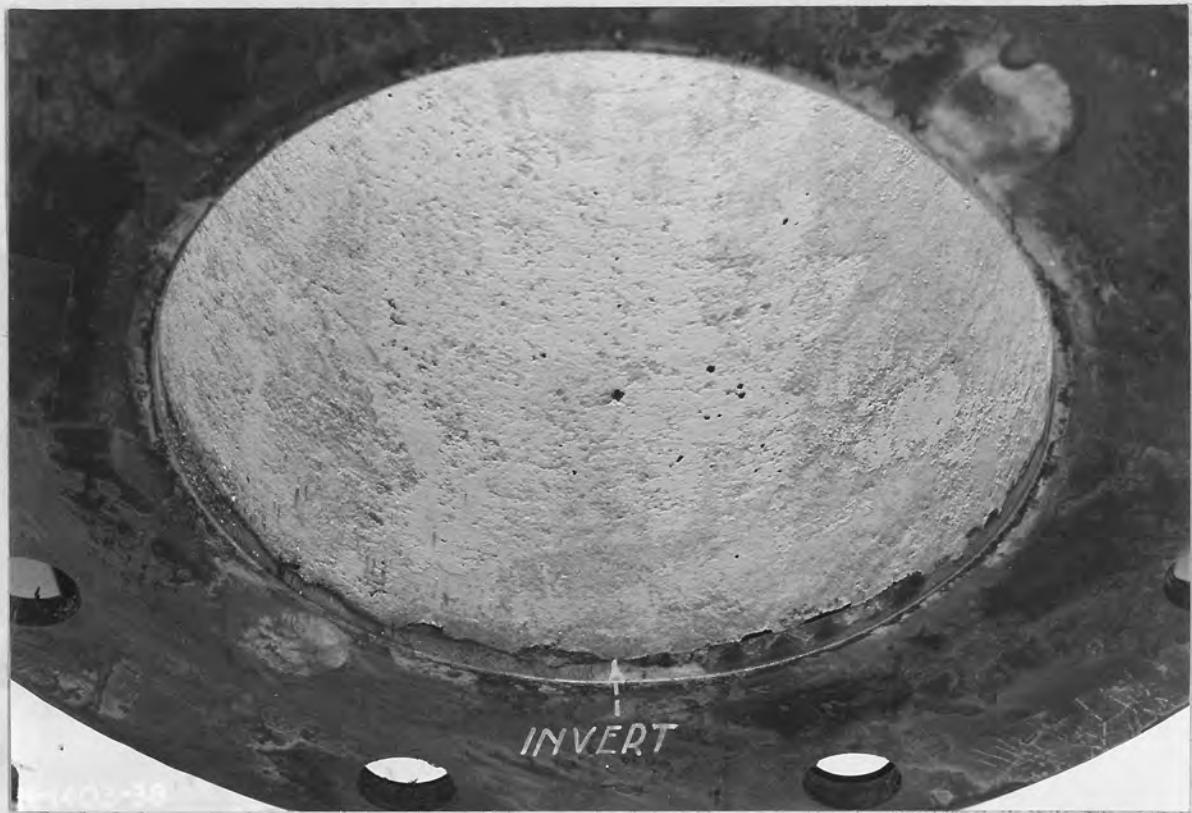
Figure 3

The erosion damage was minor in the concrete pipe with only a small amount of laitance being removed after 11 hours of testing. (Figures 3 and 4). The areas in which the laitance was removed coincide roughly with the areas of dye which were removed with a dye curing time of 5 hours.

Test duration 2 hours;  $K = 0.33$ ; 15 days curing time

Cavitation erosion in concrete pipe; water/cement =  $1/1$ ; sand/cement =  $6/1$

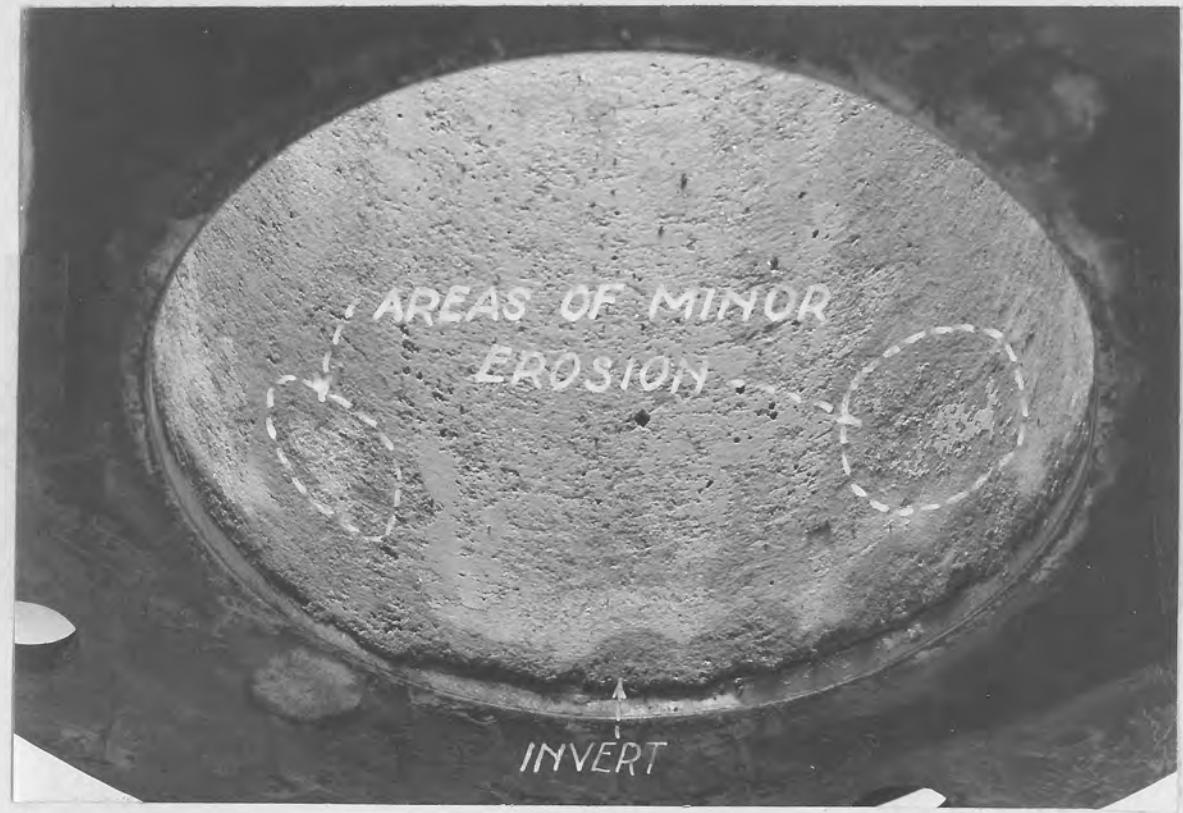
2 additional hours;  $K = 0.30$ ; 17 days curing time

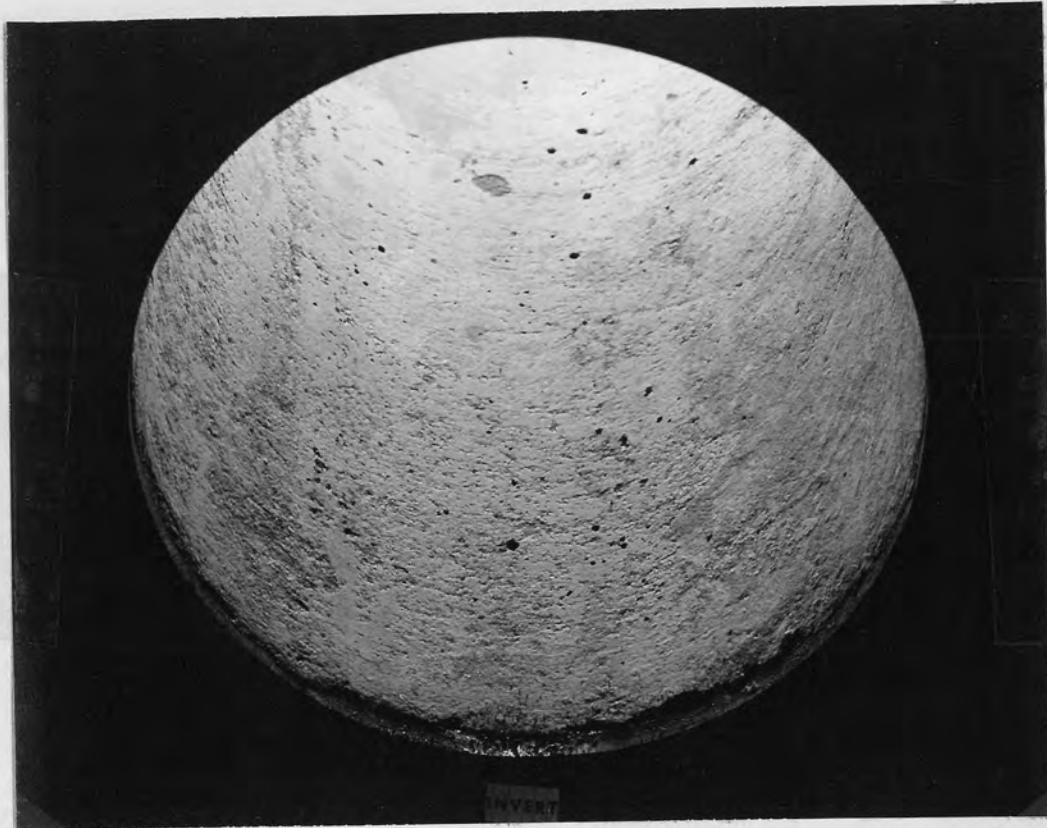
Figure 4

Total test duration 6 hours,  $K=0.32$ , 18 days curing time

Cavitation erosion in concrete pipe, water/cement =  $1/1$ , sand/cement =  $6/1$

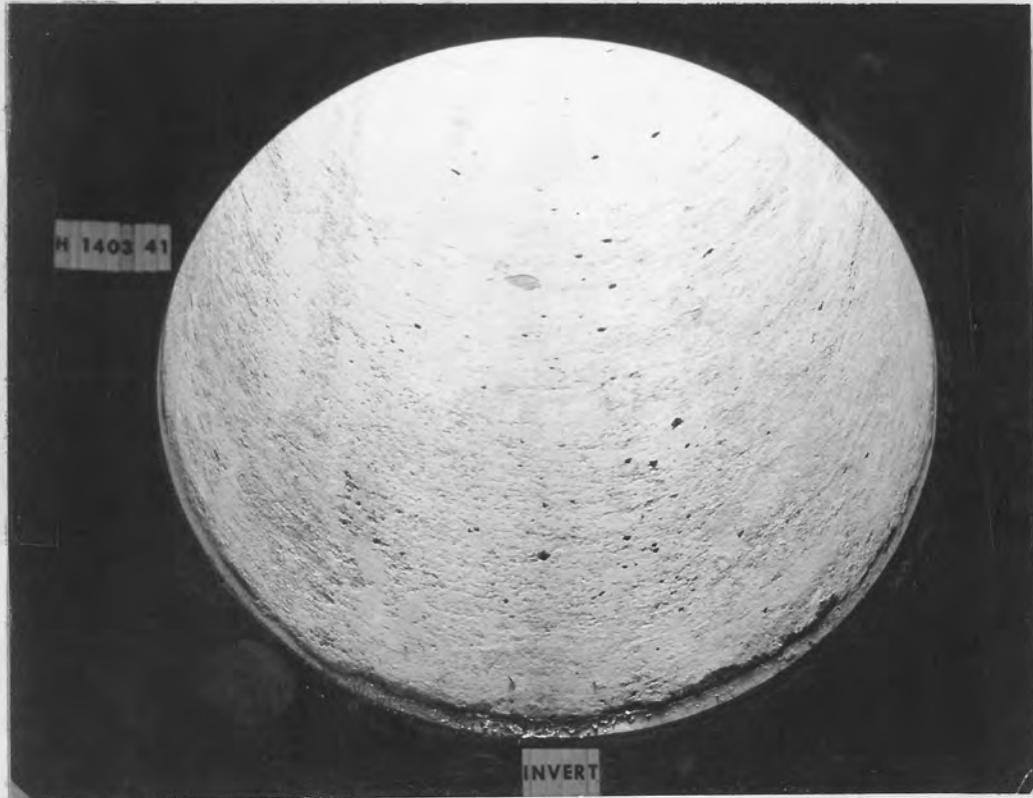
Total test duration 11 hours,  $K=0.33$ , 29 days curing time
