# Performance of Glen Canyon Dam Diversion Tunnel Outlets

William E. Wagner, F. ASCE

ASCE Environmental  
Engineering Conference  
Dallas, Texas  
February 6-9, 1967/\$0.50

PERFORMANCE OF GLEN CANYON DAM  
DIVERSION TUNNEL OUTLETS

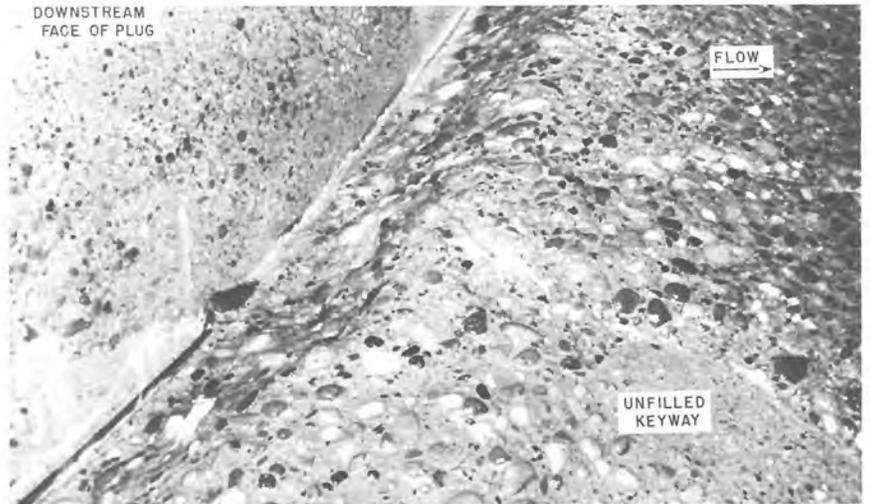
Concrete Lining from Plug to Flip Bucket.--The inspection revealed considerably more erosion damage had occurred to the lining since the diversion tunnel outlets were placed in operation in 1963. The surfaces of the unfilled plug keyway immediately downstream from the tunnel plug were eroded sufficiently to expose the aggregate (Figure 7A). This damage extended nearly to the springline of the tunnel and up the downstream face of the plug. Loose aggregate and foreign material

were deposited in this location to a depth of about 5 feet. For a distance of about 200 feet downstream from the unfilled keyway, aggregate was exposed for approximately 10 feet either side of the invert centerline (Figure 7B). The texture of the eroded surface was generally smooth.

FIGURE 7A CONCRETE SURFACES IN UNFILLED KEYWAY

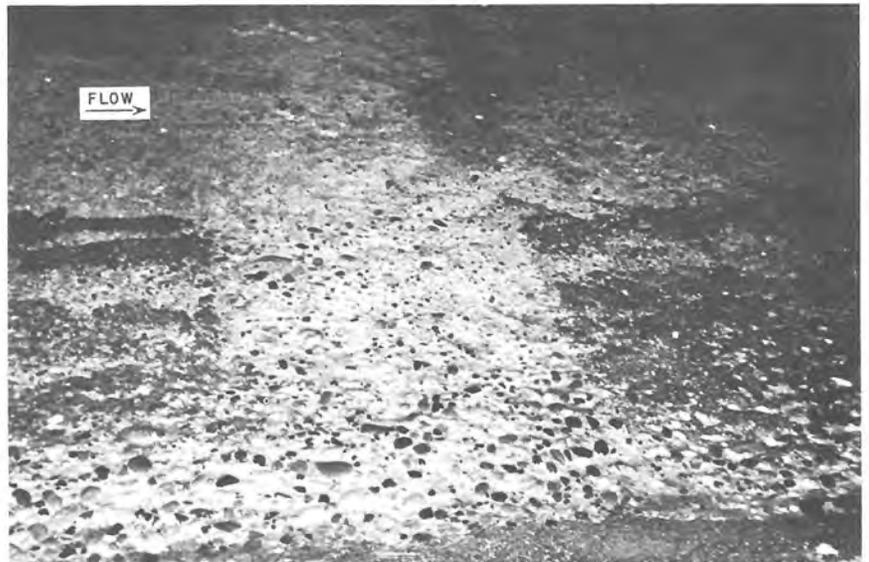
FIGURE 7B CONDITION OF CONCRETE IN JET IMPINGEMENT AREA  
NEAR STATION 24 + 55

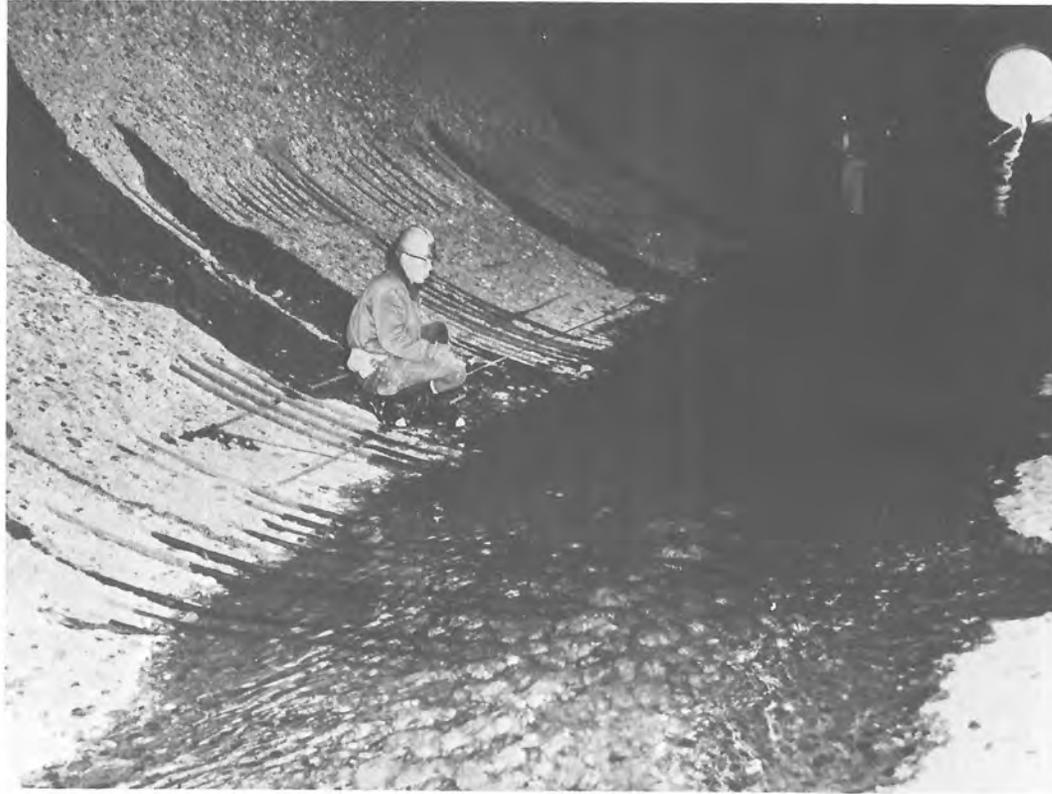
The most severely damaged area was located between Stations 26+40 and 27+20 (Figures 8 and 9). In this area, the invert was eroded to a maximum depth of 0.8 foot and many reinforcement bars were exposed or missing. Laterally, the damage decreased almost uniformly to the original lining surface at a maximum height of 5 to 10 feet above the tunnel springline. Exposed reinforcing bars and stubs of missing bars were worn smooth indicating that an abrasive material had caused the damage. No deposits of foreign materials were found in the tunnel downstream from the unfilled plug keyway.

STA. 26+51

FIGURE 8 CONDITION OF LEFT DIVERSION TUNNEL - FEBRUARY 24, 1965

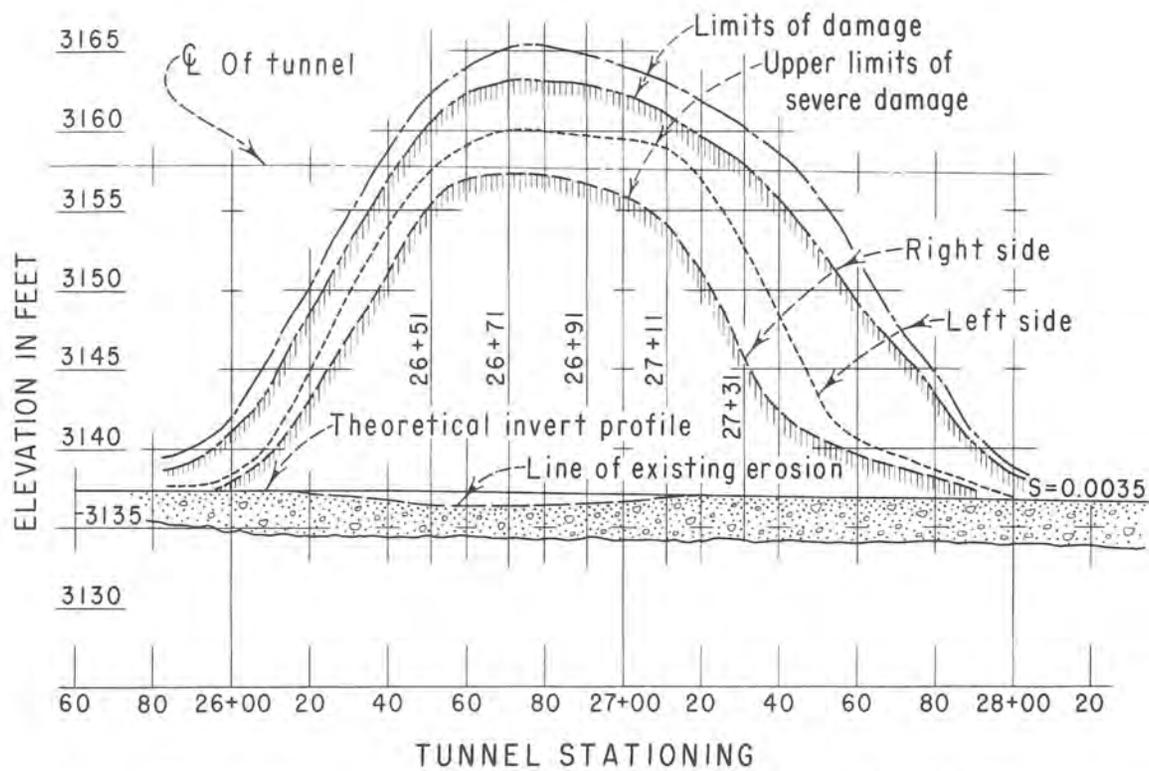
FIGURE 9 EXTENT OF SIDEWALL DAMAGE  
LEFT DIVERSION TUNNEL

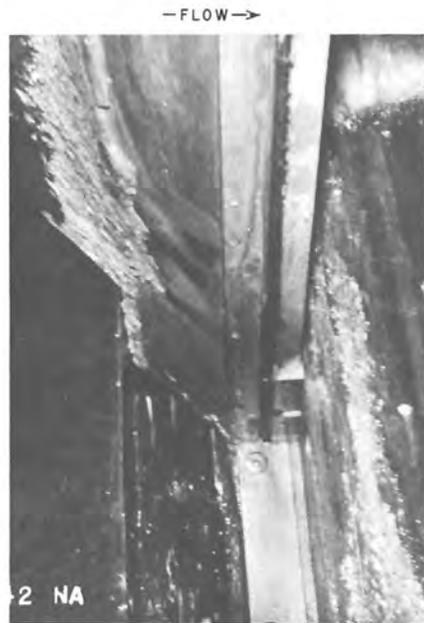
were painted with a heavy-bodied, cold-applied coal tar to prevent corrosion. Generally, the surfaces of the gates and liners were in good condition except at points of surface irregularities. Figure 10A shows the bottom of the service gate and the narrow gate slot about 5 feet above the invert. Removal of the paint by cavitation action was evident immediately downstream from the slot edge. Similar, but more severe, damage was observed at the base of the slot (Figure 10B). Here the steel was pitted to a maximum depth of 3/8-inch about 6 inches from the edge of the slot. The two bands of spotted liner are rust spots where the paint was removed from the vicinity of rows of piezometers located 3/4 inch and 23-3/4 inches above the inverts, prior to operating the outlets.

A. BOTTOM OF GATE LEAF

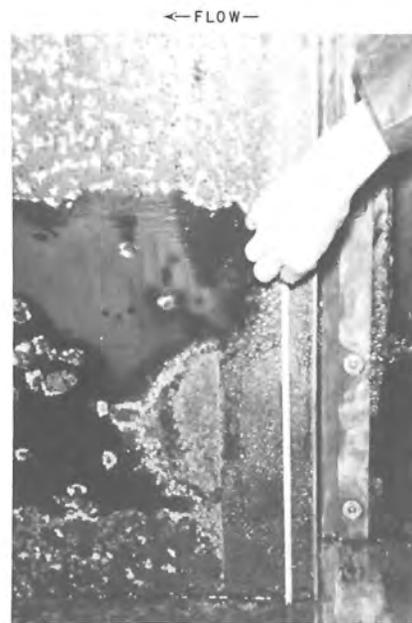
B. PITTED AREA DOWNSTREAM  
OF GATE SLOT

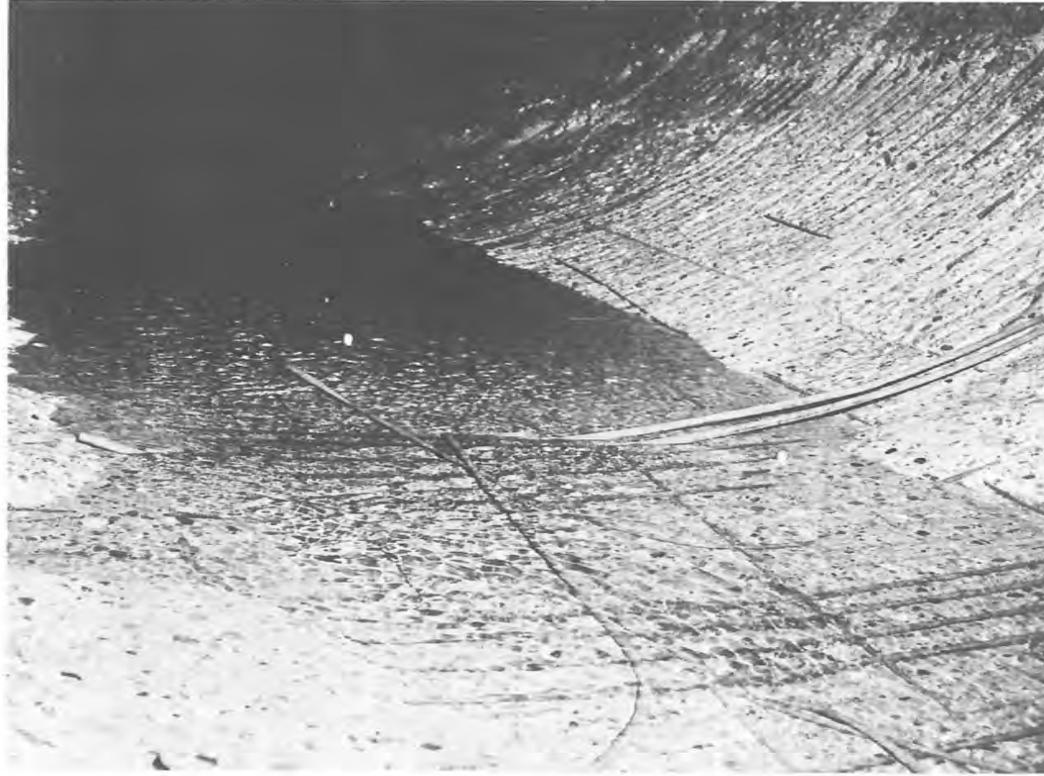
Concrete Lining from Plug to Flip Bucket.--Figure 12 shows the condition of the concrete lining in the most severely eroded section near Station 26+70. Although additional reinforcement bars (which were exposed prior to the February inspection) had been torn loose, a surprisingly small amount of aggregate was eroded during the March-July operation.

← STA. 26+70

FIGURE 12 CONDITION OF LEFT DIVERSION TUNNEL - JULY 15, 1965

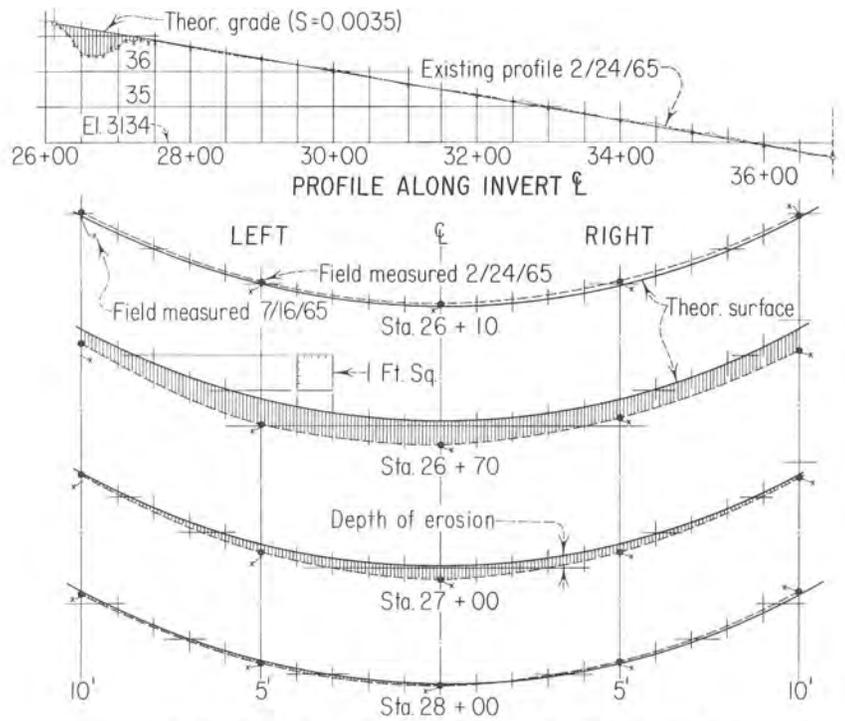
Comparative field surveys of the tunnel in February and July (Figure 13) showed no appreciable additional damage at the invert centerline. The additional damage indicated on the left side of the eroded area probably resulted from spalling where the exposed reinforcement bars were torn out by the high-velocity flow.

**FIGURE 13 EROSION ALONG INVERT  
OF LEFT DIVERSION TUNNEL**

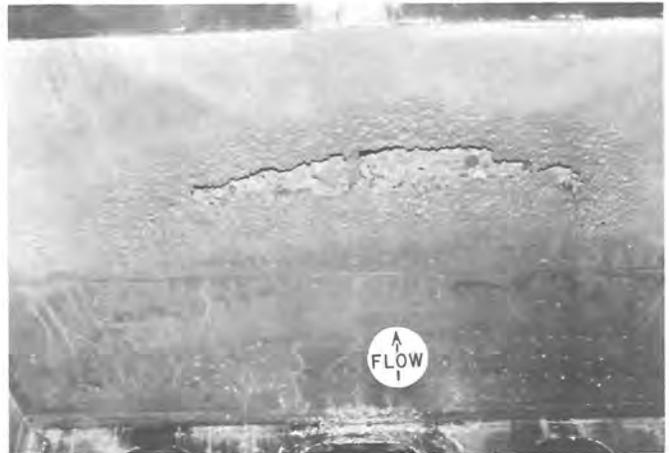
The most severe damage was found in the top of the left fluidway between the guard and service gates (Figure 15), where cavitation produced pitting over a large part of the upstream body of the service gate and eroded a hole through the 1-inch steel plate. The maximum dimensions of the hole were about 3 feet transversely and 8 inches longitudinally in the direction of flow. The embedding concrete behind the steel plate was eroded to a depth of about 8 inches. This extensive cavitation damage was triggered by a 1/8-inch offset protruding into the flow superimposed on the 65:1 slope between the guard gate recess and the body joint. The offset had been slightly rounded by grinding at the time of installation but was sufficiently pronounced to produce damaging cavitation. Paint was entirely removed from the top and about halfway down both sides of the fluidway between the two gates. A similar cavitation damage pattern was observed in

FIGURE 15 CAVITATION DAMAGE IN TOP OF FLUIDWAY UPSTREAM FROM THE SERVICE GATE

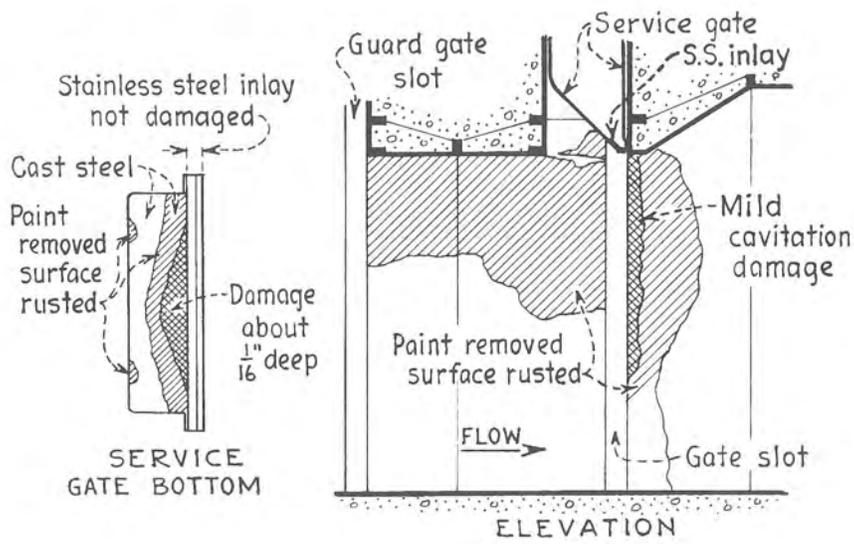
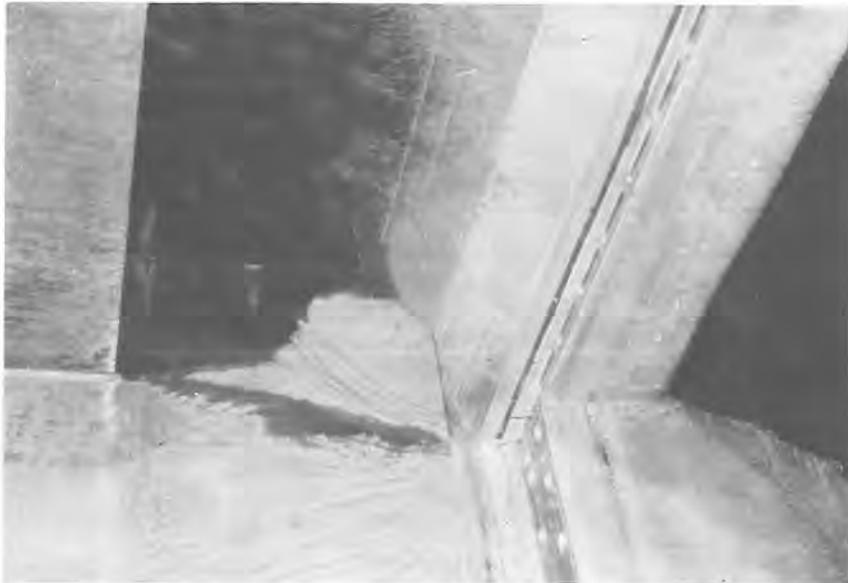
The condition of the left service gate and slot is shown in Figure 16. The damage consisted mostly of paint removal, but mild pitting was noted immediately downstream from the gate slot. An unexpected area of damage was found on the sloping bottom of the gate leaf. The lower 5 inches of the sloping face and the sealing surfaces are stainless steel inlay and showed no damage. Immediately above the stainless steel inlay, the cast steel was pitted about 1/16-inch in depth. The damage feathered to the original painted surface in 6 to 15 inches. To a lesser extent, similar damage was found on the other two service gates.

FIGURE 16 CONDITION OF LEFT SERVICE GATE

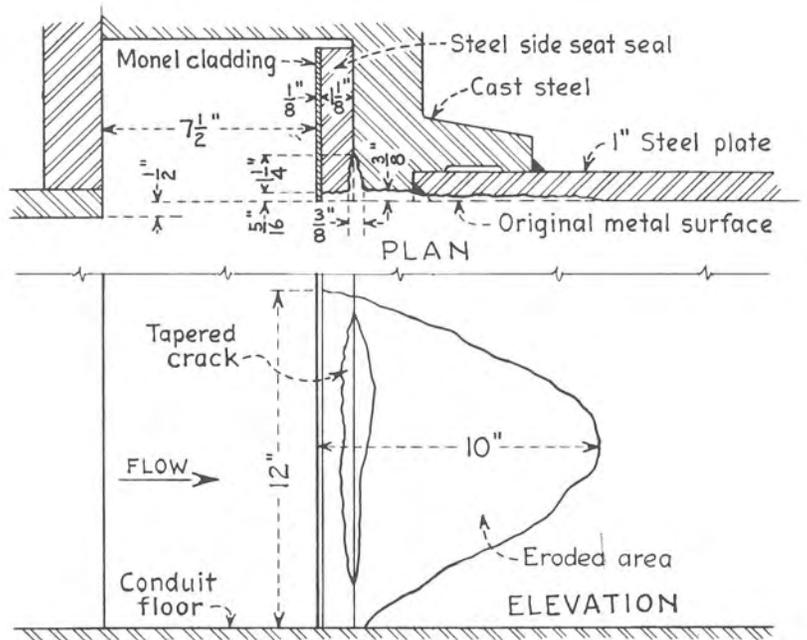
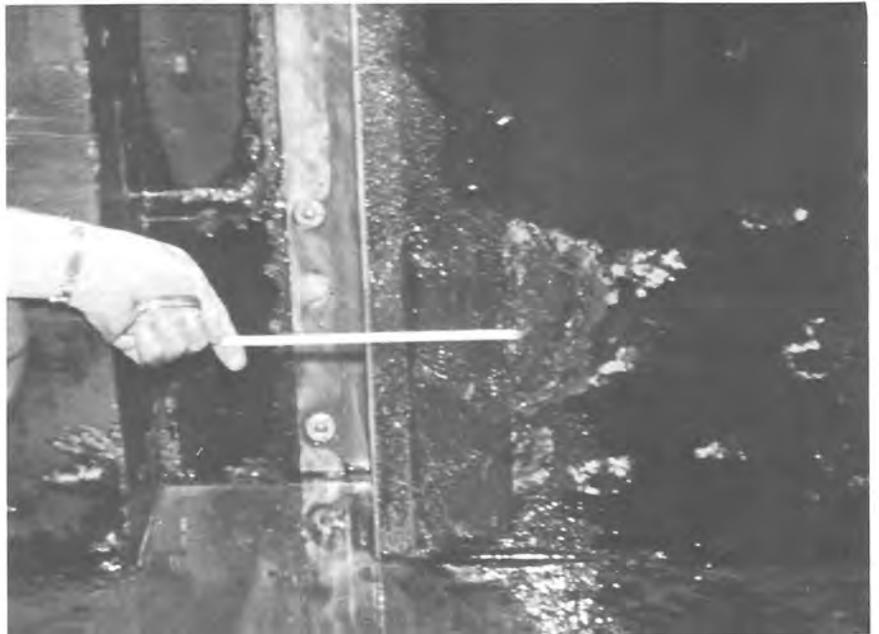
Figure 17 shows the condition of the center service gate just downstream from the seating surface in the slot. There was no apparent damage to the 1/8-inch-thick Monel cladding on the gate seat. Immediately downstream from the cladding, the steel was pitted about 3/8-inch deep. At the joint between the seat and the cast steel gate body, there was a 3/8-inch-wide crack which tapered inward about 1-1/2 inches from the original fluidway surface. The pitted area extended about 12 inches above the conduit floor and about 10 inches downstream from the slot. Both sides of the center gate showed similar damage; however, less severe damage in a similar pattern was noted downstream from the

FIGURE 17 CAVITATION DAMAGE DOWNSTREAM OF CENTER GATE SLOT.  
 DAMAGE WAS LESS AT OUTSIDE GATES

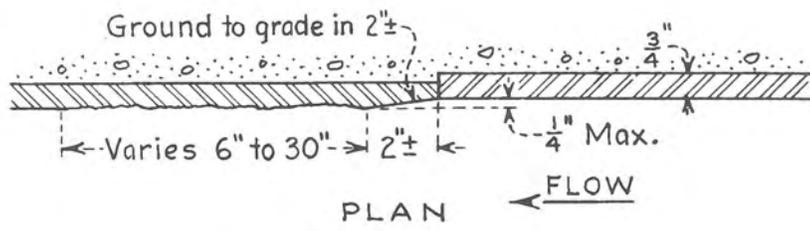
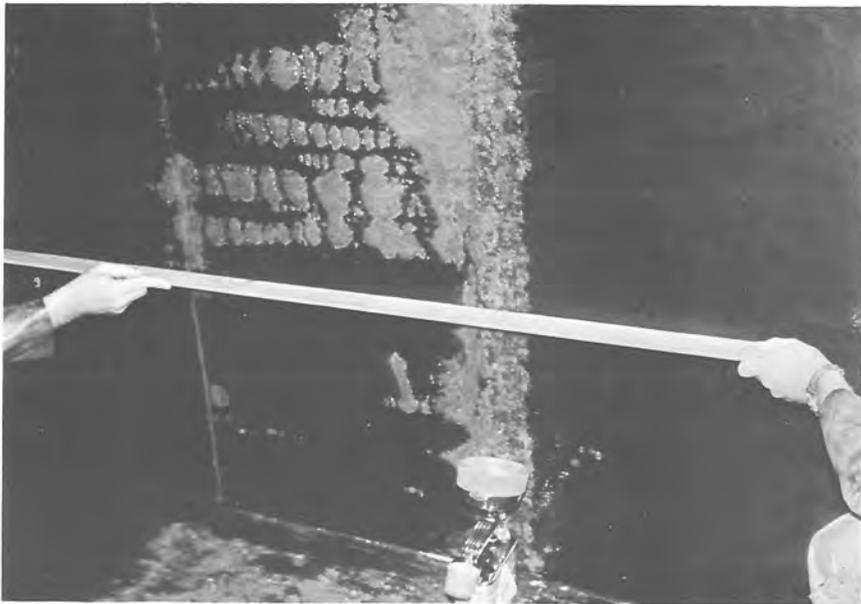
Numerous other areas of minor cavitation damage were noted in the conduit liner downstream from the gate. Cavitation in these isolated areas, which were found throughout the 68-foot length of liners, was caused by poor alinement of the liner joints, projecting joint welds, and minor ridges and depressions in the paint coating. While the larger offsets of 1/8- to 1/4-inch resulted in some pitting of the metal, most of the damage to the liners was limited to paint removal. It was noted that offsets protruding as little as 1/32 inch into the flow produced marked damage and the degree of damage increased with larger offsets. Depressed offsets in the surface appeared to cause no damage until they were about 1/8 inch in depth, while 1/4-inch depressed offsets produced paint removal and minor pitting. Typical cavitation-damaged surfaces with a sketch of the irregularity producing the cavitation are shown in Figures 18 and 19.

FIGURE 18 DAMAGE AT SLOPED OFFSET 20 FEET  
DOWNSTREAM FROM GATE

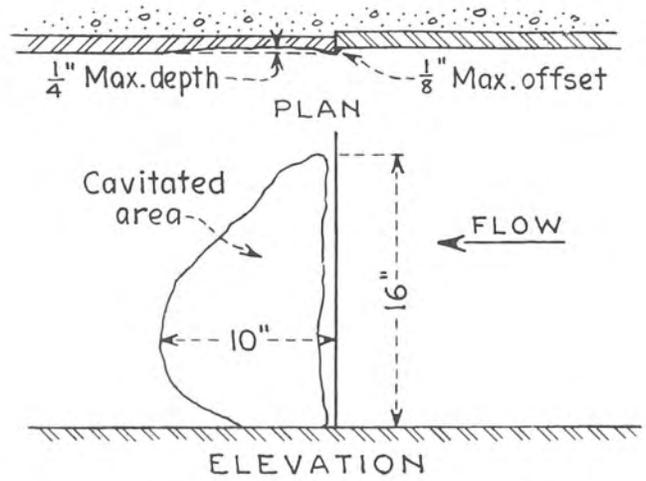
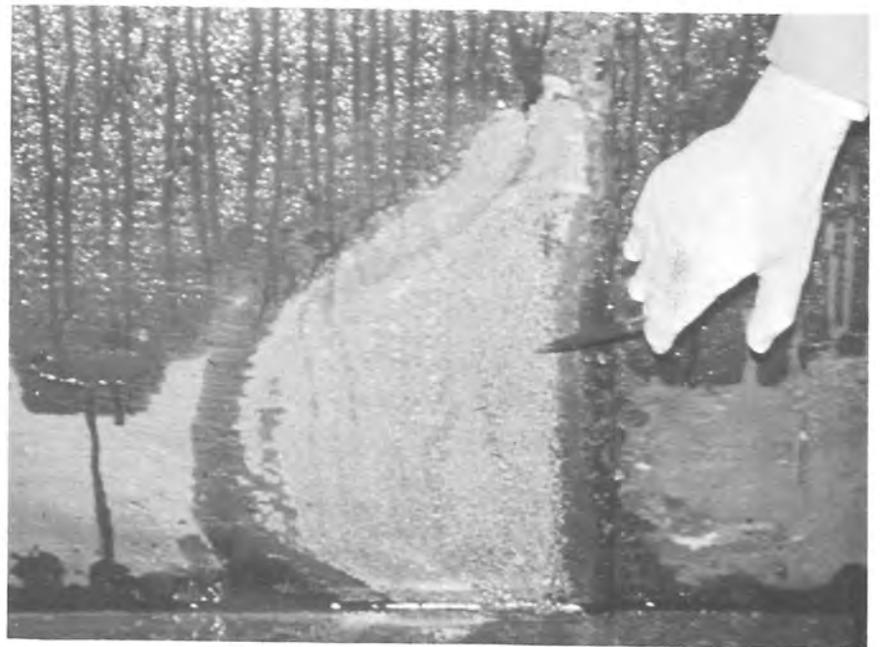
The damaged area downstream from the 1/8-inch offset noted in the February inspection and described on page 7 showed very little change; the maximum depth of pitting remained at 1/4 inch and paint was removed for 2 inches farther downstream (Figure 19).

**FIGURE 19 DAMAGE AT MISALIGNMENT 50 FEET  
DOWNSTREAM FROM GATE**
