LABORATORY TESTS AND INSPECTION OF TWO MEASURE-RITE  
OPEN-FLOW PROPELLER METERS

BUREAU OF RECLAMATION  
HYDRAULIC LABORATORY

October and November 1966

These studies were made to determine the accuracy of the flow rate indicated by two Measure-Rite meters that had been used for the "study of the use of water on Federal irrigation projects" in the Angostura Unit, Missouri River Basin Project, South Dakota.

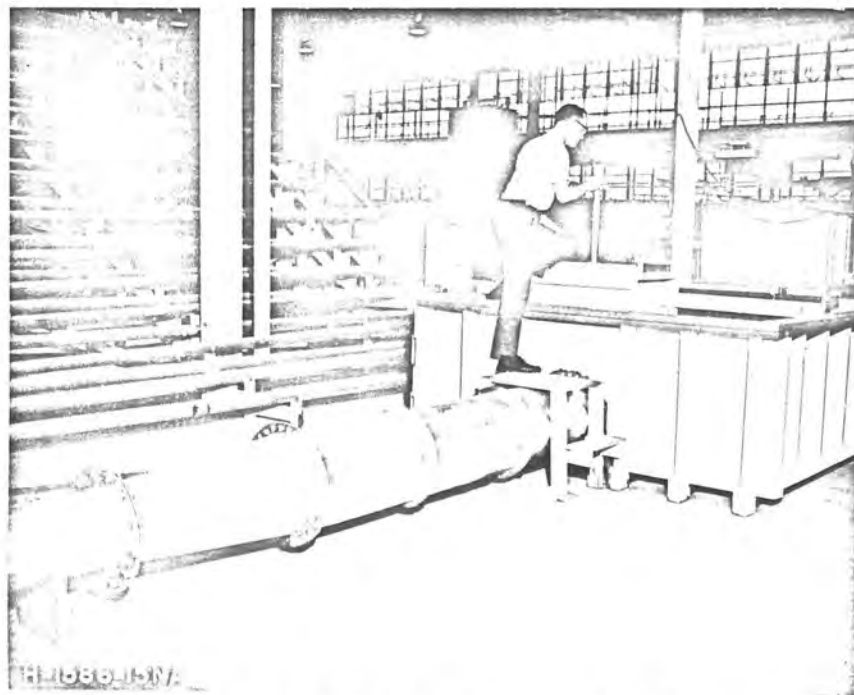
A. Laboratory installation for testing Measure-Rite meters showing the expansion from 12-inch laboratory pipe to the 8-foot-long, 18-inch delivery pipe.

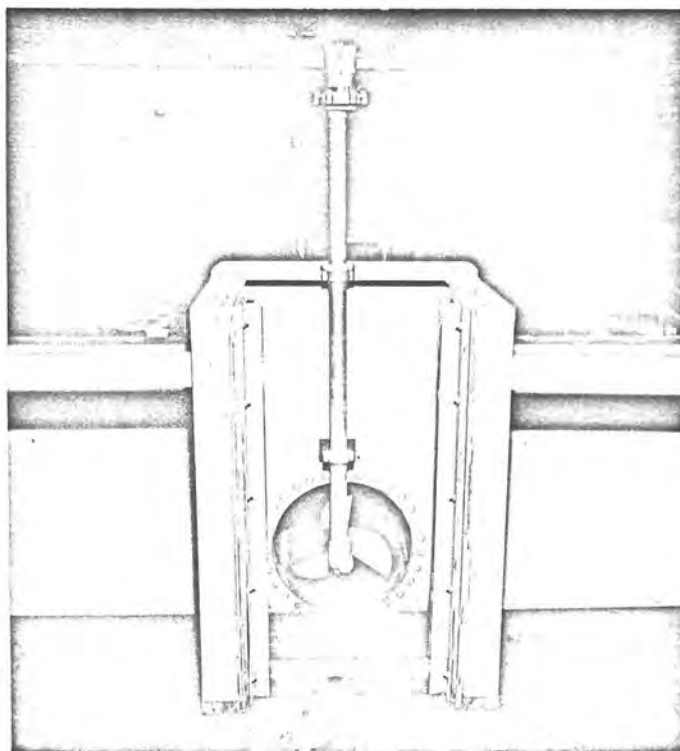
B. Looking upstream at Measure-Rite meter in the 18-inch delivery pipe. One stop plank in place across end of control well.

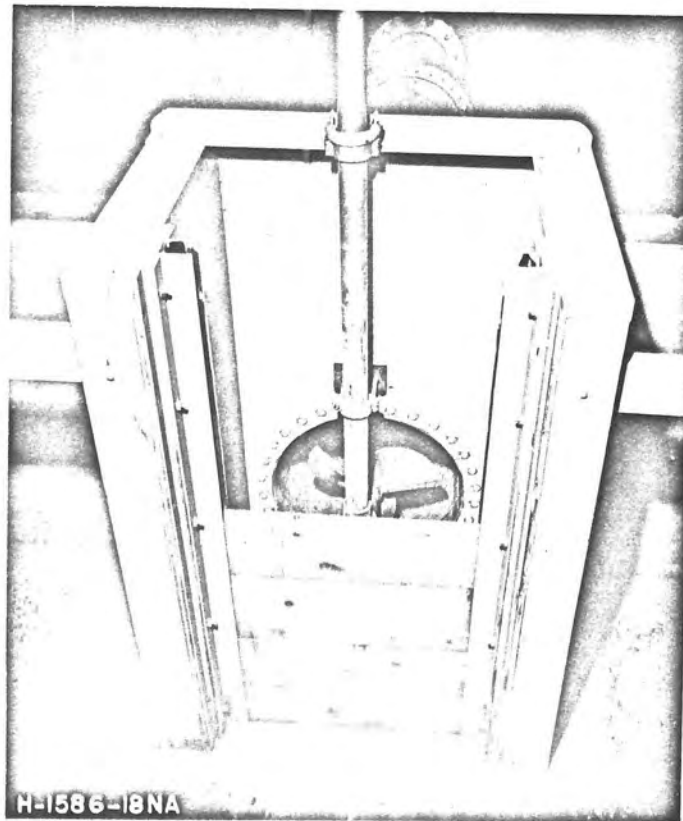
Figure 3

Upstream view of Measure-Rite meter in 18-inch delivery pipe. Stop planks installed to maintain minimum 9-inch head on delivery pipe.

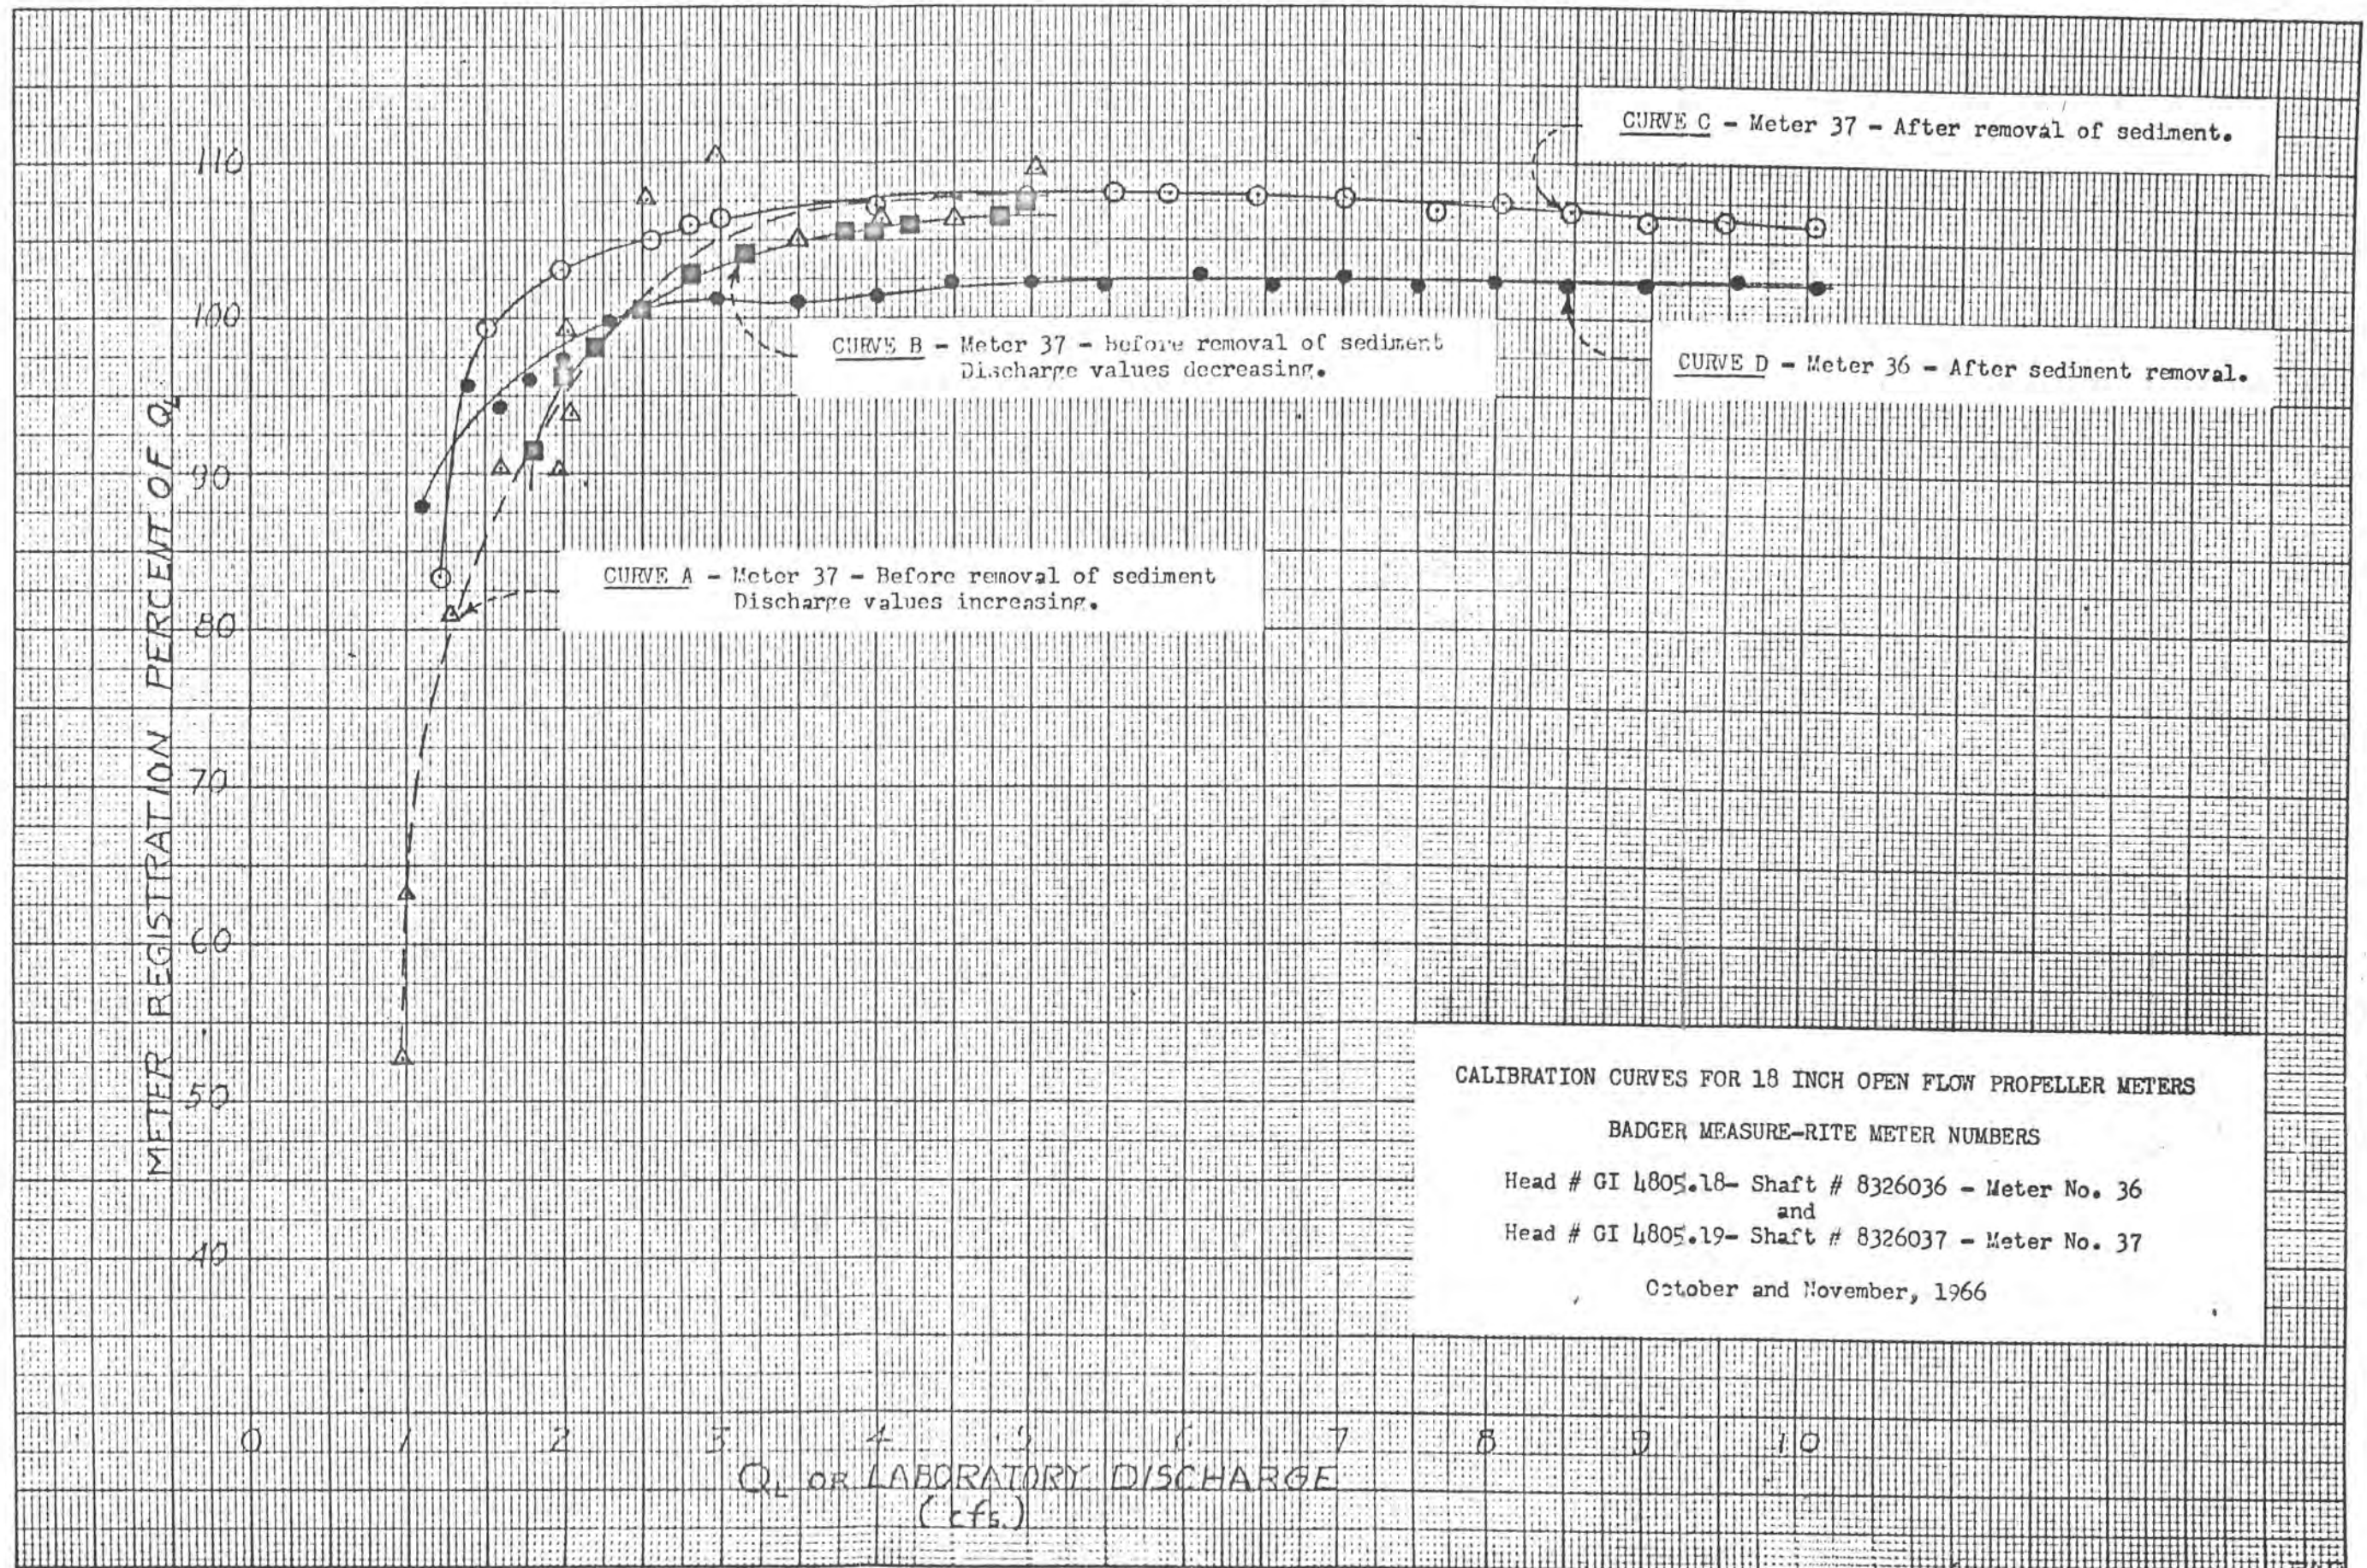
FIGURE 4

Calibration of Meter No. 37.--Meter No. 37 was installed and calibrated as received from the field. The first test was made for a laboratory discharge rate of 1 cfs; the rate was then increased in increments up to 5 cfs. The data for this calibration are plotted as open triangles in Figure 4. These data show much scatter about the dashed line labeled Curve A. To further define and verify the previous calibration data, additional data were obtained with the discharge decreasing in increments. These data are plotted as solid squares, Figure 4, and have much less scatter. However, the propeller ceased to rotate at 1.8 cfs rather than at 1 cfs as shown

in Curve A of Figure 4. Because of the decrease in data scatter and the higher discharge required to start propeller rotation, these data were considered a separate calibration and the curve was designated Curve B.

Recalibration of Meter No. 37.--After removing the sediment and reassembling and installing the meter in the laboratory facilities, the meter was calibrated over the full discharge range. These data, obtained as previously discussed, are shown as open circles and the calibration is identified as Curve C in Figure 4.

The laboratory calibration Curves C and D in Figure 4 show that Meter No. 36 had  $\pm 2.5$  percent accuracy from 2 to 10 cfs and Meter No. 37 had this accuracy from about 1.4 to 2 cfs. In Tables 1 and 2, the laboratory registration data are compared with the company meter test record data. These tables show that during the laboratory test, the propellers of both meters would not turn at the lowest discharge used by the company for their meter tests. Table 2 shows that the difference between laboratory and the company registration for Meter No. 36 was within 2 percent for discharges equal to and greater than 4.6 cfs. Table 1 shows a difference between laboratory and company calibrations for Meter No. 37 ranging to 11 percent for discharges equal to and greater than 4.6 cfs.

2. As shown by Curve A (triangular data points) in Figure 4, the sediment found in the propeller shaft housing caused scatter in the measured discharge values.

3. The presence of sediment may have caused erratic measurements during field use of the meter.
4. As shown in Curve D, Figure 4, Meter No. 36 had registered the discharge with an accuracy of  $\pm 2.5$  percent of a calibrated Venturi meter flow, from 2 to 10 cfs, after removing sediment from the propeller shaft housing and using clean laboratory water.

5. As shown in Curve C, Figure 4, Meter No. 37 registered the discharge with an accuracy of  $\pm 2.5$  percent of a calibrated Venturi meter flow, from 1.4 to 2 cfs, after removing sediment from the propeller shaft housing and using clean laboratory water. Differences ranging to 8 percent were measured for discharges larger than 2.0 cfs.

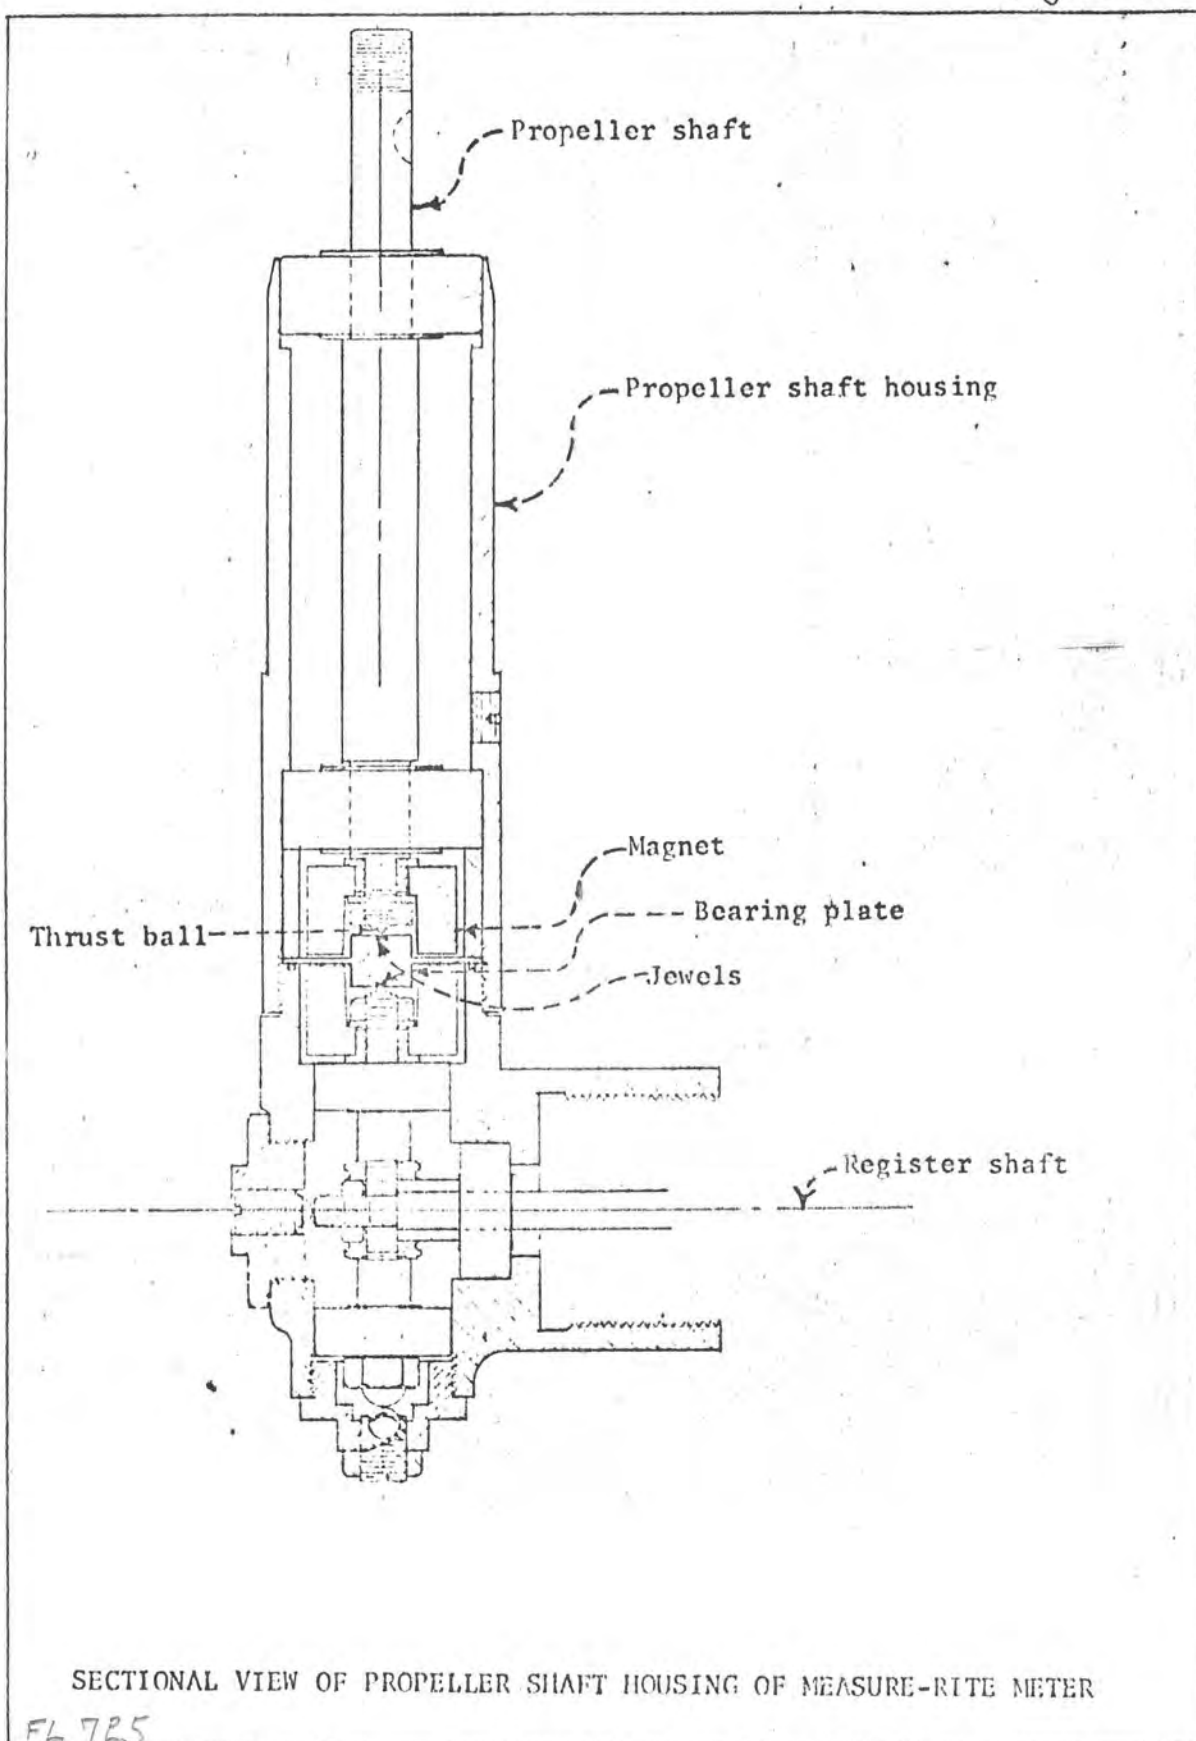
Inspection of pivot bearing, Meter No. 37.--After obtaining the data for Curve B, the propeller was turned by hand. The bearing sounded noisy. The mechanical parts and the inside wall of the propeller shaft housing, Figure 5, were repeatedly flushed with clear water which was caught in a container. A total of 14.5 grams dry weight of silty clay sediment was removed. This was after the meter had delivered 6.7 acre-feet of clean laboratory water. The dry sediment cake is shown in Figure 6A.

The propeller housing was removed from the register shaft housing, Figure 5, and the jewel pivot bearings and the brass bearing plate were inspected. The jewel on the propeller side of the brass-bearing plate showed considerable wear and fracturing. Enough of the jewel was missing (shown magnified nine times in Figure 7A) to allow the sediment around the thrust ball to wear the brass bearing plate around the periphery of the jewel. The jewel bearing on the register side, Figure 7B, was in better condition and the brass was not being worn. The thin part of the brass bearing plate shown in Figure 5 had circular scoring or groovelike wear on the propeller shaft side. This scoring may have been caused either by sediment grinding between the magnet and the bearing plate or by direct contact of the magnet on the plate as the jewel wore away, decreasing the gap between the magnet and plate.

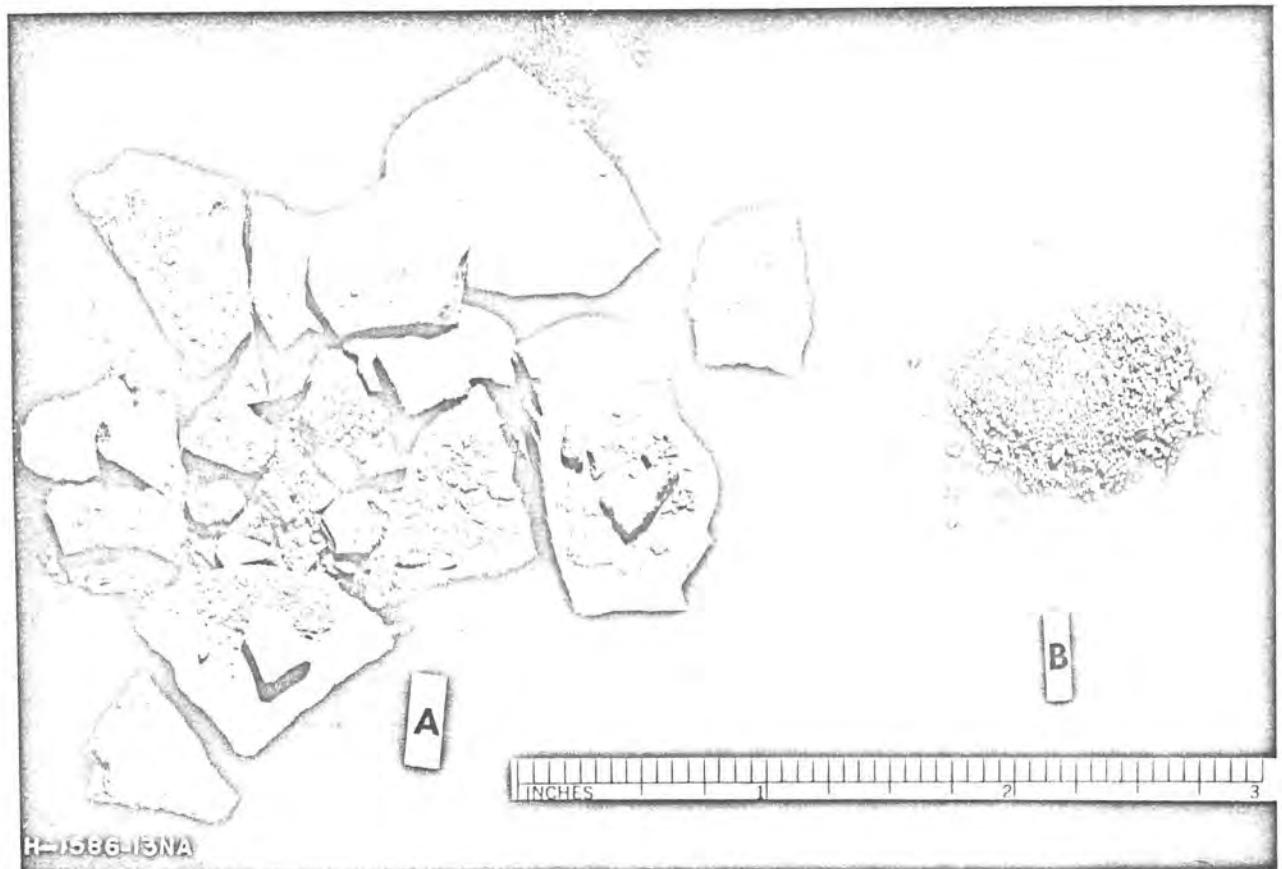
A. Silty clay sediment removed from inside the propeller shaft housing of Meter No. 37 after passing 6.7 acre-feet of water during laboratory calibration with clean water.

B. Sandy sediment removed from inside the propeller shaft housing of Meter No. 36 before laboratory calibration.

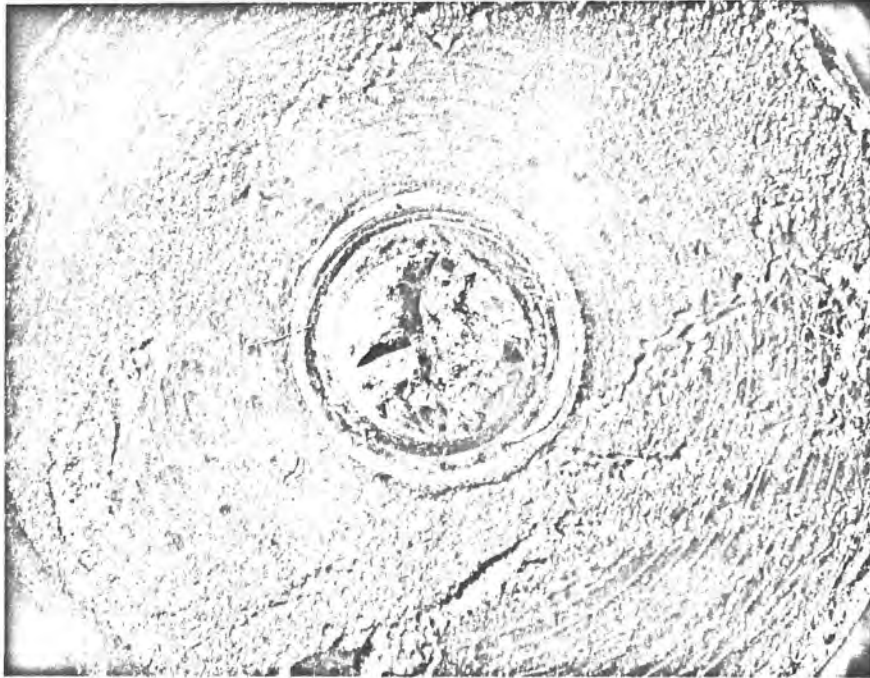
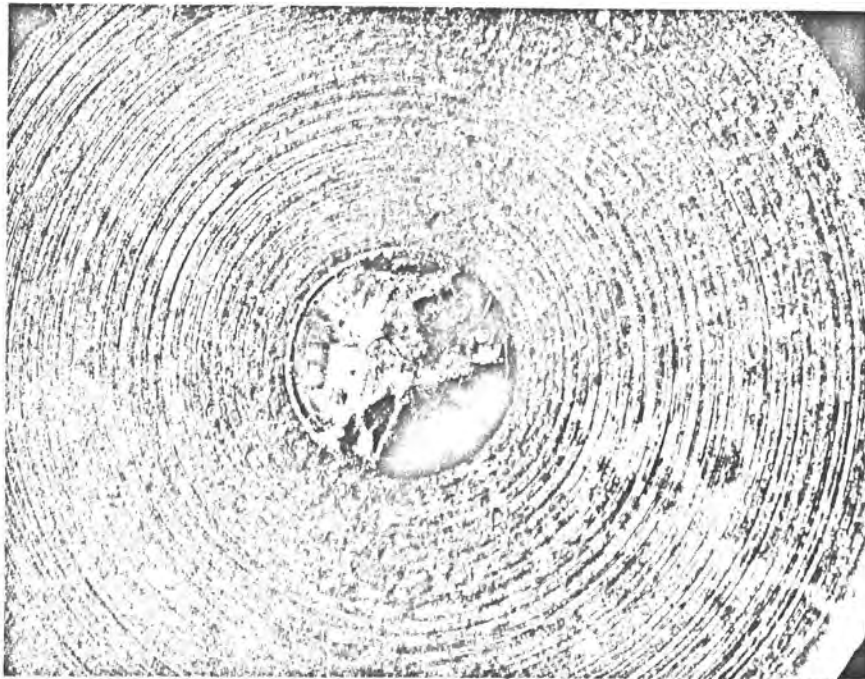
6. The jewel pivot bearing, Figures 5, 7, and 8, was badly fractured and in some cases enough of the jewel was missing to cause wear on the brass bearing plate. The fracturing was probably caused by the impact of the propeller shaft on the jewel caused by surges in the flow or by forces delivered while attaching and removing propellers, rather than by sediment grinding.

A. Propeller side (jewel in center of photograph).

B. Register side.

Condition of jewel pivot bearings and brass bearing plate of Meter No. 37 after removing sediment but before obtaining final laboratory calibration (magnified 9X).

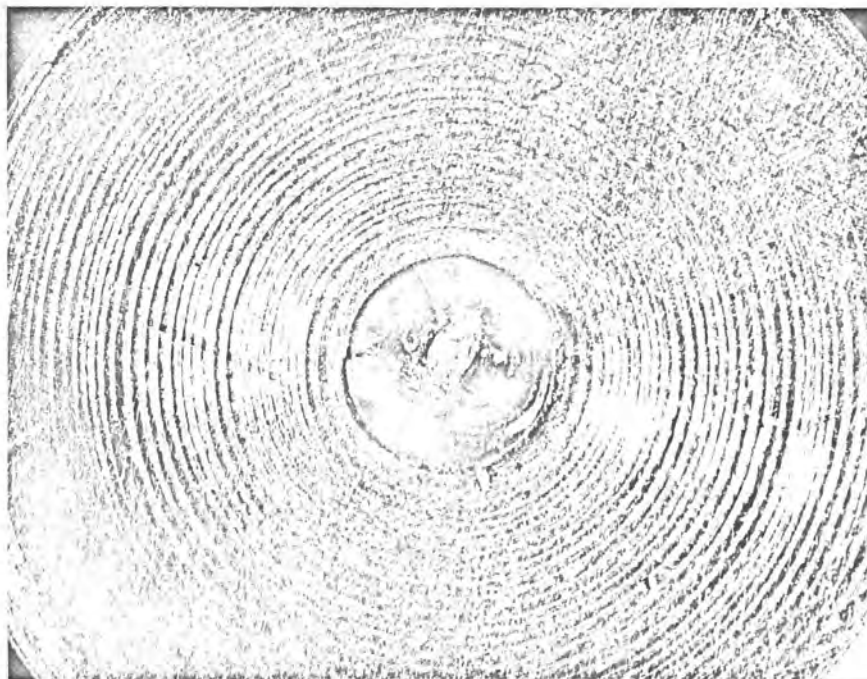
Inspection of pivot bearings, Meter No. 36.--Before calibrating Meter No. 36, the shaft housing was repeatedly flushed with clean water. A total of 0.3 grams dry weight of sandy sediment was removed. The sediment did not form a cake upon drying, Figure 6B. The jewel pivot bearings were inspected and each was found to be worn and each was fractured, Figures 8A and 8B; the jewel on the register side of the meter was damaged less than the other three inspected bearings. Calibration data were obtained as previously described and the calibration of Meter No. 36 is shown as Curve D, Figure 4.

A. Propeller side (jewel in center of photograph).

B. Register side.

Condition of jewel pivot bearings and brass bearing plate of Meter No. 36 after removing sediment before obtaining laboratory calibration (magnified 9X).
