Preliminary report on hydraulic model studies, Bartlett Dam  
Spillway

This report summarizes the investigations on a 1:100 scale model of the Bartlett Dam spillway and discharge channel. Corrective measures as determined from the study are suggested. A formal report on the studies will be distributed as Laboratory Report No. Hyd-576.

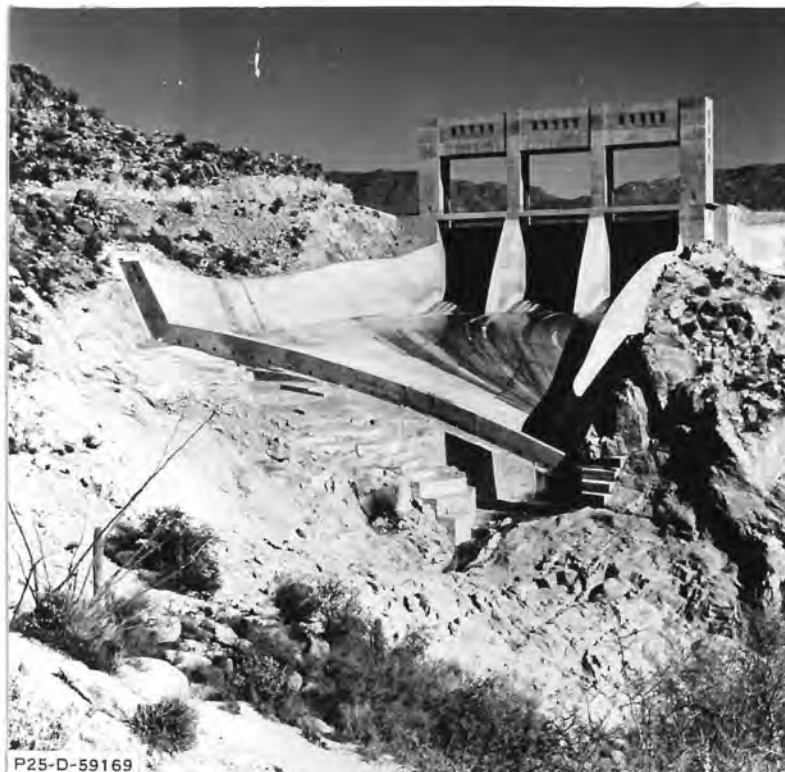
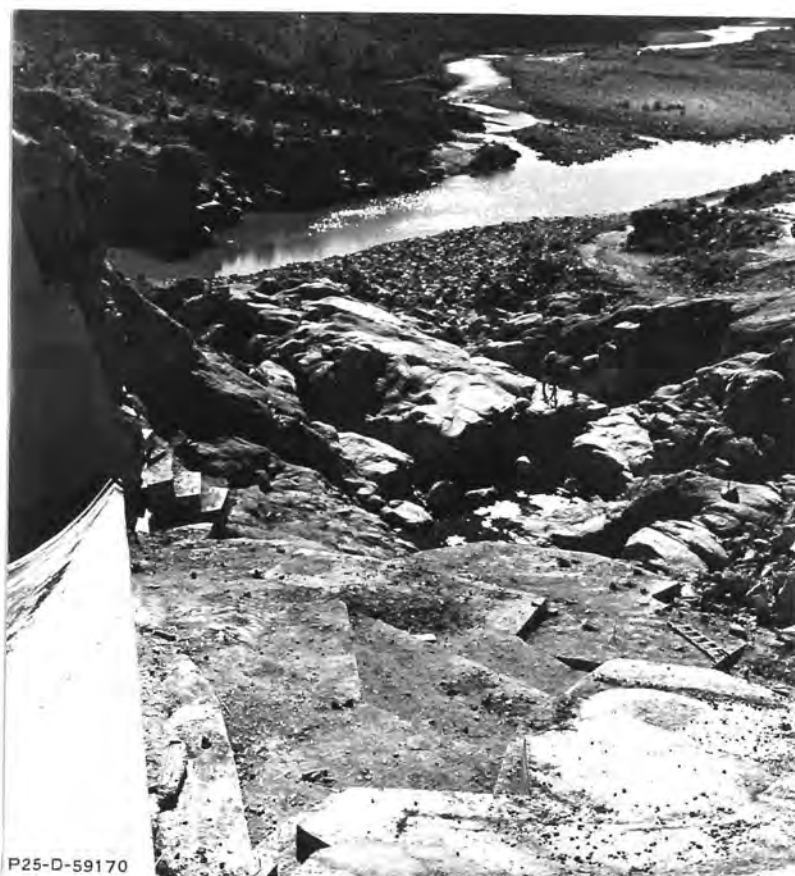
BARTLETT DAM SPILLWAY  
DISCHARGE CHANNEL EROSION AND REPAIRS  
PRIOR TO THE 1965-66 FLOOD

Floods in 1942 and 1965-66 severely eroded the excavated channel. Prior to the 1965-66 flood the channel was repaired by placing mass concrete in retaining walls and blocks in the badly eroded portion of the channel near the downstream end of the chute (Figure 2). The 1965-66 spillway flows, estimated at 28,500 cfs from near maximum reservoir elevation, washed out or undermined these concrete slabs and blocks in several areas (Figure 3). Erosion of the rock was quite rapid where the concrete had overlain the weak, weathered granite. At the base of the steep portion of the eroded channel,

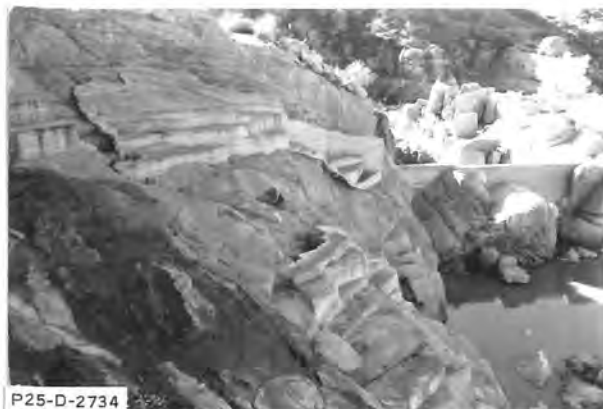
A. Note the undermining of previous channel repairs.

BARTLETT DAM SPILLWAY  
DISCHARGE CHANNEL EROSION  
Caused by 1965-66 Flood

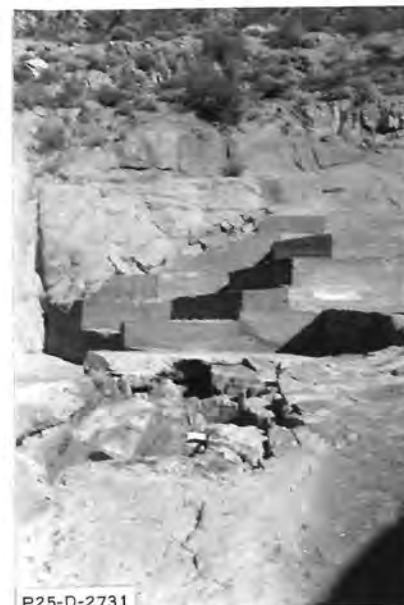
B. View looking towards right bank.

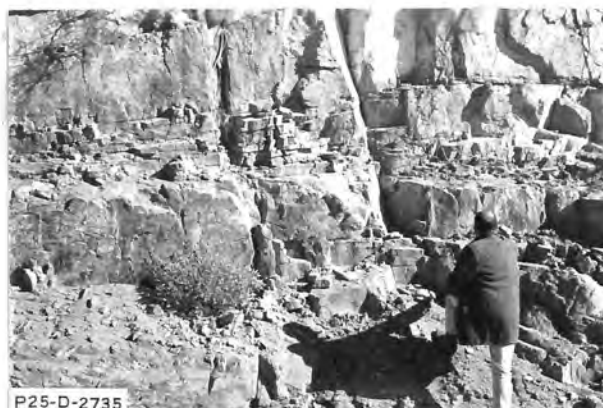
This weathered rock is weak and easily eroded, but the underlying rock is hard and sound. The other type of granite is fine grained, competent, and resistant to erosion. Three dominant systems of joints affect both rock types--two near-vertical systems and one irregularly developed horizontal system.

C. Note both vertical and horizontal joints in the weathered rock.

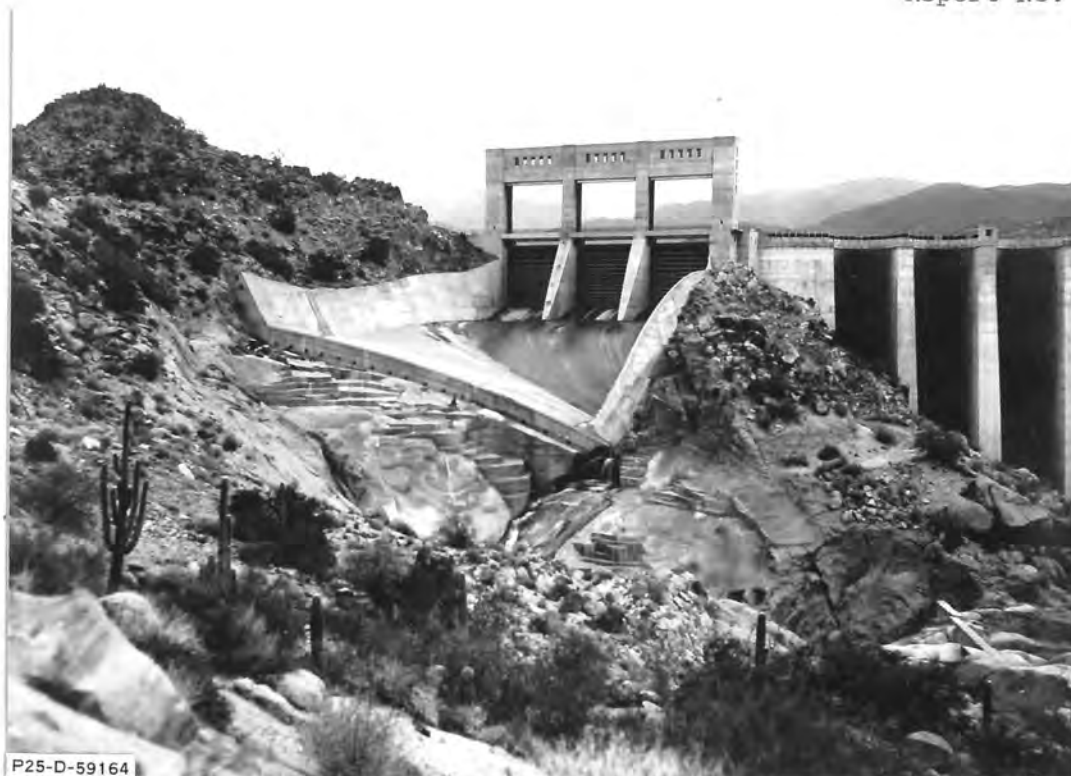
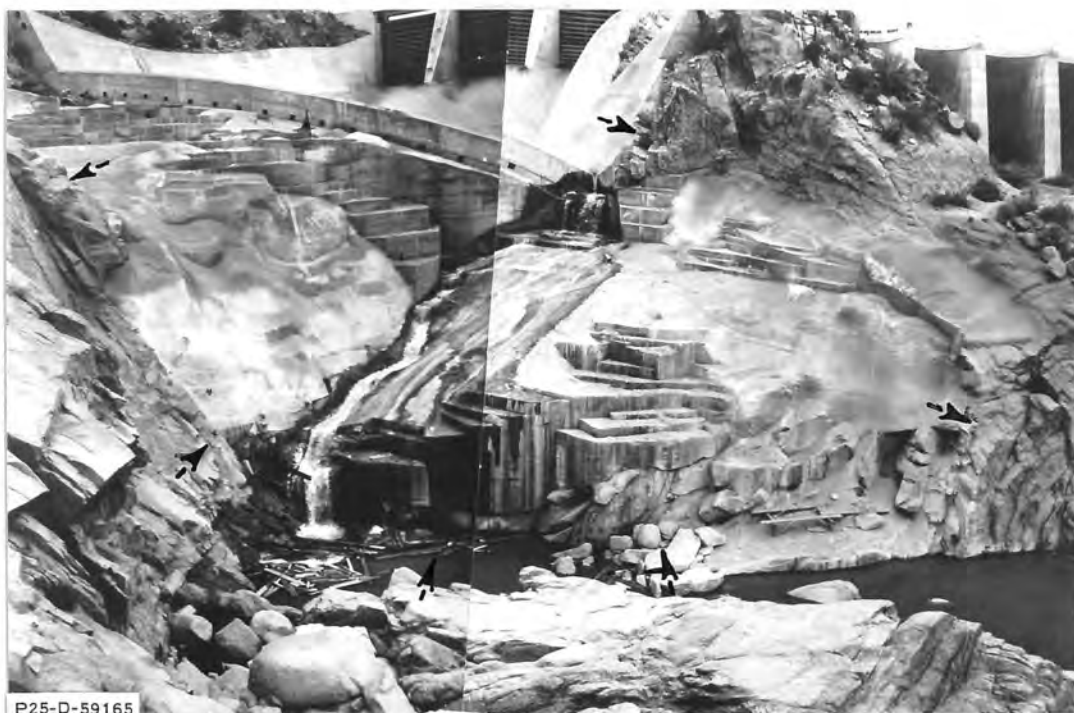
BARTLETT DAM SPILLWAY  
Repairs to Discharge Channel Following  
the 1965-66 Flood

Spillway discharges have eroded a 15-foot-deep hole at the base of the steep slope in the prototype discharge channel (Figure 4). Further spillway operation possibly will increase the size of this hole and undermine the concrete paving on the steep slope. This hole should be filled with concrete extending from the existing concrete on the upstream side to the rock on the far side of the pool (Figures 7 and 11). Sloping this concrete fill downward from approximately el. 1635 to el. 1615 in the direction of flow along the existing channel (Figure 7) will flush loose rock downstream during spillway operation.

Water stands in a 15-foot (4.57-meter)-deep hole eroded at the base of the steep slope. Areas subject to future erosion are indicated by the arrows.

3. The deep erosion hole at the base of the steep slope should be filled with concrete (Figures 4, 7, and 11). This concrete fill should extend from the existing concrete on the upstream side of the hole to sound rock on the far side. The floor should slope downward to the left in the direction of flow to flush loose rock from the channel.

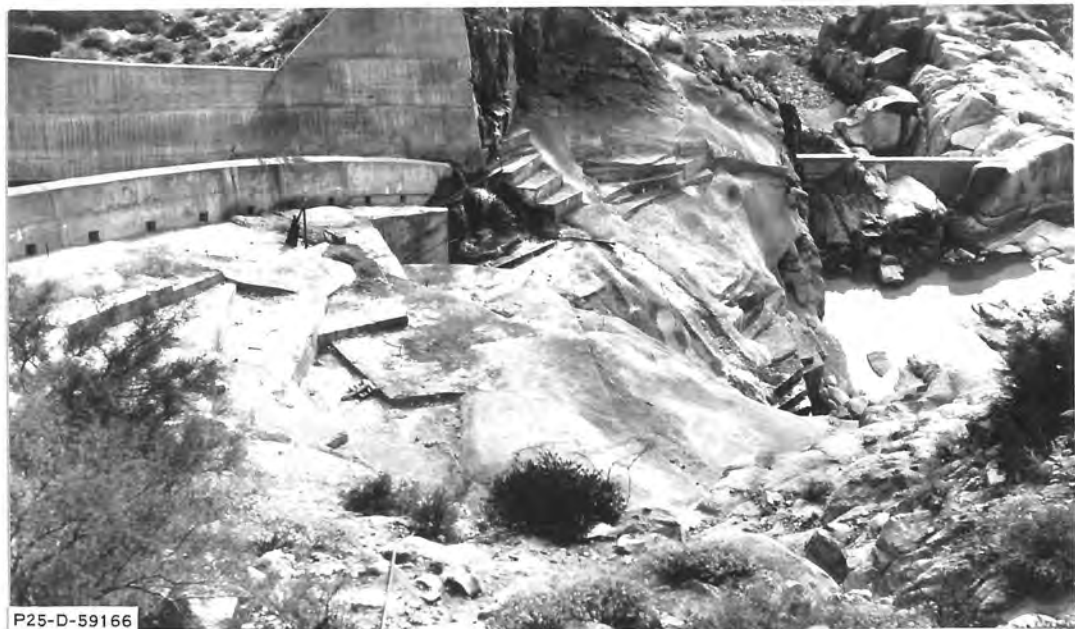
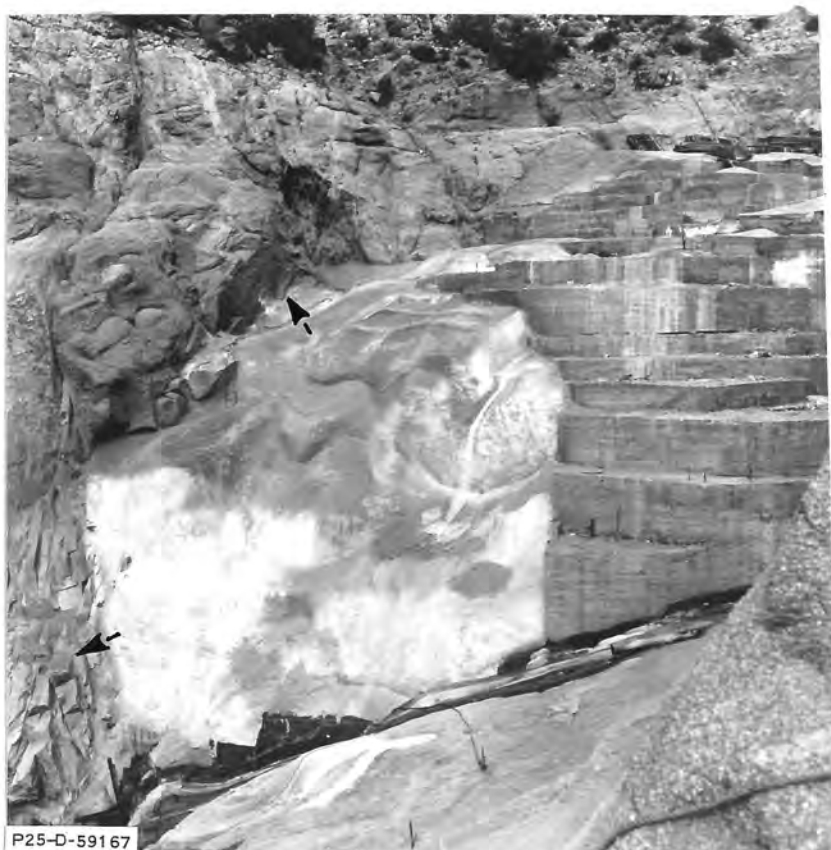
BARTLETT DAM SPILLWAY  
Repairs to the Discharge Channel Following  
the 1965-66 Flood

Even with all three gates equally opened, portions of the flow impinged on the left and right sides of the discharge channel beyond the limits of the paved area. These areas of impingement are subject to erosion during future spillway discharges (Figures 4, 5 and 8). Erosion on the right side will occur far enough downstream that it is not likely to endanger the structure or undermine the paved area (Figure 5). Erosion may occur adjacent to the left concrete wall of the spillway chute and farther downstream along the left bank (Figure 4). Additional paving should be extended to prevent this erosion (Figures 9 and 11).

Areas subject to future erosion are indicated by the arrows.

2. Repairs made after the 1965-66 floods appear to be well located but the paving should be extended a little higher and farther downstream along the left bank (Figures 4, 9, and 11).

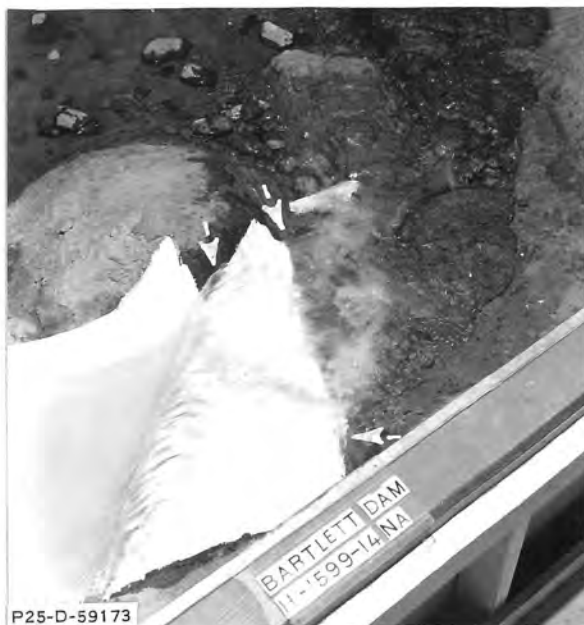
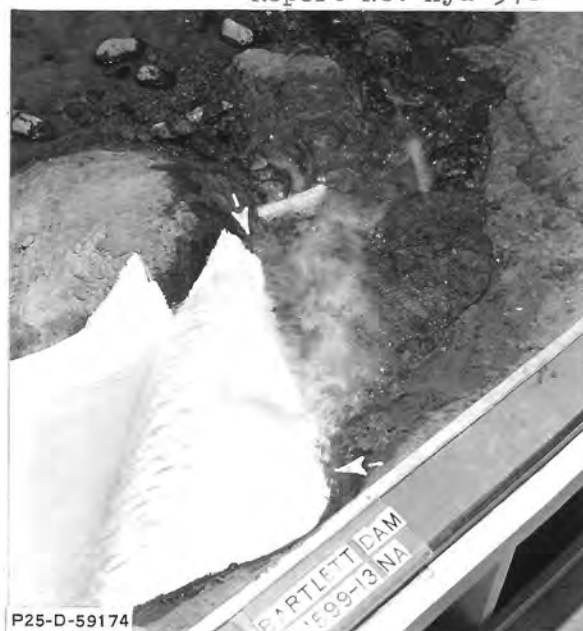
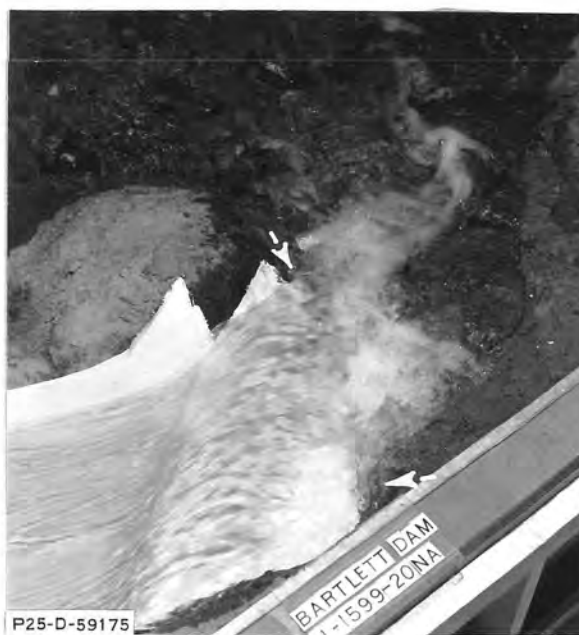
BARTLETT DAM SPILLWAY  
Flow in Discharge Channel  
1:100 scale model

The model was operated at discharges up to 50,000 cfs to determine flow conditions that might have caused the erosion. At discharges of 10,000, 20,000, and 50,000 cfs, flow from the spillway impinged on the areas that had been badly damaged in the prototype channel (Figure 8). The severest damage appeared to have occurred where the impact forces of the jet had apparently loosened and eroded the rock at the weathered joints. Initial tests made using an erodible channel inadvertently constructed of 3 parts sand to 1 part pozzolan showed that the erosion began at the left downstream corner of the concrete-lined chute and progressed downstream as the discharge increased (Figure 9). This test confirmed the belief that the major portion of the erosion was due to flow impact rather than to rocks churning in the turbulent flow.

The areas of flow impingement on the left and right banks beyond the white paved area are indicated by the arrows.

5. The spillway gates should be equally opened for best operation (Figure 8).
6. The two ridges partially blocking the downstream end of the channel should not be removed (Figure 13).

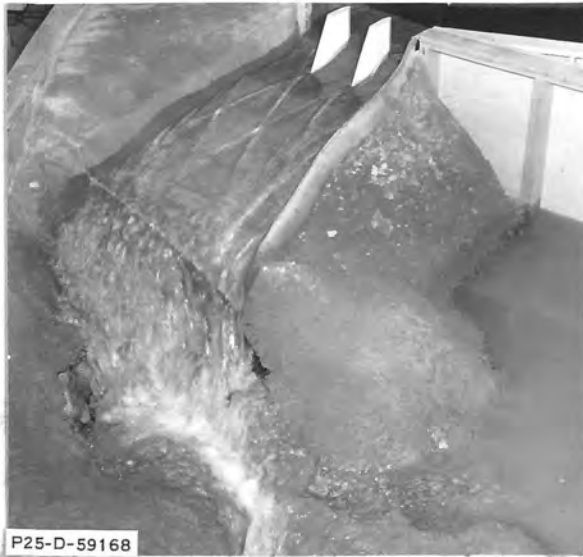
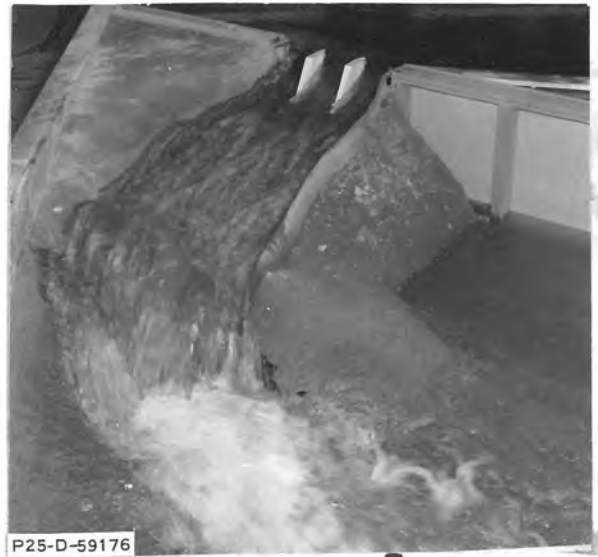
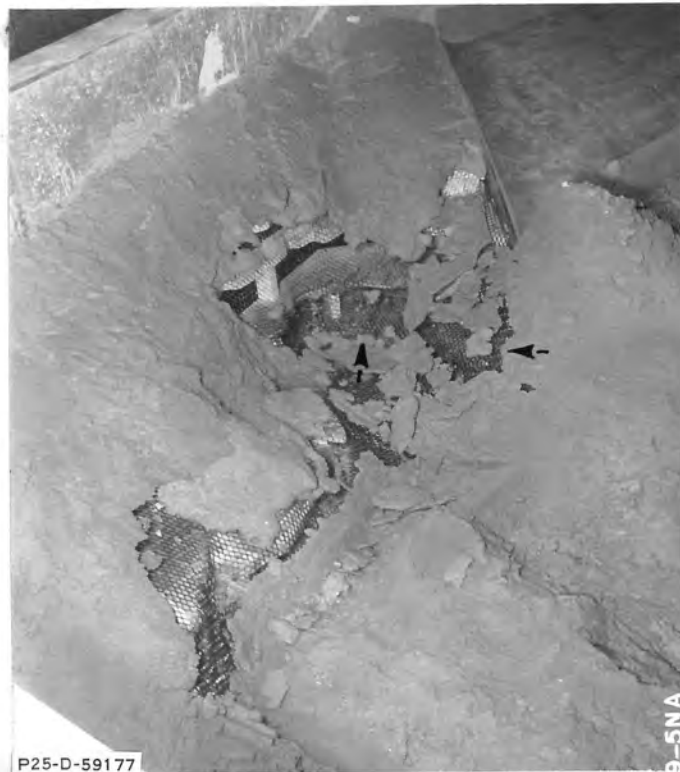
BARTLETT DAM SPILLWAY  
Erosion Test  
1:100 scale model

1. The model confirmed that the erosion damage in the discharge channel was almost entirely due to the impact of the flow impinging on the badly fractured rock and breaking it loose rather than to the churning of loose rock in the turbulent flow (Figure 9).

Areas requiring additional concrete protection are indicated by the arrows.

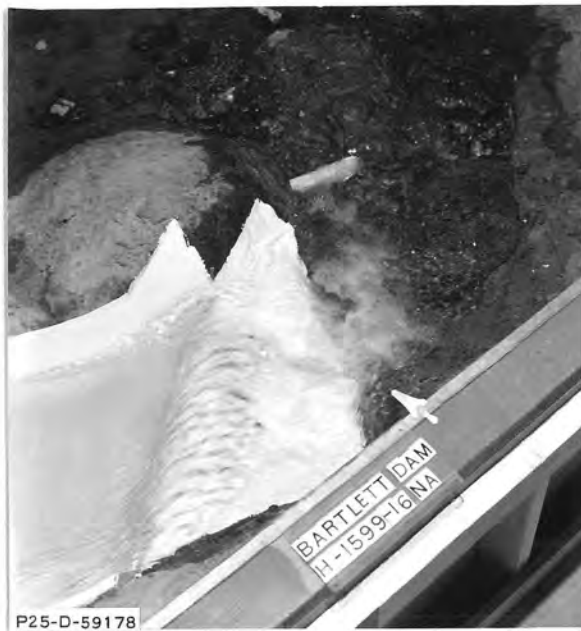
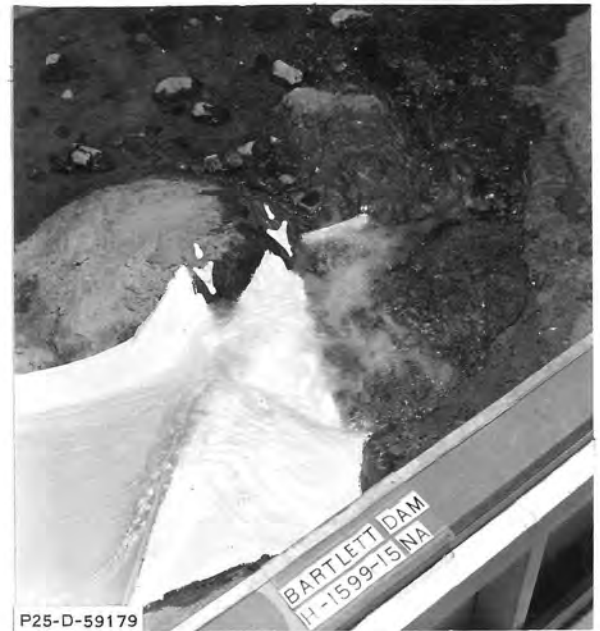
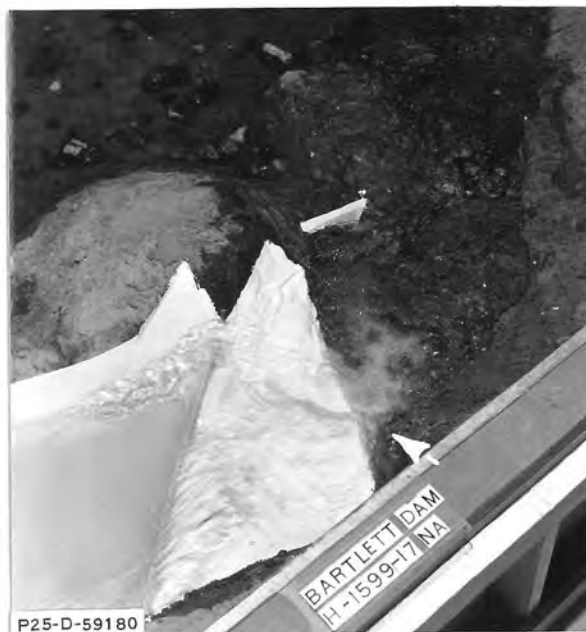
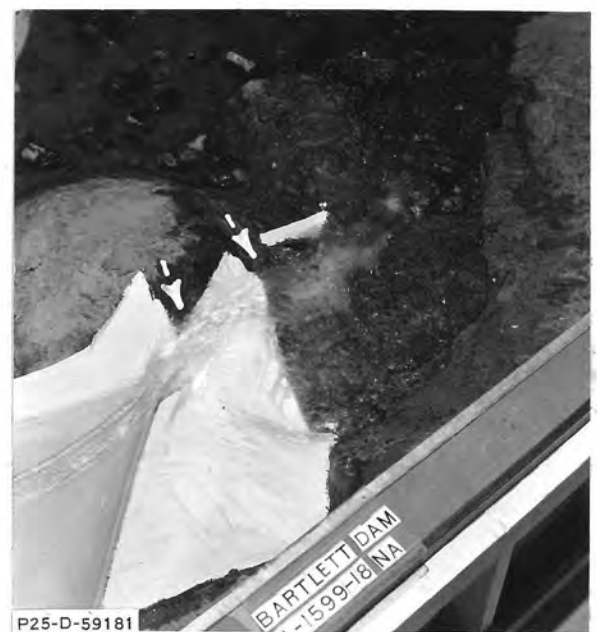
BARTLETT DAM SPILLWAY  
Flow with unsymmetrical gate operation  
1:100 scale model

Various combinations of gate openings were tested (Figure 10) to determine the best combination of gates for regulating the flow. These tests showed that closing the right gate will reduce the flow impingement on the right bank along the edge of the paved area and increase the impingement along the left bank. With the left gate closed, the reverse is true. These flow conditions were more pronounced when either the left or right gate was operated singly. The tests showed that all three gates should be opened equally for best operation.

The areas of flow impingement on the left and right banks beyond the white paved area are indicated by the arrows.

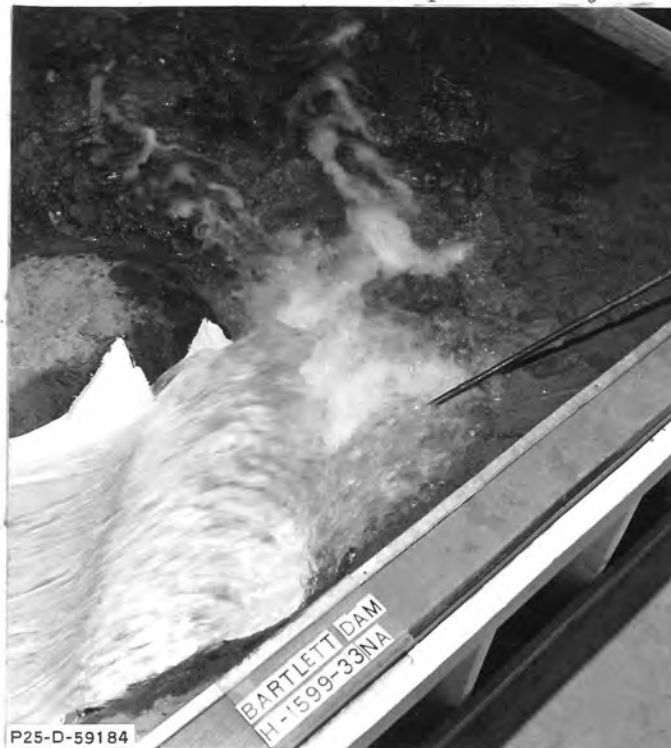
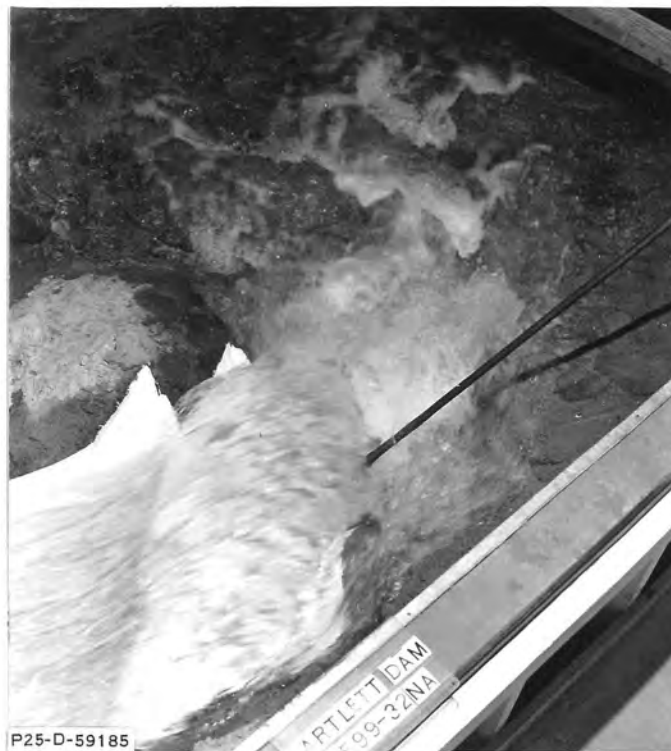
BARTLETT DAM SPILLWAY  
Flow Conditions with Channel Protection

At flows of 100,000 and 175,000 cfs (Figure 12) part of the jet impinged near the first ridge in the downstream portion of the discharge channel beyond the paved area. Discharges of this magnitude will probably cause considerable erosion in the prototype; however, the damage will be remote from the spillway chute and probably not require repair.

4. At flows greater than about 50,000 cfs, part of the jet will impinge in the downstream portion of the channel beyond the paved area (Figure 12); however, erosion damage will be remote from the spillway and should not require repair.

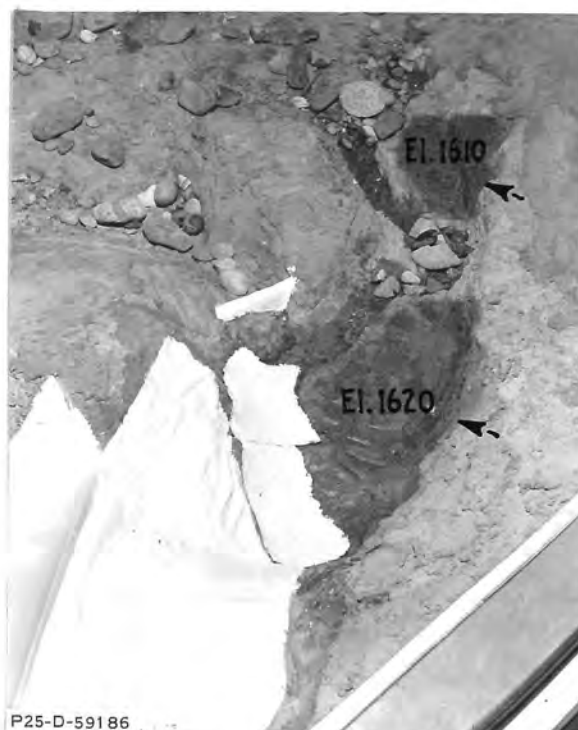
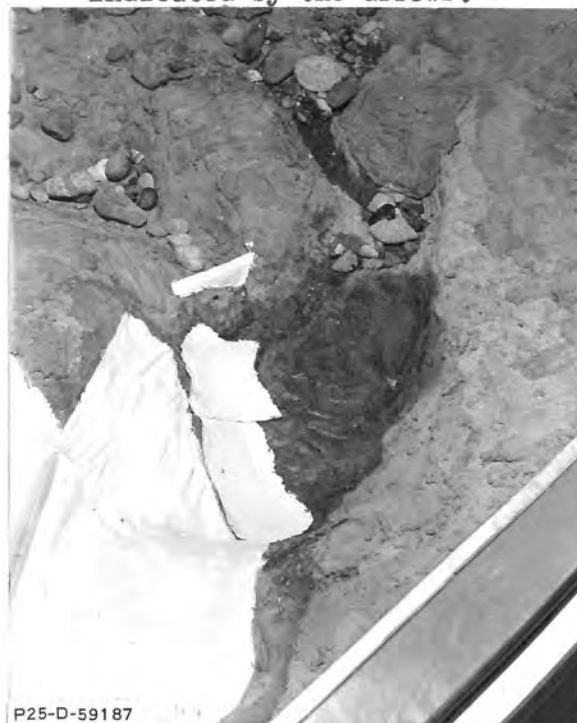
BARTLETT DAM SPILLWAY  
Channel Alterations Tested  
1:100 scale model

The two ridges were constructed in the model so that the channel could easily be tested with and without the ridges in place (Figure 13). Tests were run at discharges of 20,000 cfs and 50,000 cfs to determine the effect of removing either or both ridges. The tests showed that any loose rock that might fall into the channel will flush from the area, with or without the ridges in place. Actually the upstream ridge and the existing weir at approximately el. 1640 in the left branch of the discharge channel (Figure 14) aid in maintaining a pool for flows up to 50,000 cfs. This pool appeared to absorb part of the energy of the falling jet which would reduce the erosion damage (Figure 14).

A. First and second ridges are removed to the elevation shown. Ridge locations are indicated by the arrows.

B. First ridge only is removed.

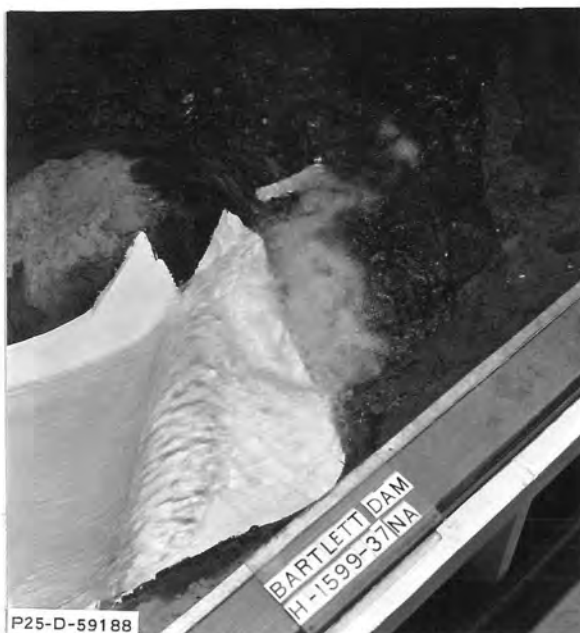
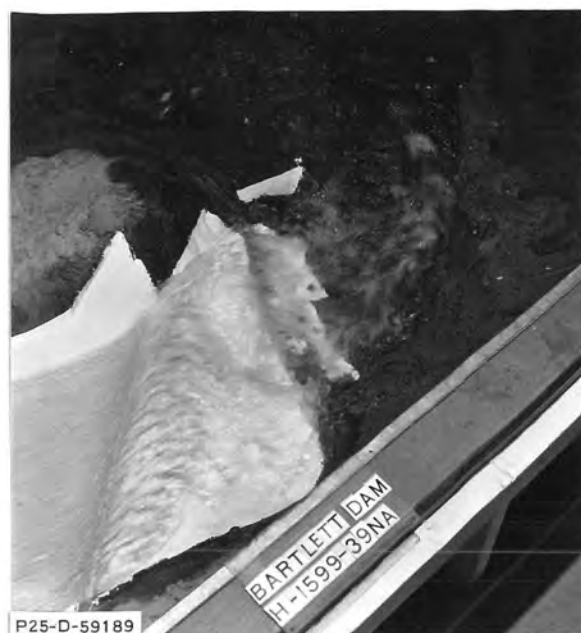
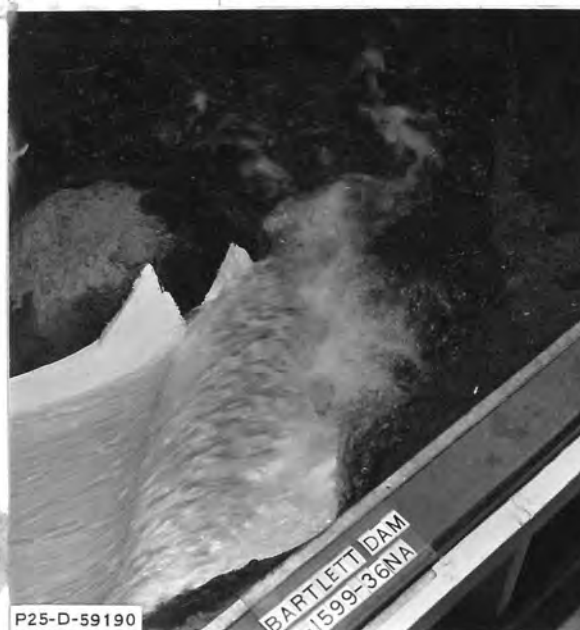
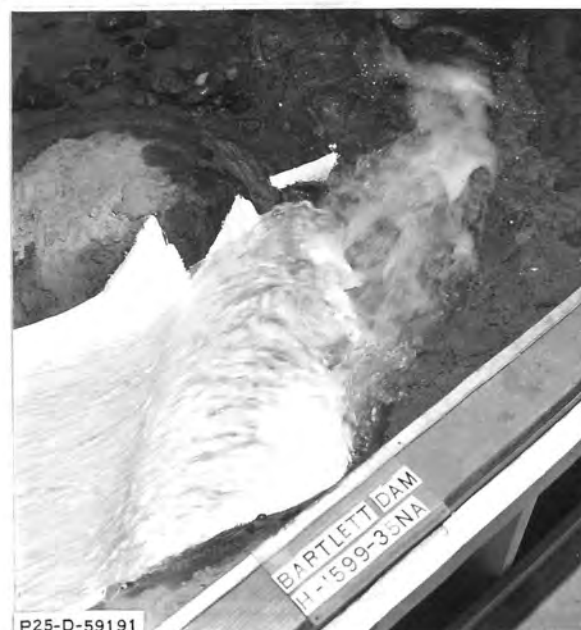
BARTLETT DAM SPILLWAY  
Flow conditions with and without First Ridge

7. The upstream ridge and the existing weir in the left branch of the channel help form a shallow pool at the base of the paved slope for flows up to 50,000 cfs (Figure 14). This pool aids in absorbing some of the energy in the jet and in reducing the erosion damage.

A. Recommended concrete fill.

B. Concrete fill with first ridge removed is not recommended
