ICE PROBLEMS IN WINTER OPERATION RECOMMENDATIONS FOR RESEARCH

Engineering and Research Center
Bureau of Reclamation

APRIL 1971

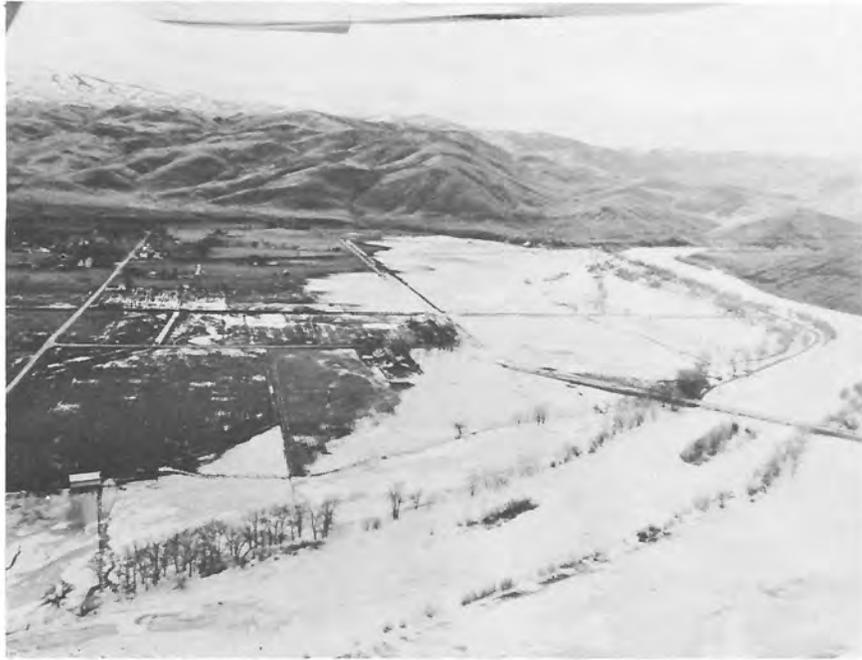
An ice jam occurred on the north fork of the Payette River some 17 miles downstream from Cascade Dam several years ago. The release at Cascade Dam was changed from over the spillway to the high-pressure gates. Within a week's time the warmer water had cut a channel through the jam and the riverflow returned to within its channel.

Aerial view of Montour, Idaho area flooding January 10, 1971. Photo P3-162-908NA

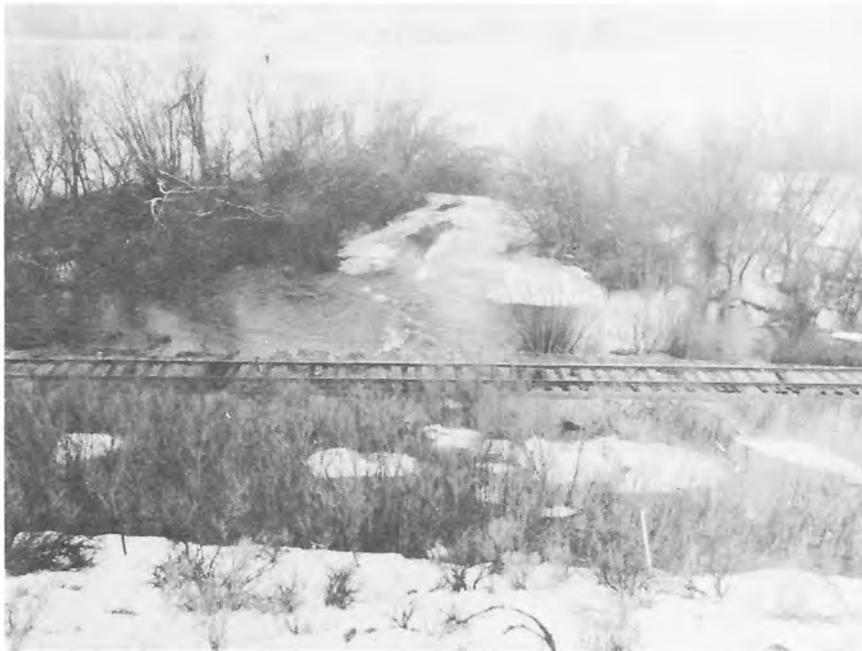
Water flowing through washed-out railroad right-of-way behind the McConnell Ranch January 9, 1971. Photo P3-102-903NA

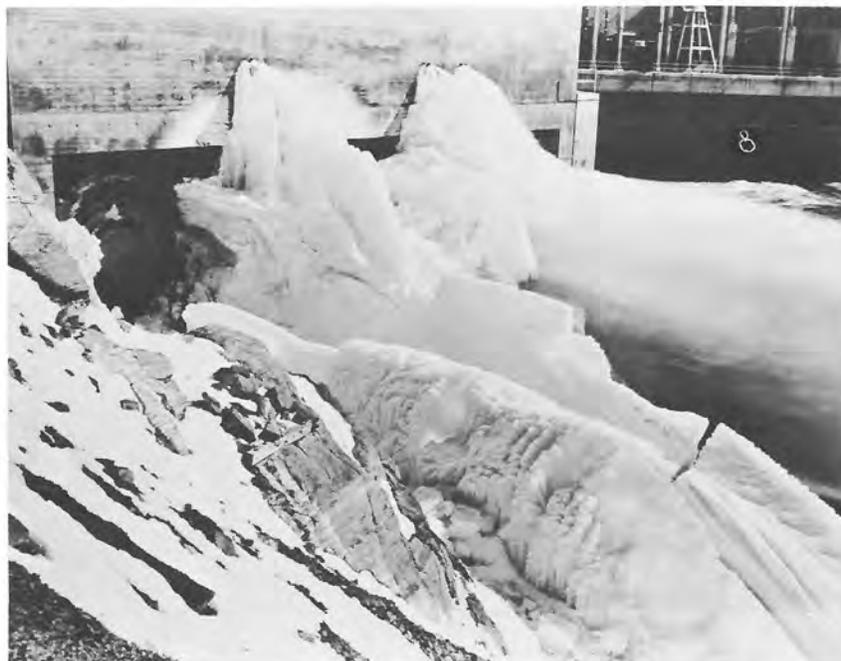
Ice conditions occur on the outlet tube structure, the hollow jet valves, and associated piping if they are used for discharge during the winter. No major problems have developed. However, it could be of considerable inconvenience if maintenance were required during this period.

Closeup view of Hungry Horse outlet works showing ice buildup resulting from operation of the three 96-inch hollow-jet valves - No. 3 jet valve is still operating. March 23, 1965. Photo P447-105-6750NA

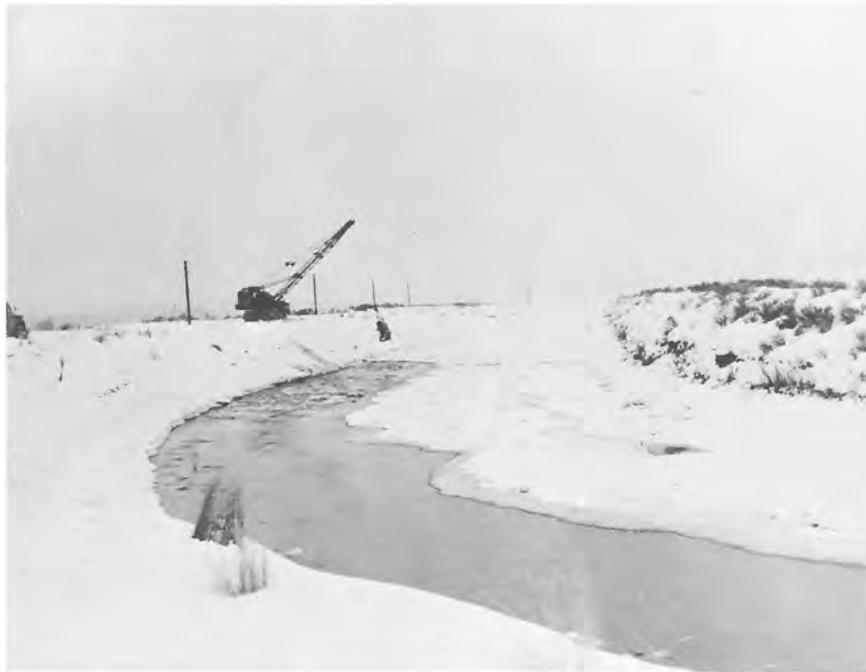
Ice formation in the power canals has caused several outages for the Roza and Chandler generators. The project has some deicing equipment at the Roza and Chandler Powerplant forebays and at Roza Diversion Dam, but this is not adequate. The anchor ice and floating ice problems are generally severe enough that the powerplants and canals are shut down until the temperatures rise and the water temperature is above freezing.

Roza I. D. breaking ice in Roza Canal at Mile 8, preparatory to starting Roza powerplant generator. Dragline can reach only half width of canal. January 11, 1965. Photo P33-109-6966NA

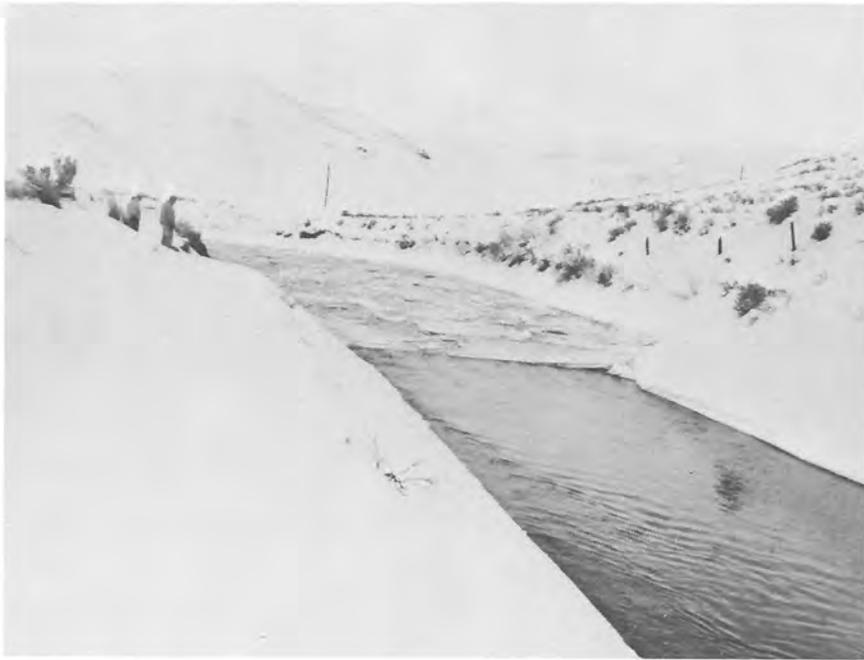
Lower end of ice jam in Roza Canal Mile 8.3, unlined to lined canal transition; flow 300 \pm cfs. January 7, 1965. Photo P33-109-6960NA

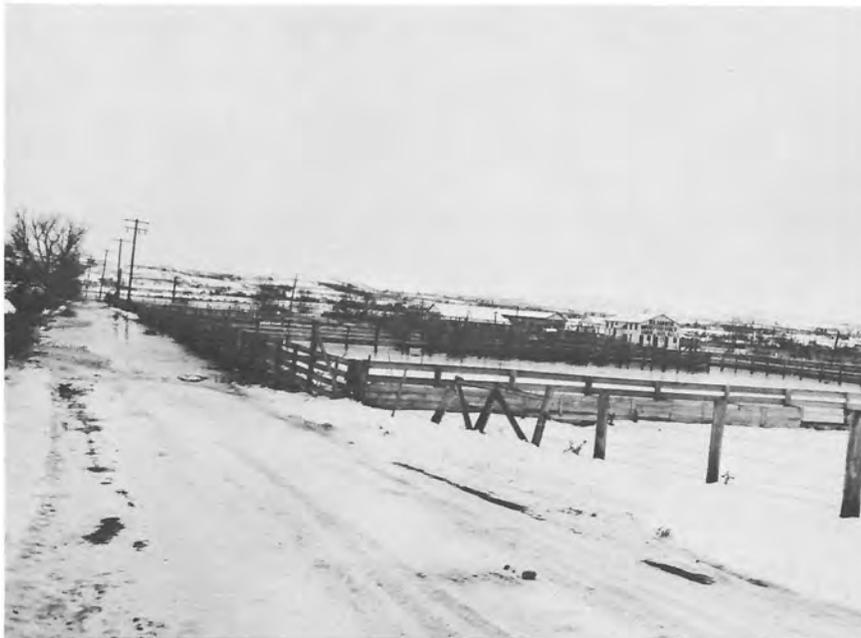
Flood caused by Yakima River ice jam, about 1 mile long, below railroad bridge, East Selah area. Hammon cattle ranch at right. January 7, 1965. Photo P33-109-7618NA

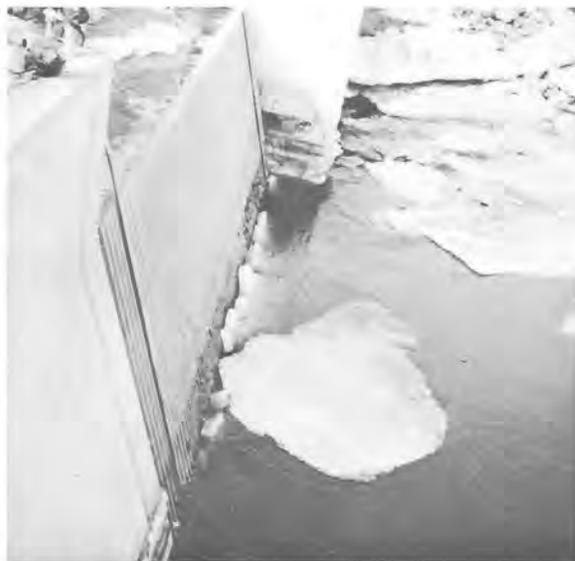
Floating ice against the trashracks. Note how the ice slabs have turned and flattened against the rack, greatly reducing the intake cross section. February 4, 1970. Photo CN66-436-828NA

They have found that by maintaining the water surface as high as possible they can develop an ice cover high enough that the effective flow area of the trashrack is much improved over that at a lower water-surface elevation.

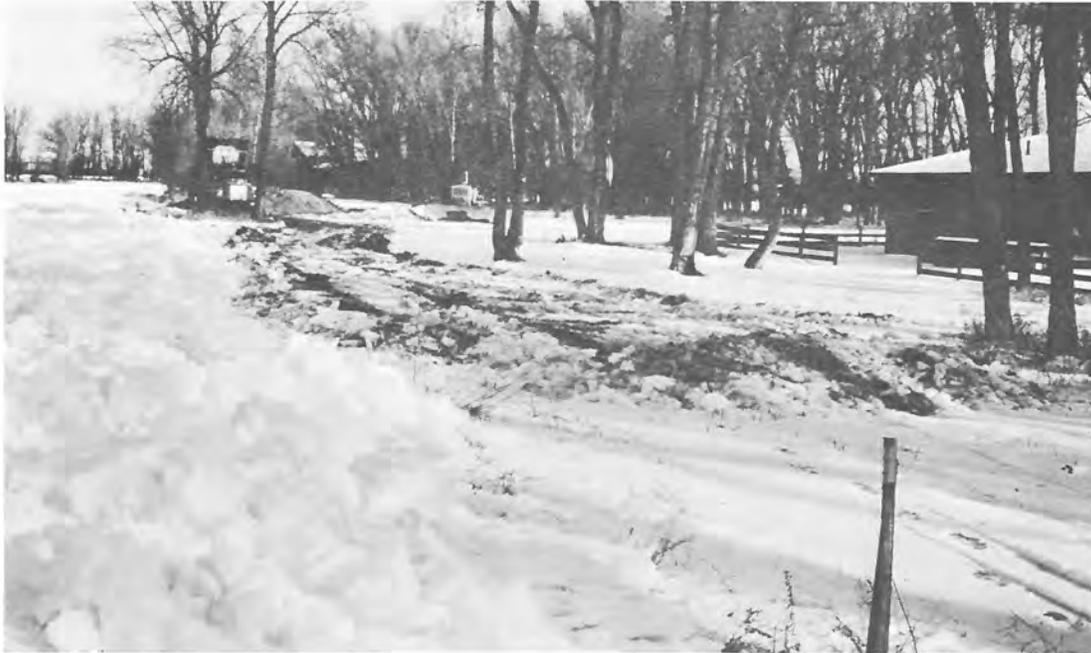
View looking upstream on the Gunnison River adjacent to the Dos Rios Homesites. Note the emergency dikes being placed to contain water forced out of channel by ice. January 8, 1971. Photo P622-D-68761NA

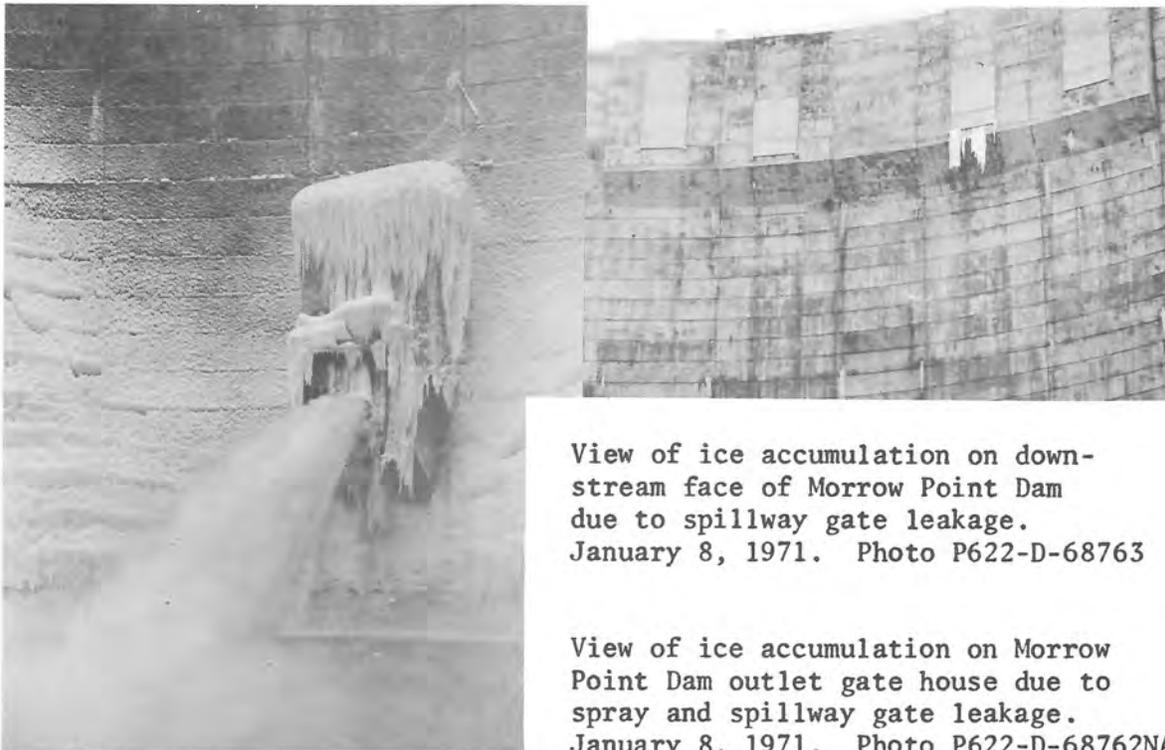
There have been heavy accumulations of ice buildup on the outlet works gatehouse. The icing results from spray, and from leakage past

the spillway gate seals. When the ice breaks off or melts it falls on the walkway and has damaged the handrail on the walkway. The ice formation will prevent operation of the weather doors and is a hazard to personnel.

View of ice accumulation on downstream face of Morrow Point Dam due to spillway gate leakage. January 8, 1971. Photo P622-D-68763

View of ice accumulation on Morrow Point Dam outlet gate house due to spray and spillway gate leakage. January 8, 1971. Photo P622-D-68762NA

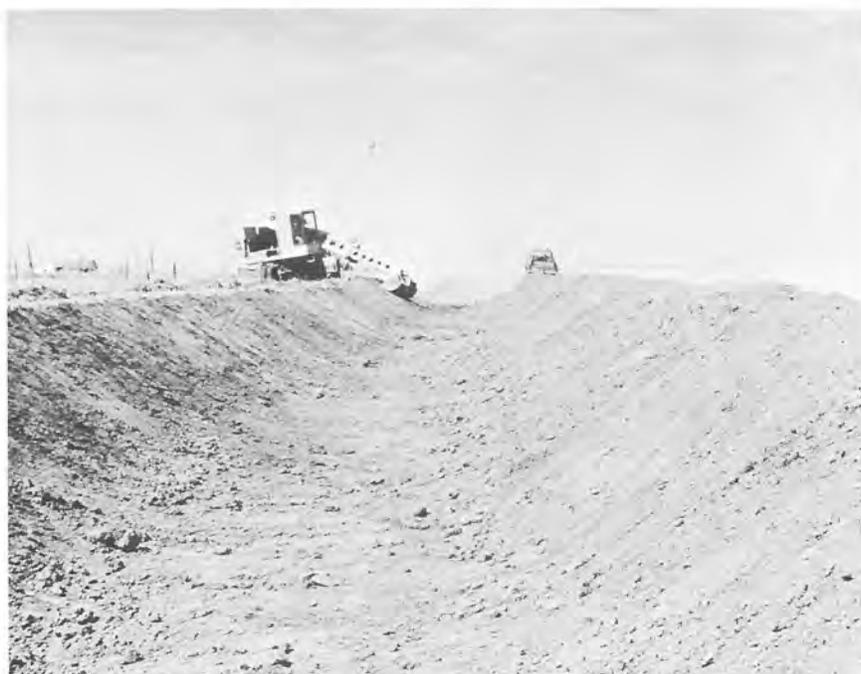
protruding from the banks of the canal. The truck moves along the canal at a moderate speed while an operator on the truck maneuvers the buckets of the machine so as to break off any shore ice. The object is to keep the ice moving. If it stops it would soon jam the whole channel cross section. At times they use light charges of explosives (1/4 sticks) to keep ice moving.

Typical truck-mounted, hydraulically operated excavating machine. Photo P257-D-47911

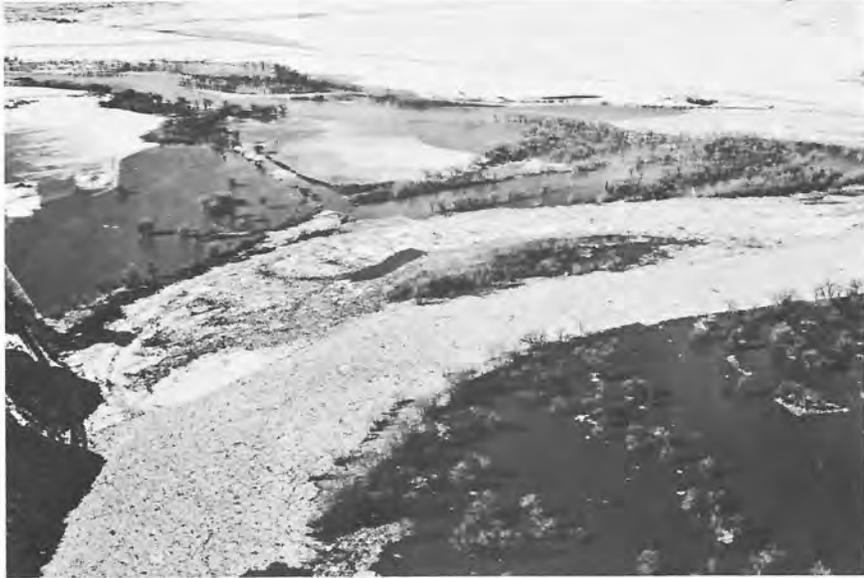
Yellowstone River, Montana - Aerial view looking upstream at an ice jam 8 miles west of Miles City, Montana. Note flooding on both sides of the river channel. February 16, 1971. Photo AX-600-36NA

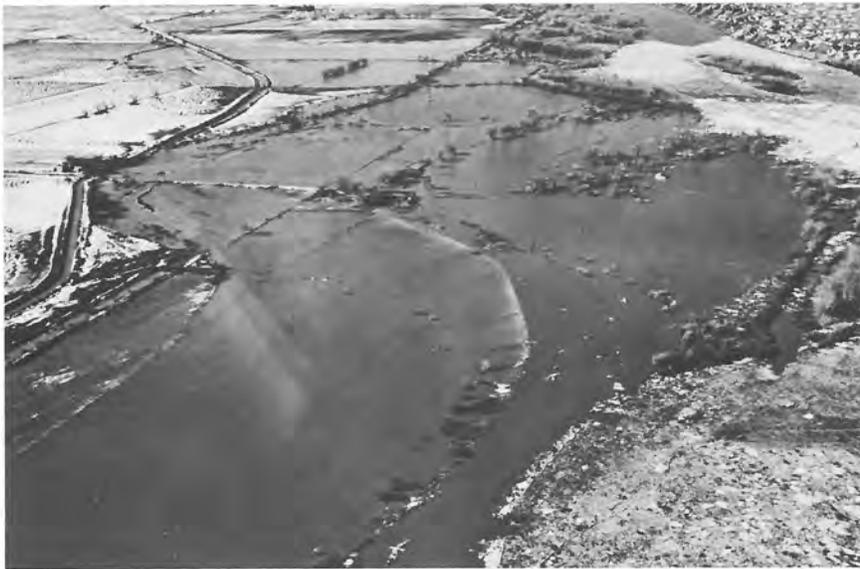
Yellowstone River, Montana - Aerial view looking upstream at flooded farmland and buildings in the Yellowstone Valley near Hysham, Montana. Note ice jam upper right corner of photo. February 16, 1971. Photo AX-600-31NA

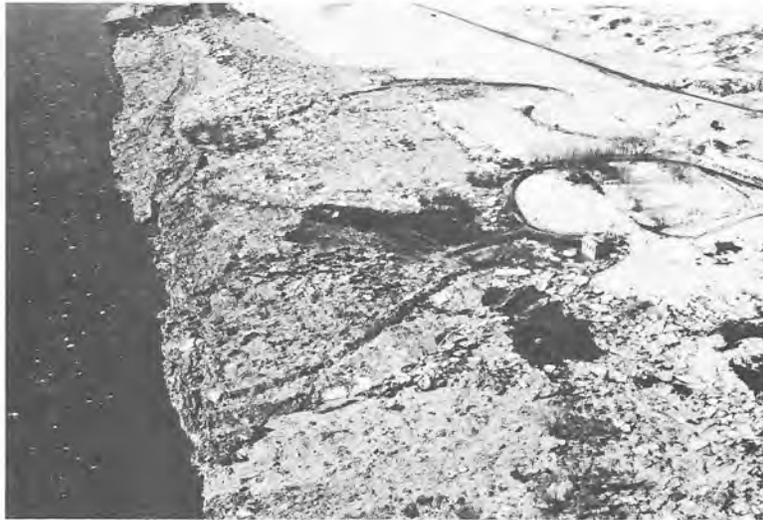
Aerial view looking upstream at the Glendive Pumping Plant on the Yellowstone River near Fallon, Montana. Note ice on the left riverbank and ice plug in the intake channel. Water reached elevation 2159.25 and entered pumping plant windows and door. This elevation was 4.25 feet higher than the record of 2155.0 set in February 1943. February 16, 1971. Photo A243-600-8NA

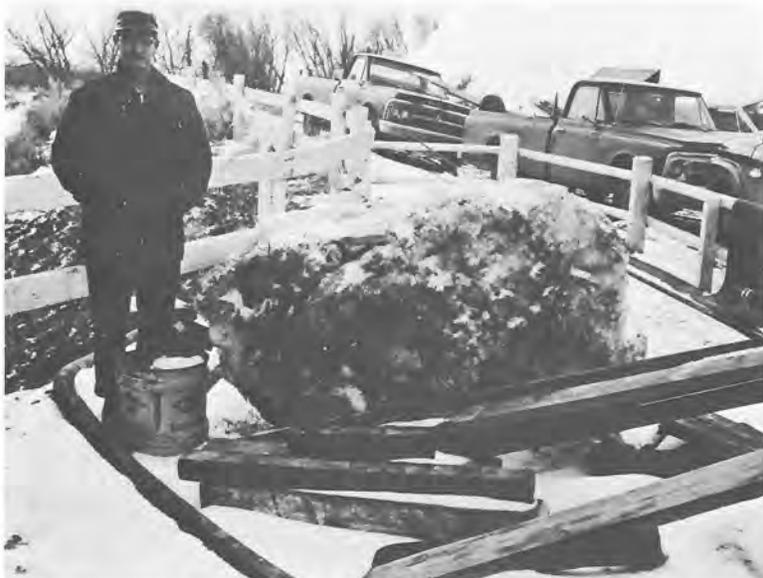
Large chunk of ice that floated into the pumping plant area during flood. Pumping plant building is at the man's right. High water elevation was approximately at the top of the man's head. March 1, 1971. Photo P243-D-68759

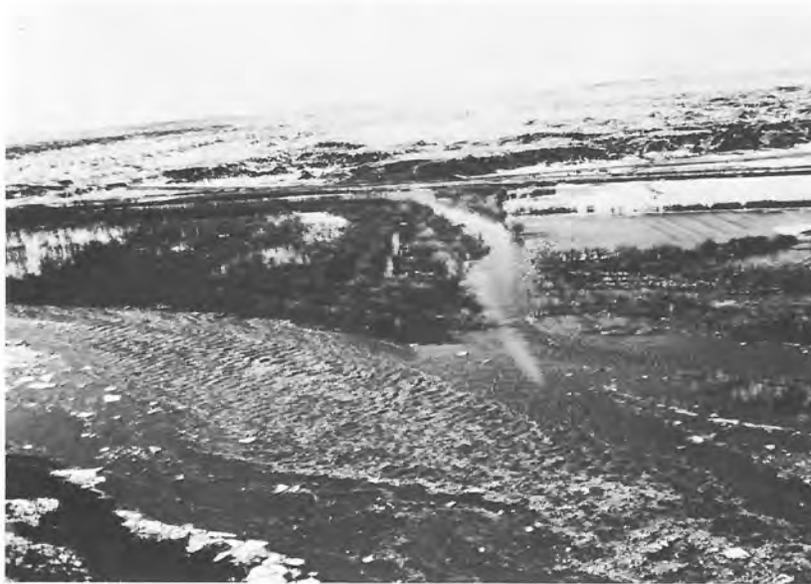
Floodwaters move swiftly down the Yellowstone River following release of an ice jam downstream from the Lower Yellowstone Diversion Dam. Note turbulent flow. February 16, 1971. Photo A14-600-34NA

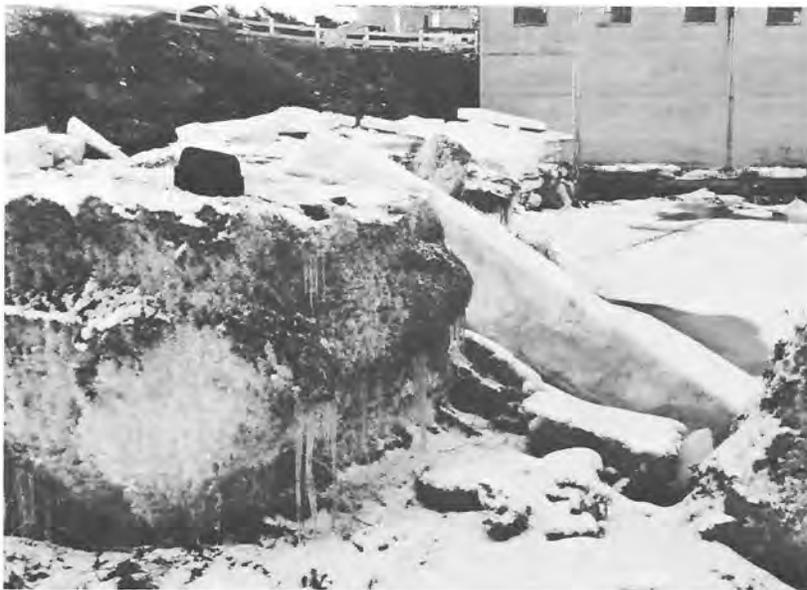
Looking at intake side of pumping plant showing large chunks of ice that were left after flood that occurred February 15, 1971. Note trashracks. March 1, 1971. Photo P243-D-68760

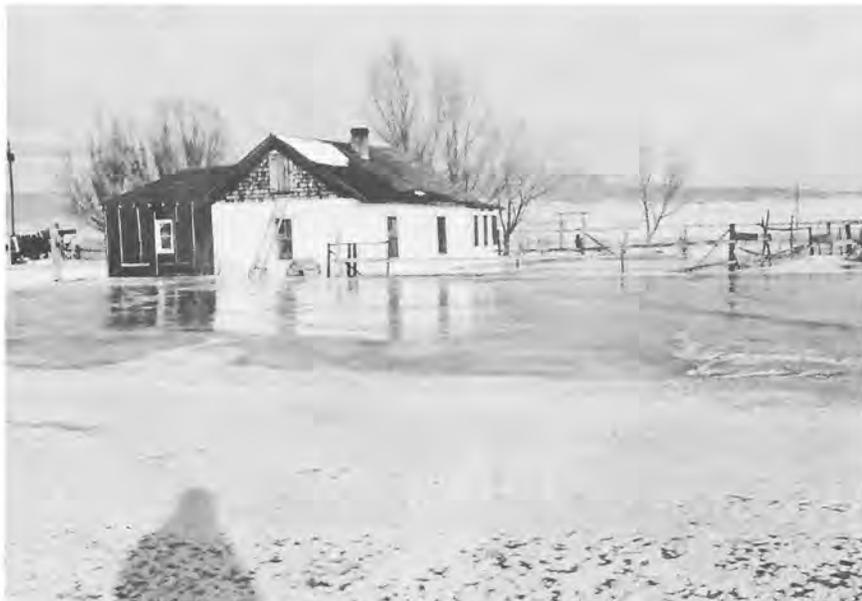
Ice jams forming on the Missouri River in the Townsend area have been a serious problem for many years. This problem has allegedly resulted from the impoundment of water in Canyon Ferry Reservoir. The winter of 1959-1960 seemed to be particularly severe with ice jams and resulting flooding in November and December. In November several head of cattle were lost and flooding of property adjacent to the river resulted in bitter feelings between residents of Townsend, Montana, and the Bureau of Reclamation.

Missouri River flooding condition - Head of Canyon Ferry Reservoir near Townsend, Montana. November 18, 1959. Photo P296-600-803

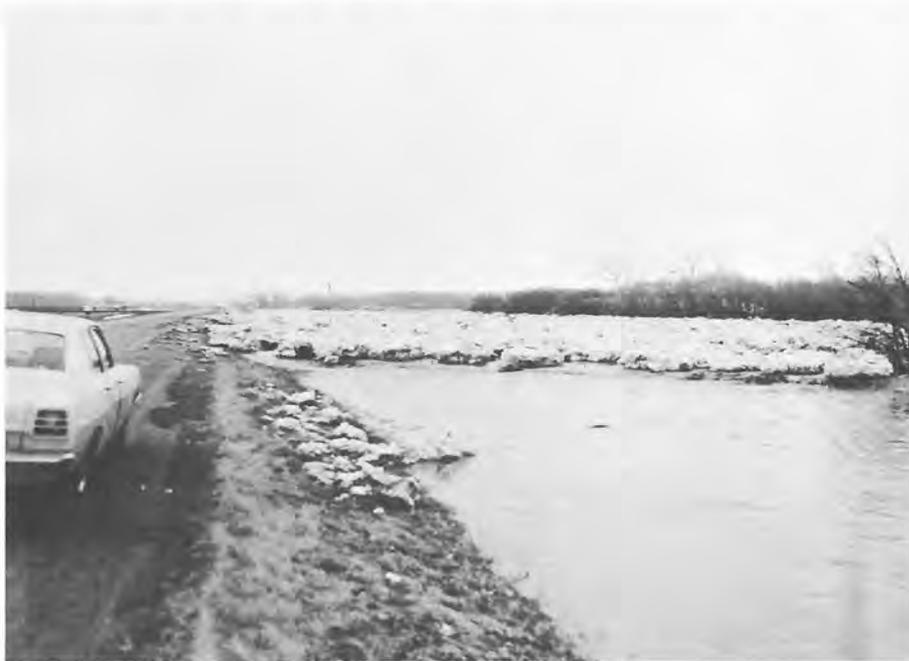
The spring thaw on the Heart River generally precedes that of the Missouri River by about 2 weeks. The floating ice from the Heart River is prevented from entering the Missouri River by the cover ice of the Missouri. This results in an ice jam on the Heart River at its confluence with the Missouri.

View looking west along old U.S. Highway No. 10 west of Mandan, North Dakota. The water had receded about 1 foot at the time photo was taken. Note the ice blocks. April 4, 1969. Photo P1112-603-76NA

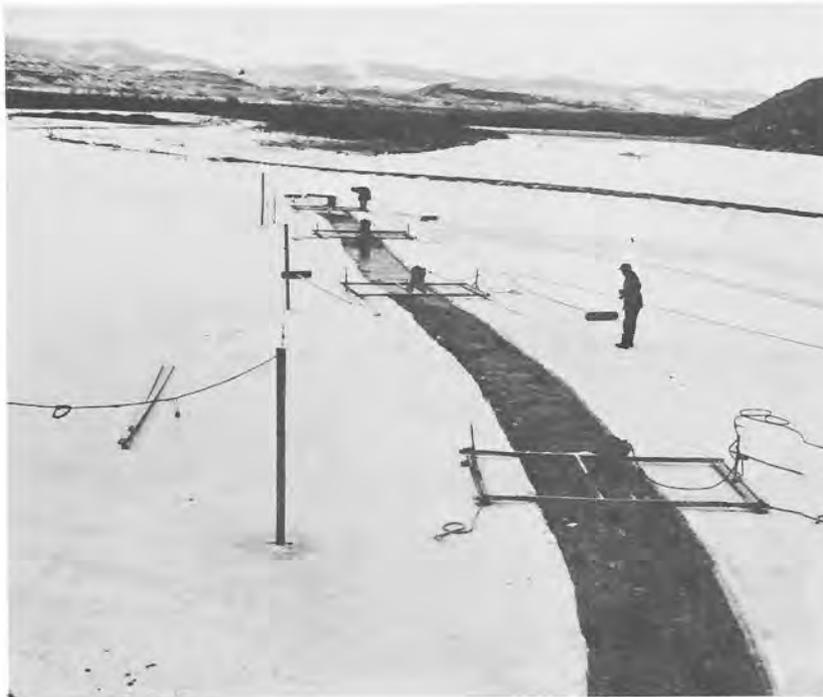
View looking upstream at channel cut in ice at the Wind River Diversion Dam. Four outboard motors and propellers have been placed in the channel to divert slush ice over the dam, thus preventing entry of ice into power canal. December 14, 1967.
Photo P36-703-23NA

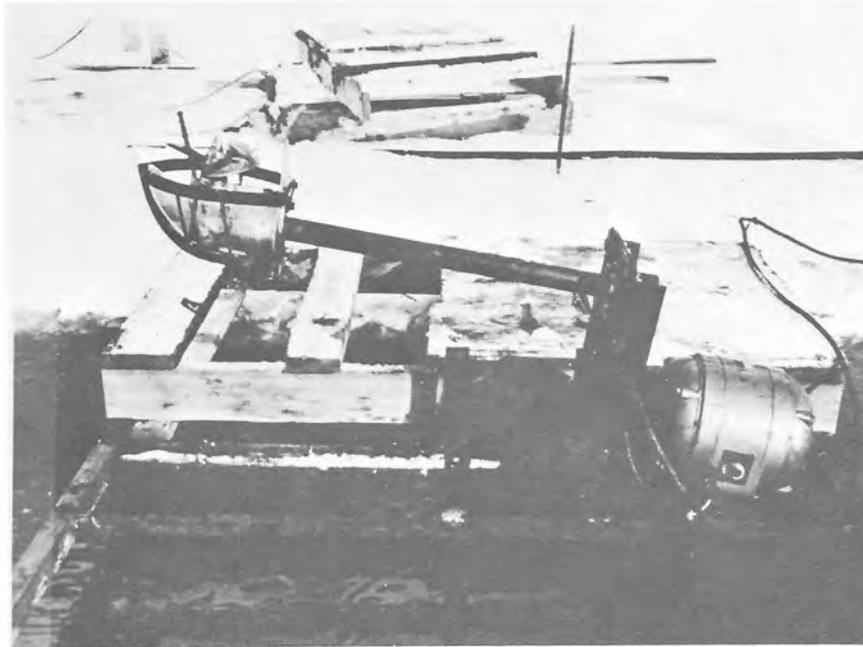
View showing one of the electric ice machines over the slush ice channel above diversion dam with the propeller out of the water. January 14, 1950. Photo A-580

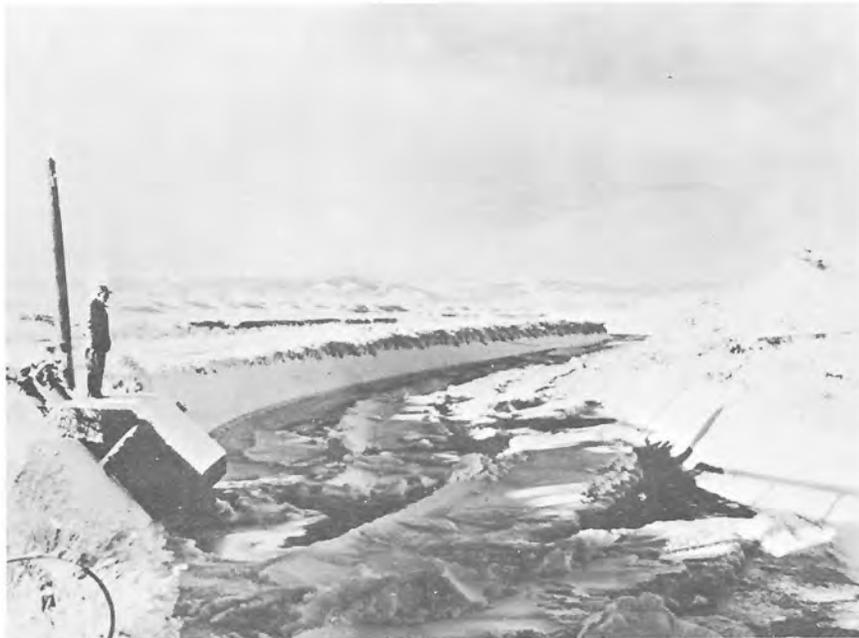
Ice condition, intake Midwest Siphon. December 27, 1948. Photo A-232

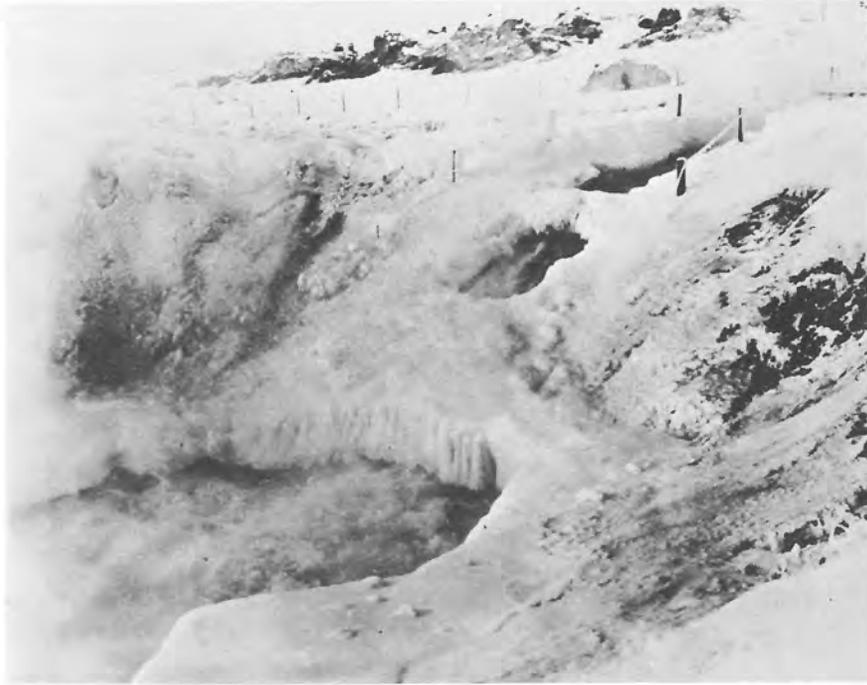
Ice in Pilot Butte Wasteway. January 26, 1949.
Photo A-191

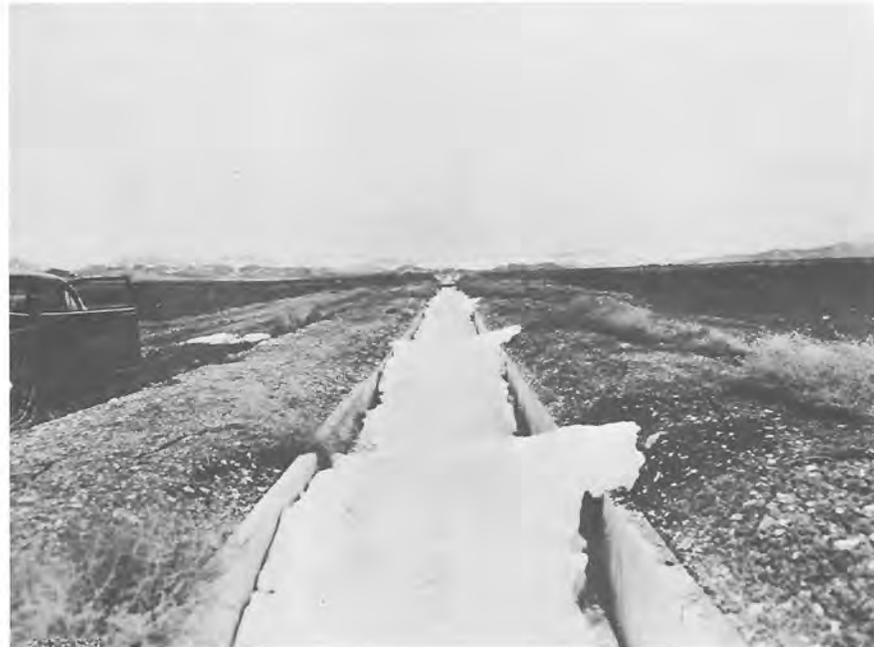
The Ralston Chute, an open rectangular concrete structure that runs due east from Heart Mountain main canal, is a very effective trap for snow and ice produced by the late April or early May blizzards. When the chute plugs with snow and ice, the delivery of irrigation water to the thousands of acres beyond it comes to a halt. Dipping the mixture of snow and ice out of the chute with a dragline bucket is expensive and damages the lining. The district has decided to cover approximately 3 miles of the chute at a cost of \$50,000 over a 3-year period.

Ralston Chute plugged with snow and ice. Photo SP394

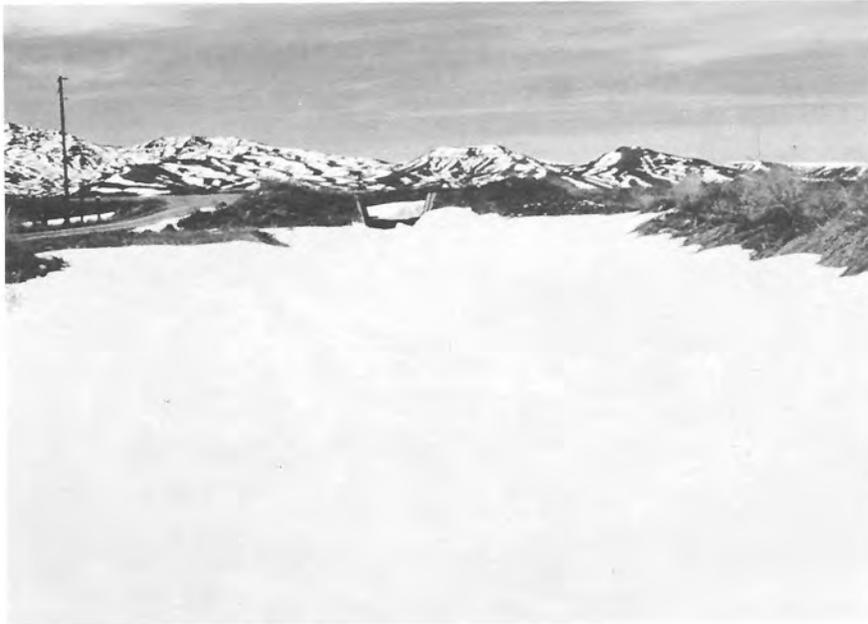
Ralston Chute plugged with snow and ice.
Photo PX-D-68694

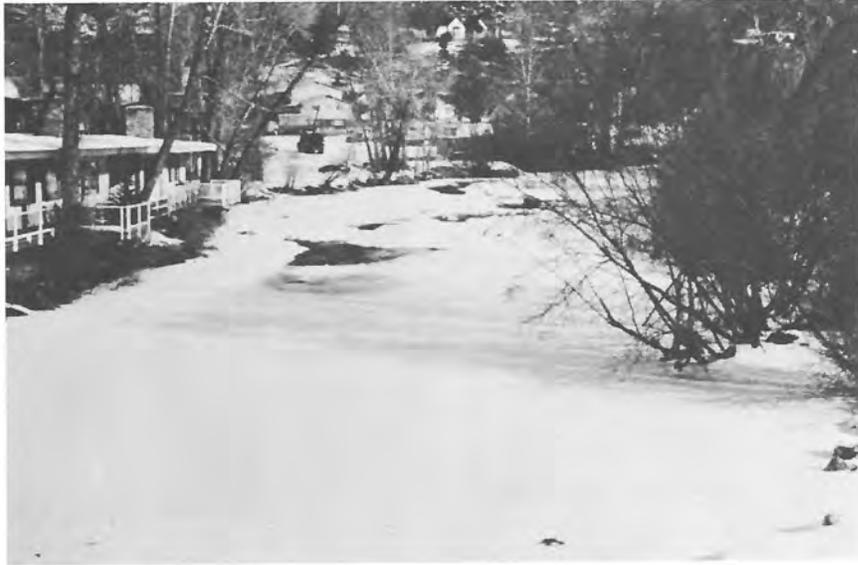
In January of 1970 ice jamming developed along the Fryingpan River from Ruedi Dam to its confluence with the Roaring Fork River at Basalt, Colorado. When the ice jams developed, causing the backwaters to build up, the releases from Ruedi Dam were reduced from 95 cfs to a native flow of about 45 cfs. Although there was no physical damage from the ice jams and resulting backwaters, it is worth noting that flows larger than the native flows of rivers can result in an ice-jamming situation more severe than normally experienced.

Ice buildup on Fryingpan River in Basalt, Colorado.
January 13, 1970. Photo C382-706-401NA

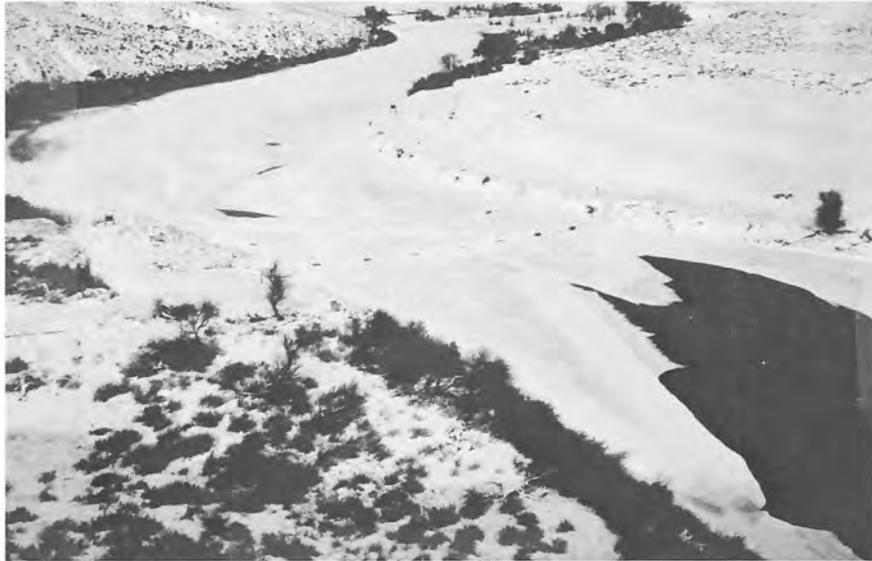
Log boom - North Platte River - North Platte Project - Wyoming. Panoramic view of log boom. January 4, 1971. Photo C20-703-1207

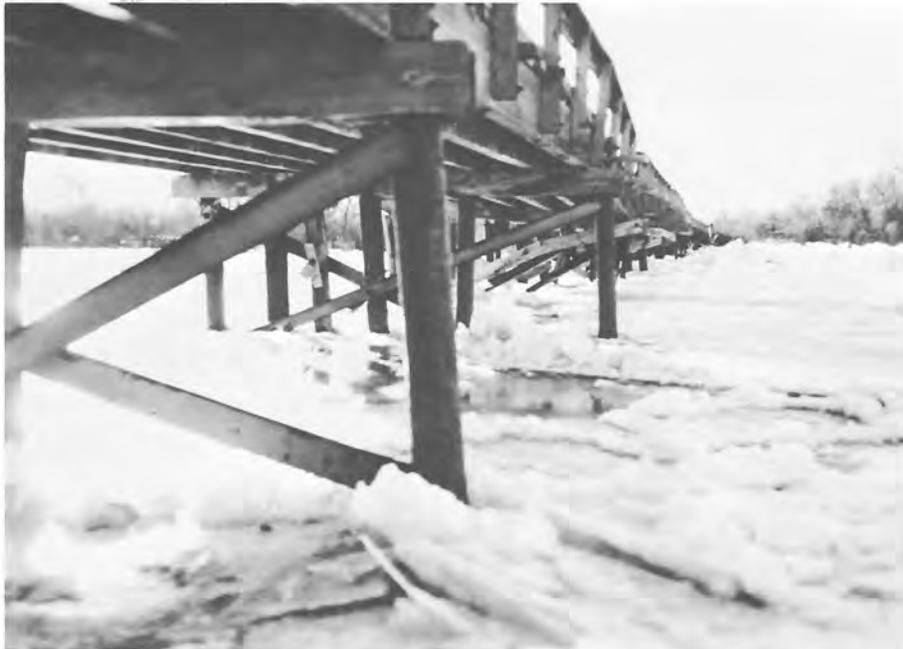
View showing stringers of Ervine Bridge on North Platte River, some broken by the ice. Upstream side of bridge. January 4, 1967. Photo P20-703-5715NA
