ASCE National Water Resources
Engineering Meeting
January 24-28, 1972 • Atlanta, Georgia \$0.50

AERATION MITIGATES CAVITATION IN SPILLWAY TUNNEL

Donald Colgate, M. ASCE and
James Legas, M. ASCE

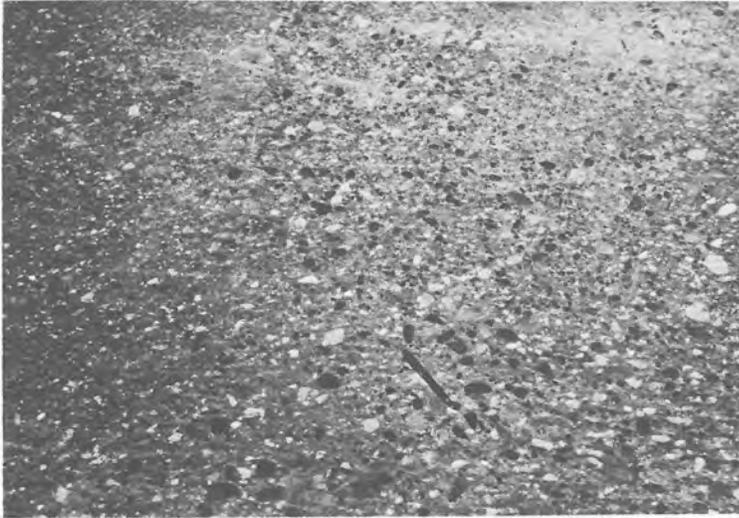
The eroded tunnel invert was generally smooth, Figure 2; however, some exposed aggregate had popped out, and spalling had occurred at a few construction joints.

Figure 2. - Condition of eroded invert in the near horizontal reach of spillway tunnel. Photo No. P459-640-3687 NA

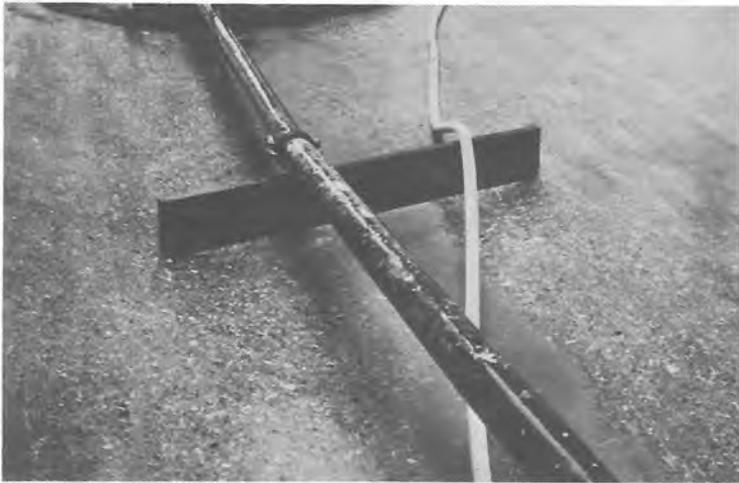
Figure 3. - Eroded invert surfaces of stilling basin. Photo No. P459-D-55582 NA

The condition of the stilling basin invert was excellent considering the amount of silt-laden materials passed during diversion. The surface was sufficiently eroded to expose aggregate, see Figure 3, but the texture of the eroded surfaces was generally smoother than similarly affected areas in the spillway tunnel. Depth of erosion was greatest at the basin centerline and decreased uniformly to the original surface in a distance of 6 to 8 feet from the centerline.

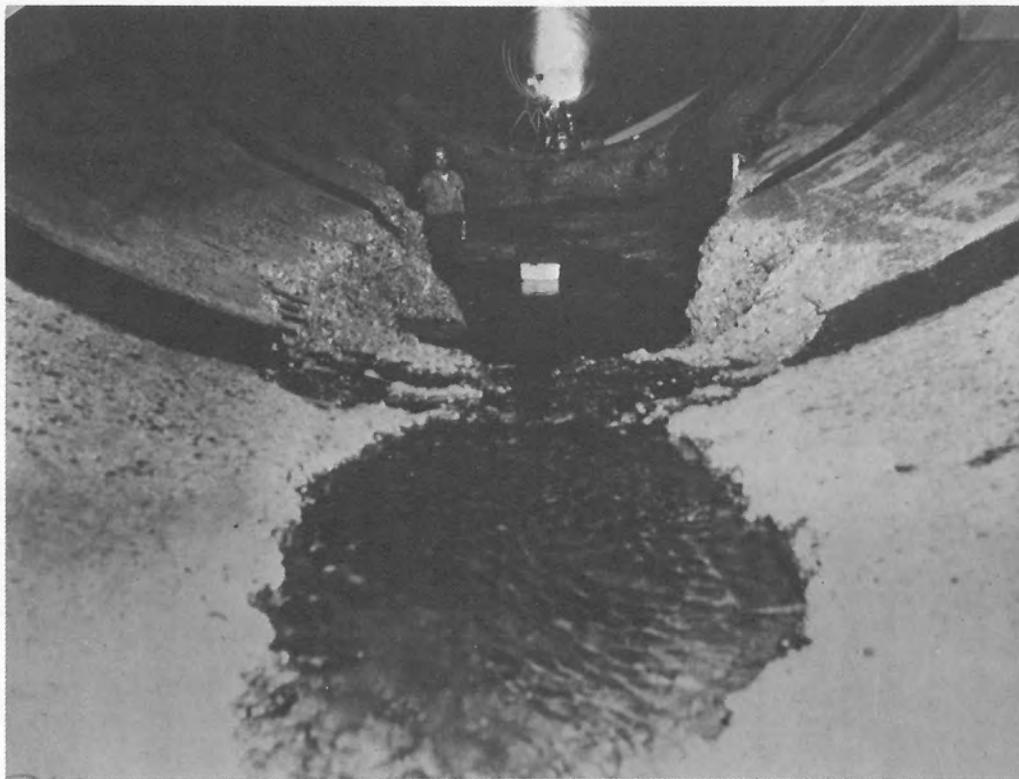
The most severe damage in the tunnel resulted from the failure of an epoxy mortar patch approximately 1/4-inch deep, 6 inches wide, and 10 inches long. Cavitation damage started immediately downstream from the patch failure (Station 10+40+) in the form of a small damaged area about 3 feet long, followed by a large teardrop-shaped area about 20 feet long. Damage in the latter area was sufficiently deep to expose reinforcement. Immediately downstream from Station 10+80+ and extending 46 feet down the tunnel, the cavitation-induced damage progressed through the lining and into the limestone foundation. Depth of damage was 7 feet maximum below the invert grade and about 19.5 feet wide in the transverse direction. Downstream from the large hole, the damaged area became progressively less severe and terminated at Station 11+65. The remainder of the tunnel downstream from Station 11+65 and including the stilling basin-flip bucket structure was essentially in good condition and similar in appearance to the surfaces observed after diversion. Surface irregularities that had been left unrepaired to determine

their action under high-velocity flow did not change in appearance nor did they initiate cavitation damage. Figure 4 shows the most severely damaged area in the near horizontal tunnel reach.

Figure 4. - Damaged area in tunnel approximately 50 feet downstream from the vertical bend. Photo No. P459-640-4042 NA

Restoration of damaged surfaces and areas included repairs with bonded concrete, epoxy-bonded concrete, and epoxy-bonded epoxy mortar. Preparation of the surface for bonded concrete repairs was made by sawcutting around the perimeter of the damaged area to a depth of 1-1/2 inches. Damaged or undercut concrete and all loose rock were removed. Damaged reinforcement was removed and replaced either by welding or lapping new reinforcement in place. All concrete or rock surfaces to receive the concrete were sandblasted, washed clean, and surface dried before placement of the repair concrete. Where the depth of damage was greater than 6 inches, concrete was applied directly to the clean dry surface. Where the depth of damage was between 2 and 6 inches, an epoxy bonding agent was applied to the clean dry surface, and while in a tacky state, overlain with repair concrete.

For damaged areas less than 2 inches deep, the surface was prepared by sandblasting, washing, and drying to receive an epoxy bonding agent, and a veneer of epoxy mortar was then applied to the area. This type of repair with epoxy-bonded epoxy mortar veneer was applied over practically the entire invert surface of the vertical bend.

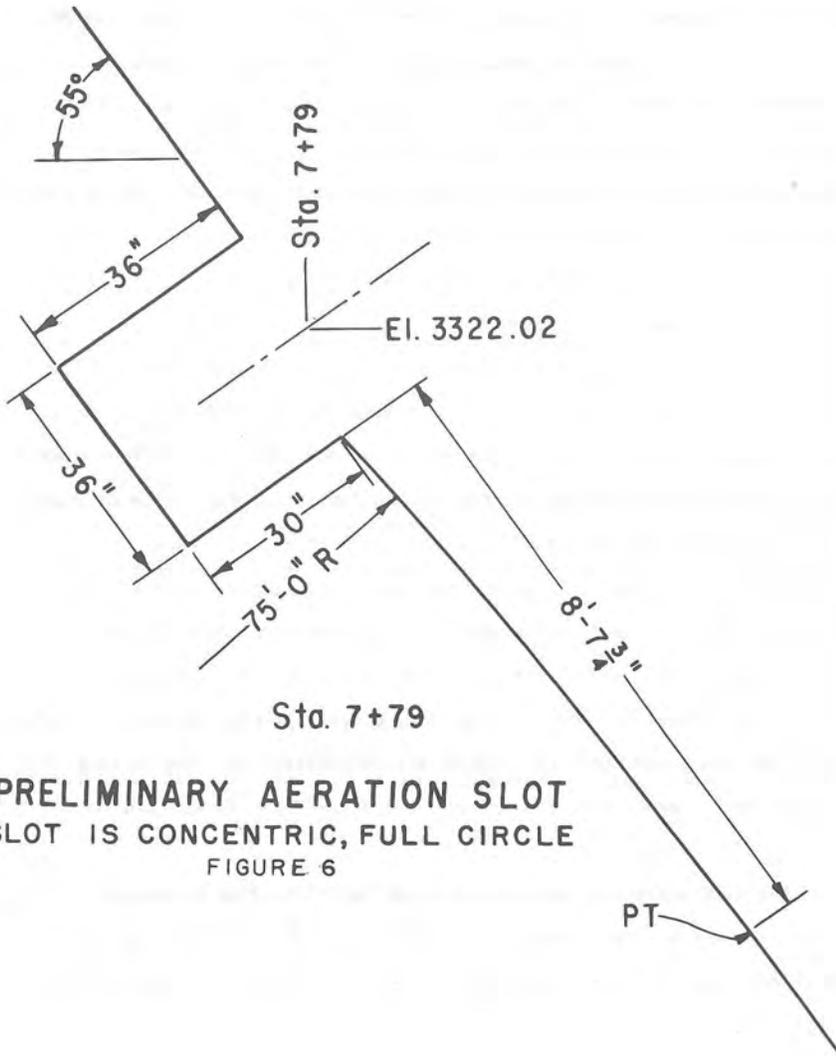
PRELIMINARY AERATION SLOT
 SLOT IS CONCENTRIC, FULL CIRCLE
 FIGURE 6

A preliminary aeration slot, uniform in cross section for the entire circumference of the tunnel, was installed 28 feet upstream from the P.C.

of the bend (Figure 6). Although air was entrained in the flowing water for low flows, the edges of the jet near the water surface impinged on the downstream edge of the slot and water entered the slot. As the discharge increased, greater amounts of water entered the slot. As more water entered the slot, the amount of air entrained in the flowing water decreased and stopped entirely when the discharge was about 50,000 cfs.

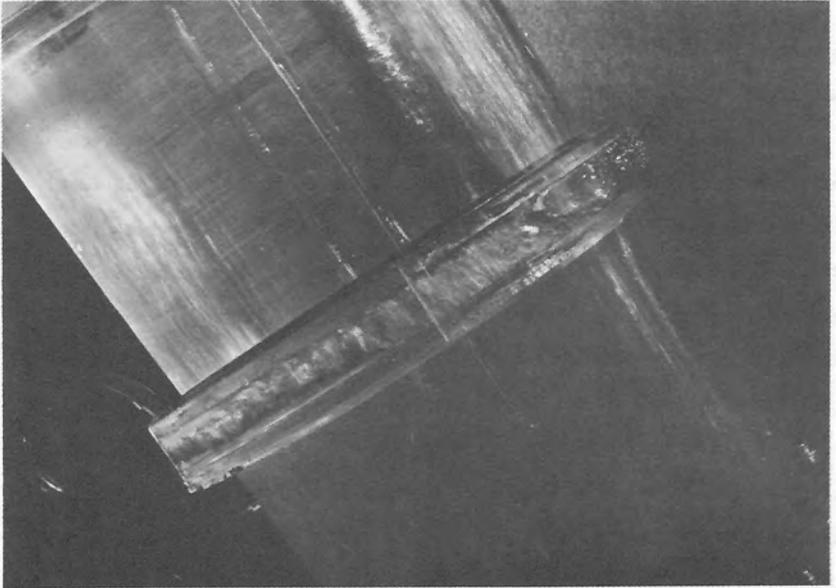
Figure 7 shows the preliminary slot with 92,000 cfs flowing in the tunnel. Note the absence of entrained air downstream from the slot. In an attempt to prevent water from entering and filling the slot, the slot was narrowed to 6 inches, with a 6-inch away-from-the-flow offset downstream. Although some air was entrained in the jet at low discharges, water entered the slot near the water surface for all spillway discharges. For discharges less than 20,000 cfs, water drained down the slot and flowed out into the jet at the tunnel invert, reducing the amount of entrained air as the spillway discharge increased. At a spillway discharge of 20,000 cfs, the water surface in the slot was at the same elevation as the spillway water surface, and no air entered the jet. For spillway discharges greater than 20,000 cfs, the water was forced into the slot at a sufficiently high head to cause it to boil up the slot above the spillway water surface and spill out onto the surface of the jet.

Figure 7. - Preliminary aeration slot, Station 7+79. Discharge is 92,000 cfs. The slot has filled with water thus preventing air from entering the jet. Photo No. P459-D-68807

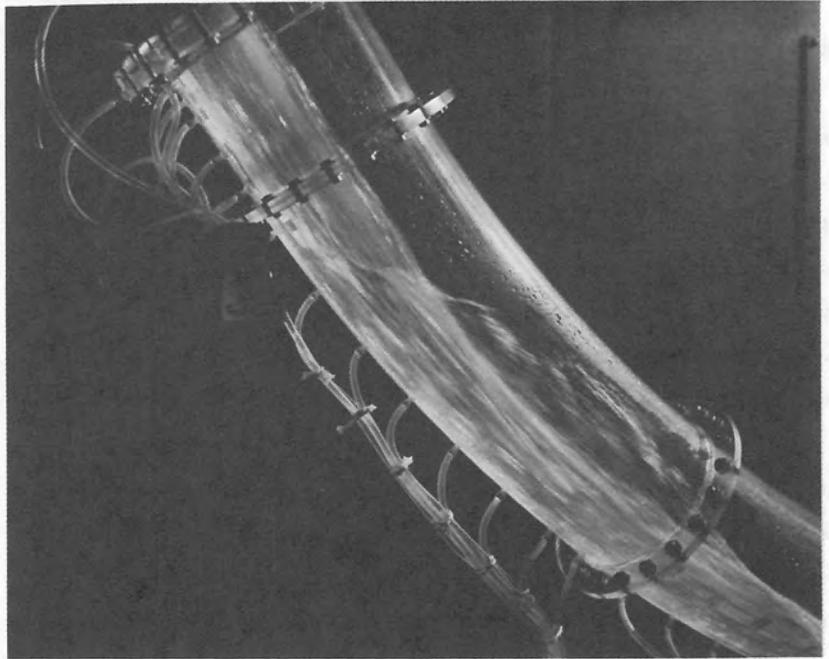
The impingement of the jet on the tunnel invert downstream from the aeration slot caused side fins to form. For discharges less than 30,000 cfs, these side fins swept uninterrupted up the walls of the tunnel past the contracted jet. These side fins were not objectionable and did not reach the top of the tunnel (Figure 9). Since the lift diminished as it neared the tunnel spring line, the upper portion of the jet was subjected to less contraction than the lower portion. Consequently, the upper elements of the jet impinged on the walls of the tunnel further upstream and at a much smaller angle as the discharge and flow depth increased. For discharges greater than 30,000 cfs, the upper portion of the jet interfered with and reduced the side fins, and for discharges greater than 50,000 cfs, the side fins were entirely contained by the upper portion of the jet.

Figure 9. - Recommended aeration slot, Station 7+79. Discharge is 30,000 cfs. These maximum side fins, one each side of the jet, do not reach the crown of the tunnel. Photo No. P459-D-68809

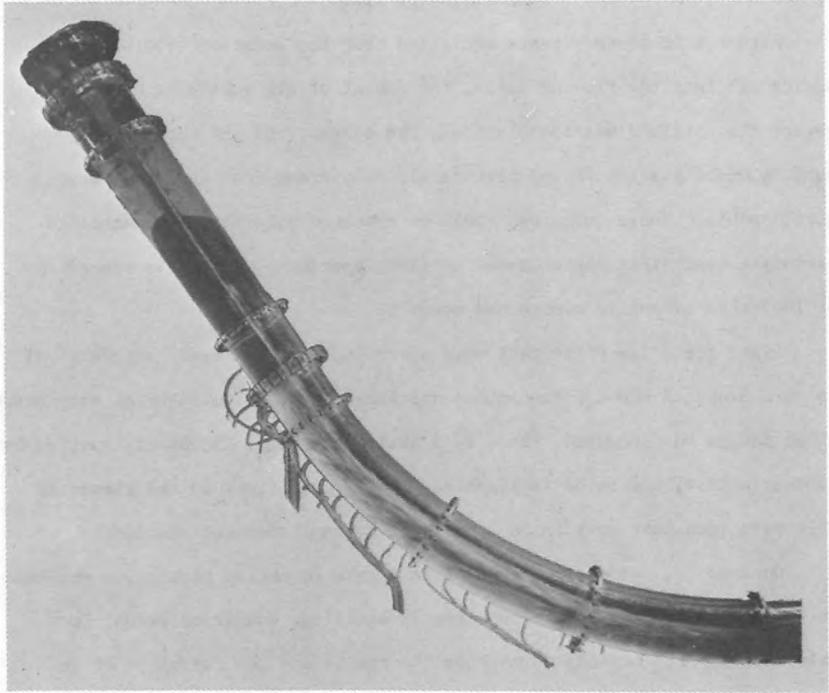
Air was visible in the model jet starting at the air slot and continuing well downstream from the P.T. of the bend (Figure 10). However, it was not known whether the amount of air remaining adjacent to the tunnel flow surfaces in the downstream portion of the bend would be sufficient to prevent cavitation damage. The relationship between model and prototype with respect to entrained air is at best poorly understood. Therefore, the model tests were continued to study the proposed aeration slot in the downstream portion of the bend.

Figure 10. - Overall view of the spillway model. Recommended aeration slot at Station 7+79. The slot at Station 6+64, upper left, has been closed. Air entrained at the aeration slot continues throughout the bend. Mixing tends to reduce the air near the flow surfaces in the downstream portion of the bend. Photo No. P459-D-68808
