EMERGENCY REDESIGN OF SILVER JACK SPILLWAY

G. W. Center

T. J. Rhone

Prepared for presentation at the American Society of Civil Engineers
Water Resources Engineering Conference in Washington, D.C.,

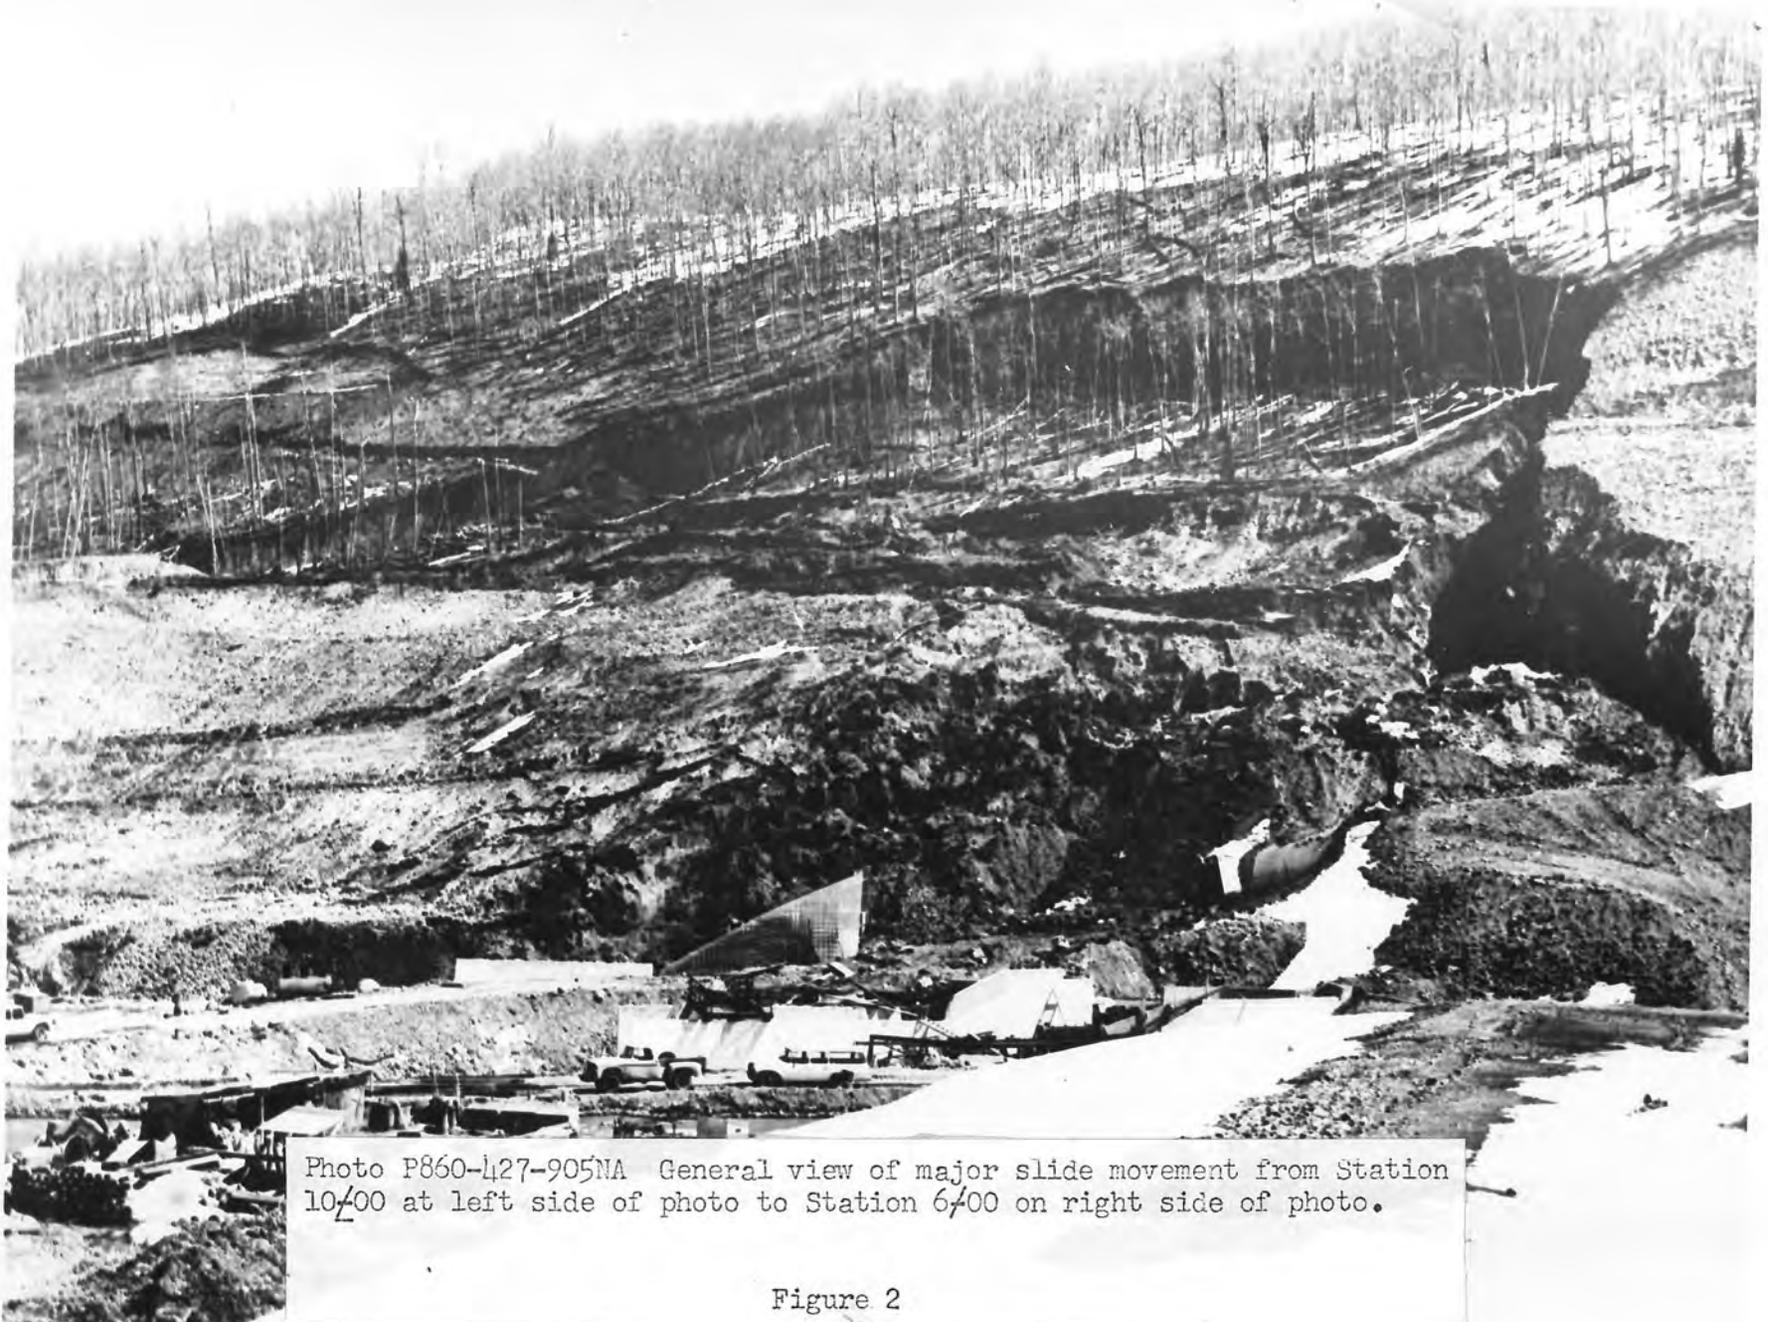
Figure 2

The contractor resumed operations in April 1969. During the night of April 22, 1969, a major earth movement occurred involving about 700,000 tons (635,000 metric tons) of glacial material from about 9.5 acres (3.8 hectares). The toe of the slide extended into the area occupied by the spillway stilling basin and outlet channel. The stilling basin walls were broken and several sections of conduit were badly cracked, Figures 2, 3, and 4.

Photo P860-427-905NA General view of major slide movement from Station 10/00 at left side of photo to Station 6/00 on right side of photo.

After examination of the damage, it was decided to remove the cracked sections of the spillway conduit and to construct an elbow, a new chute, a new stilling basin, a retaining wall, and a new outlet channel to the left of the damaged portions of the spillway.

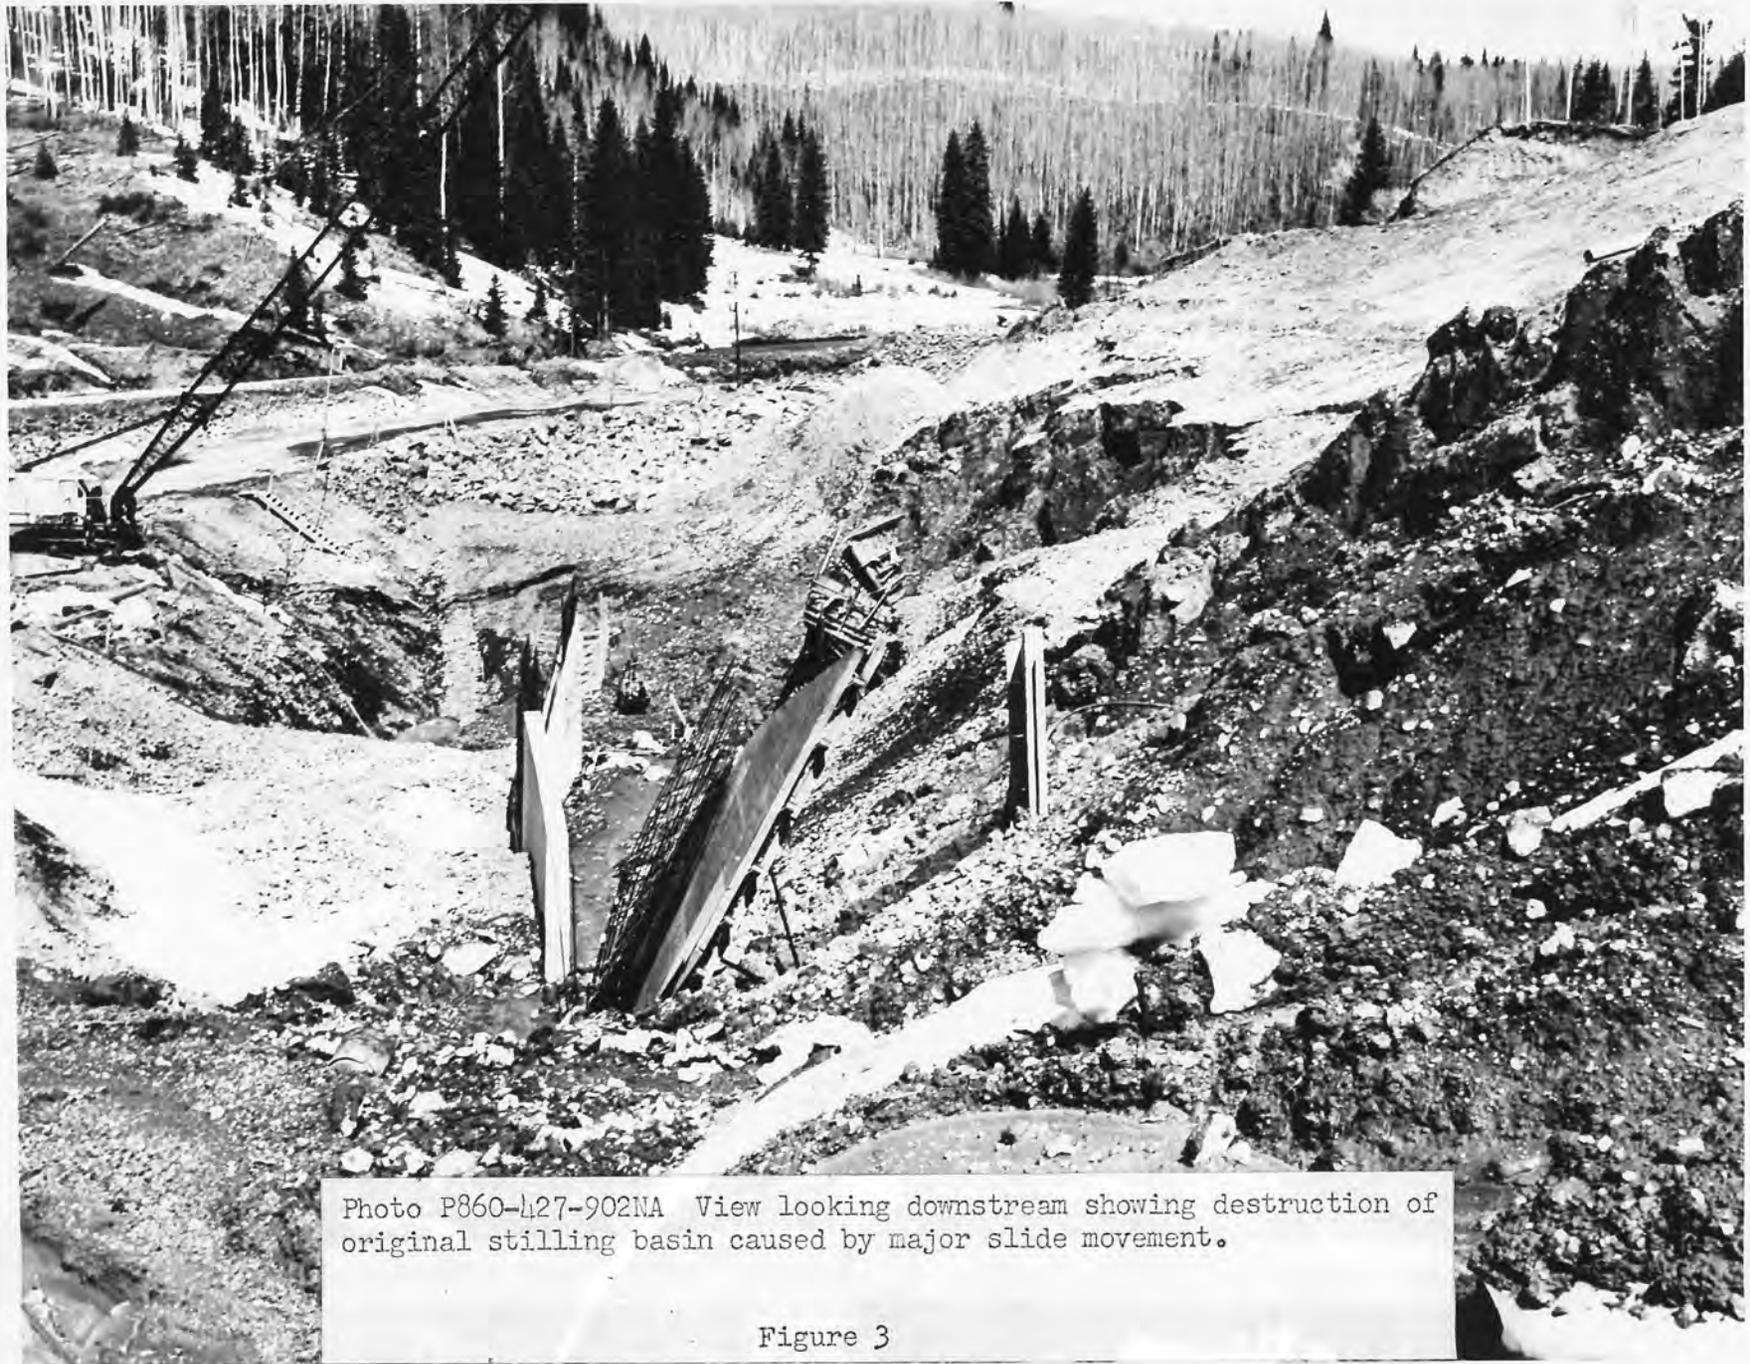
Figure 3

Photo P860-427-902NA View looking downstream showing destruction of original stilling basin caused by major slide movement.

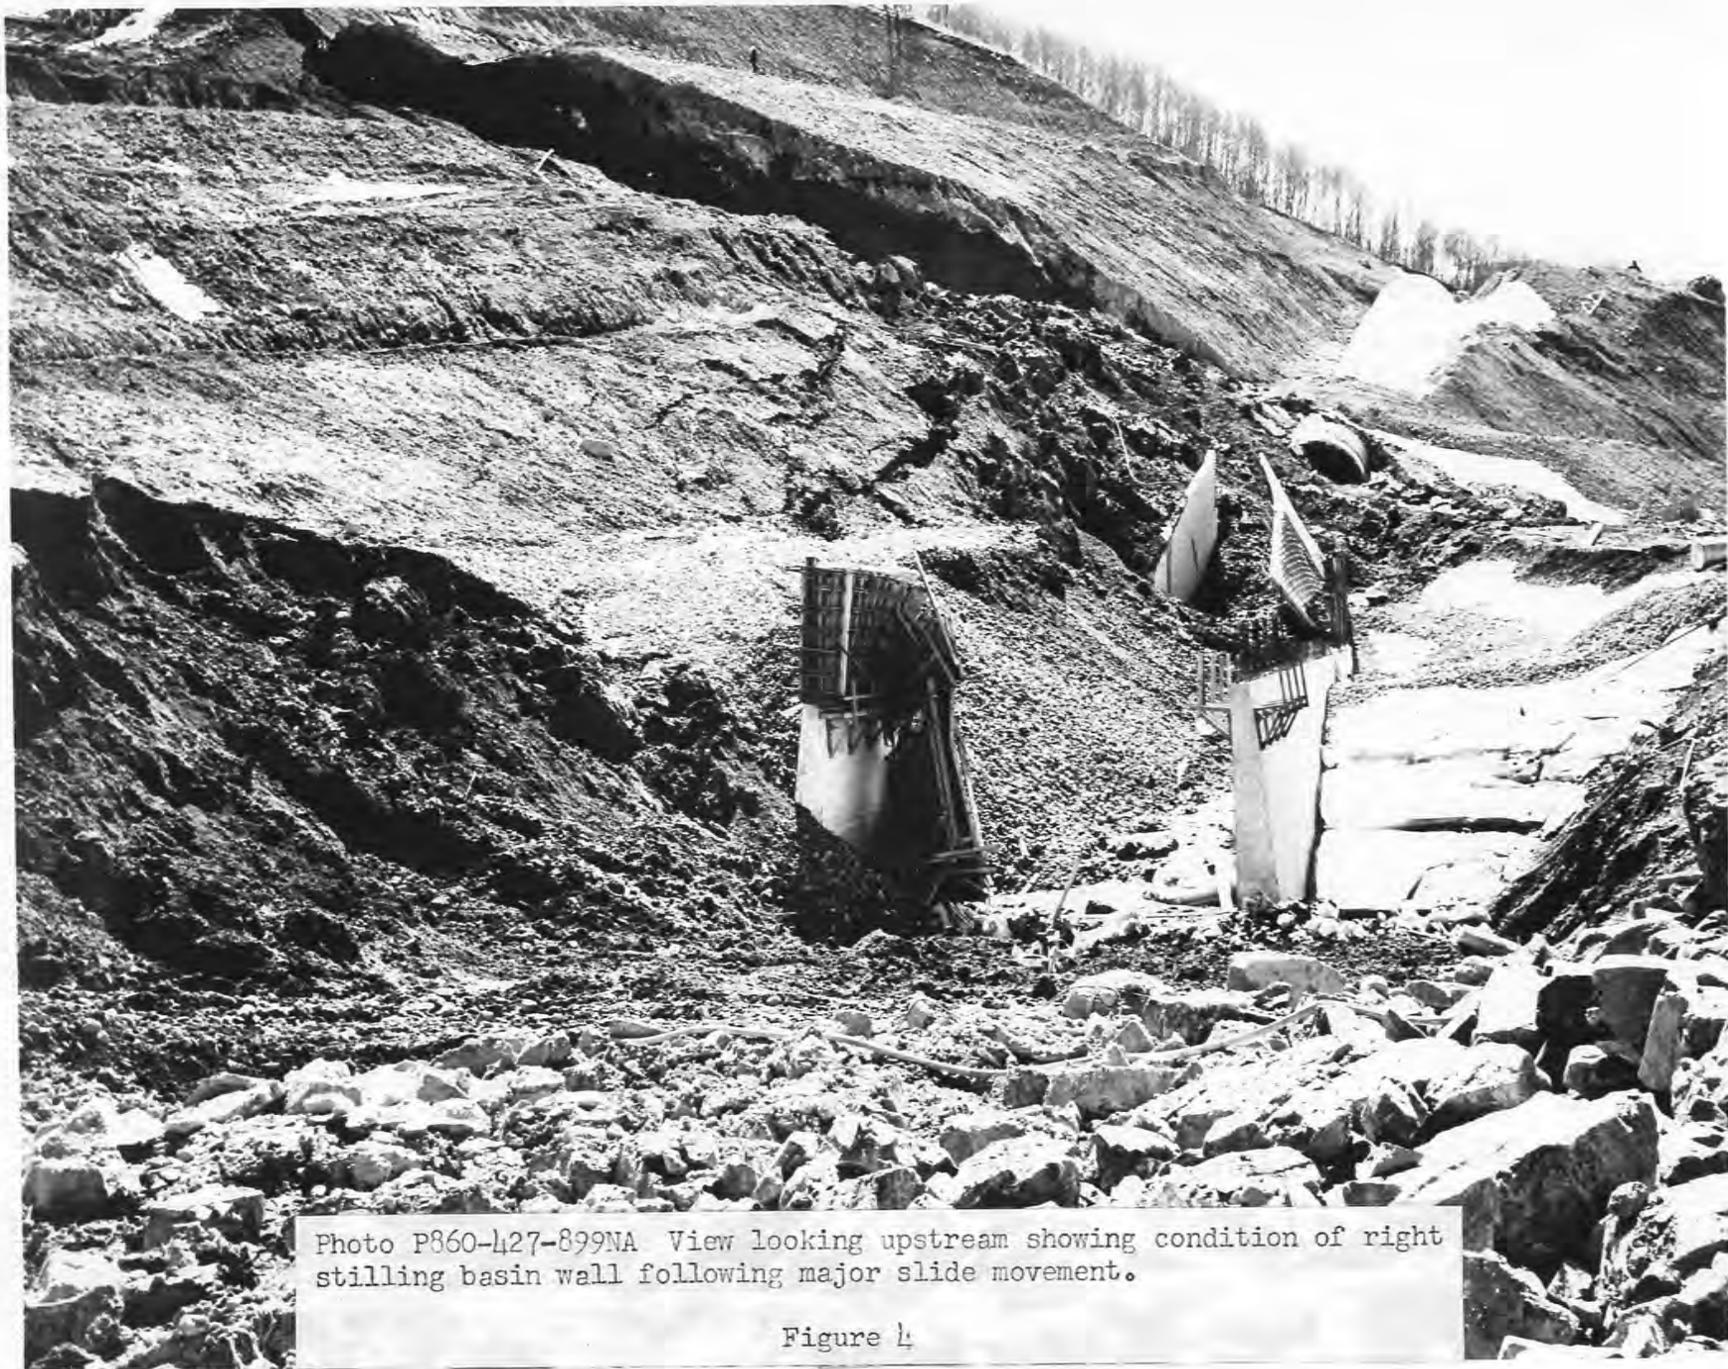
Figure 4

Photo P860-427-899NA View looking upstream showing condition of right stilling basin wall following major slide movement.

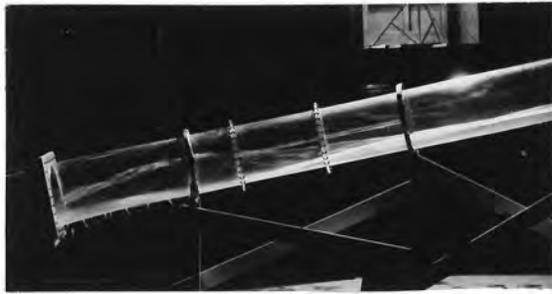
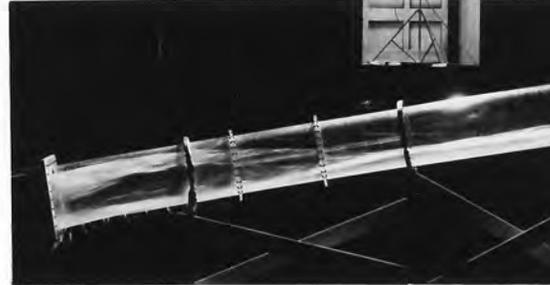
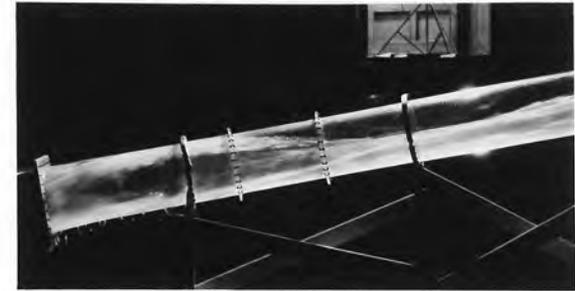
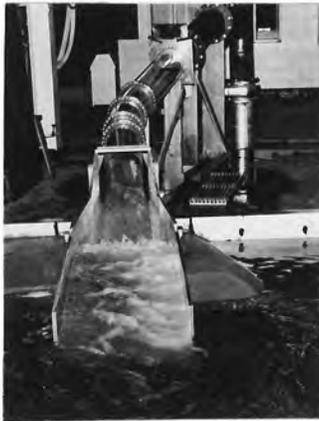
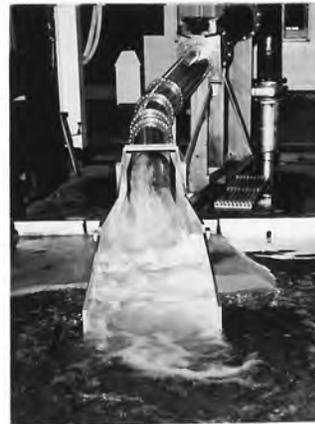
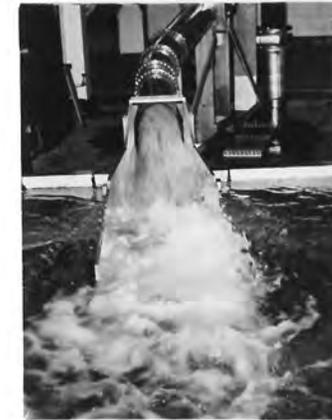
Figure 5

SILVER JACK DAM
Hydraulic Model Studies
1:17.25 Scale Model
Flow in Conduit, Chute
and Stilling Basin—Preliminary Design

from the P.T. of the bend downstream to the end of the transition. The wall prevented the flow from crossing over the crown of the conduit. However, it deflected the flow vertically downward into the part of the flow moving along the conduit invert, and the merging of the two high velocity flows resulted in an excessive amount of splashing and spray downstream from the conduit portal.

To prevent the direct impingement of the deflected flows, the wall was moved to the right of the crown. Three trials were made with the wall off center 15° , $28\text{-}1/2^\circ$, and 45° from vertical. All of the off-center locations reduced the splash and spray, but the $28\text{-}1/2^\circ$ location, Figure 6, caused the least disturbance and also improved the flow distribution at the tunnel portal.

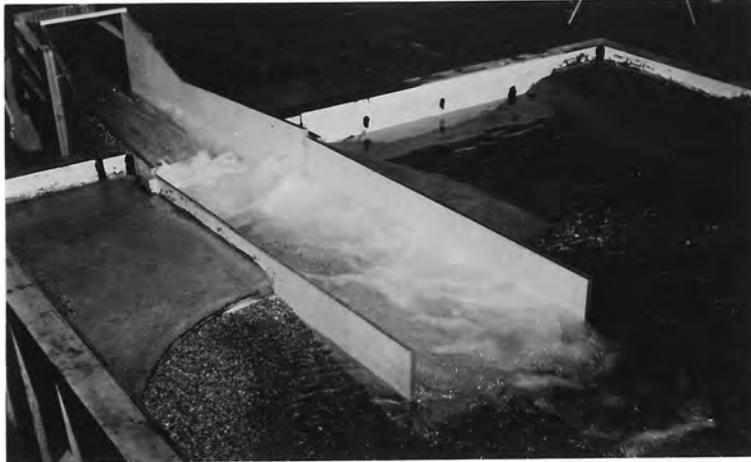
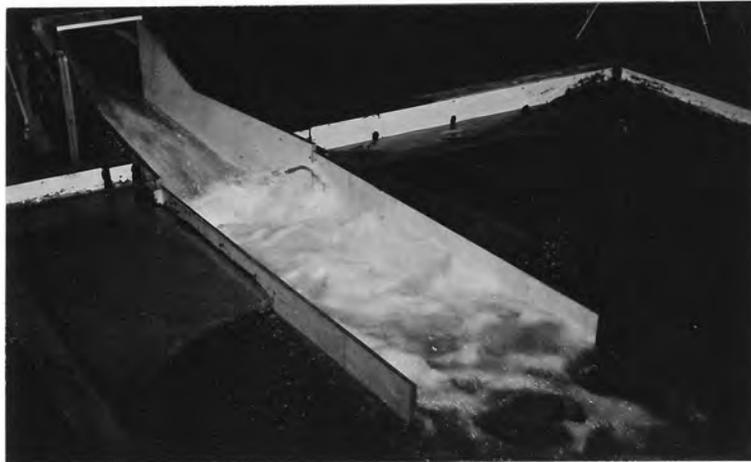
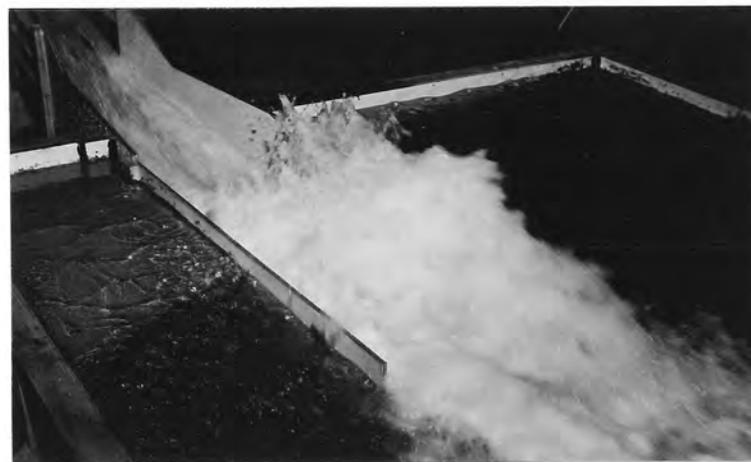
Figure 7

Flow entering the diverging chute leading to the stilling basin was very unsymmetrical, and the unequal distribution carried into the stilling basin. In the preliminary design, the flow was concentrated on the left side of the basin with the 1,650 cfs (46.75 cu m/sec) and 6,280 cfs (177.8 cu m/sec) discharges, but with the 3,140 cfs (89.0 cu m/sec) discharge, the flow was more concentrated on the right side, Figure 7. Longitudinal guide vanes dividing the chute in thirds were developed to provide symmetrical distribution of the flow entering the stilling basin. Both vanes are 2 feet (0.61 m) wide and extend between Station 7+99.50 (2+43.8 m) and Station 8+50.00 (2+59.2 m). The height of each vane and the configuration at the upstream end were developed by cut and fit until the optimum distribution of the flow entering the stilling basin and the minimum amount of disturbance near the upstream end of the vane were obtained for all three test discharges. The configurations of the vanes are shown on Figure 8, and the flow appearance in the basin is shown on Figure 9.

SILVER JACK DAM
Hydraulic Model Studies
1:17.25 Scale Model
Stilling Basin Performance
Preliminary Design

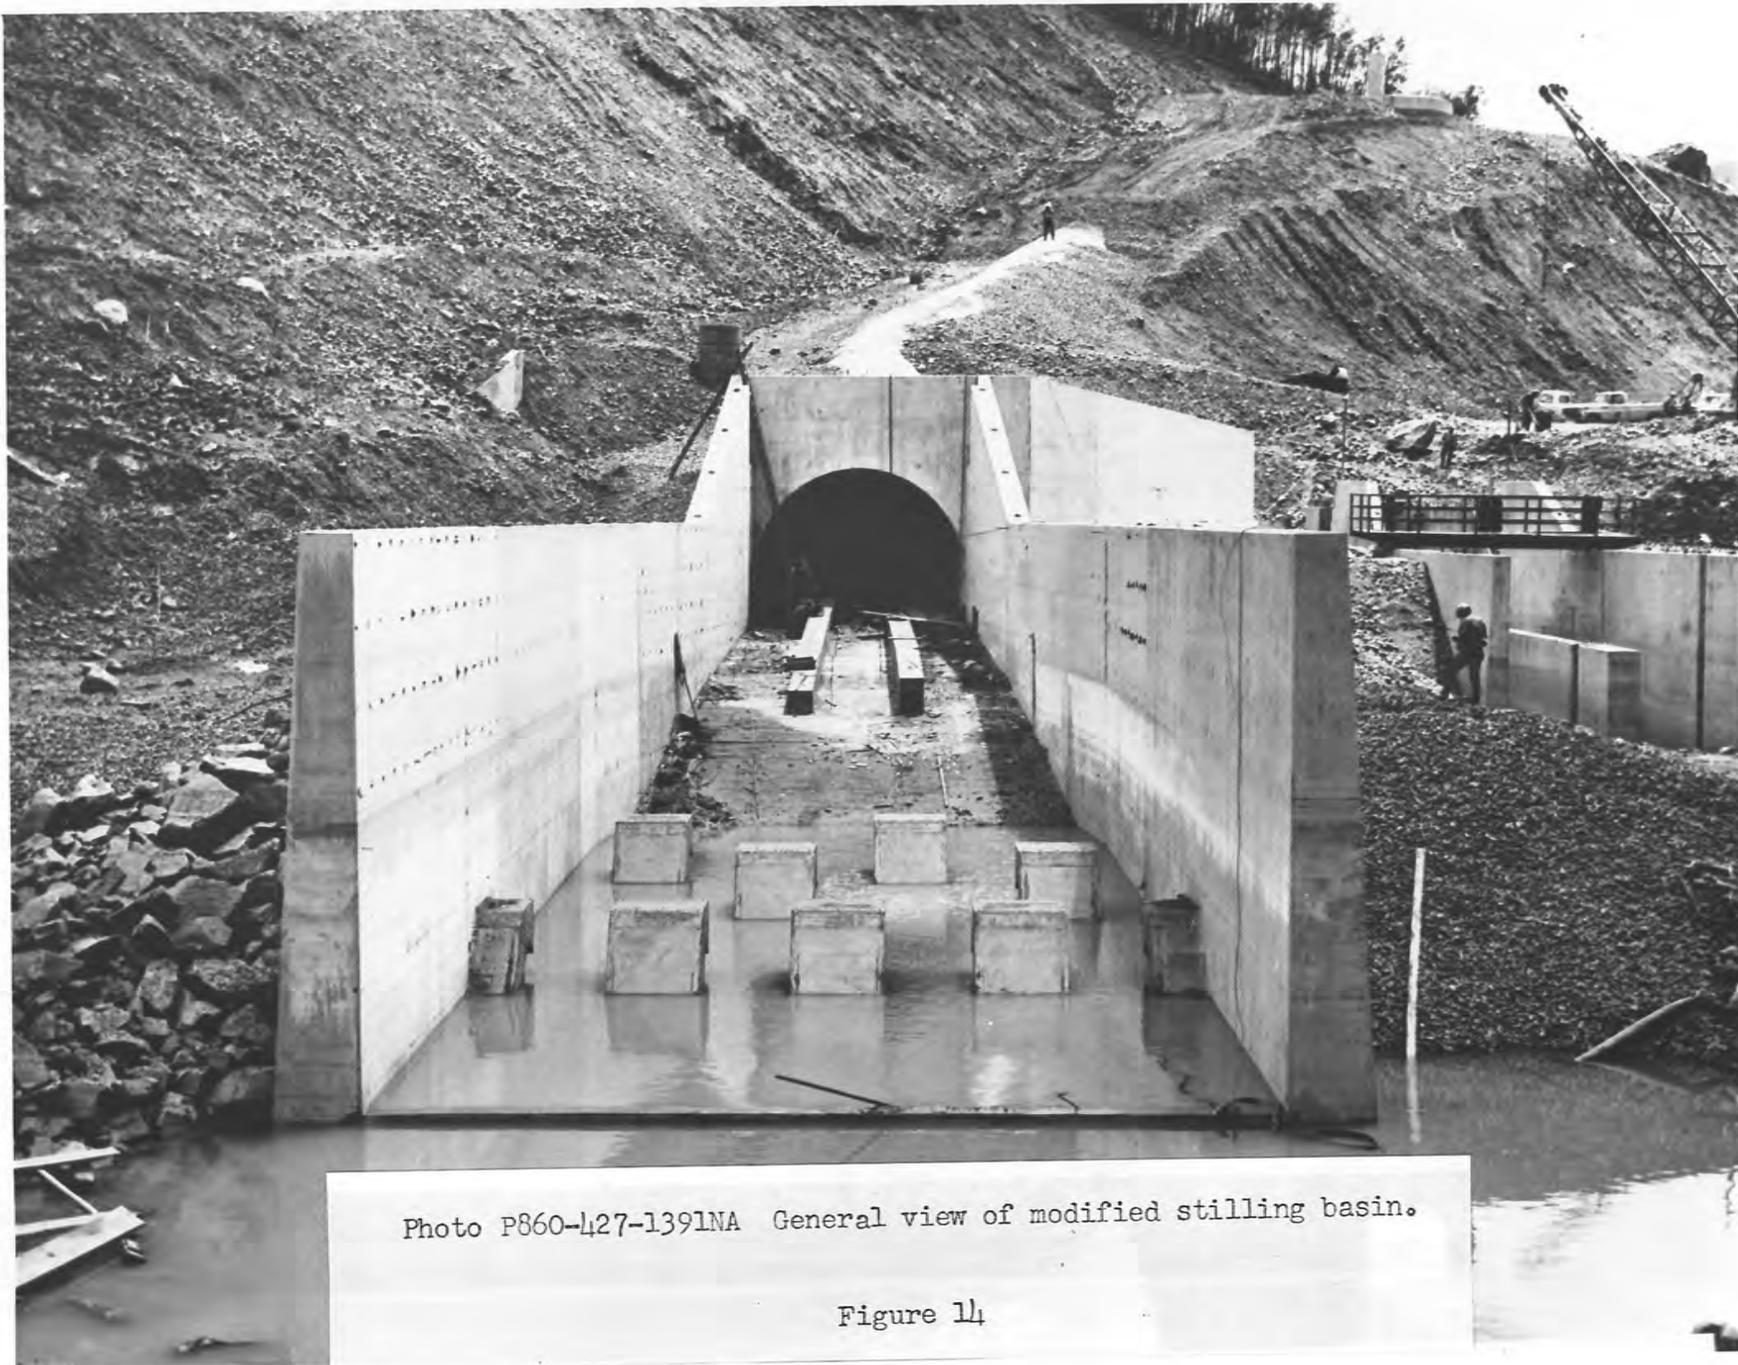
Figure 14

Photo P860-427-1391NA General view of modified stilling basin.

The basin was redesigned and constructed as indicated by the model studies, Figure 14. Also, an extra 3 inches (76 mm) of cover for reinforcing were provided on inside surfaces of the walls and floor to allow for some abrasion.

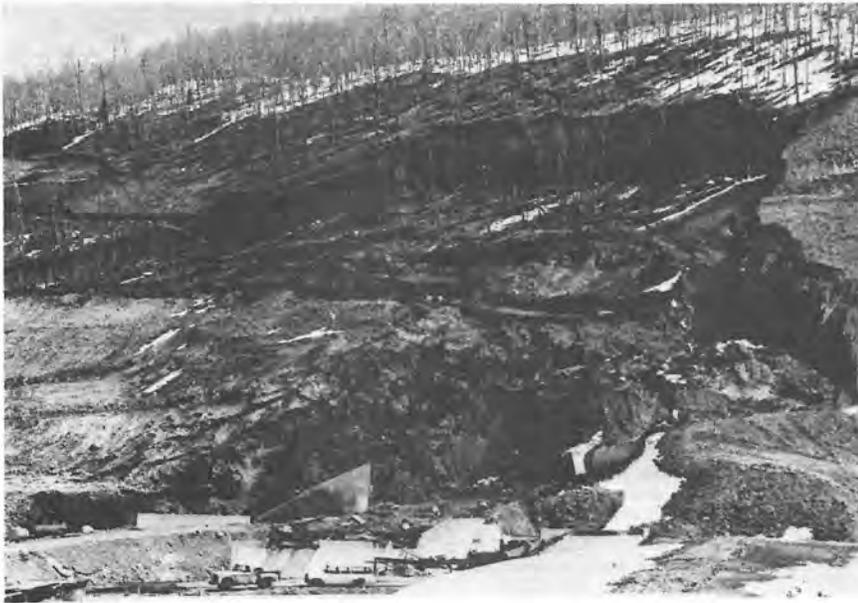
Melting snow saturated the slopes of the exposed cut in this area where the spillway cut crossed an old landslide. This 400-ft (120-m) wide slide destroyed the newly constructed stilling basin at Silver Jack Dam, Colo.

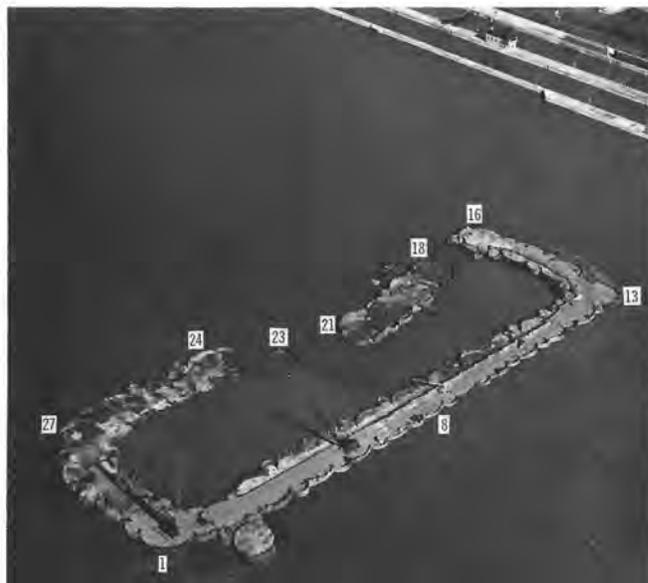
This aerial view shows the cofferdam failure at the Uniontown Locks and Dam as seen from the upstream Kentucky corner toward the downstream Indiana corner. Some of the numbered sheet pile cells are referred to in the article.

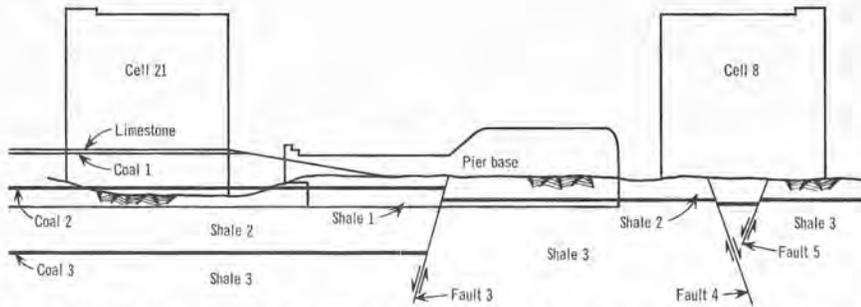
Fig. 1. A geologic section through pier 8 show the faulting and bedrock stratification that runs the length of the cofferdam.

Movement occurred along coal and underclay 2. The overlying shale and limestone moved intact as a block until it encountered fault 3, which dips upstream with a displacement of 10 to 35 ft (3.0 to 10.6 m) and the more resistant shale 2 that served as a baffle block thus forcing the failure to follow fault 3 and daylight. The depth of failure corresponds with the elevation of coal 2 and sheared a maximum thickness of 16 ft (4.9 m) of rock.
