PAP-304

BUTTERFLY VALVE TESTS

HYDRAULIC LABORATORY
DIVISION OF GENERAL RESEARCH
ENGINEERING AND RESEARCH CENTER
DENVER, COLORADO

February 1974

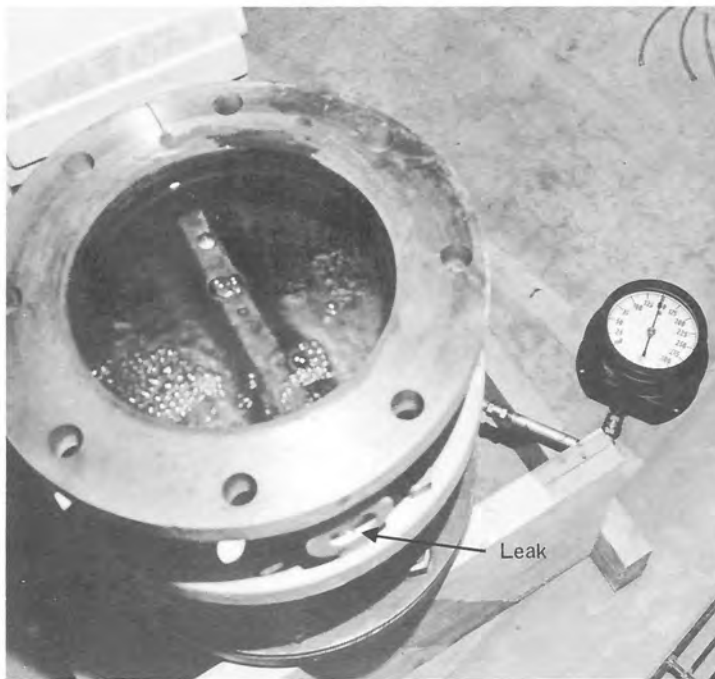
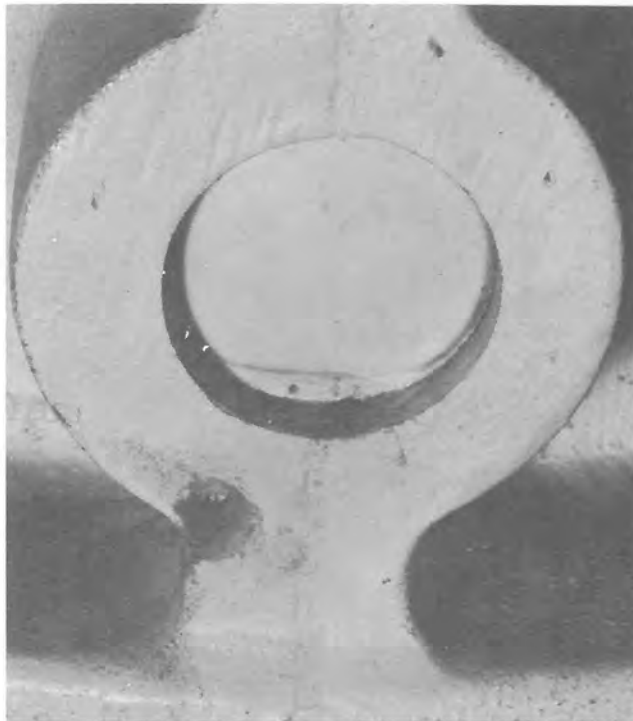
The valve was then tested for bubble tightness and leakage photographed (Figure 6-P). The major portion of the leakage occurred between the seal and leaf, about 80° clockwise from the shaft. The remainder occurred at the shaft-seal point. The leakage began at 95 psig (6.68 Kg/cm²) and increased up to the 150 psig test limit. Also, a slight leak was found in the seal from the shaft to the outside of the valve (arrow on Figure 6-PA). The cover was removed from the slider box to see if any water had leaked into the mechanism, but none was found.

A. Leakage at 150 psig. Also note arrow showing leakage around shaft seal. Photo P801-D-74499

B. Location of shaft seal leakage. Photo P801-D-74500

Figure 6P. Bubble tightness test on Pratt valve. Air at 150 psig under water. Leakage began at 95 psig (6.68 kg/cm^2). Photo P801-D-47500

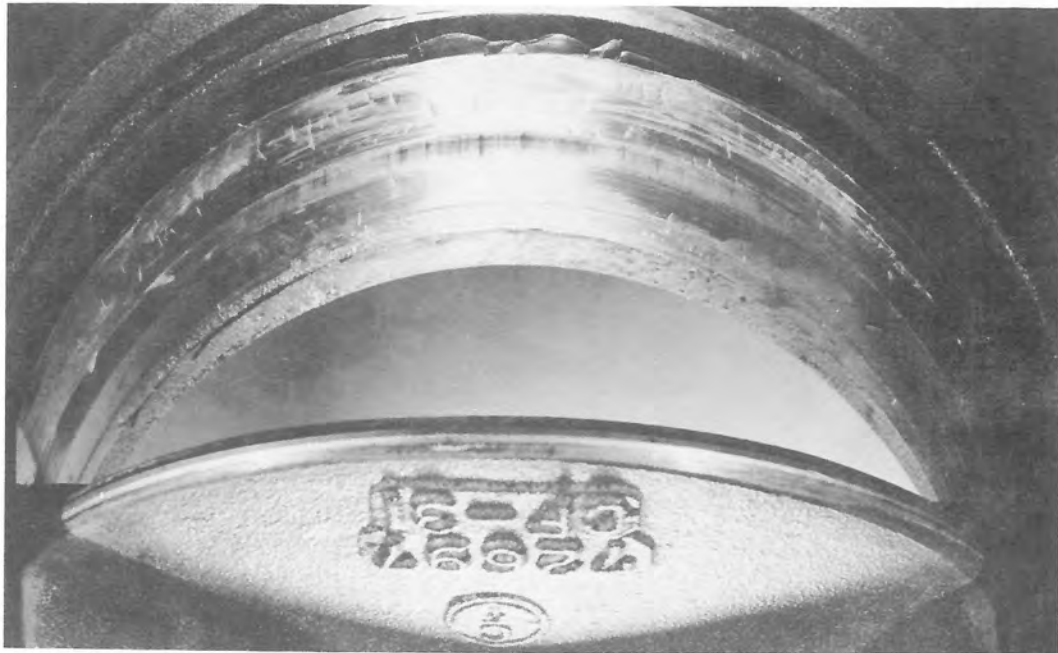
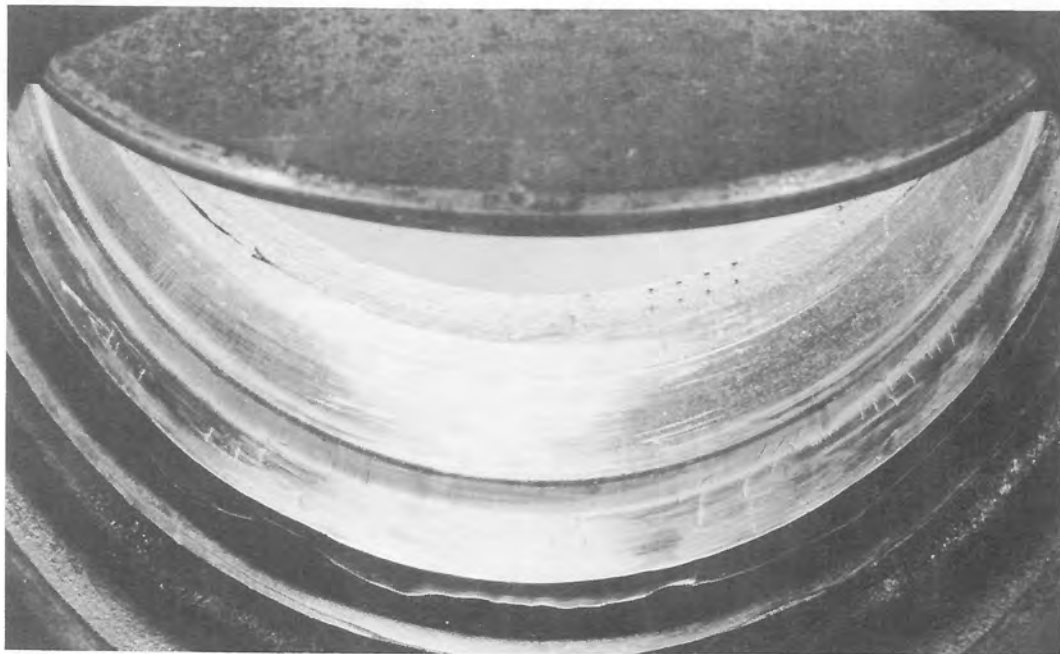
Figure 7P. Cracks in factory-bonded rubber seat of the Pratt valve.

The seal leakage was a result of cracking of the factory bonded rubber seal (Figure 7-P). A local Pratt Company representative requested we return the valve to the manufacturer, where a new seal could be installed and the valve returned for further testing. The valve was shipped to the factory on May 11, 1970. No further word was received from Pratt Company regarding the valve.

Upper portion of seat. Photo P801-D-74501

Lower portion of seat. Photo P801-D-74502

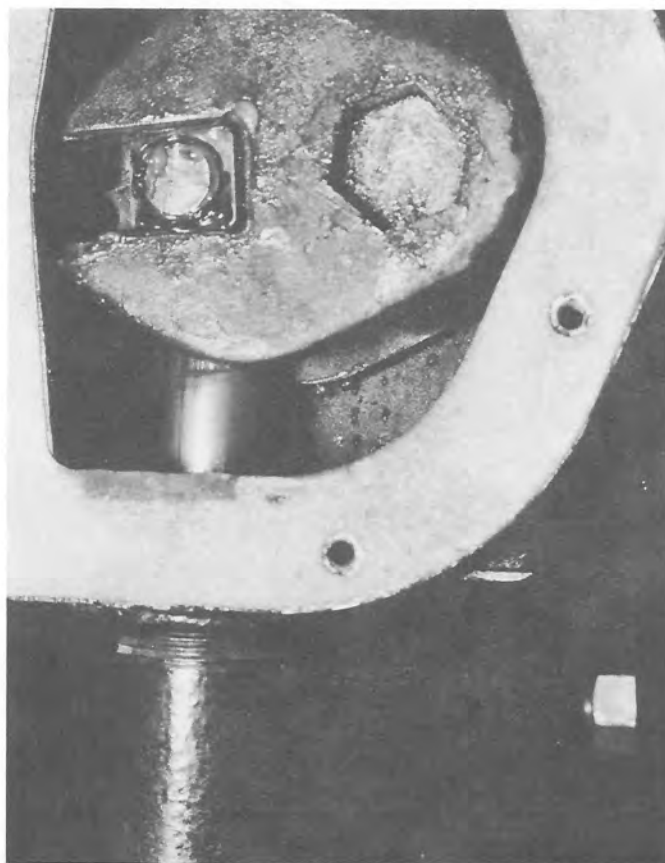
At 150 psig the valve performed quite well. Smooth leaf travel still existed for opening cycles and only minor effects from hydraulic forces occurred during the closing cycle. These effects produced only slight variations in leaf closure speeds, however, at no time was leaf control affected (Figure 8-D). Also, a slight leak was observed in the slider box (Figure 9-D). This leak occurred only when the valve was in an intermediate position on an opening or closing cycle. The factory inspection after the valve was returned for modification revealed a metal shaving had damaged the shaft seal. The shaving apparently had been in the valve since the initial assembly.

Figure 9D. Shaft seal leak developed from wear due to a metal shaving which was not removed during assembly. Leak occurred only when valve was in an intermediate position. Photo P801-D-74506

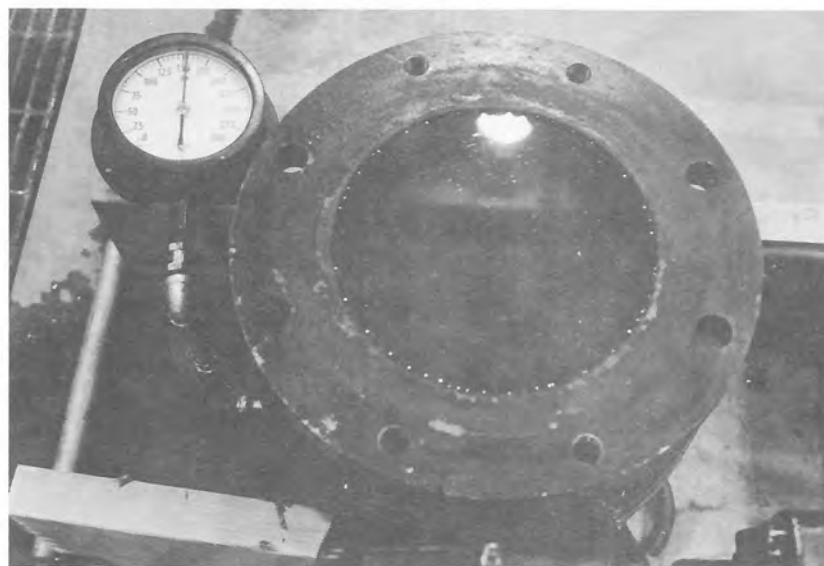
Figure 10D. Bubble tightness tests on Dresser valve after over 4,000 cycles of opening and closing. Air at 154 psig (10.83 kg/cm²) under leaf. Photo P801-D-74507

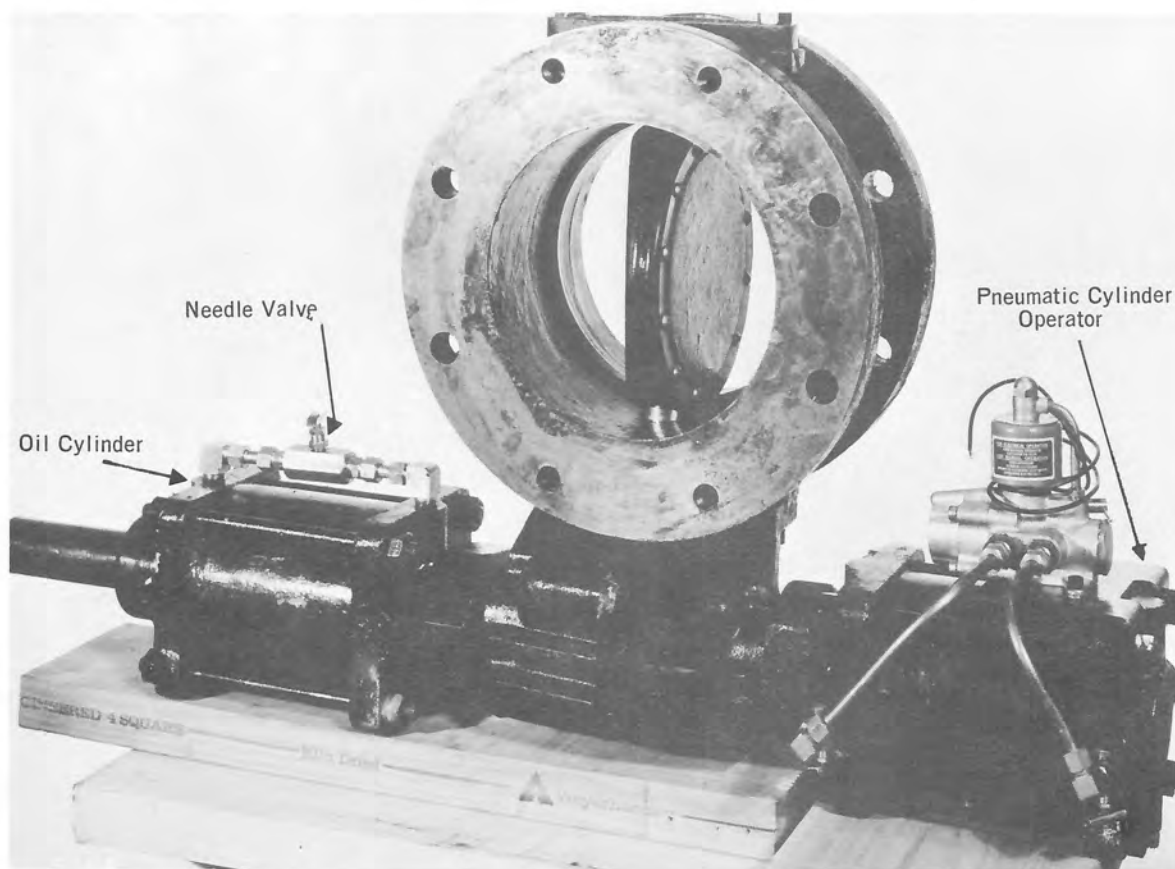
Figure 11D. Double cylindered Dresser valve. Oil cylinder added to eliminate unsteady leaf movement. Photo P801-D-74508

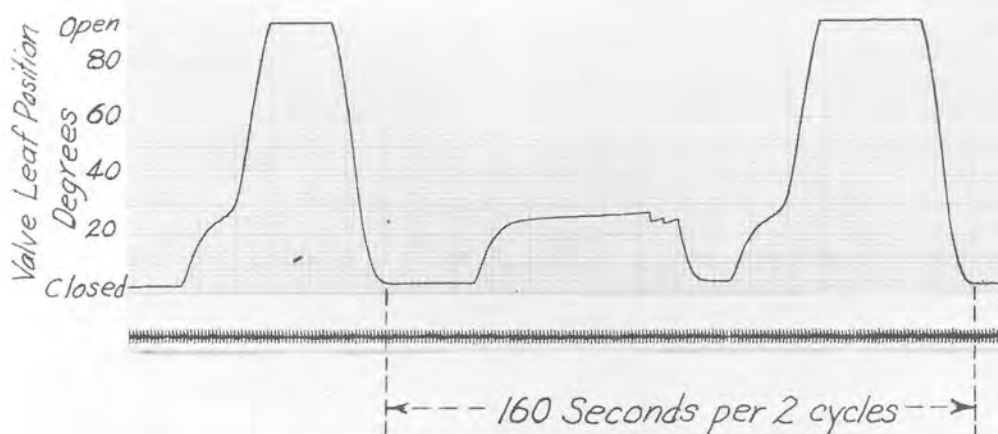
A. Leaf Flat Downstream

The valve was placed on the high head test facility with the flat of the leaf downstream. After shutoff tests where no leakage was noted at 150 psig, 500 cycles of opening and closing were performed on the valve at shutoff heads of 43.3 and 86.6 psig without difficulty. As before, dynamic forces on the leaf caused nonuniform leaf movement, but control was not seriously affected. When the shutoff head was raised to 150 psig problems occurred. After 330 cycles of opening and closing, the valve was observed to fail to open completely after every third to sixth cycle. The valve would open to between 20° and 30° and remain in that position until the timer recycled the valve (Figure 12-D).

Note leaf failing to completely open on second cycle. Also, note nonuniform travel during opening. Line pressure 150 psig.

The tests were terminated and Mr. W. C. Gilmore of Dresser Manufacturing, Bradford, Pennsylvania, was notified. Subsequently, Mr. Gilmore called and stated he had made torque calculations on the valve and found maximum torque of 1,280 inch-pounds (14.75 m-Kg) to occur at the 12° open position, but that required torque remained at or above 1,200 inch-pounds (13.83 m-Kg) from 2 to 26 degrees open. He felt the addition of the oil cylinder was overloading the pneumatic cylinder and stalling the valve. The alternatives were to replace the 5-inch (12.7-cm) pneumatic cylinder operator with a 6-inch (15.2-cm) unit, or to specify the direction of flow for the valve.

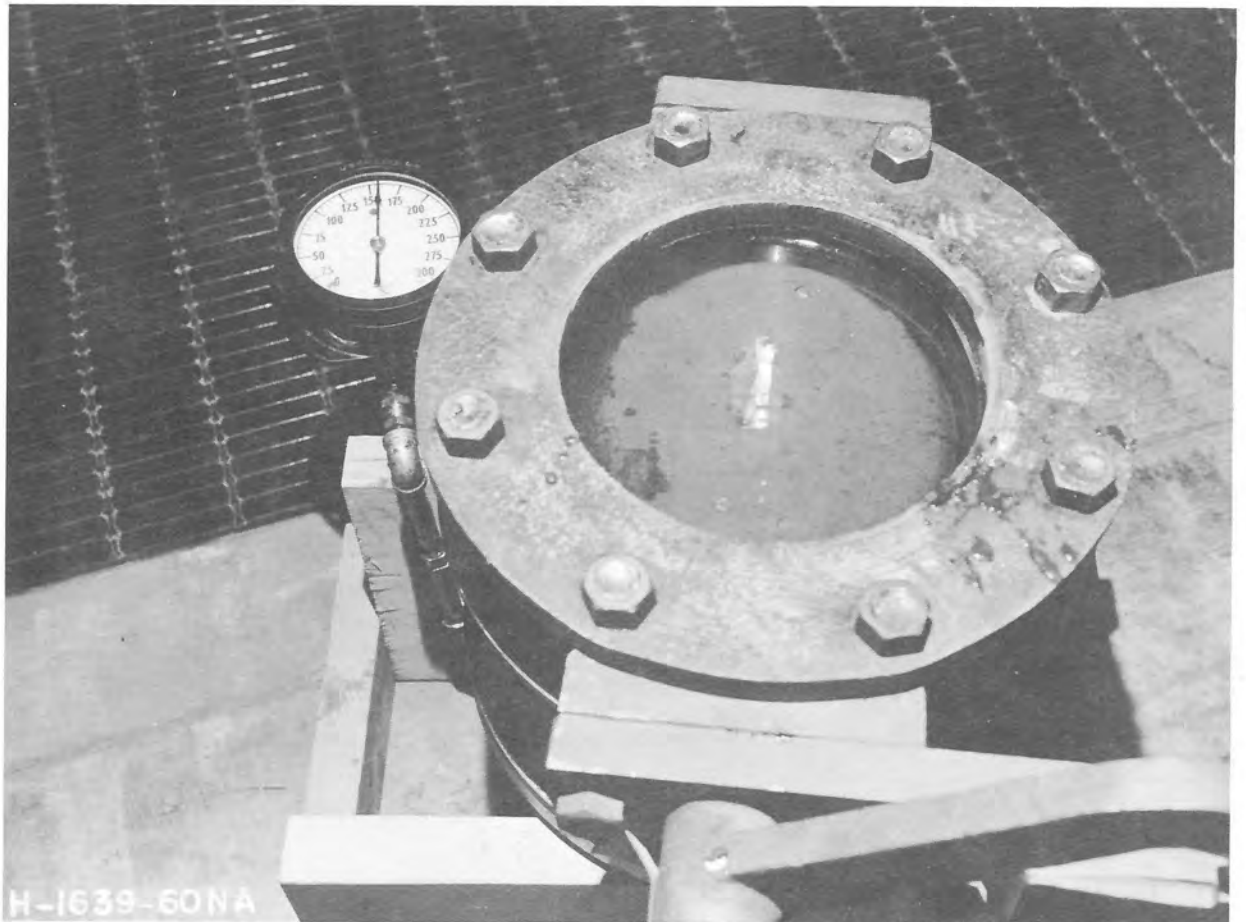
Figure 9AC. Bubble tightness tests on Allis-Chalmers valve after 4,000 cycles of opening and closing. Air at 156 psig (10.97 kg/cm²) under the leaf. Photo P801-D-74512

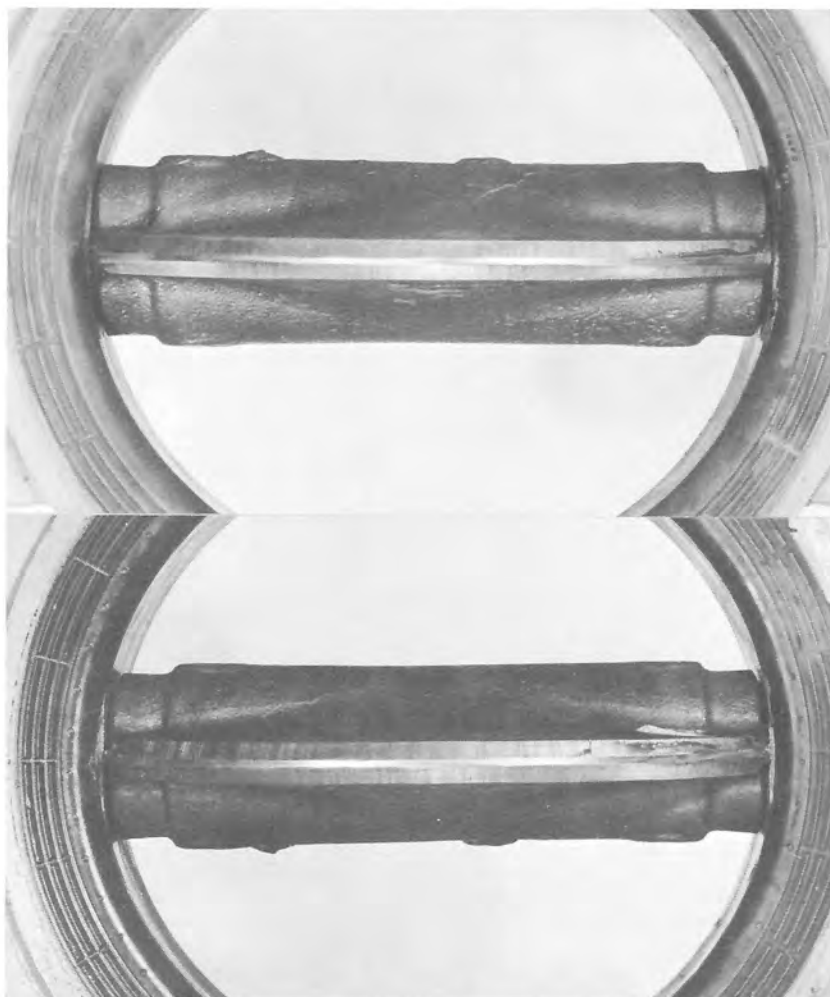
Figure 2CR. View of opposite ends of the butterfly leaf. Note rough machining on surface which contacts rubber seat. Photos P801-D-74514 (upper), P801-D-74515 (lower)

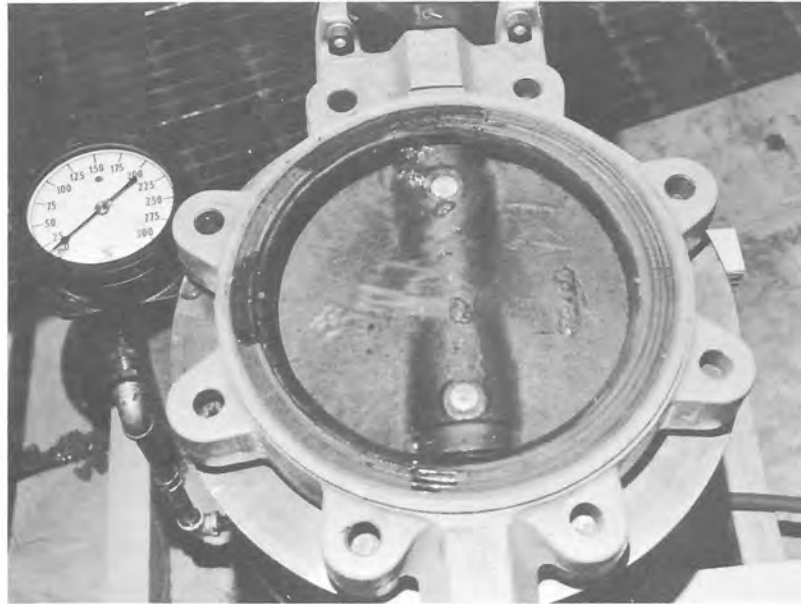
Figure 6CR-A. Bubble tightness tests on Crane valve after 2,500 cycles of opening and closing. Air at 12 psig (0.84 kg/cm²) under leaf. Photo P801-D-74516

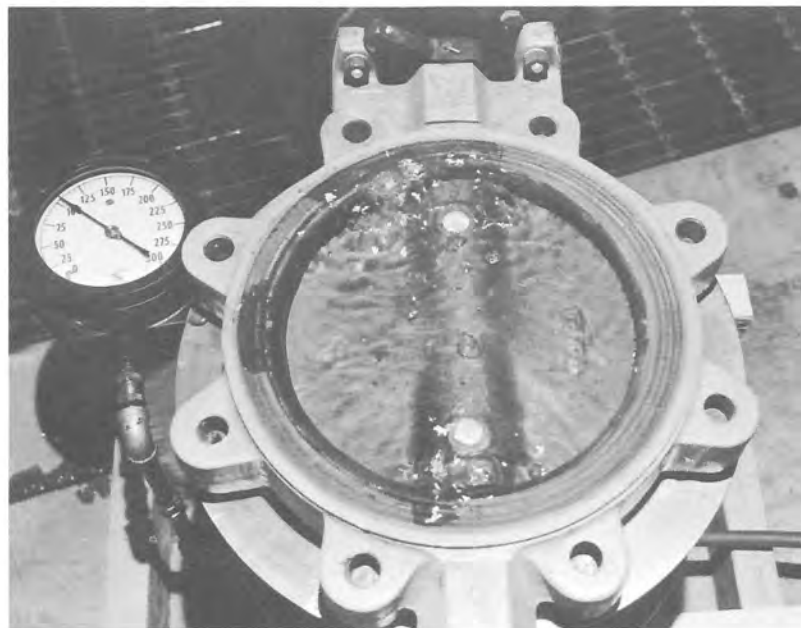
Figure 6CR-B. Bubble tightness on Crane valve after 2,500 cycles of opening and closing. Air at 106 psig (7.45 kg/cm²) under leaf. Photo P801-D-74517

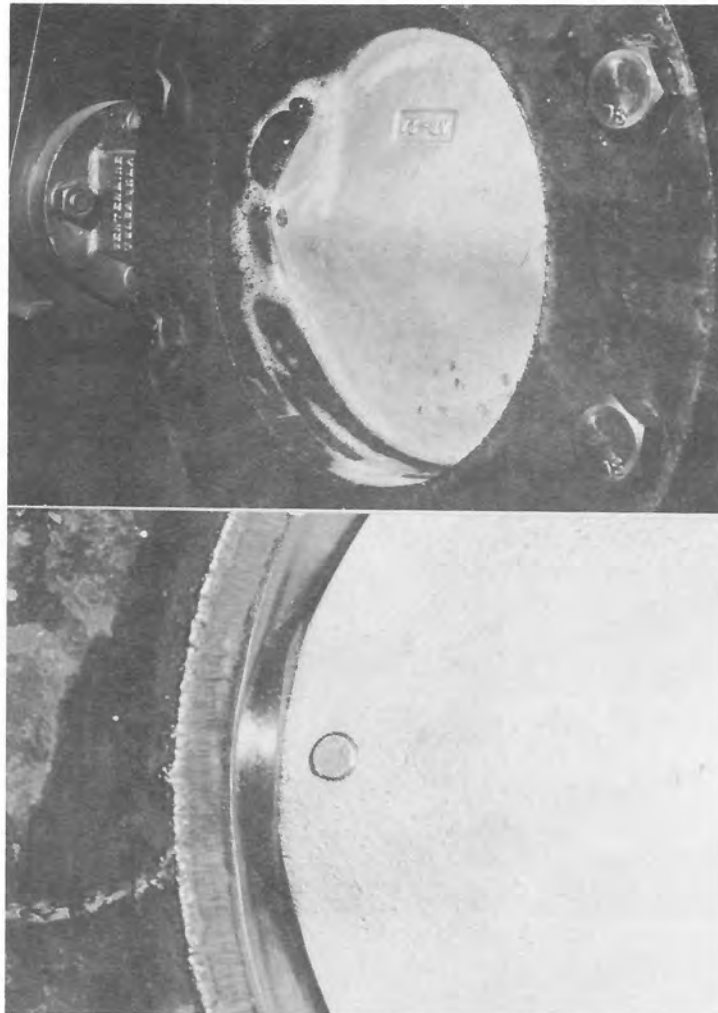
Figure 3CL. Air leakage from around the shaft seal area. The valve had been opened and closed 1,000 times with air at 75 psig against the leaf. Lower photo shows molded flats where stem passes through the rubber seat. Photos P801-D-74520 (upper), P801-D-74521 (lower)

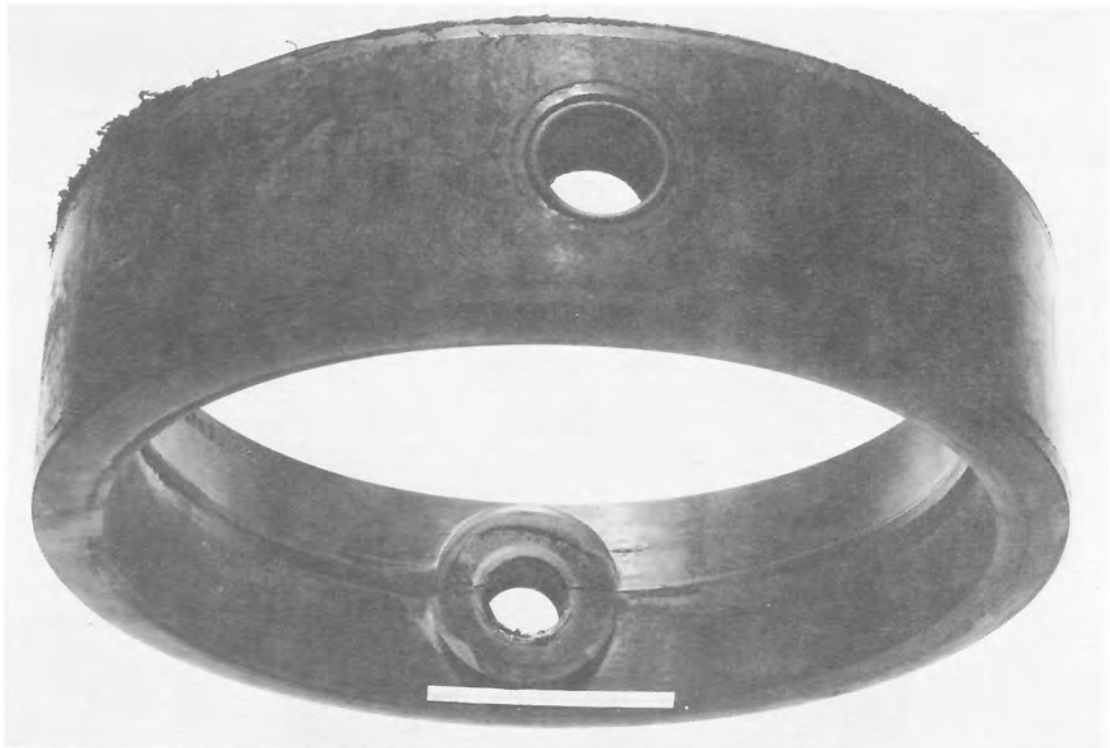
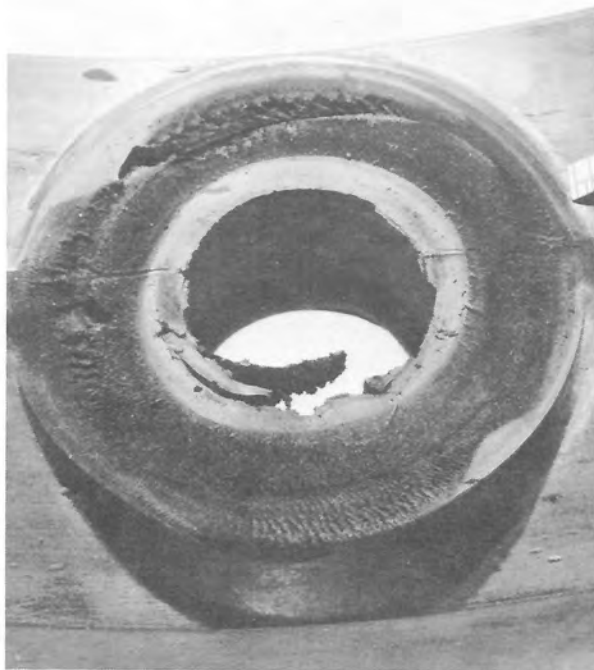
The replaceable rubber seat of the Center Line valve appears to be an excellent idea, however, leakage from the seat and molded flat area must be eliminated before the design would be acceptable. The travel of the leaf which appeared quite smooth for rapid operation

Figure 7CL. Damaged replaceable rubber seat removed from valve body. Closeup shows damage to opposite end. Major damage was to molded rubber flats. Photos P801-D-74522 (upper), P801-D-74523 (lower)
