Memorandum
Chief, Water Conveyance Branch

Denver, Colorado
May 18, 1978

Cavitation Tests Performed on Controller 3ORFAV-4, Flamingo Flow Control Station and Observations on Hitachi Pumps - Southern Nevada Water System

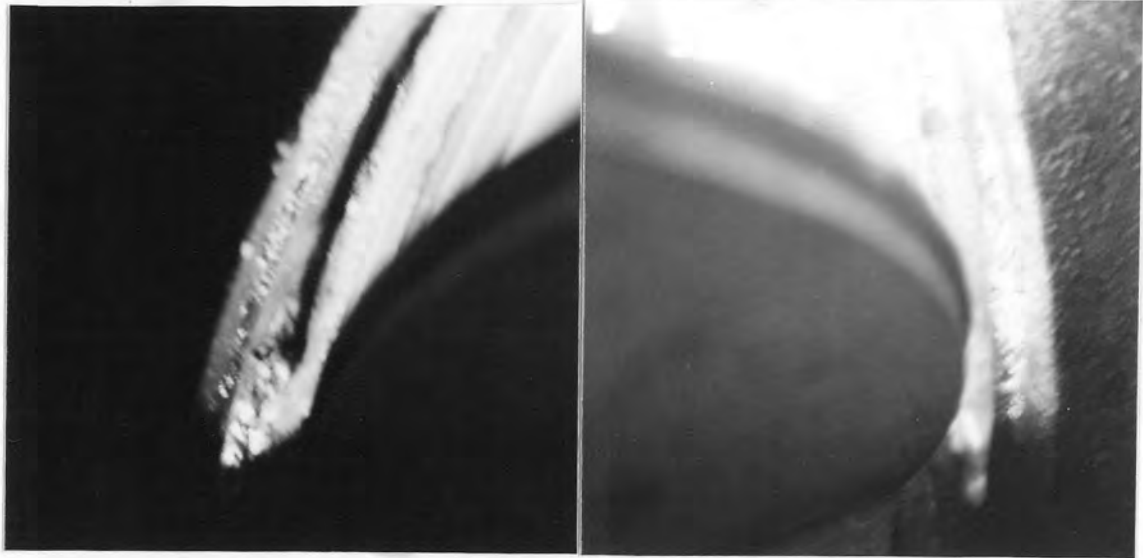
FIGURE 4

Several areas of cavitation erosion in the valve body were noted (figures 4 and 5). One was on both sides of the body downstream of the seal and slightly above the shaft. The other was on the invert upstream of the seal on both sides of the centerline. The erosion on the invert was in a Devcon filler placed to eliminate the offset on the upstream side of the seal retainer. Considering the

relatively low resistance of the Devcon material to cavitation erosion, the damage is minimal. The erosion covers a total area of about 7 in² (4500 mm²) on either side of centerline to a maximum depth of about 1/16 inch (1.6 mm). The Devcon filler was not as smoothly applied as it should have been, which may have contributed to the erosion. The eroded areas on either side of the body above the shaft extended about 3 inches (76 mm) vertically and 3/4 inch (19 mm) horizontally downstream from the seal.

CAVITATION EROSION TO BODY ABOVE SHAFT - FROM DOWNSTREAM

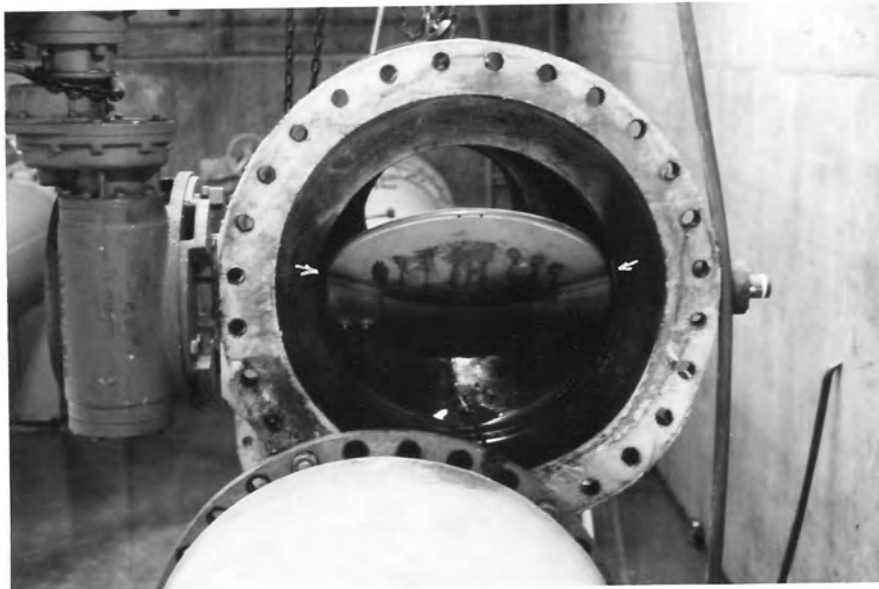
VIEW OF CONTROLLER FROM DOWNSTREAM END SHOWING 2 ADDITIONAL
HOLES ON TRAILING EDGE, AND LOCATION OF EROSION ABOVE SHAFT

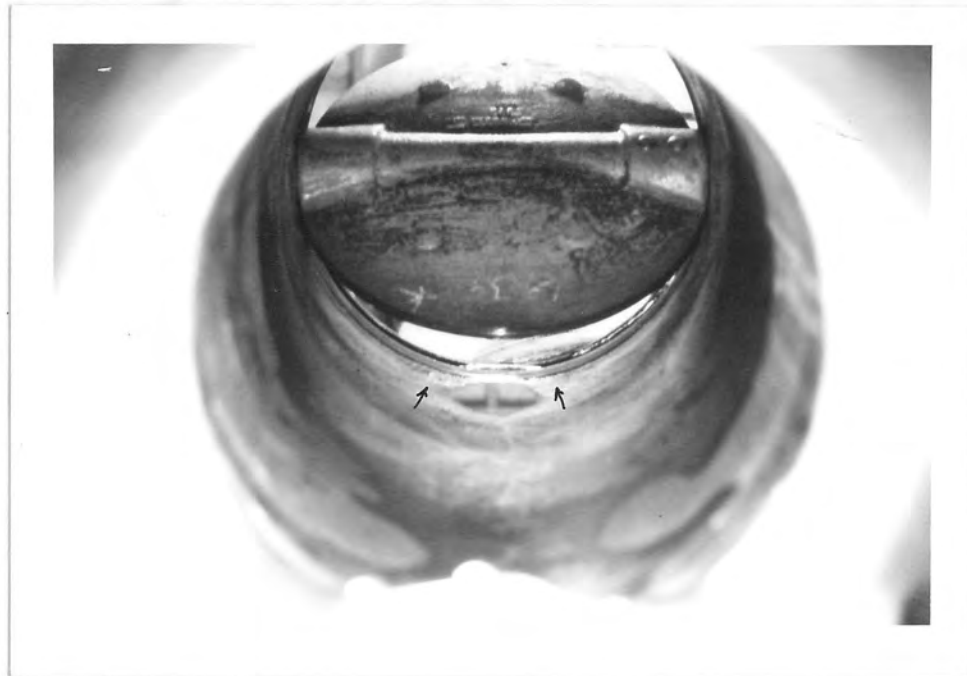
CAVITATION EROSION ON INVERT - FROM
UPSTREAM SIDE OF CONTROLLER

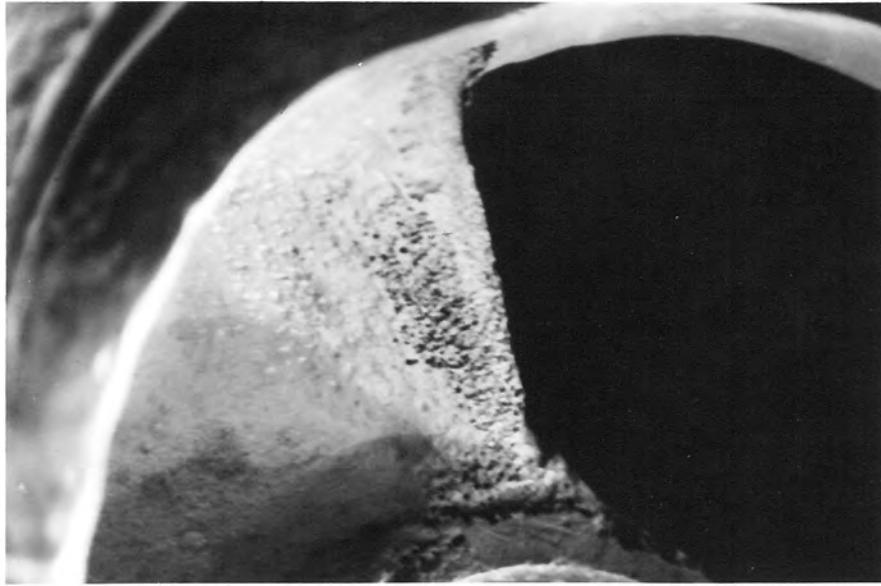
FIGURE 7

The pumps were disassembled and being readied for protective coating at the time of my visit. The general condition of the pumps appears to be poor and concern for pump longevity warranted. There is a high degree of corrosion as well as cavitation erosion, which if not stopped, will definitely shorten the pump life. The heaviest damage has been to critical areas in the cast housings such as casing ring support material, material adjacent to the stuffing boxes, and to the suction baffle (figure 7). Several areas of cavitation damage within the pumps appeared to be due to local irregularities in the flow surfaces, particularly on the suction baffle. Also, several eroded areas on the bottom portion of the housing near the part line were observed. These point to the possibility that an offset exists in the flow passage between the two halves, causing cavitation to occur (figure 7). A method was suggested to evaluate alignment. This would require the use of a cardboard template placed between the two halves of the pump and compressed so as to leave an imprint. An indicating fluid such as a red lead could be applied to the corners of the flow passages in the upper and lower halves to improve the definition of the imprint. Flow passage imprints should remain on

CAVITATION EROSION TO SUCTION Baffle

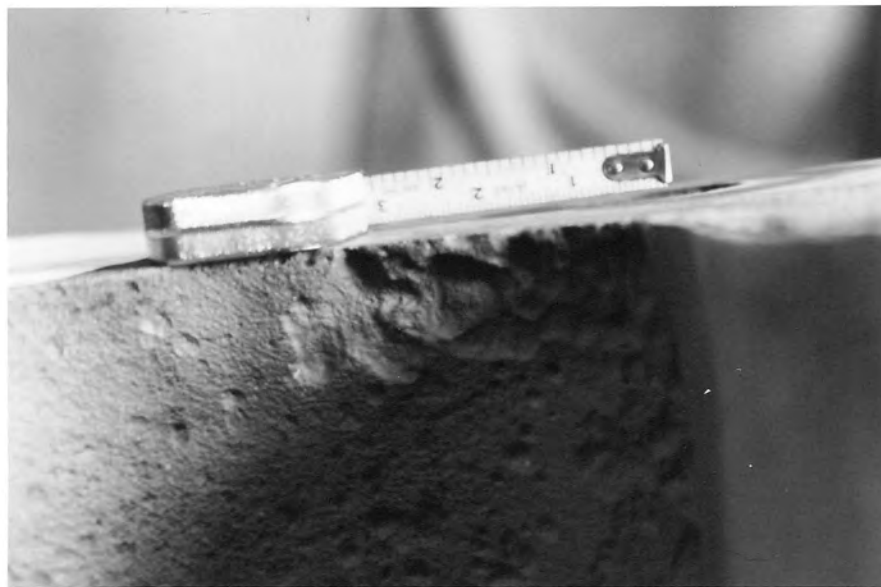
AREA OF EROSION IN BOTTOM HALF OF PUMP
HOUSING JUST DOWNSTREAM OF PART LINE
