HYDRAULIC MODEL TESTS OF ROCK MATERIAL  
IN CANYON FERRY DAM SPILLWAY STILLING BASIN

Subject: Hydraulic Model Tests of Rock Material in the Canyon Ferry Dam  
Spillway Basin

SUBJECT: Hydraulic Model Tests of Rock Material in Canyon Ferry Dam Spillway  
Stilling Basin

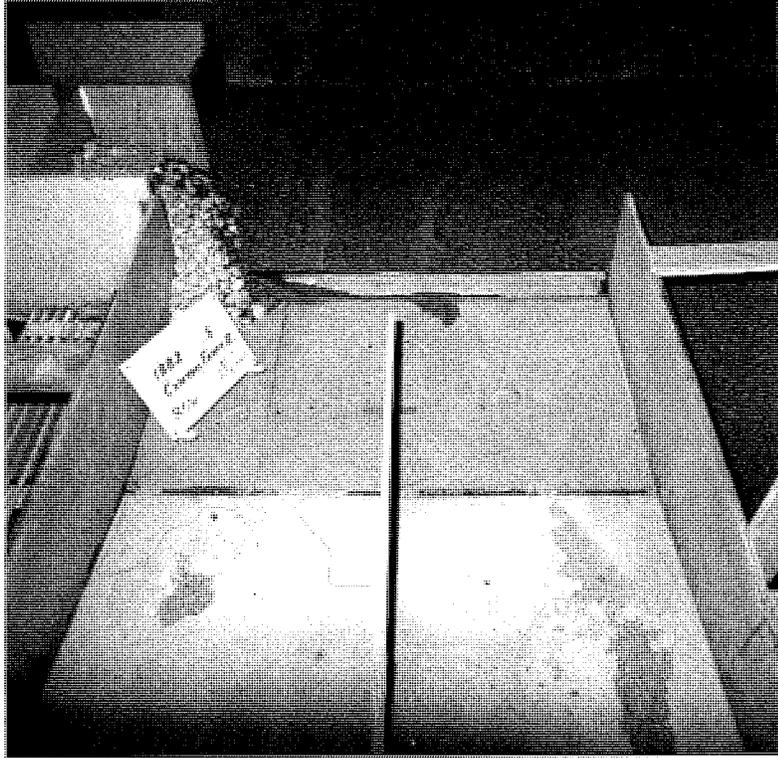
Only river outlets No. 1 and 4 operated, each with a 67.9-m<sup>3</sup>/s (2400-ft<sup>3</sup>/s) discharge. Sand was carried into the basin. Most sand entered during the first hour of model operation, a very slight amount the next 2 hours, and no sand appeared to enter during the remaining 3 hours. Sand in the basin and erosion downstream from the basin is shown on figure 2.

Figure 2. - Sand in basin after test No. 2.

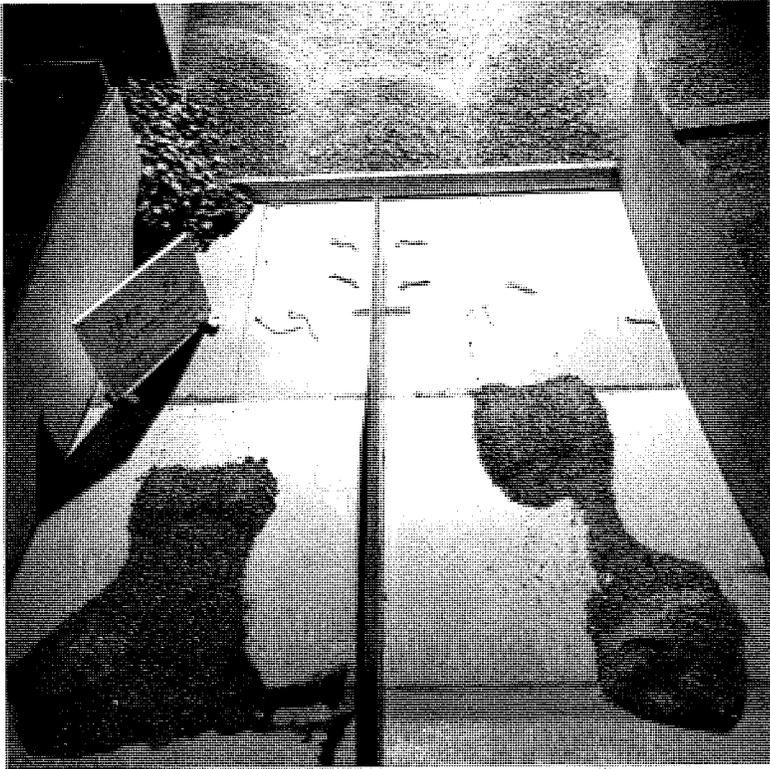
All four river outlets operated, each with a 67.9-m<sup>3</sup>/s (2400-ft<sup>3</sup>/s) discharge. Sand was immediately carried into the basin at the start of the test and more sand entered the basin than in the previous test (fig. 3a). Similar to the previous test, most of the sand entered at the beginning of the test and none was detected entering the basin during the latter part of the test. The eroded areas downstream from the basin showed a tendency for fines to be removed and some coarser particles (fig. 3b). Thus armoring appeared to develop and stop the erosion process.

a. Sand in basin after test.

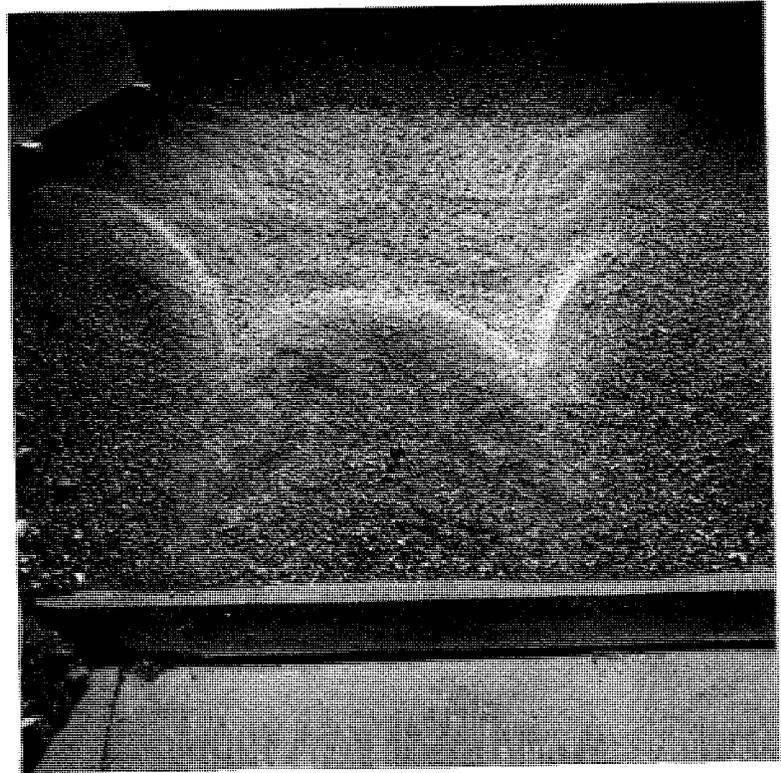
b. Armoring effect at eroded areas.

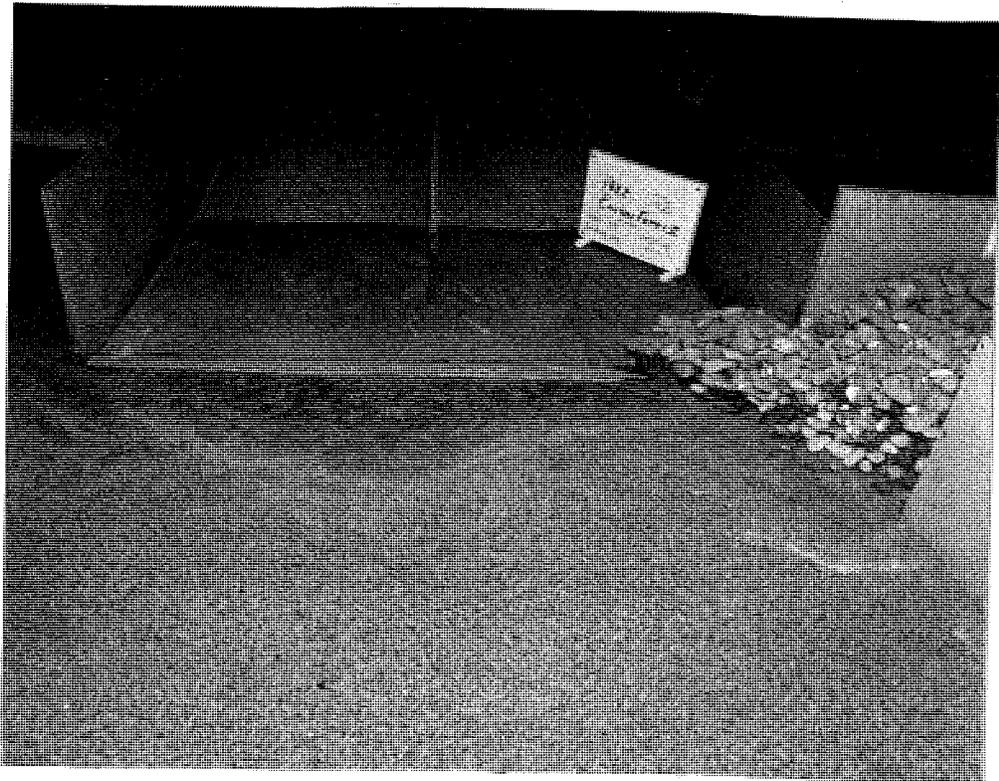
For this test the finer sand was used, and model flow was the same as test No. 1. Only slight erosion occurred downstream from the basin and no appreciable amount of sand entered the basin (fig. 4). At the left side of the photograph a few sand grains can be seen next to the basin wall and just upstream from the end sill, but not enough to measure.

Each of the three flow conditions (tests No. 4, 5, and 6) had a different erosion pattern downstream from the end sill (figs. 4, 5, and 6). For test No. 4, erosion downstream from the end sill was slight. The erosion had a general distribution across the basin width with a maximum at the center and decreasing toward the sides (fig. 4). For test No. 5, erosion was more localized and there was an erosion hole on each side of the basin (fig. 5). The difference in erosion between tests No. 4 and 5 showed that operating the two inside spillway gates effectively decreased erosion forces in the downstream channel. For test No. 6, the erosion was again localized but with three erosion holes. A smaller hole was located at the middle of the basin (fig. 6). The various erosion patterns that developed for the different flow conditions indicate that the prototype is susceptible to movement and changing patterns of rock material downstream from the end sill.

Figure 4. - Practically no sand in basin after test No. 4.

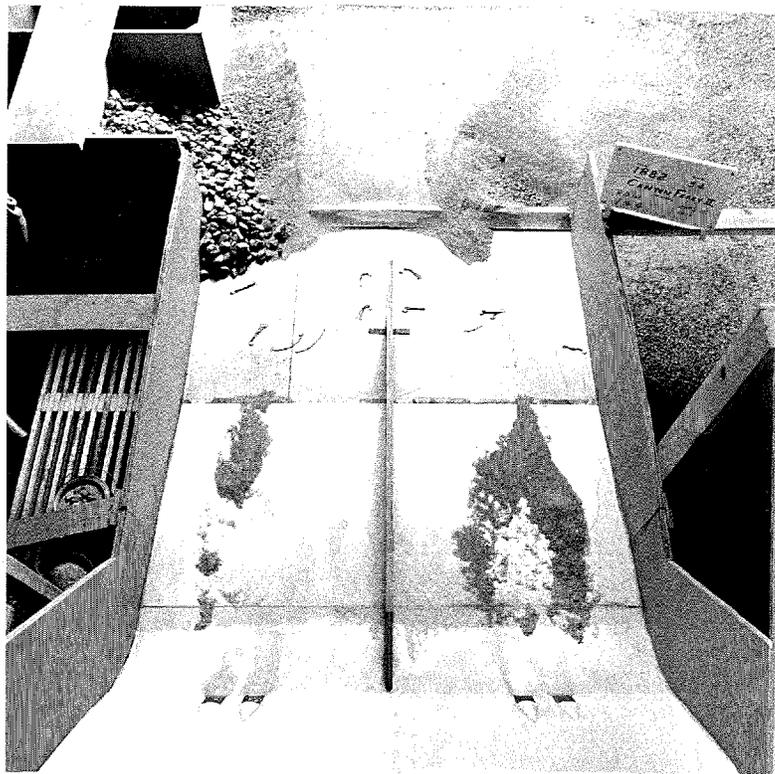
Model flow conditions were the same as for test No. 2 with the finer sand. Some sand was carried into the basin and erosion occurred downstream from the basin (fig. 5).

Figure 5. - Sand in basin after test No. 5.

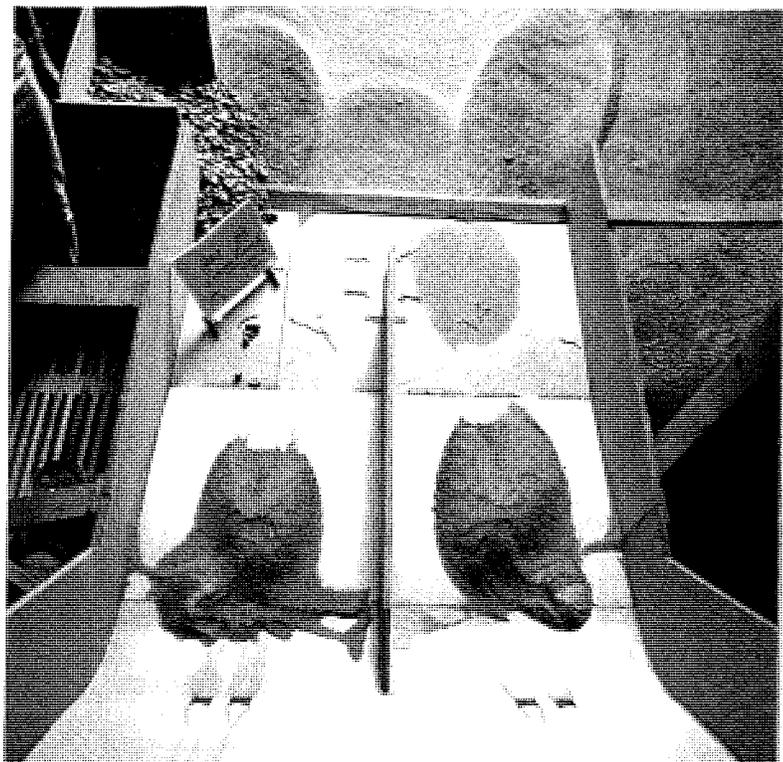
Model test conditions were the same as for test No. 3 except the finer sand was used. The sand carried into the basin is shown in figure 6a. Also some rocks were carried into the left bay of the stilling basin (fig. 6b). The rocks came from the downstream left corner of the model stilling basin. Rocks were used in the model to represent remnants of the cofferdam from construction of the pumping plant.

a. Sand in basin after test.

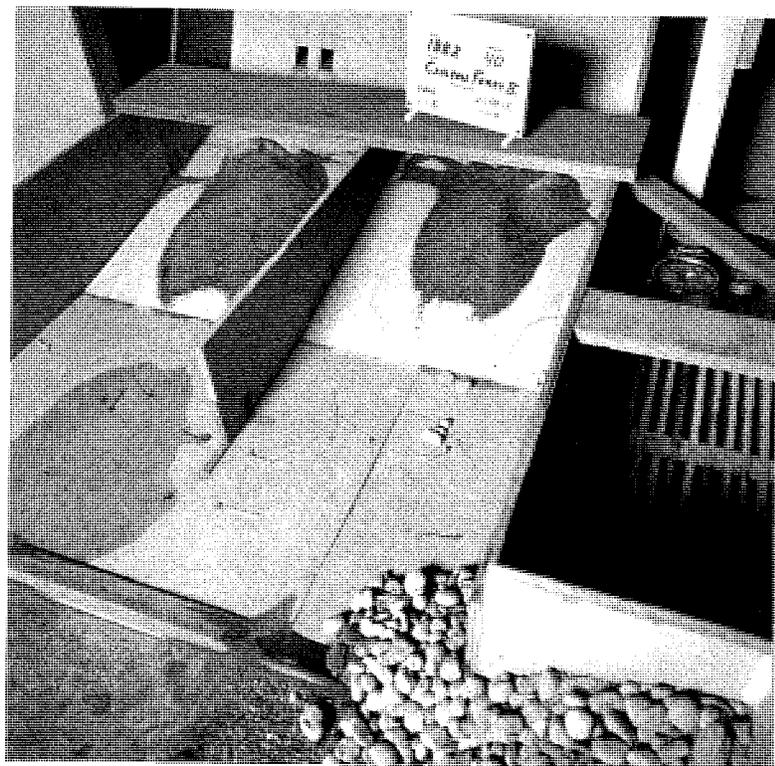
Location of the large rocks that moved into the stilling basin during test No. 6 was coincidental to location of the large debris of the previous model study. Note in figure 6b the two squares marked on the floor just left of the rocks. These two squares note the location of two 1- by 1-m (3.5- by 3.5-ft) concrete slabs found in the prototype stilling basin. These rocks in the model stilling basin indicate the possibility of erosion from the cofferdam remnant.

b. Rock drawn into the left bay of the stilling basin.

Model test No. 6 had some large rocks from the cofferdam remnant carried into the stilling basin. Possibly in a future underwater inspection the divers should look at the integrity of the grouted rock area at the downstream left corner of the stilling basin and also the steep channel side (if its structural stability depends upon grouted concrete) between the end of the basin and the pumping plant.

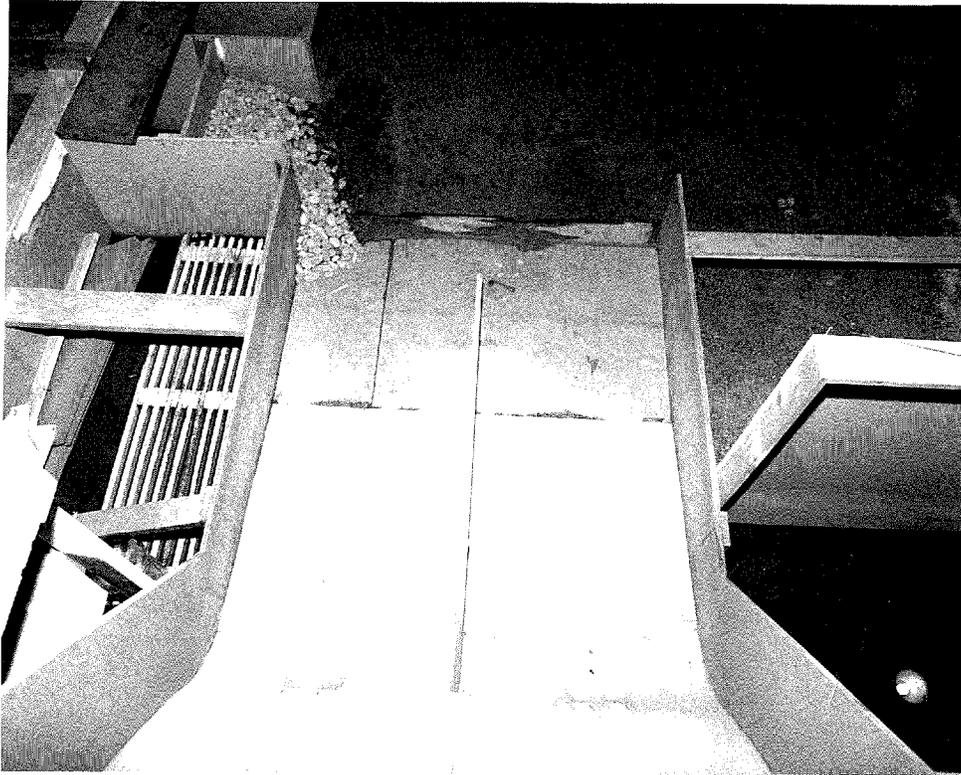
All four river outlets operated, each with a 21.2-m<sup>3</sup>/s (750-ft<sup>3</sup>/s) discharge. A slight amount of sand was drawn into the stilling basin, figure 7.

Previous model tests indicated outlet flows of  $84.9 \text{ m}^3/\text{s}$  ( $3000 \text{ ft}^3/\text{s}$ ) or less brought very little sand into the model stilling basin, figure 8 of REC-ERC-74-27. Test No. 7 was made with the  $84.9\text{-m}^3/\text{s}$  outlet works discharge and with finer model sand. Again, very little sand was drawn into the basin, figure 7 and table 1. The amount of sand drawn into the basin did not appear much different when using the finer sand, and test No. 7 did not refute the earlier model tests with somewhat coarser sand. Thus model test results do not explain how rock material was drawn into the prototype stilling basin at outlet works discharge of  $84.9 \text{ m}^3/\text{s}$  ( $3000 \text{ ft}^3/\text{s}$ ) or less.

Figure 7. - Very slight amount of sand in the basin after test No. 7.
