# SPILLWAY TESTS AT GLEN CANYON DAM

*July 1985*

*Engineering and Research Center*

Hydraulics Branch  
Division of Research and Laboratory Services  
Engineering and Research Center  
Denver, Colorado  
July 1985

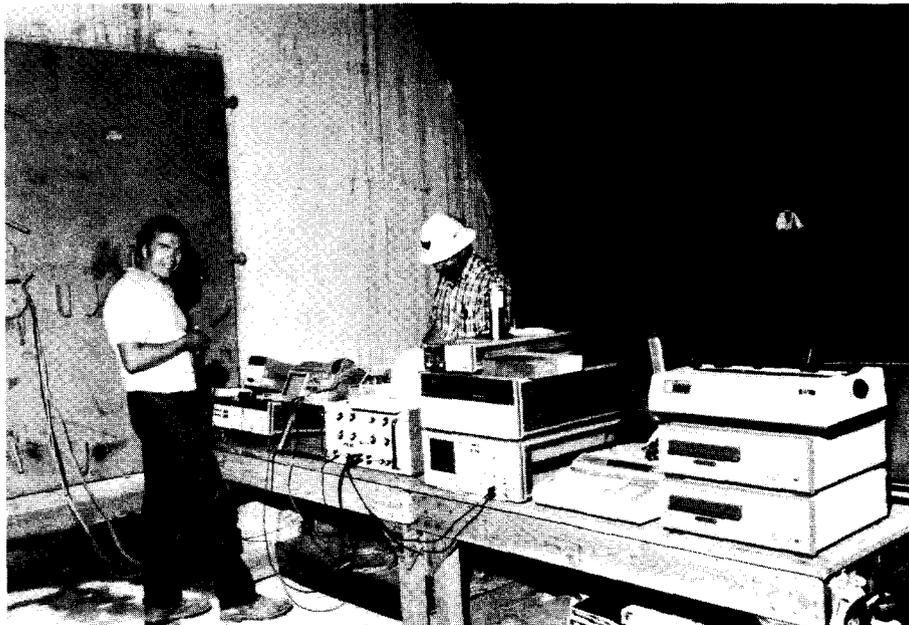
Figure 2. - Data acquisition equipment in the access tunnel. (Note watertight door leading into spillway tunnel.)

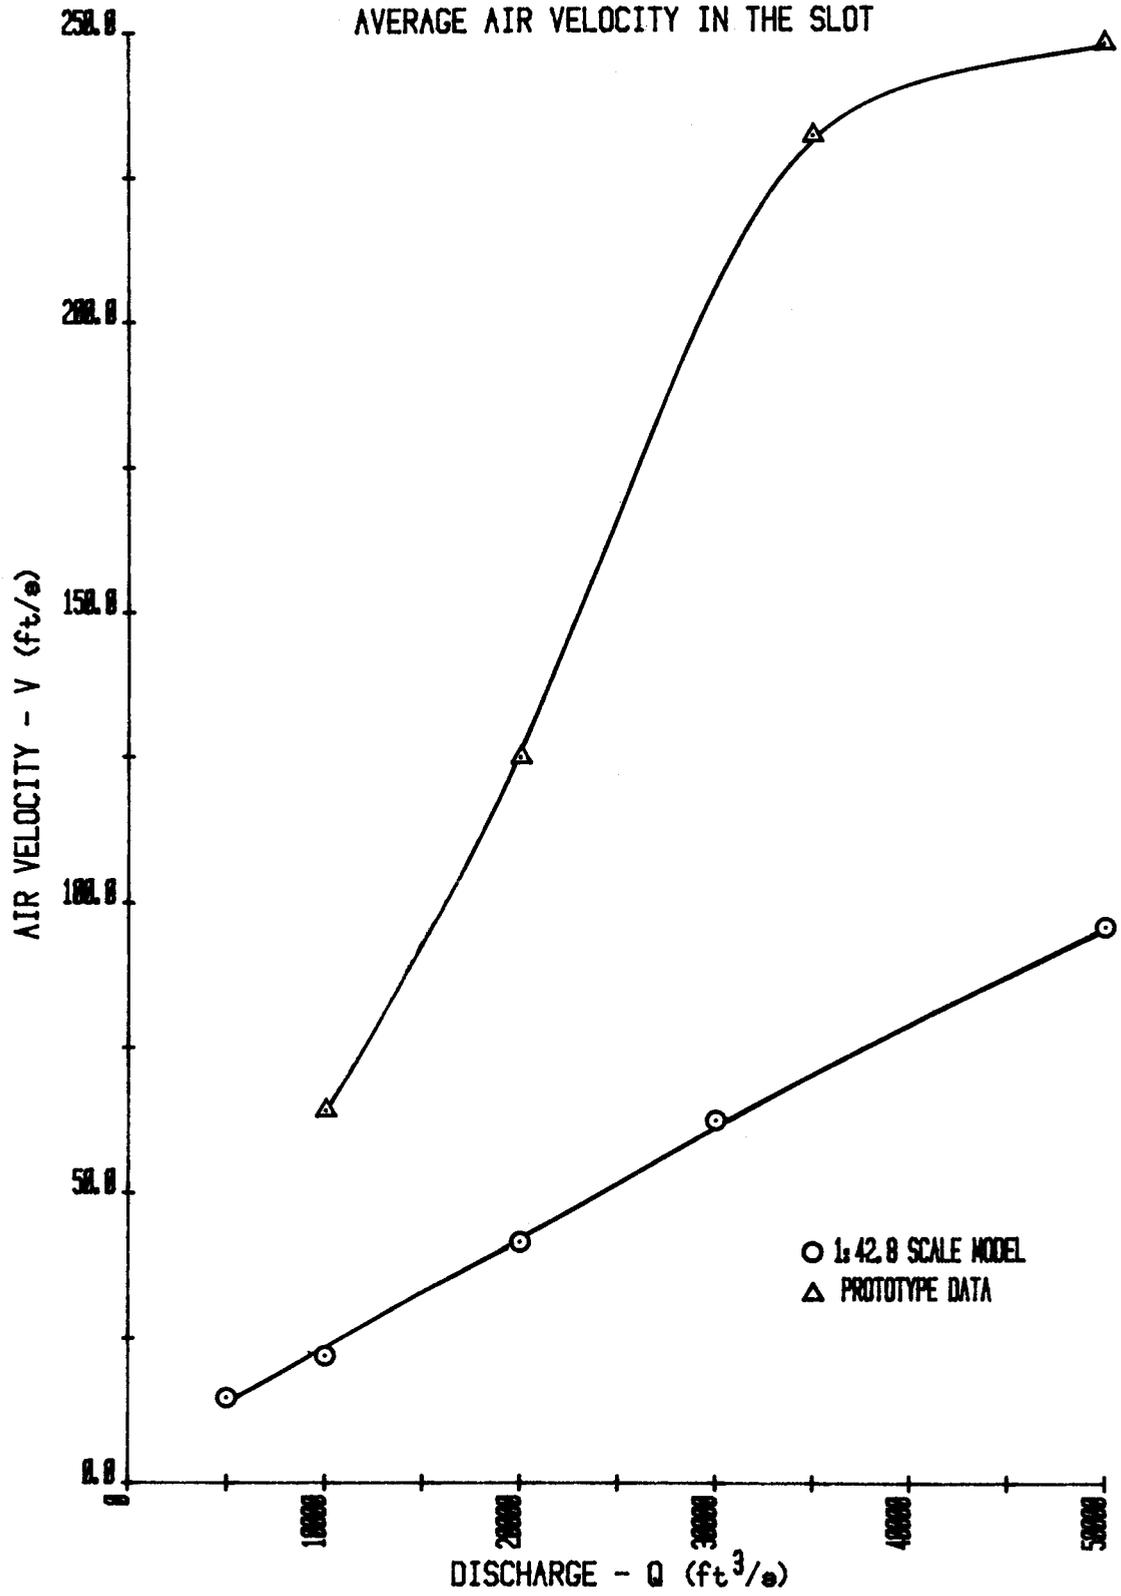
A comparison of these velocities with scaled model values is shown on figure 3. The single point velocity data can be integrated into a volumetric flowrate by assuming a velocity distribution in the slot. A standard logarithmic distribution was assumed along with symmetric performance of the slot. A comparison of air demand, for model, prototype, and computed data is shown on figure 4. It should be noted that measurements in the model and prototype only reflect air demand passing through the slot. Additional air is entrained through shear drag on the free surfaces of the jet and at flows below 30,000 ft<sup>3</sup>/s air may enter beneath the jet downstream from the slot because the sides of the jet are not sealed against the tunnel walls.

Figure 3. - Air velocity measurements in the air slot.

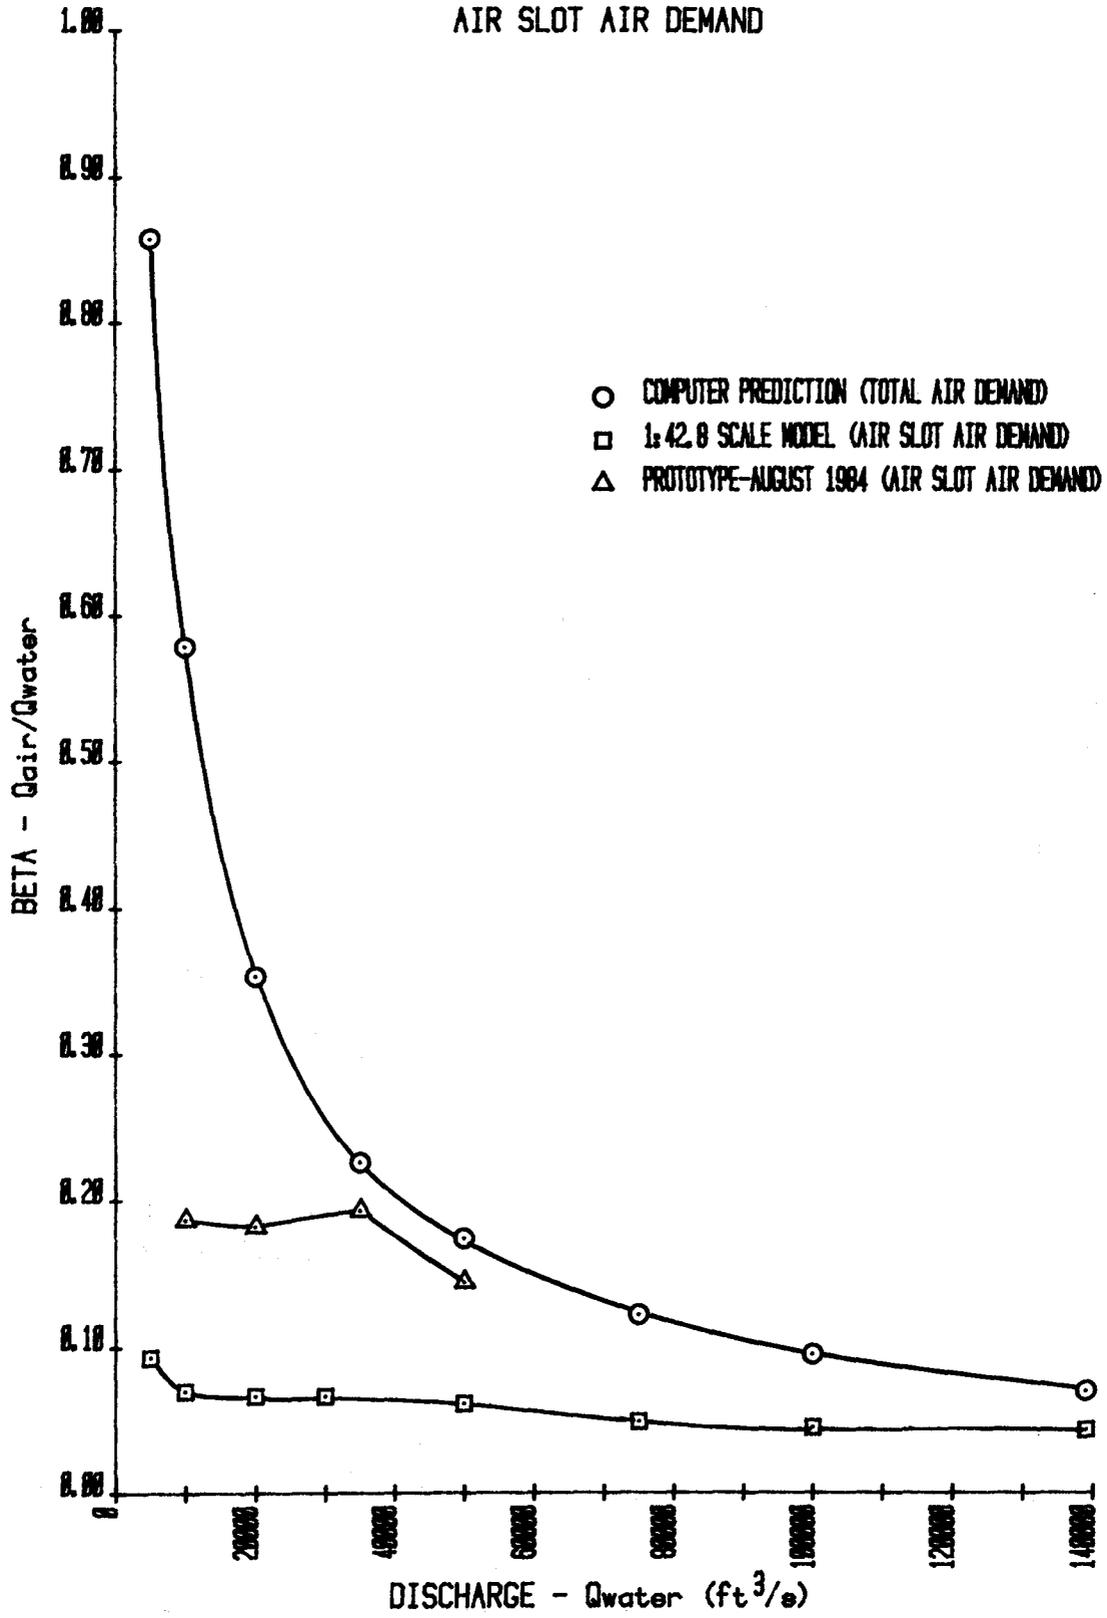
Figure 4. - Air demand comparison - computed-model-prototype.

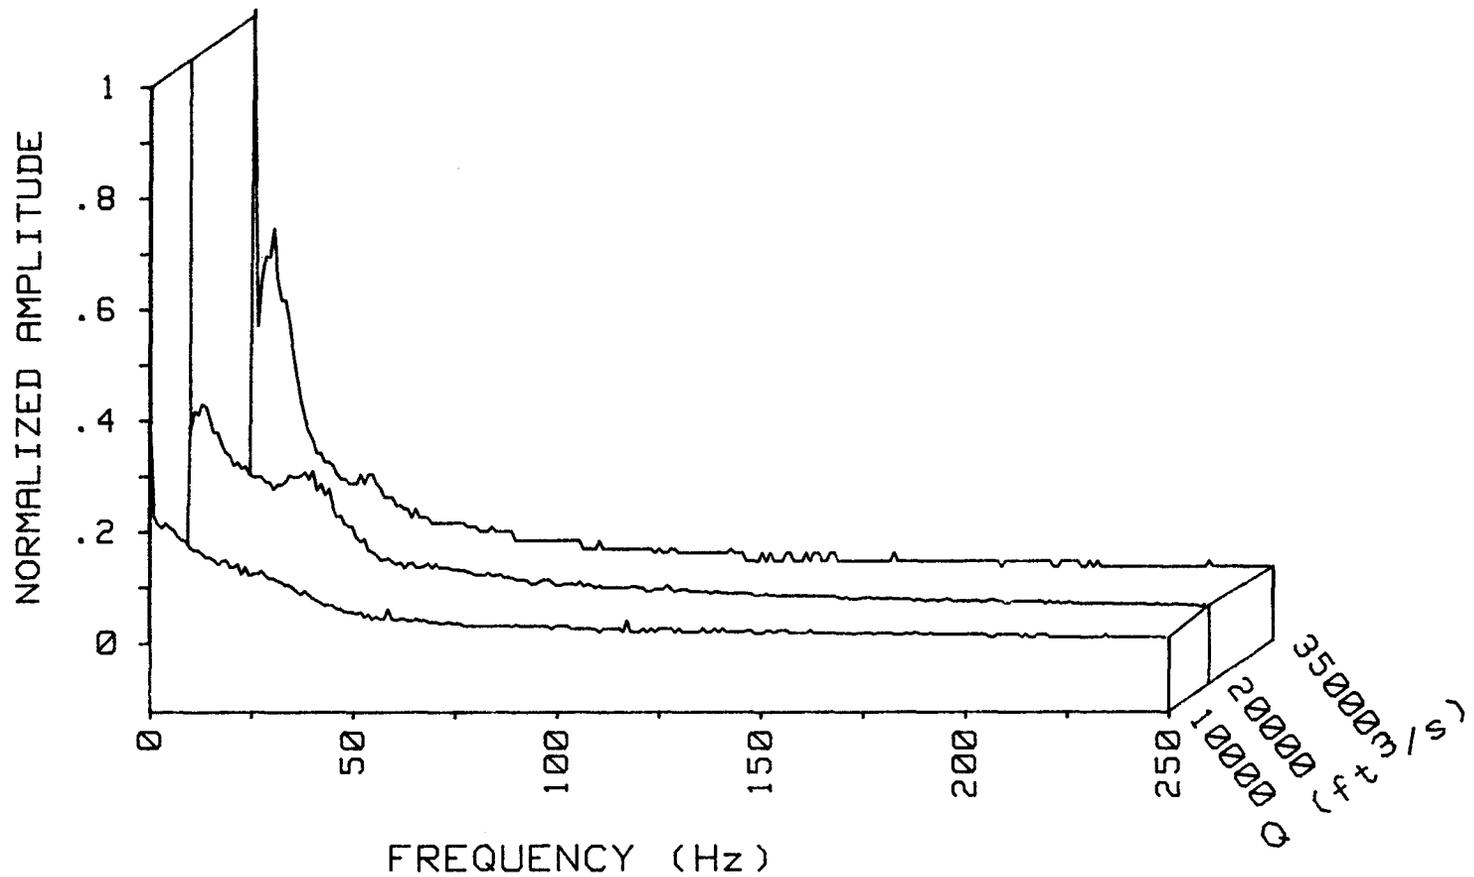
Figure 19. - Energy spectrums of dynamic pressure fluctuations at Sta. 25+80 (Box 7), for flows of 10,000, 20,000, and 35,000 ft<sup>3</sup>/s.

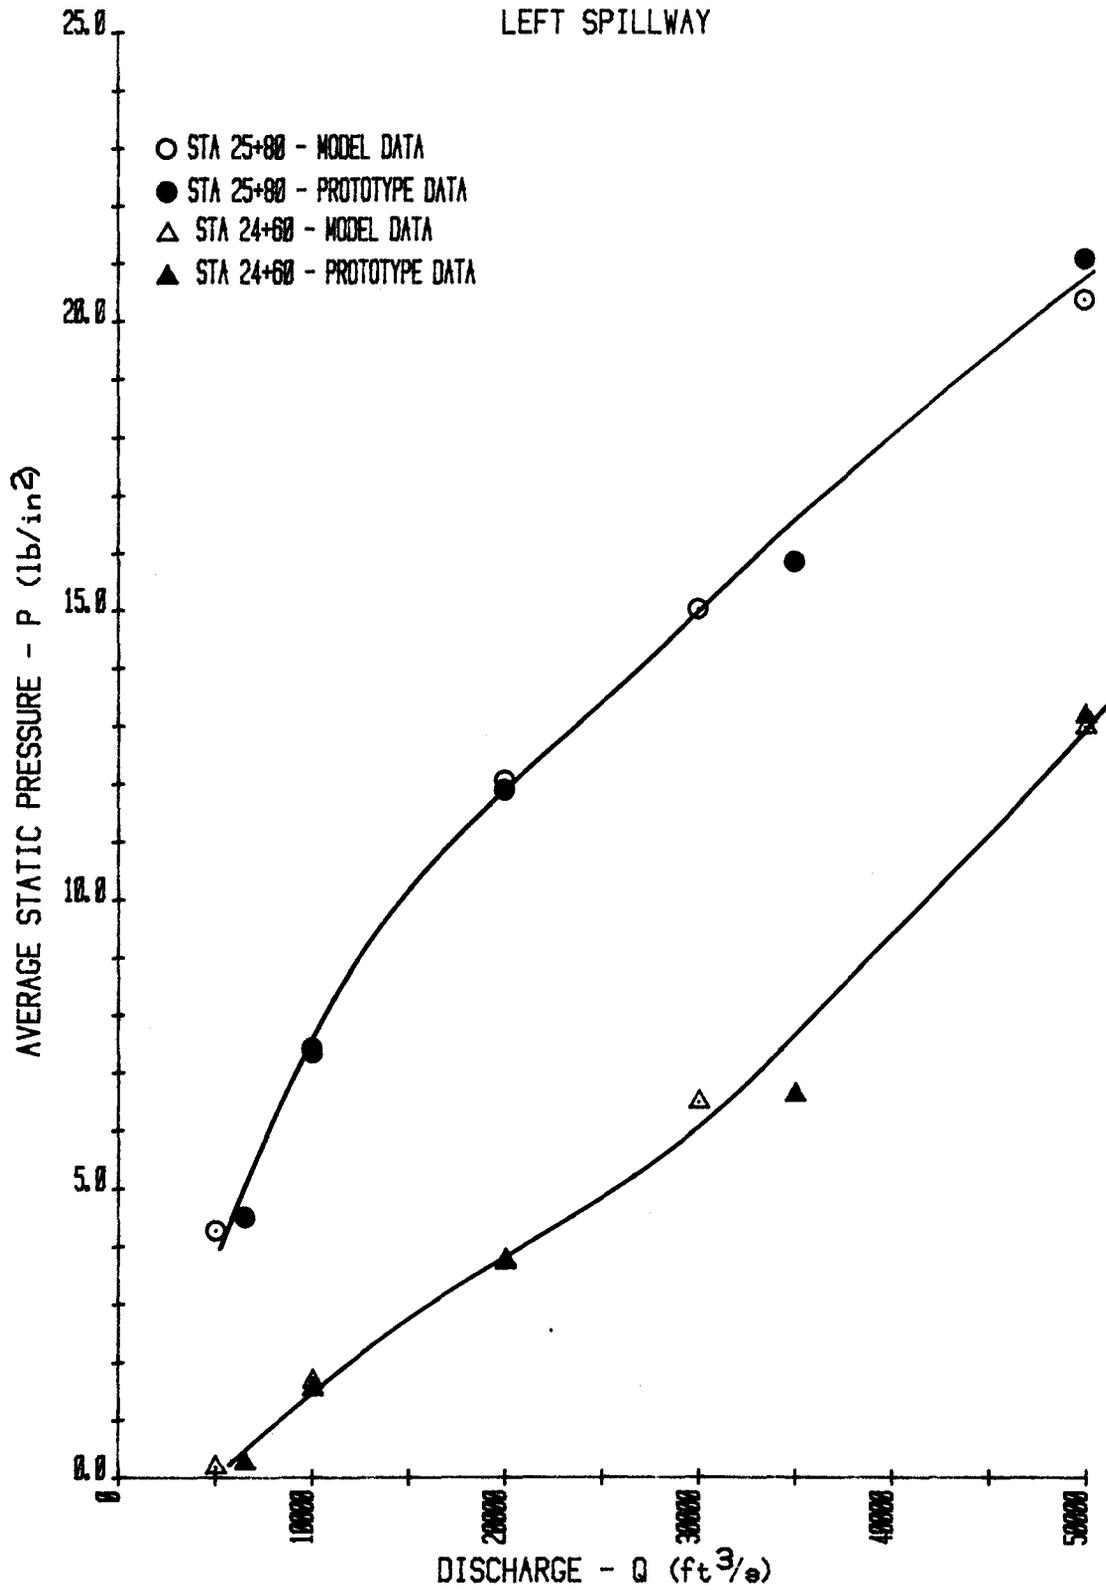
Figure 20. - Model-prototype comparison of static pressures at sta. 24+60 (Box 6), and Sta. 25+80 (Box 3).

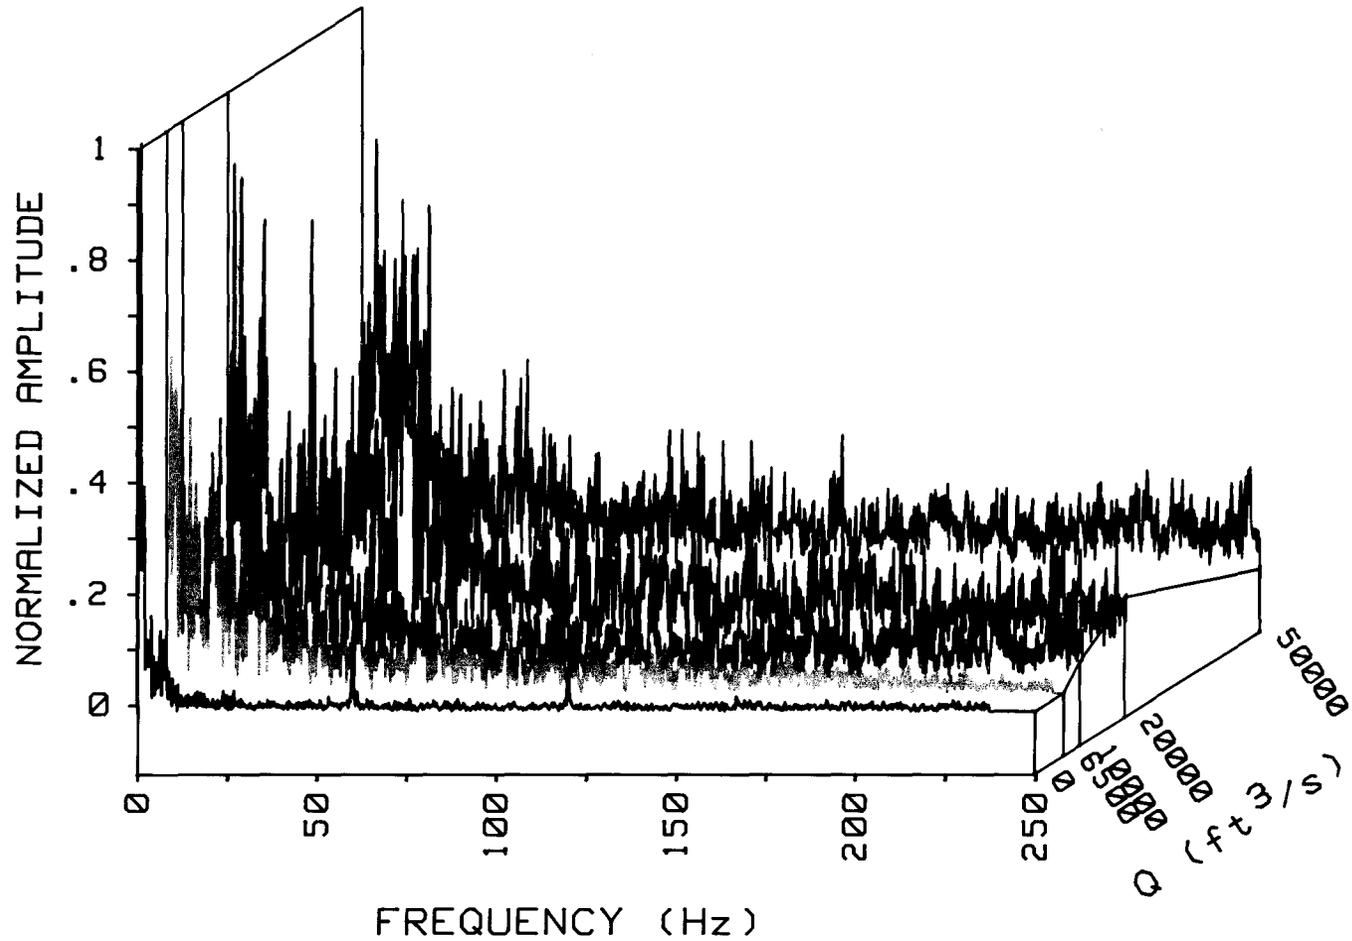
Figure 21. - Prototype frequency spectrums (by FFT) of dynamic pressure fluctuations at Sta. 24+20 (Box 7).

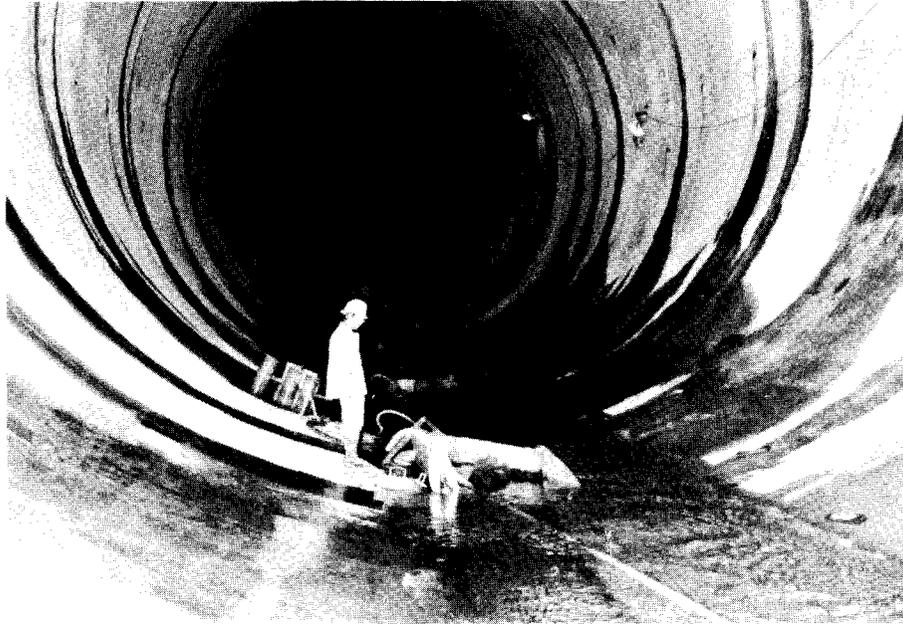
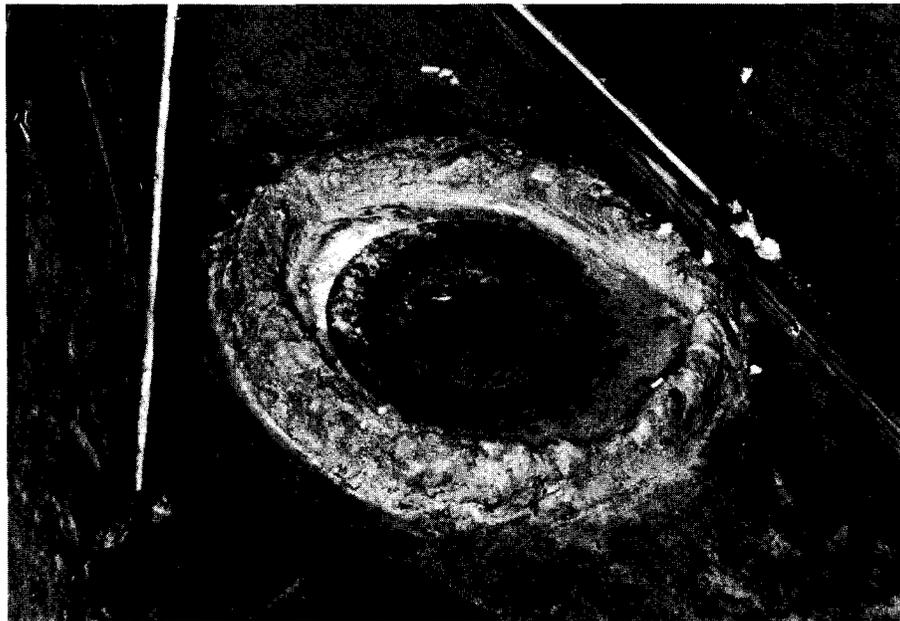
(a) Boxes 1-7 with water diversion structures in place.

(b) Typical installation.

Figure 6. - Boxes 1-7 in lower elbow and horizontal tunnel section of left spillway.
