Tunnel Spillway Performance at Glen Canyon Dam

Philip H. Burgi, Chief, Hydraulics Branch
Melissa S. Eckley, Civil Engineer
Bureau of Reclamation, Denver, Colorado USA

SUMMARY: Colorado River runoff at the 216-m-high Glen Canyon Dam was 180 percent of normal in the summer of 1983. A high reservoir combined with late spring runoff required the use of both 12.5-m-diameter tunnel spillways. Operating these spillways for 2 months eroded 2150 m³ of the concrete liner and foundation rock. The tunnels were repaired, an aeration slot installed, and subsequent tests verified acceptable performance.

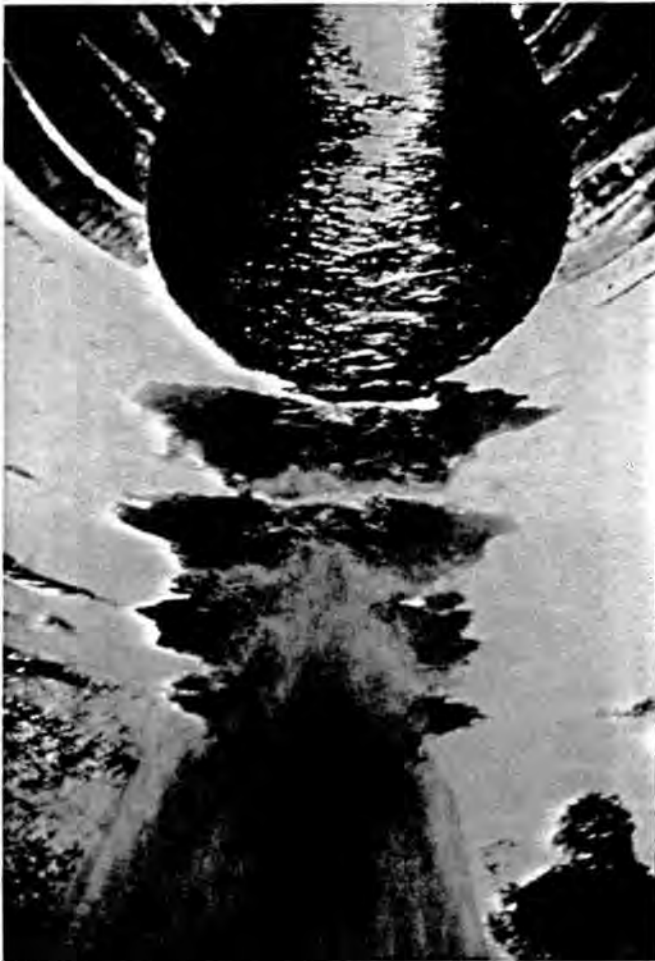
Several large holes were found in the tunnel invert at the downstream end of the elbow, figure 3. Although some of the damage was initiated by cavitation forming on small calcite deposits along the tunnel invert, there is also speculation that a subatmospheric core vortex, caused by secondary currents, may have formed in the elbow which on contact with the flow surface caused severe damage in a very short period of time. This might explain the rapid increase in damage over a period of 72 hours.

Figure 3. - Series of
large holes found in
Glen Canyon Dam left
tunnel spillway 3 days
after start of spill.
June 6, 1983.

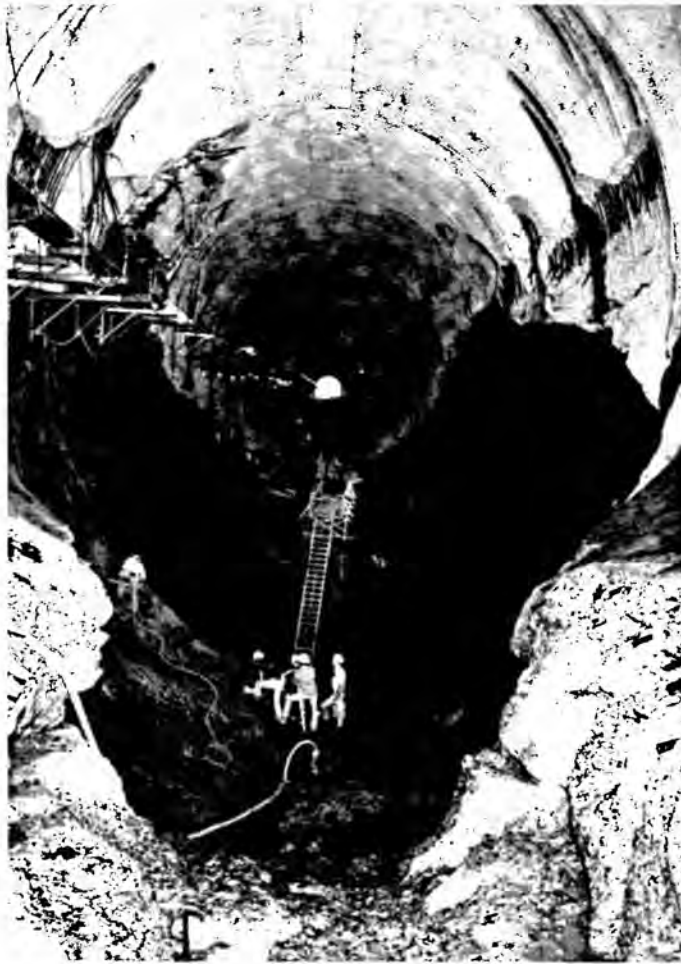
Extensive damage had occurred in the tunnel elbow. Immediately downstream from the elbow, a hole 10.7-m deep, 40.8-m long, and 15.2-m wide had been excavated in the sandstone by the high energy spillway flow. Three-fourths of the tunnel liner circumference had been removed in the area of the deep hole, figure 4.

Figure 4. View looking downstream across the 10.7-m-deep hole in the invert liner at base of the vertical bend - left tunnel spillway. September 1983.

Repair of the concrete tunnel liner in each spillway tunnel involved a monumental task in a very short time frame (3). Approximately 10 months were available to complete the repairs and aerator construction including mobilization time. Field personnel were assigned to one of two 10-hour, 6-day a week shifts throughout the construction period. Tunnel lining and invert replacement was made to the same line and grade as specified in the original construction.
