PAP-526

Cavitation in Bureau of Reclamation Tunnel Spillways

C. A. Pugh and T. J. Rhone

1988

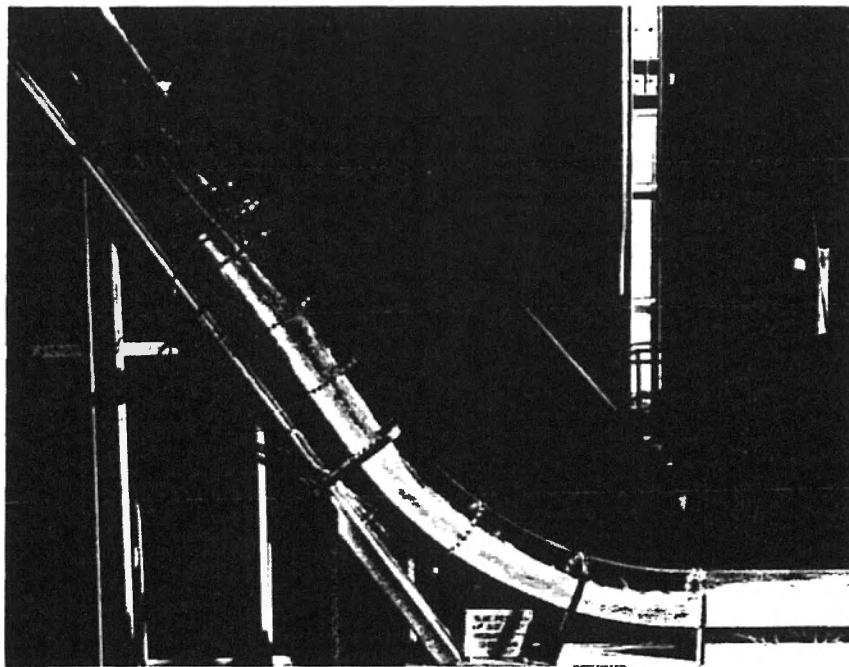
Figure 2. - Blue Mesa model operating with aerator at a simulated $566 \text{ m}^3/\text{s}$.

Blue Mesa. - Model studies were conducted for the Blue Mesa tunnel spillway at the same time as Glen Canyon. By this time, impending cavitation damage in high-head tunnel spillways could be predicted, even with little operational experience. The Blue Mesa spillway was not required to pass flood flows during 1983 and 1984 since maximum releases were sustained through the outlet works and powerplant. The Blue Mesa aerator was completed in 1985 after which the tunnel was operated at flows up to $57 \text{ m}^3/\text{s}$ for several days with no reports of resulting damage. Figure 2 shows the 1:22 scale Blue Mesa model (with aerator) operating at a simulated $566 \text{ m}^3/\text{s}$.

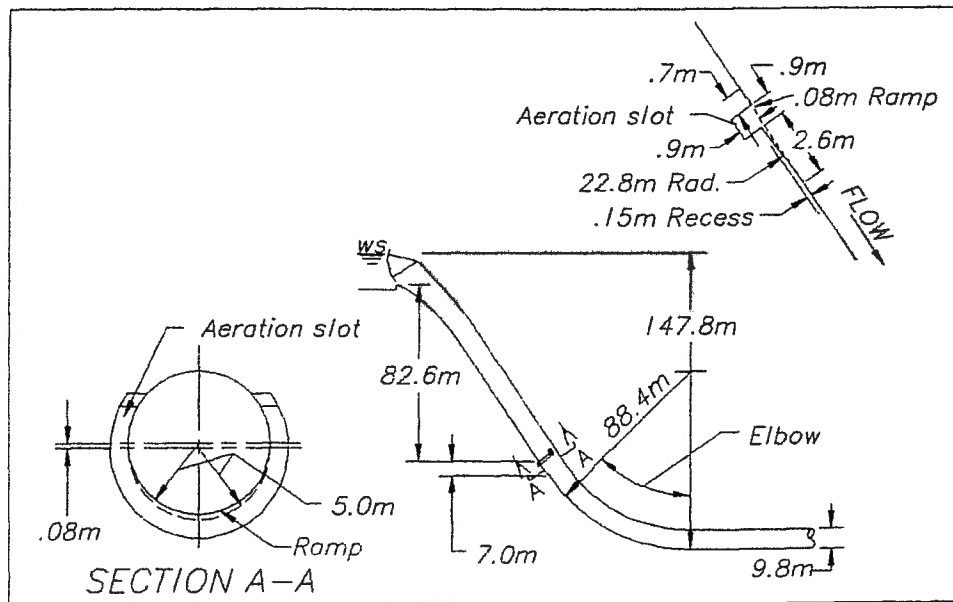
Yellowtail Studies. - In 1967, prototype operation of the tunnel spillway at Yellowtail Dam in Montana caused severe damage to the tunnel near the vertical bend [Colgate, 1971]. Model studies were conducted to develop an aeration device to be installed during tunnel repairs on the premise that entrained air would help prevent cavitation damage in the future.

A conical nozzle (ramp) was installed at the upstream face of the aeration slot just above the vertical bend. This cone was successful in entraining air in the flow; however, a large fin formed on both sides of the tunnel where the contracted jet impinged on the sidewalls. The recommended design corrected this problem by using a 0.9-meter by 0.9-meter slot with a 76-mm ramp in the invert to lift the jet over the slot. The ramp offset varied from 76 mm at the invert to 0 just above the springline. This configuration minimized the effect of side fins especially at higher flows where the upper portion of the jet is not contracted. The location just above the vertical bend was chosen since it was the most effective in aerating the flow through the vertical bend at all spillway discharges.

Figure 3. - Aerator details - Yellowtail Dam.

This configuration was installed in the prototype structure. The damaged area was repaired with backfill concrete, epoxy-bonded concrete, and epoxy-bonded epoxy mortar. The epoxy mortar was used as a veneer over practically the entire invert surface from Station 7+70 to Station 10+50 to correct the surface texture such as aggregate popout and cavitation damage caused by calcium buildup [Borden, et al., 1971].

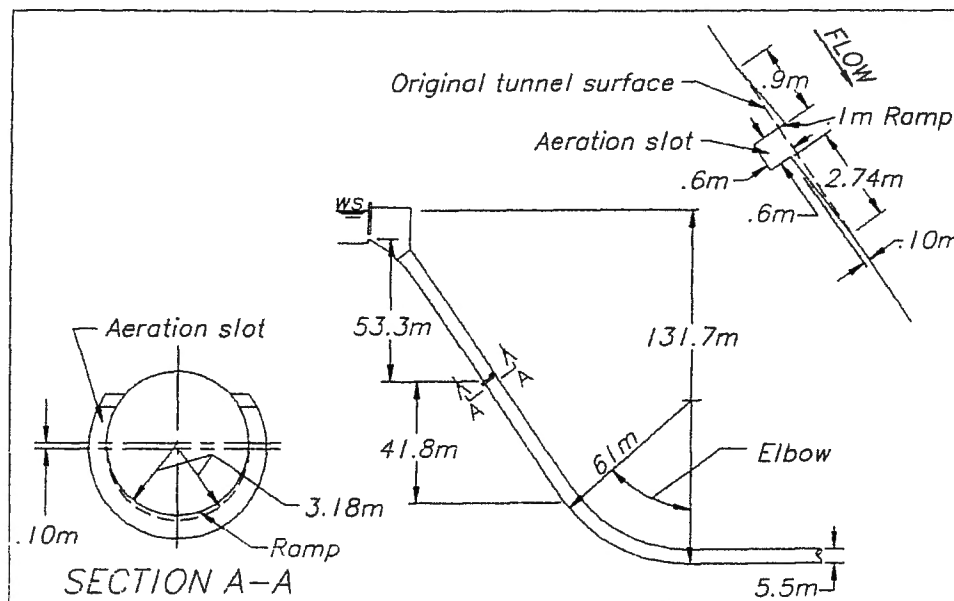
of Reclamation structures with high-head tunnel spillways. In July 1975, tests were conducted at Flaming Gorge to determine if a cavitation problem existed [Falvey, 1989]. During the limited tests at a flow of $142 \text{ m}^3/\text{s}$, no apparent cavitation damage occurred in the tunnel. However, the concrete in the tunnel was very poor and needed repair. A decision was made to install an aeration device during the repairs. The aerator was patterned after the Yellowtail device. However, the slot was located further upstream where the minimum cavitation index is 0.181. Model studies were not conducted.

Figure 4. - Aerator details - Flaming Gorge Dam.

In 1983, the aerator had been installed; however, repairs on the concrete surface downstream from the slot were not complete. The tunnel was required to pass flows from 113 to $142 \text{ m}^3/\text{s}$ for 30 days. There was no cavitation damage observed in the construction zone where the jet impinged, attesting to the effectiveness of the aeration in preventing cavitation damage.

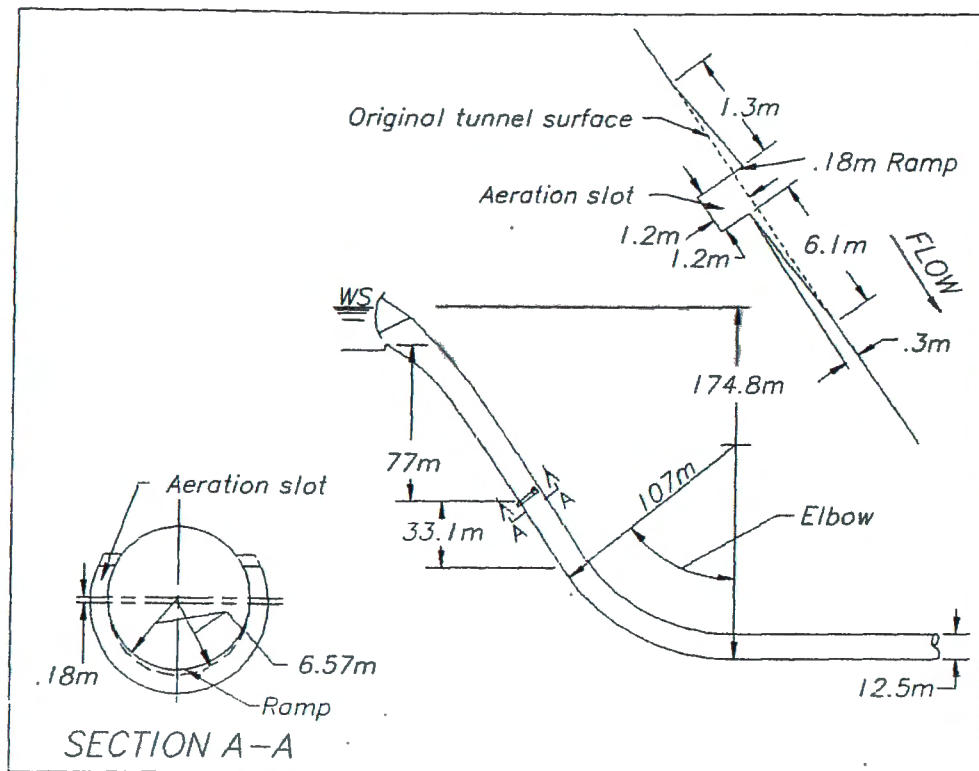
During the flood, 2.4-m-high flashboards were added to the 15.9-m-high radial gates controlling flow into the tunnel spillways. This allowed the spillways to be shut down much sooner than would have otherwise been possible. Massive erosional damage had been sustained in both the left and right tunnels. In the left tunnel, a series of holes had been created in the now familiar "Christmas tree" pattern. The largest hole, near the end of the vertical bend, was 11 meters deep, 41 meters long and 15 meters wide. Most of the tunnel liner had been removed in this area. A smaller but similar hole was found in the right spillway.

Figure 5. - Aerator details - Glen Canyon Dam.

Emergency repairs were begun immediately. At the same time model studies were initiated to develop aeration devices [Pugh, 1984]. The initial aerators were located and designed using the technology and experience developed up to that time. The aerators were located in the conical reducing section of the tunnel about one-half of the way down the tunnel between the intake and the vertical bend. Different ramp heights and offsets away from the flow on the downstream side of the slot were tried. A successful design was developed and installed in both tunnels during the winter and spring of 1983 and 1984. A schematic diagram of the Glen Canyon aerator is shown in figure 1. During the spring of 1984 a major flood again occurred in the Colorado River basin. Even though the reservoir had been drawn down during the winter, the lake level rose onto the flashboards before the construction was complete.

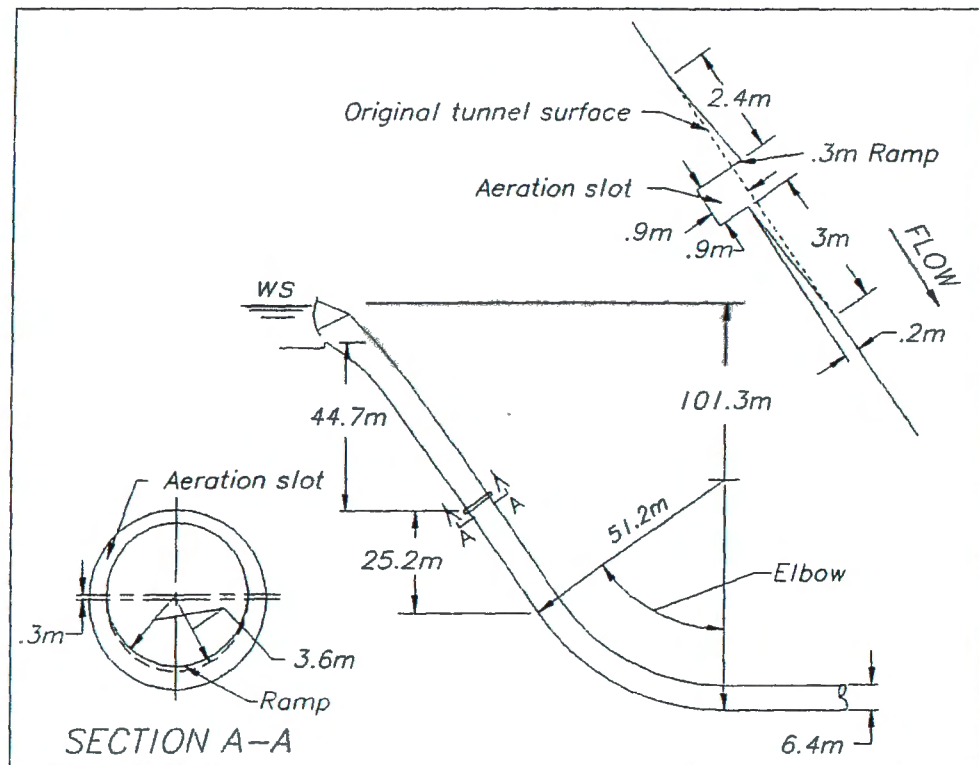
Figure 6. - Aerator details - Blue Mesa Dam.

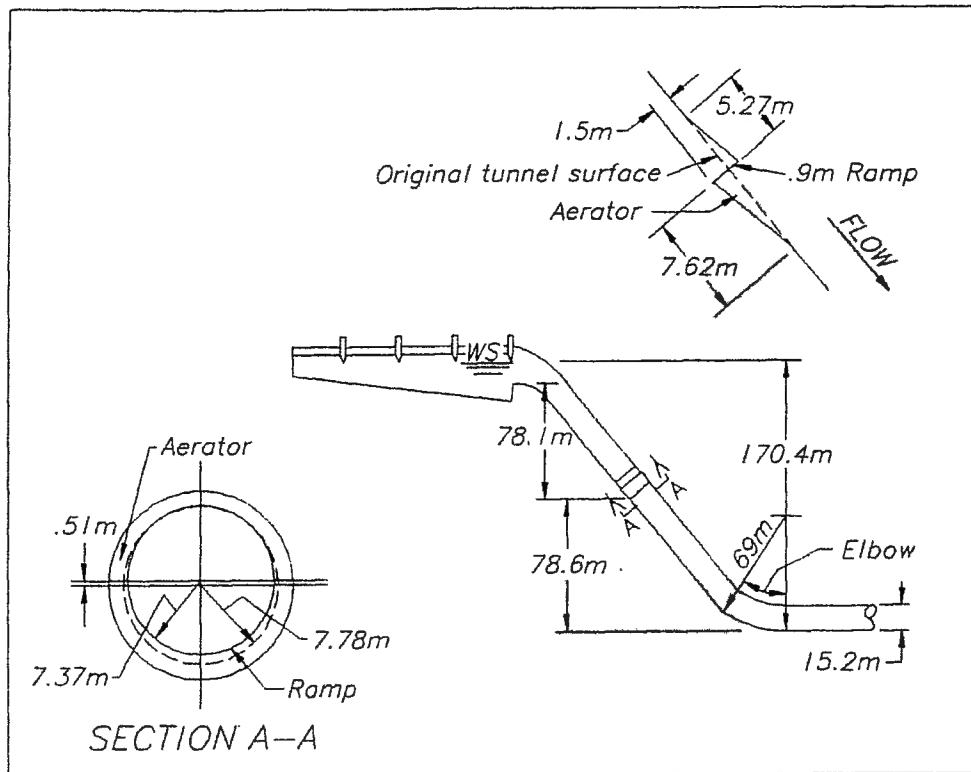
Hoover. - During the 1983 flood, flows of less than $283 \text{ m}^3/\text{s}$ were passed through both spillways at Hoover. Minor cavitation damage occurred as a result. Aeration devices for Hoover were studied in a model of the Arizona tunnel in 1984. Unstable flow from the side channel inlet structure and pressure flow in the downstream tunnel at high discharges caused by the flip bucket geometry prompted changes to the previous aeration device designs [Houston, et al., 1985]. Aerators determined from the model studies were installed at Hoover during 1985 and 1986.

Figure 7. - Aerator details - Hoover Dam.
