NAVAJO VALVE OPERATOR STUDY

SUBJECT: Failure of Limitorque Valve Operators - Navajo Indian Irrigation Project -  
Laboratory Test Results (Your Memorandum Dated July 11, 1988) (Hydraulic  
Research)

## NAVAJO VALVE OPERATOR STUDY

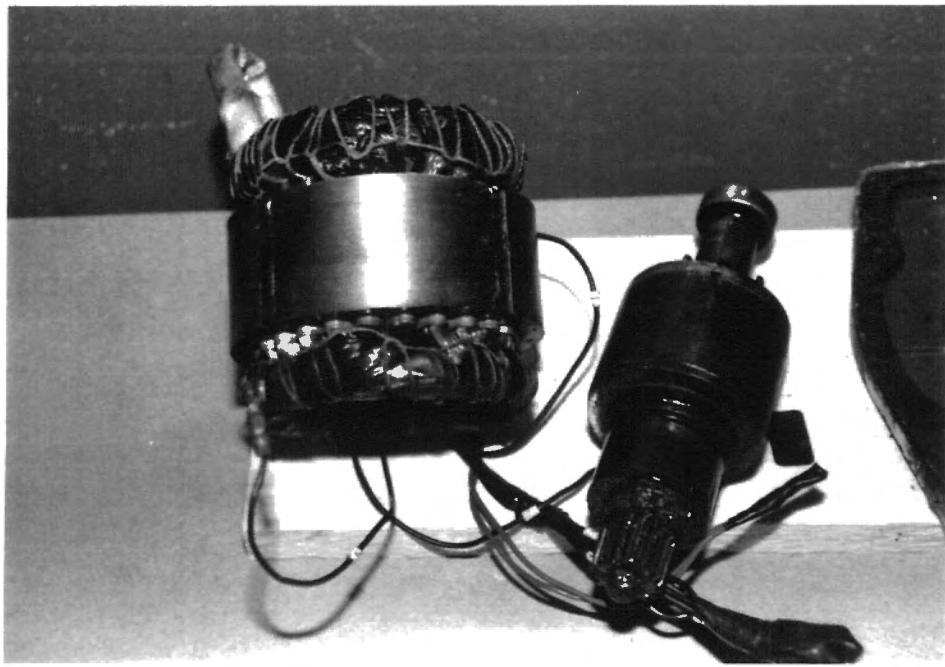
**PHOTOGRAPH 1**

In summary, one valve was inoperative due to a corroded gear assembly  
and a burned out motor. The gear assembly would prevent the motor  
from turning; however the torque limit switch should provide protection  
for the motor when wired properly. Apparently the motor was wired  
incorrectly at one time. The second (operational) valve operated  
properly under all laboratory conditions and was sized properly for  
the application.

Another area of concern was the burned motor. The torque and mechanical limit switches normally protect the motor from damage unless these switches either malfunctioned, were bypassed, or the electrical phasing of the motors was reversed (installed incorrectly) or otherwise wired improperly. Reversing the phase rotation causes the motor to turn the opposite direction, in effect bypassing both the mechanical and torque limit switches. The excessive damage to just one winding could be explained by incorrect wiring of the 3-phase power to the motor.

**Motor Stator and Rotor**  
**Burned windings are at upper and lower left**

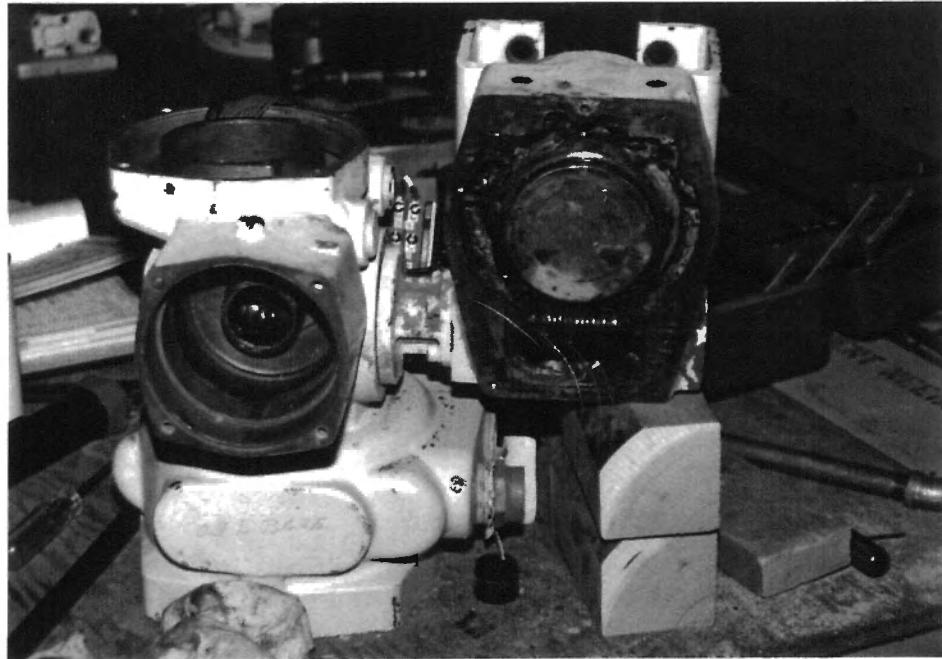
**PHOTOGRAPH 2**

The gear assembly was then removed from the motor operator. The sleeve and shaft between the motor operator and output gear were corroded and the void was filled with a gritty black substance that appeared to be carbon. The gear assembly was still difficult to turn while the motor operator components turned with little friction and were well lubricated.

The output gear assembly was further disassembled so that the worm, shaft and worm gear could be inspected. The worm shaft showed wear and scouring on both ends on the outboard side of the "O" rings. The worm gear also showed wear and scouring on the inboard side of the valve. In both cases there are "O" rings to prevent water or moisture leakage into the gear assembly, but there is no positive way to lubricate the shafts.

Disassembly of the gear drive proved most interesting. The worm and worm gear appeared to be in fine condition with only a small amount of moisture in evidence. However, when the worm shaft and worm gear were removed there was corrosion on the bearing surfaces. This corrosion appears to be the cause of the high friction and difficulty in turning the motor shaft, see Photograph 2.

**Controller Housing and Output Gear with Cover Removed**

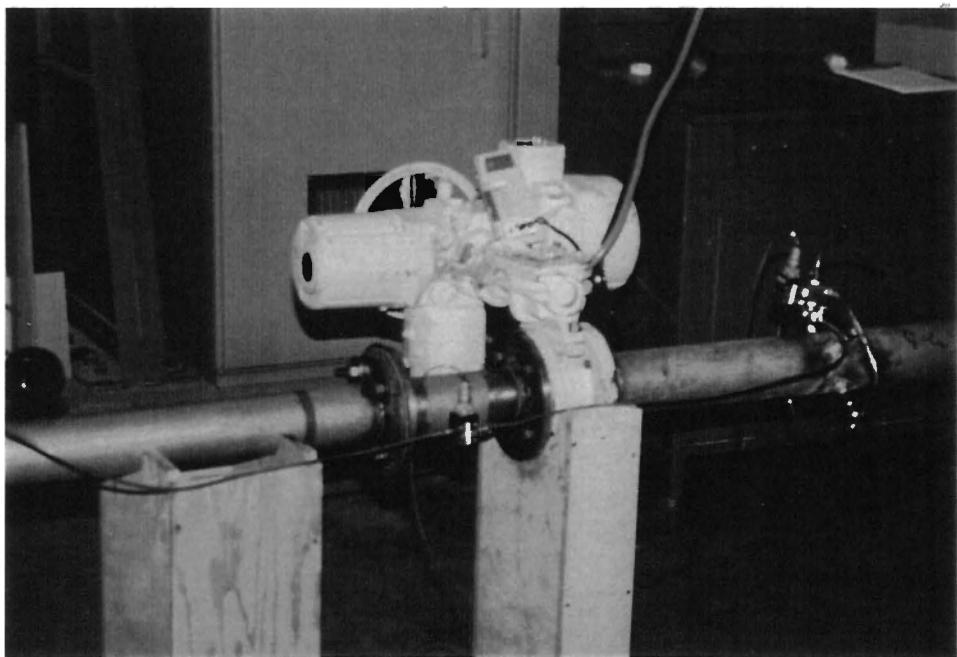
PHOTOGRAPH 3

The second (operable) valve was equipped with a heater in the wiring and torque limit switch housing. A motor controller was added in the laboratory to place the valve in operation. The identification of this valve is provided in Attachment 1. The valve was installed on the high head test facility in the Hydraulics laboratory, see Photograph 3. The high head test facility is capable of providing pressure heads from 60 to 600 feet of water.

The valve operated satisfactorily for all the tests. The direction of flow in the valve can be in either direction. The torque required varied from 50 to 150 in-lb for flow toward the flat face of the valve and from 40 to 410 in-lb for flow toward the curved face (flow reversed). The motor operator was removed in order to make the torque tests. Through the gearing in the operator, the .13 horsepower motor is capable of providing 51,480 in-lb of torque at the valve. This would result in about 25,740 in-lb at the valve shaft, assuming 50% loss for friction and other losses. Therefore, the motor can deliver about 60 times more torque than the maximum torque measured to directly operate the valve under full head.

Valve and Operator Installed on Test Facility
