PAP-551

**EXPERIENCE WITH CAVITATION
IN HIGH PRESSURE SLIDE GATES**

**K. WARREN FRIZELL
BRENT W. MEFFORD**

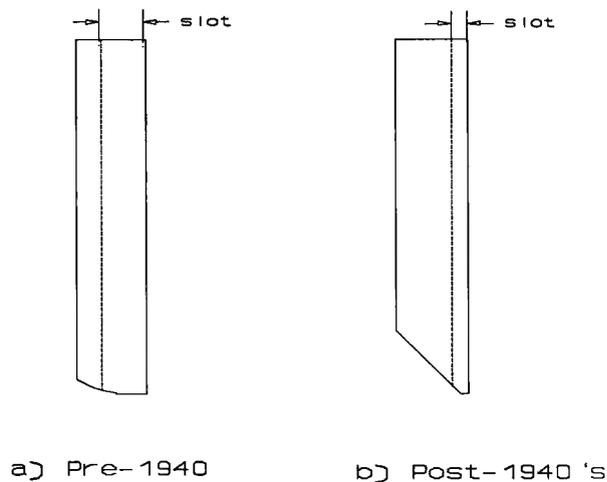
gates were abandoned after years of repeated damage. Reclamation has basically had two major designs of high pressure slide gates over the years. Before 1940, the standard design had a wide seating area and slot, with a curved leading edge on the gate leaf, figure 1a. After many years of operation, this style gate was abandoned as a regulating gate due to continual cavitation damage. During the 1940's, the standard design was modified to include a much narrower seating area and slot with a 45° leading edge on the leaf, figure 1b.

Figure 1: High pressure slide gates used by the Bureau of Reclamation.
