**Tieton Diversion Dam
Proposed Modification for Boater Safety**

by Clifford A. Pugh

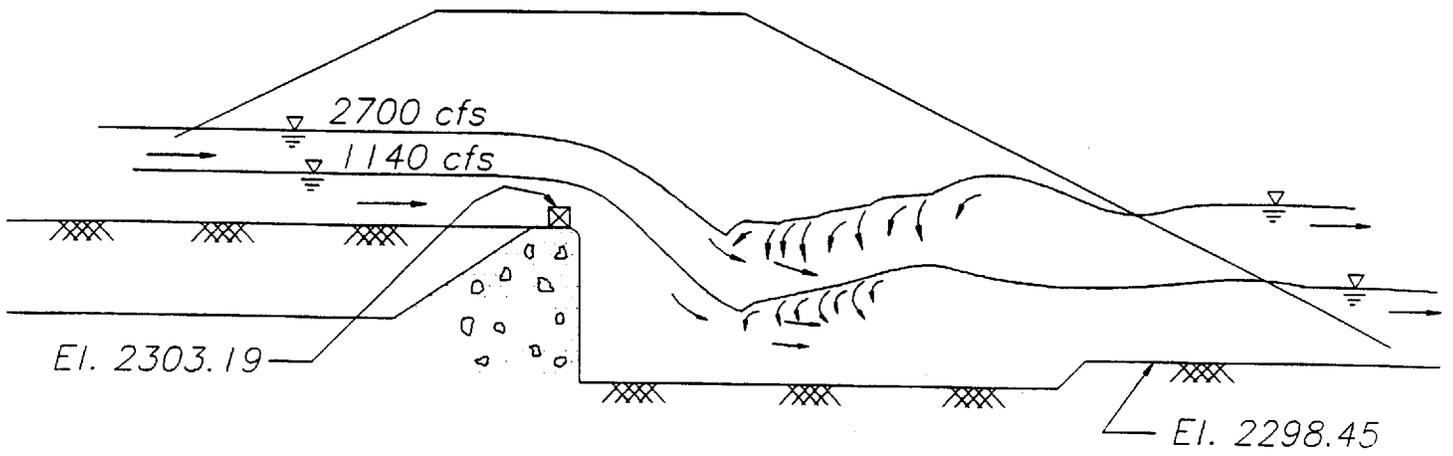
Figure 1 - Tieton Diversion Dam, existing condition

Judging from the original construction drawings, the site visit, and pictures of the dam during operation at various flows, it appears that the timber cribbing originally placed in the stilling area has been removed creating a 6-to 7-foot-deep hole immediately downstream of the crest (see figure 1). The overall drop from the top of the railroad tie bolted to the dam crest to the apron downstream of the stilling area is 4.74 feet. The hole downstream of the dam appears to be partially filled with rock near the left side of the structure, accounting for the difference in head drop from the right side to the left side of the structure. The bend in the river upstream from the structure also concentrates flow on the right side.

Figure 1 is a section through the present dam showing flow profiles at 1,140 and 2,700 ft³/s. The first modification tried was to place 2-foot riprap in the hole downstream of the crest. This approach was intended to reduce the head in steps, thus creating an undular jump and eliminating the roller which traps boaters. The drop from the top of the railroad tie to the top of the riprap was 2 feet. The riprap continued horizontally for about 10 feet downstream then dropped off at a 3 to 1 slope to the downstream apron elevation.

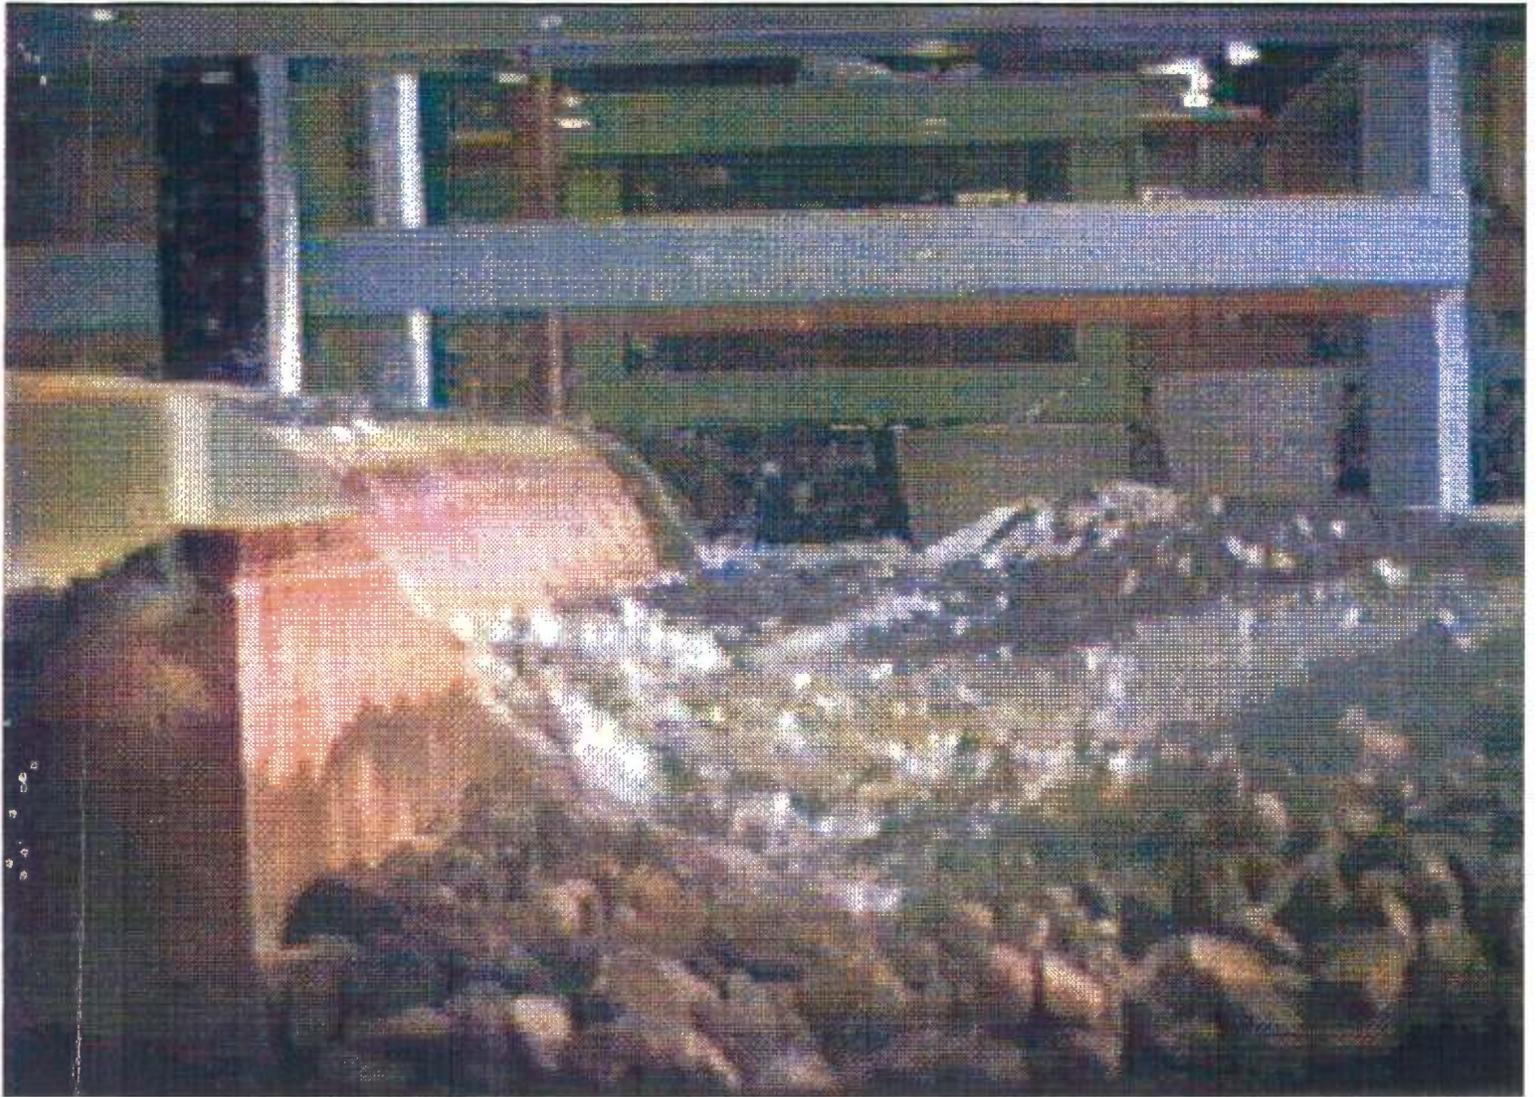
Figure 3. - Tieton Diversion Dam sectional model - existing condition.

The flow at the diversion dam was simulated in our hydraulic laboratory, using a 3-foot-wide sectional model of the site (at a model scale of 1 to 12). The enclosed reproductions of videotape still frames show the model in operation (figs. 3 and 4). The existing situation was simulated first to verify the model. When rafts passed over the dam they were trapped in the same manner as observed at the structure. The videotape demonstrates how the rafts and kayaks are trapped.
