**EROSION OF PLUNGE POOLS DOWNSTREAM OF DAMS DUE TO THE
ACTION OF FREE-TRAJECTORY JETS**

P. J. MASON

PAPER 8734

P. J. MASON, BSc, MPhil, MICE*

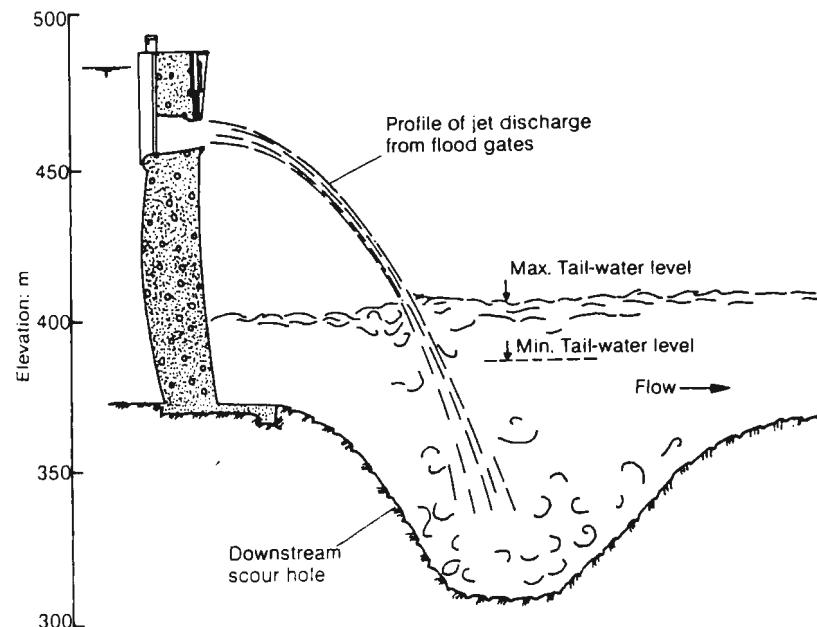
23. The action of the jet and profile of the scour hole, as surveyed in September 1981, is shown in Fig. 2.

Fig. 2. The profile of the jet issuing from the flood outlet works at Kariba Dam and the extent of the downstream scour hole as at September 1981
