ENGINEERING REPORT  
HYDRAULIC INVESTIGATION OF OUTLET  
WORKS AND STILLING BASIN  
TAYLOR DRAW DAM/KENNEY RESERVOIR,  
RANGELY, COLORADO

For  
Water Users' Association No. 1  
Rangely, Colorado

by  
Resource Consultants, Inc.  
402 West Mountain Avenue  
P.O. Box Q  
Fort Collins, CO 80522

January 25, 1991

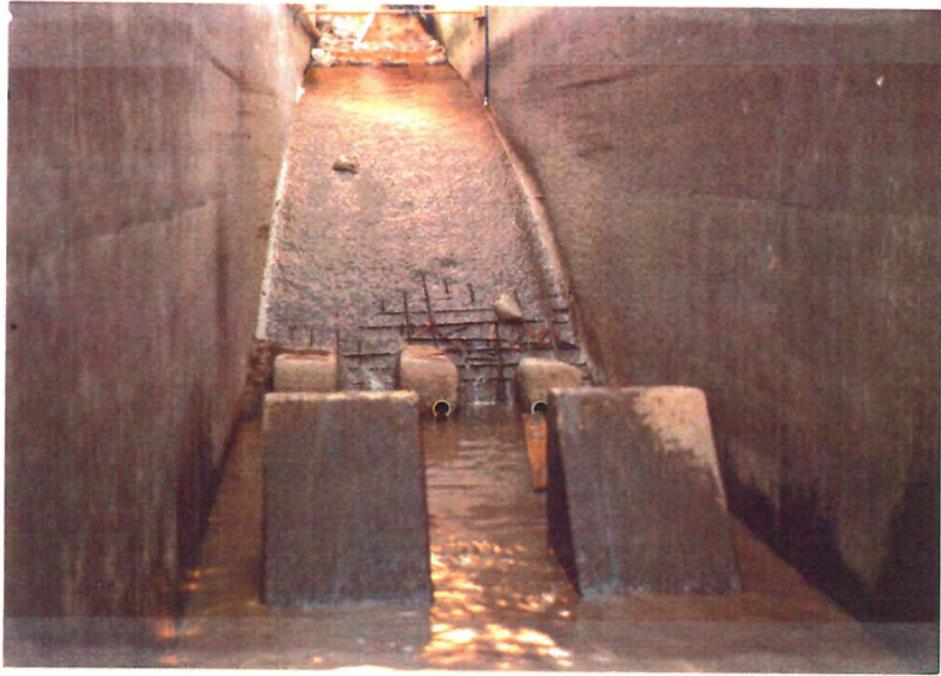
The as-built plan and profile of the stilling basin are shown in Figure 1.1. A survey of the extent of damage sustained during operations 1984-1989 is provided by Figures 2.4 - 2.6. Figures 2.4 a and b show the extent of damage visible during the 1987 inspection. Figure 2.4a looks upstream from below the baffle blocks toward the outlet gate. Abrasion of the basin chute floor and rounding of the chute blocks is apparent. The reinforcing bar is exposed on the chute floor and at the junction of the floor and left wall. The asymmetrical characteristic of the abrasion damage is also apparent, with a tendency for greater damage to the left of the basin. Figure 2.4b is looking downstream at the junction of the left wall and chute floor. Exposure of the reinforcing bar is apparent.

Figure 2.4a. 1987 Inspection - Looking upstream from below the baffle blocks.

1. Repairs necessary to restore the stilling basin floor, walls, baffle blocks, and chute blocks to original (as-built) conditions. Based on the extent of damage, as determined when the stilling basin is dewatered, a level of effort and approach similar to the 1987 repairs should be anticipated. The conceptual design and the scope and cost estimate of Chapter 5.0 are based on the assumption that the damages sustained by the outlet works/stilling basin are no worse than that sustained prior to the 1987 repair. (See Figures 2.4 a-b and 2.5 a-b.)

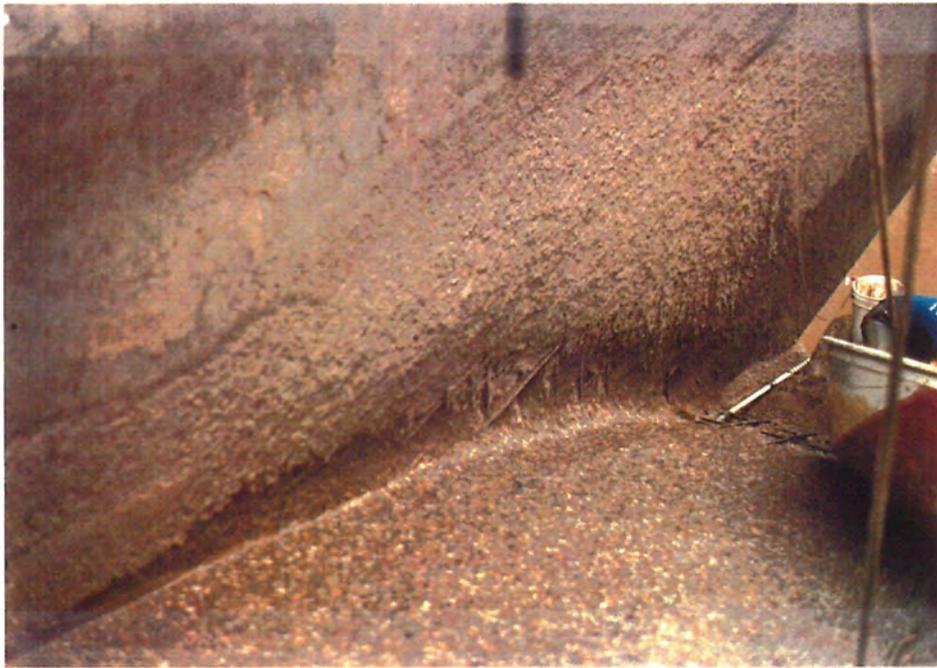
Figure 2.4b. 1987 Inspection - Looking downstream at the left wall and floor.

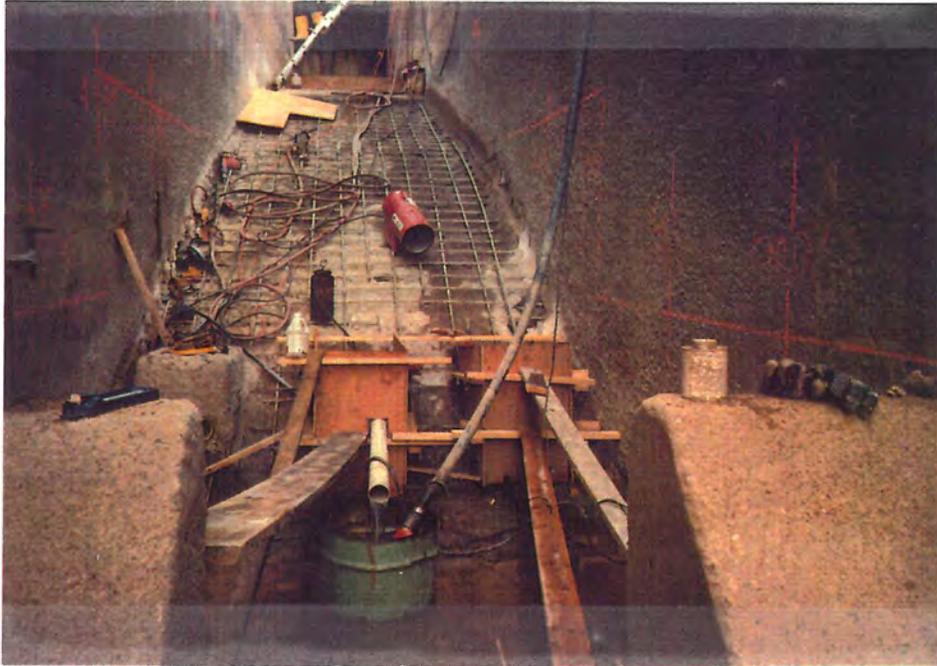
Figures 2.5 a and b show an overview of the repairs in 1987 and typical material removed from the basin floor. Figure 2.5a is looking upstream from below the baffle blocks toward the outlet gate (see Figure 2.4a for comparison). Reinforcing bars for resurfacing the chute floor and forming for the central and left chute blocks are shown. Figure 2.5b shows material taken from the basin floor prior to repairs in 1987. The material ranges in size from sand and fine gravel up to eight inch cobbles.

Figure 2.5a. 1987 Repair - Looking upstream from below the baffle blocks.

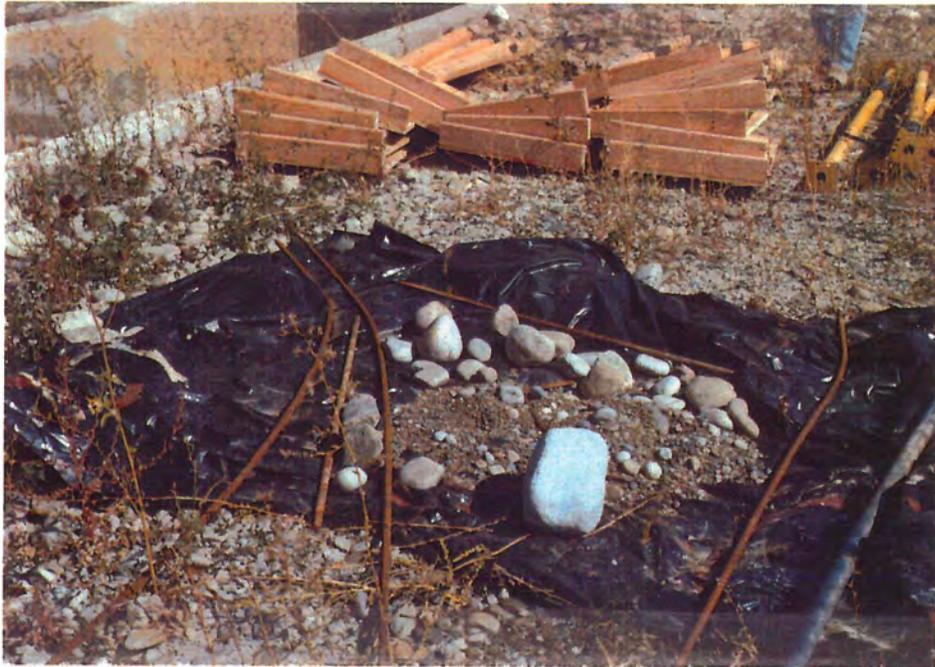
Figure 2.5b. 1987 Repair - Material removed from basin floor.

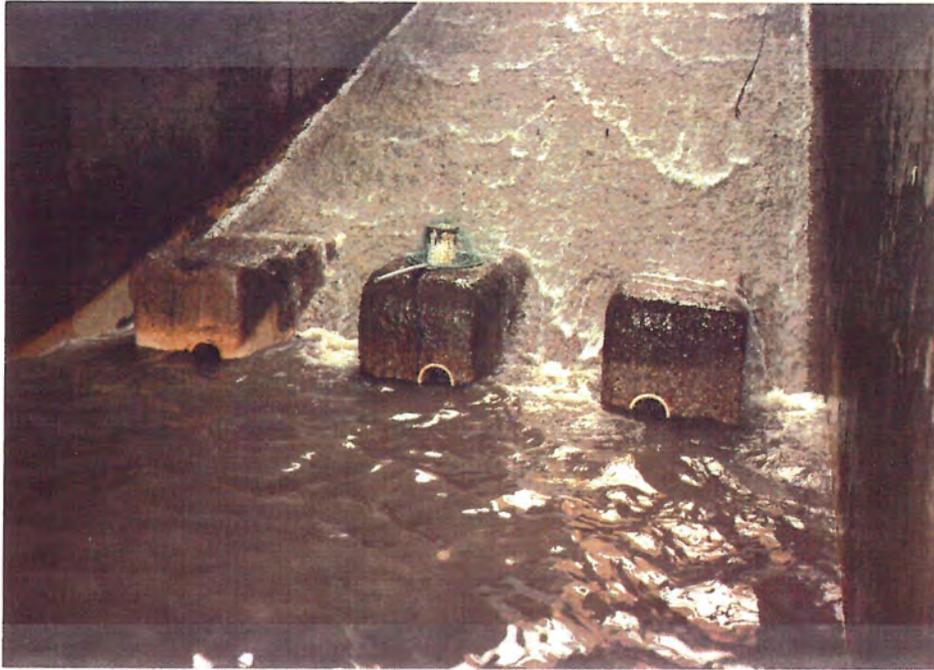
Figure 2.6a. 1989 Inspection - Looking upstream toward the chute blocks.

Figures 2.6 a and b show the extent of damage visible during the 1989 inspection. The basin was only partially dewatered at the time of the inspection. Figure 2.6a is looking upstream toward the chute blocks and Figure 2.6b is a close-up of the junction between the chute floor and the left basin wall. While the damage has a pattern similar to that observed in 1987, it is apparent that the extent of damage is less than what occurred between 1984 and 1987. A complete underwater inspection of damage was conducted in 1990 (see Appendix D).

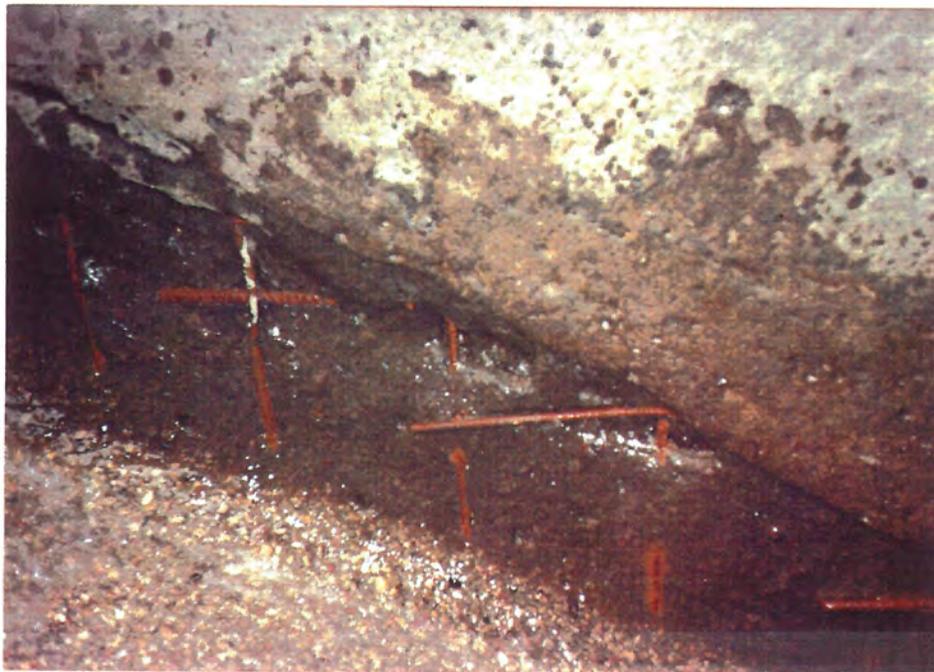
Figure 2.6b. 1989 Inspection - Close up of junction of chute floor and left wall of basin.

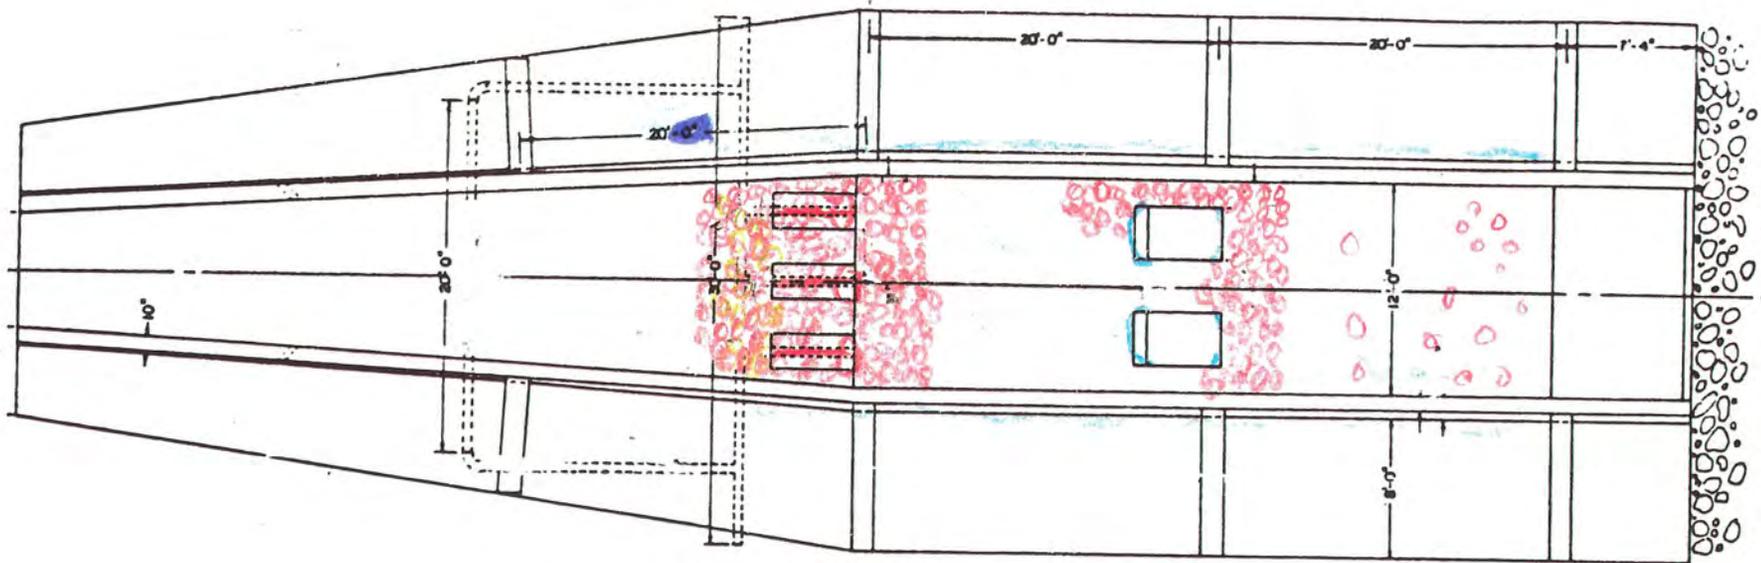
- Exposed Rebar
- 6" minus Cobble
- 9"-10" Cobble
- SCOUR
