Designed - in roughness can protect
cavitation - prone surfaces

Designing Spillways to Prevent Cavitation Damage

by Kathleen H. Frizell and Brent W. Mefford

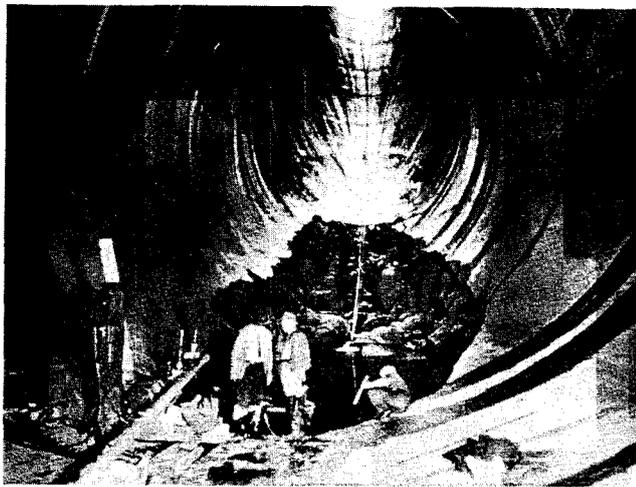
Fig. 2 — 1941 cavitation damage in the Arizona spillway tunnel at Hoover Dam.

The Arizona spillway was first operated for four months in 1941 at an average discharge of 13,555 ft³/s (383.8 m³/s). Following operation, inspection revealed a hole, approximately 30 ft wide, 115 ft long and 45 ft deep (9.14 x 35 x 13.7 m), eroded through the concrete lining of the tunnel invert (Fig. 2).

The inspection revealed a misalignment of the tunnel invert in the form of a hump a few feet upstream of the damaged area. This misalignment was generally accepted as the source of the cavitation that initiated the damage. A subsequent Reclamation report² stated:

Although aeration would be studied, the immediate repair of the damage focused on reconstructing a smooth flow surface. The eroded areas were repaired with concrete.³ After curing, the surface was stoned, then ground smooth with a small terrazzo machine.

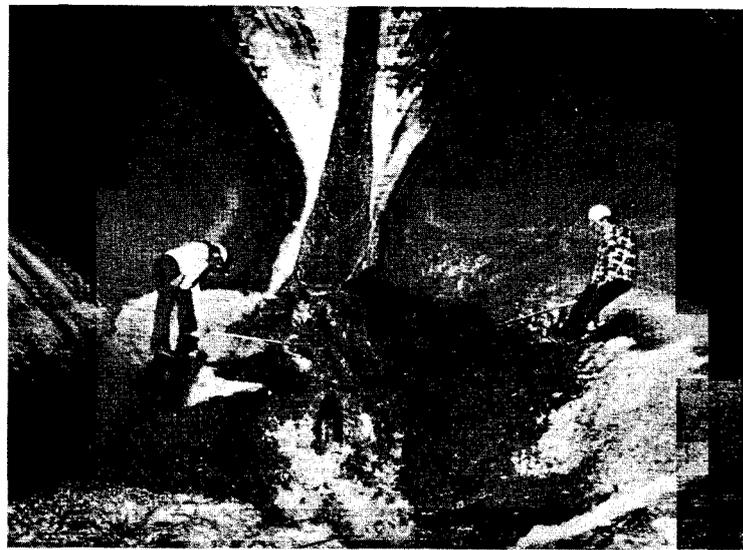
Fig. 3 — 1983 cavitation damage in the Nevada spillway at Hoover Dam.

In 1983, major spring runoff down the Colorado River caused Hoover Dam to pass water through its spillways. With releases of about 14,000 ft³/s (396.4 m³/s) significant damage occurred in the elbow of the Nevada spillway tunnel (Fig. 3) and minor damage in the Arizona tunnel. Inspection of the tunnels after the damage revealed extensive calcite deposits, some 2 in. (50.8 mm) thick, and joint offsets within the tunnels. The concrete surface had obviously roughened significantly with age. No additional damage was noted downstream of

the tunnel elbows where the rough invert had not been repaired in 1941.

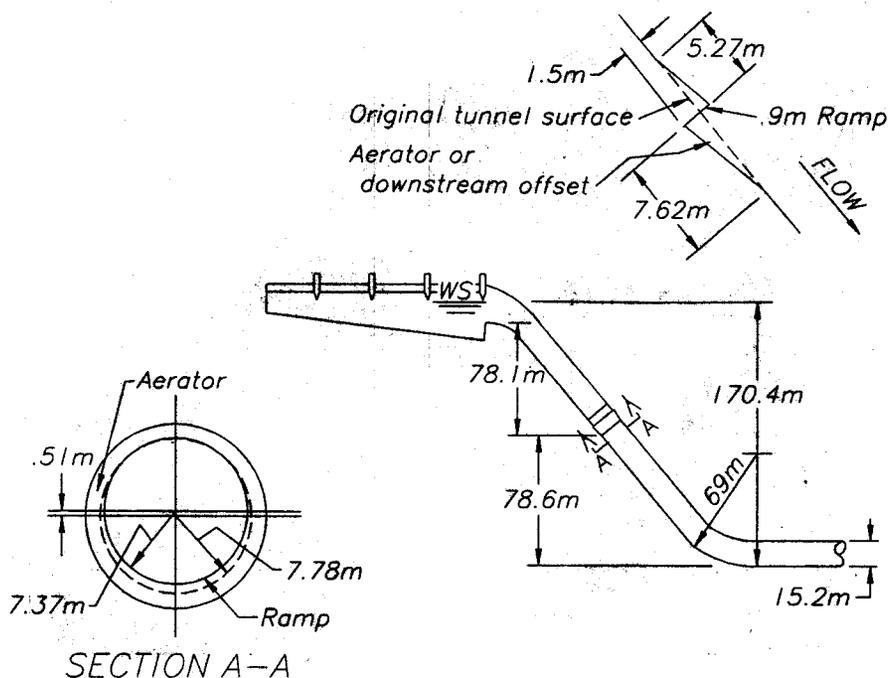
Fig. 4 — Aeration device for Hoover Dam tunnel spillways.

Extensive hydraulic model studies were undertaken to investigate adding aeration devices to prevent further cavitation damage at Hoover and several other of Reclamation's tunnel spillways. As mentioned earlier, attempts had been made previously to protect structures from cavitation by providing air to the flow surfaces. Advances in technology now indicated a properly located and dimensioned aerator would significantly reduce the potential for cavitation damage at Hoover Dam.⁵ The aerator designed for the Hoover Dam spillways is shown in Fig. 4.

The aerator was located in the tunnel based upon the point at which the cavitation index of the flow dropped to 0.2. The geometry was developed through a model study which determined the ramp or deflector size, size and shape of the aerator, and the geometry of the downstream offset.
