PAP-646

**STRAIN MEASUREMENT ON THE RUNNER
OF A HYDROELECTRIC TURBINE**

August 1994

**Presented at the ASCE 1994 Symposium on Hydraulic
Measurements and Experimentation, Buffalo, New York**

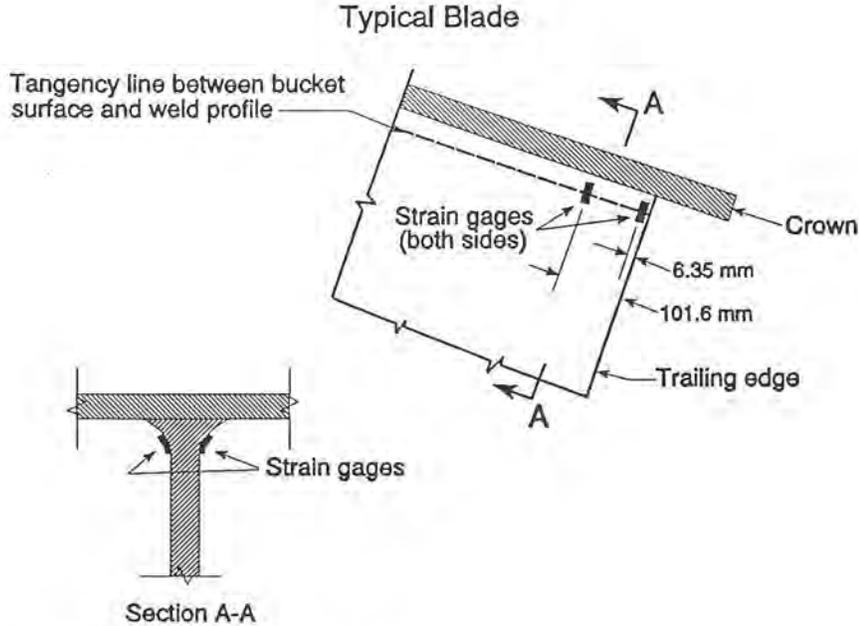
Figure 1: Location of strain gages.

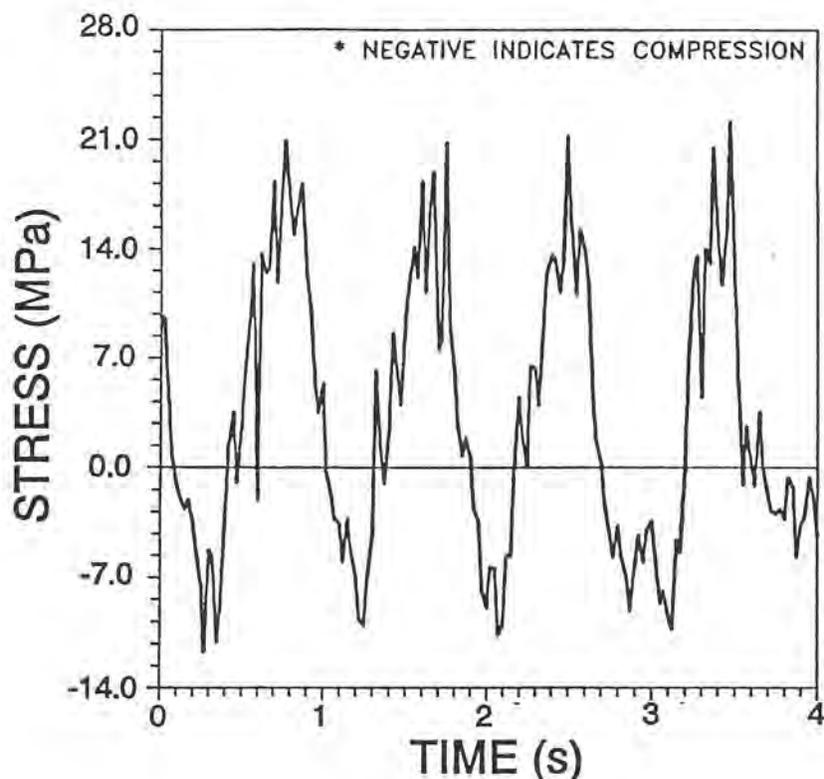
Figure 5a: Time series of stress levels on gage 10 at a 40-percent wicket gate position (note periodic draft tube surge).

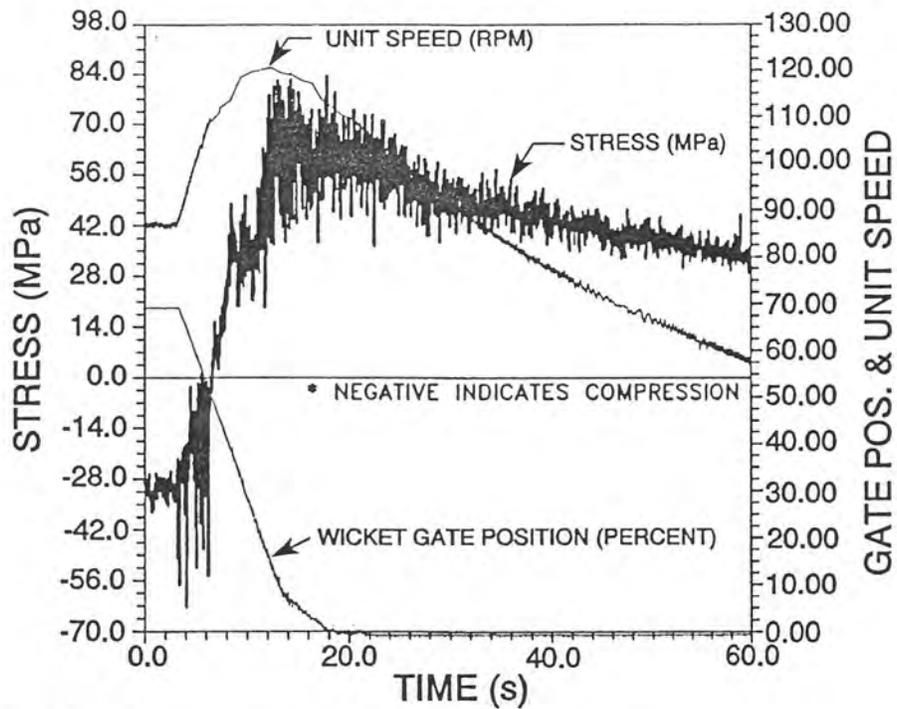
Figure 5b: Output of gage No. 10 during a load rejection.
