PAP-661

**Final Report
WATER Project NMA3A - Detection of Damaging Cavitation
Tests Conducted at Flatiron Powerplant
February 1994**

**by
K. Warren Frizell**

October 12, 1994

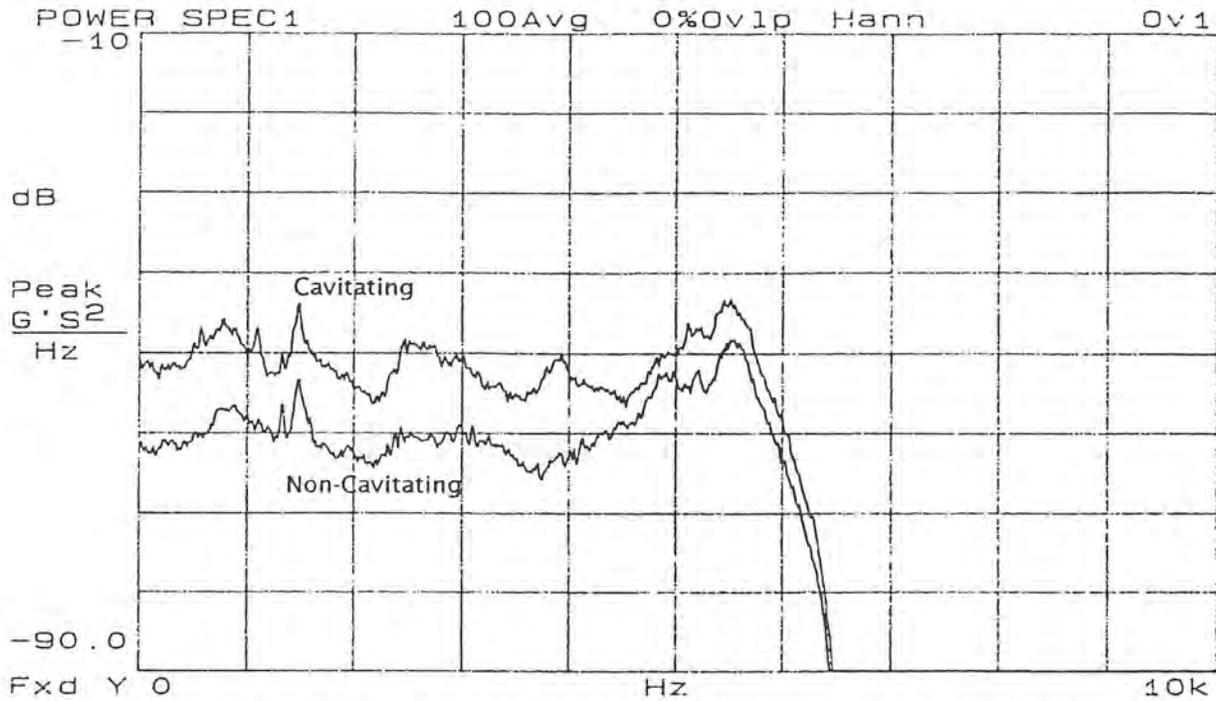
Power spectrum density plots (figures 1-4) were constructed for the output from each sensor under cavitating and non-cavitating conditions. In all four figures a 10 dB change in the power spectrum density indicates a change of one order of magnitude in the signal level. In figures 1-3, the accelerometer signals are shown in units of g's. The accelerometers on the wicket gates (figures 3 and 4) show significant increases in signal level throughout the range of 0 to 6.5 kHz, with the largest increases (about 10 dB) being below 4 kHz. The signal from the accelerometer mounted on the shaft (figure 3) was also elevated under cavitating conditions, but only below 4 kHz. The largest increases (about 15 dB) were in the range of 0 to 1.5 kHz.

Figure 1. - Power spectrum plots of accelerometer outputs from wicket gate 1 under cavitating and non-cavitating conditions. This accelerometer was mounted on the side of the wicket gate linkage cap using a magnetic base.

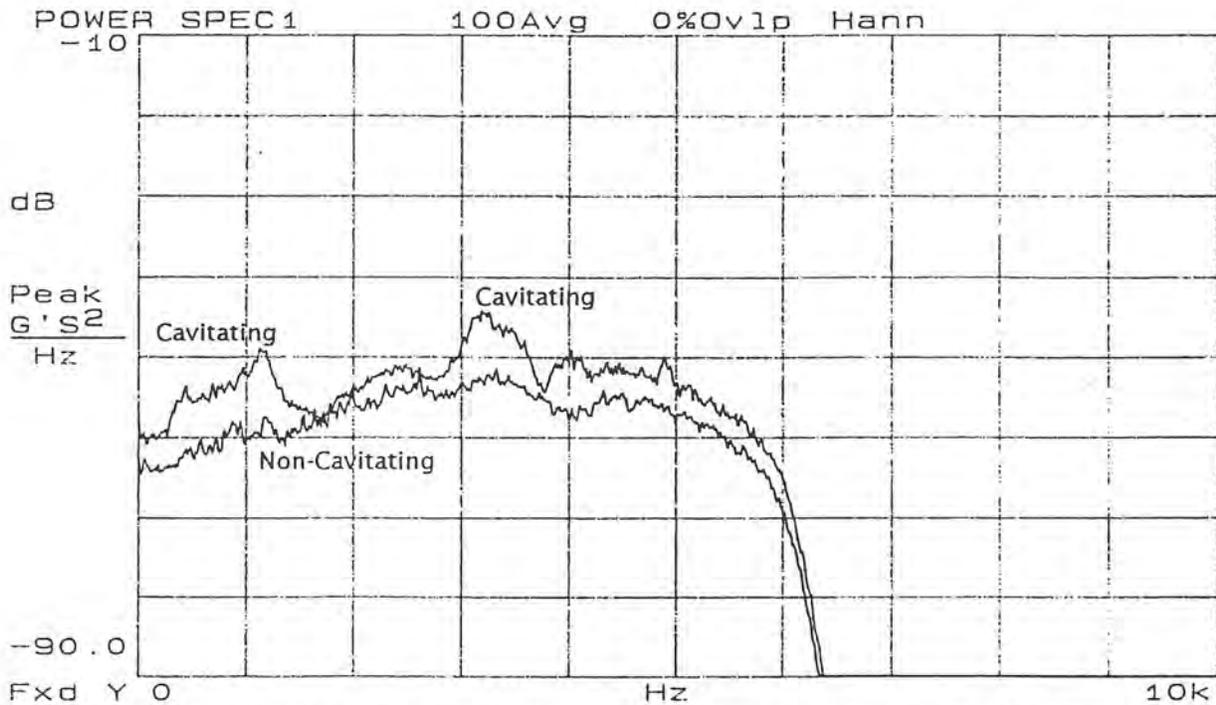
Comparing the power spectra in figures 1-3 shows that there are substantial differences in the distribution of the signals in the frequency domain and in their reaction to the presence of cavitation. By relocating and interchanging the various sensors we confirmed that both the mounting methods and the location of attachment significantly affect the signal. For each particular location, comparison of signals with and without cavitation is meaningful, but comparisons of signals recorded from different sensors at different locations or using different mounting methods would not be valid.

Figure 2. - Power spectrum plots of accelerometer outputs from wicket gate 15 under cavitating and non-cavitating conditions. This accelerometer was mounted on the top of the wicket gate link using epoxy.

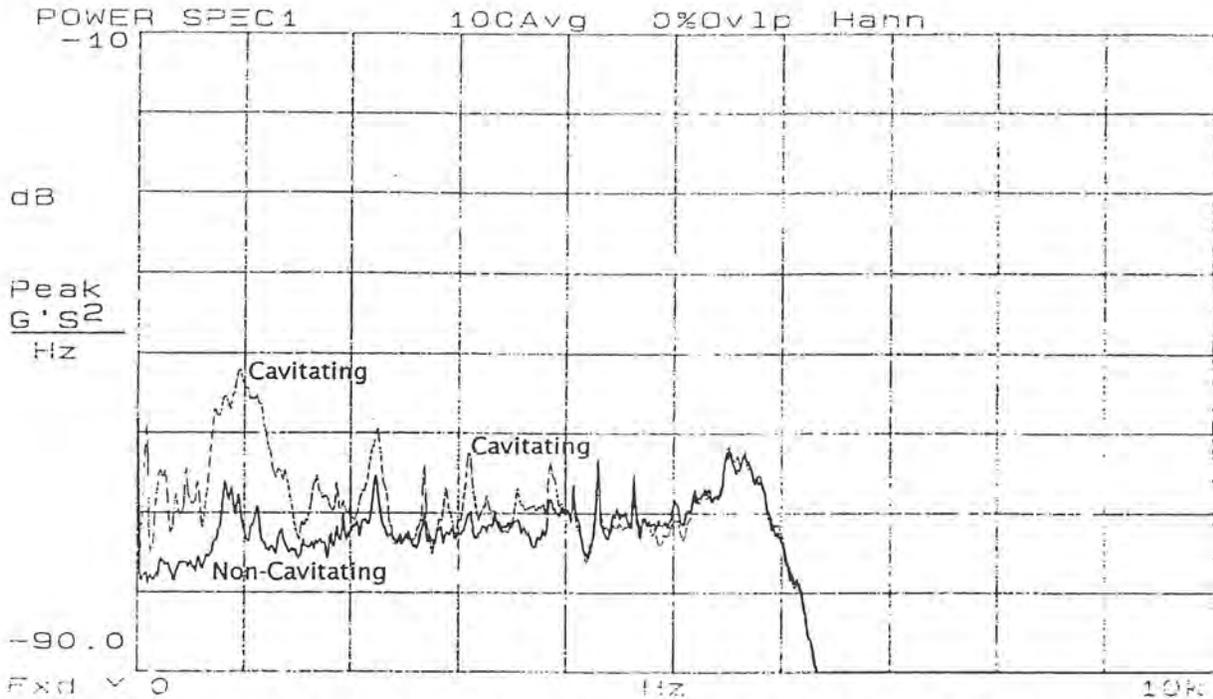
Figure 3. - Power spectrum plots of accelerometer outputs from the turbine shaft, just above the turbine guide bearing. This accelerometer was mounted to the shaft using hot glue.

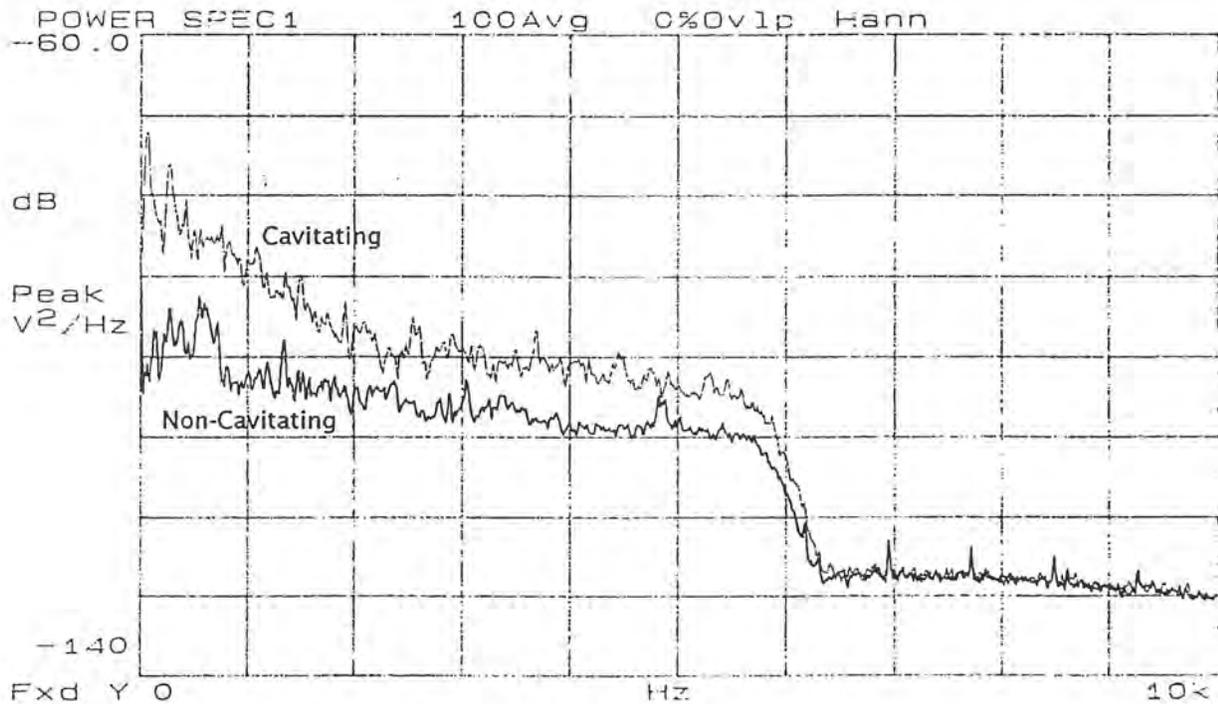
The recorded hydrophone signal (figure 4) also showed increased noise under cavitating conditions, in the frequency range 0 to 6.5 kHz. The largest increases (about 15 to 25 dB) are at frequencies below 2 kHz. Dr. Skinner also monitored hydrophone signals during the test with a dynamic signal analyzer, using one-third octave analysis. We observed significant reductions in signal level above a frequency of about 80 kHz when cavitation was occurring. Unfortunately, we did not record these one-third octave analyses and could not recreate them from the digital tapes due to the 6.5 kHz upper frequency limit of the recorded signals.

Figure 4. - Hydrophone outputs with and without cavitation.

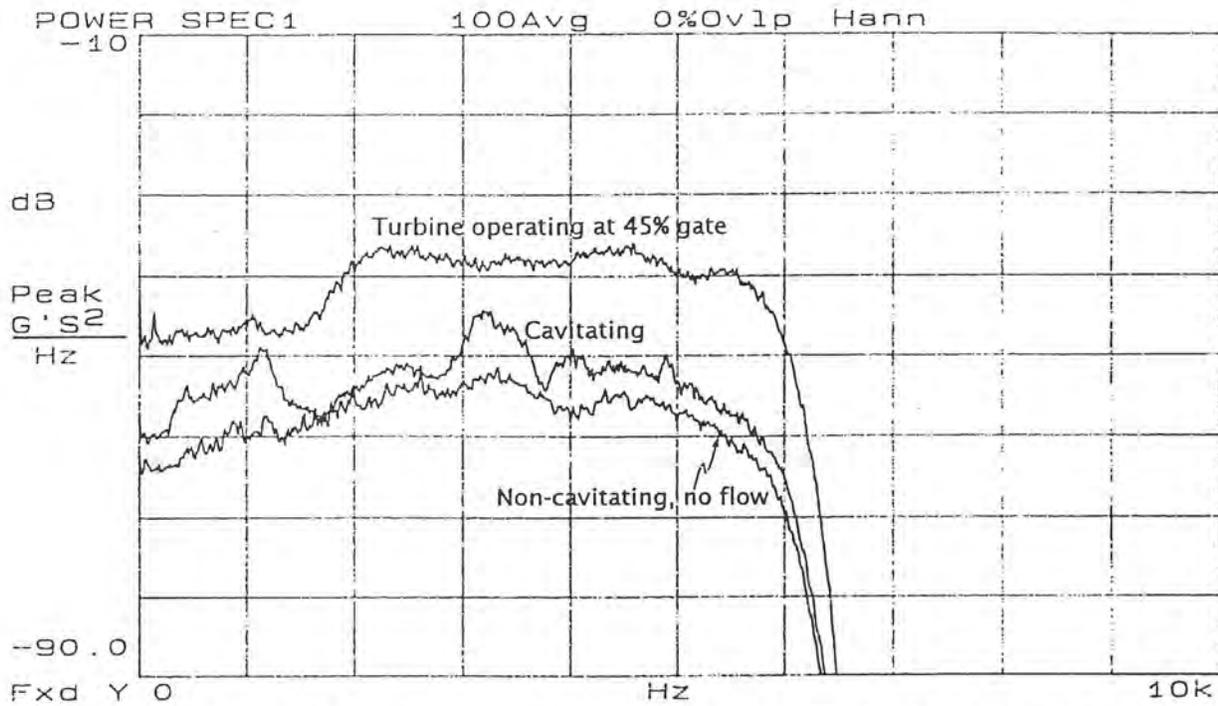
The analysis of the signals recorded from accelerometers during operation of the turbine from speed-no-load to 55 percent wicket gate opening gave no indication of wicket gate vibrations related to draft tube surging. We noted that operation of the turbine was quite smooth with no indication of severe surging in the range in which the unit operated during the test. Figure 5 shows the power spectrum of accelerometer output from the linkage of wicket gate 15 with the turbine operating at 45 percent gate. The signal level is elevated throughout the spectrum in comparison with the signals recorded with the turbine not operating (with and without cavitation of the wicket gates).

Figure 5. - Power spectra of signals recorded from wicket gate 15. The level of ambient flow noise without cavitation is about 10-15 dB higher than the noise detected during cavitation of the wicket gates without turbine operation.
