**Terror Lake Hydroelectric Project, Falls Creek Diversion Tunnel
Hydraulic Analysis**

**Terror Lake Hydroelectric Project
Falls Creek Diversion Tunnel
Hydraulic Analysis**

Terror Lake Hydroelectric Project Repair of Falls Creek Diversion Works

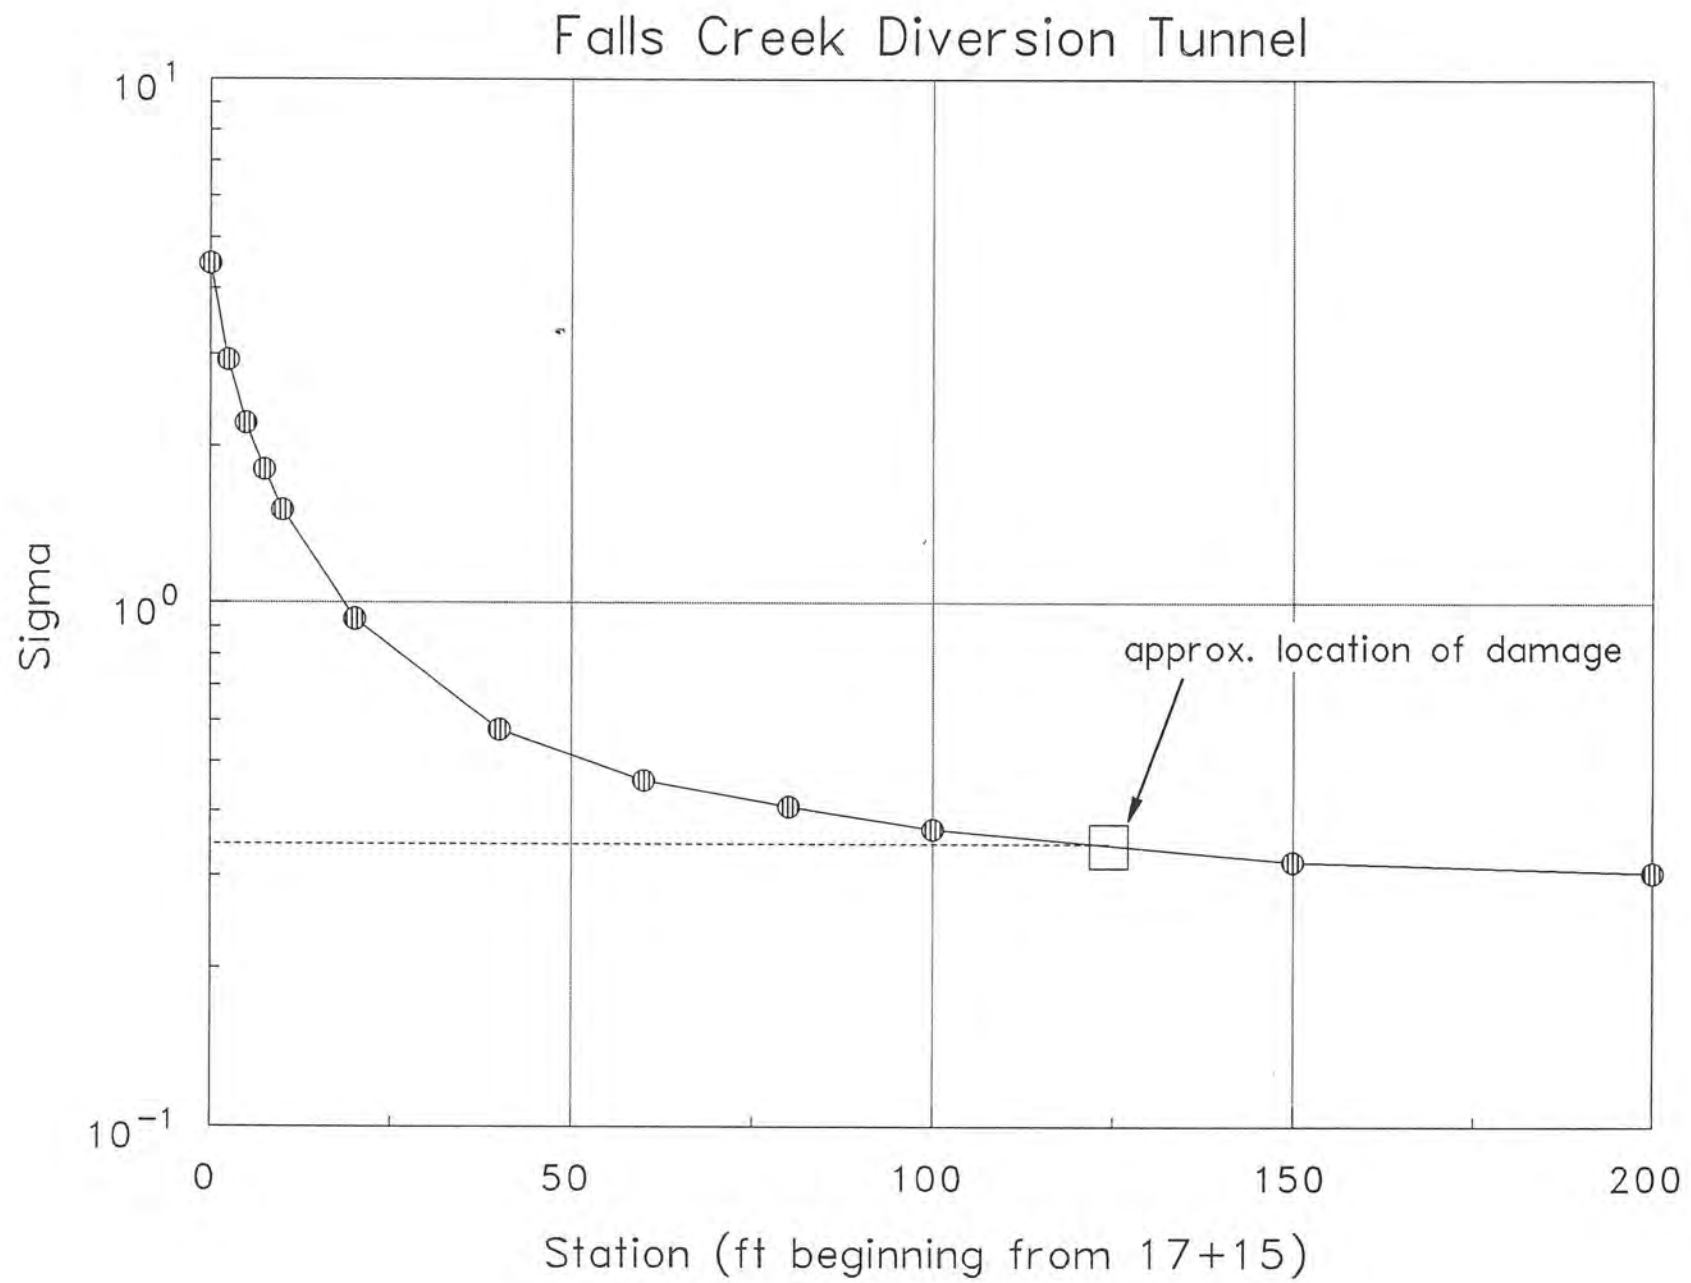
Figure 1

Results of this analysis showed that for a relatively smooth surface (rugosity = 0.002 ft) the cavitation index at the station where the damage has occurred was about 0.35 (figure 1). With a rougher surface, which would be more characteristic of an unlined rock tunnel, the cavitation indices are even higher. However, the velocities at the damage location are on the order of 75 feet/second. Taking into account the highly fractured rock which was discovered in this area during construction, hydraulic mining due to the high velocity jet along the tunnel surface is the probable cause for the existing damage and rock fall. High pressures can be generated in cracks and gaps due to high velocity flow (Hepler and Johnson, 1988). If the pressures are high enough (or the rock blocks small enough), material can easily be lifted from place and removed. Once this process begins, further damage occurs due to the increased hydraulic energy dissipation until an equilibrium is reached based on flow conditions and material properties in the area of concern.

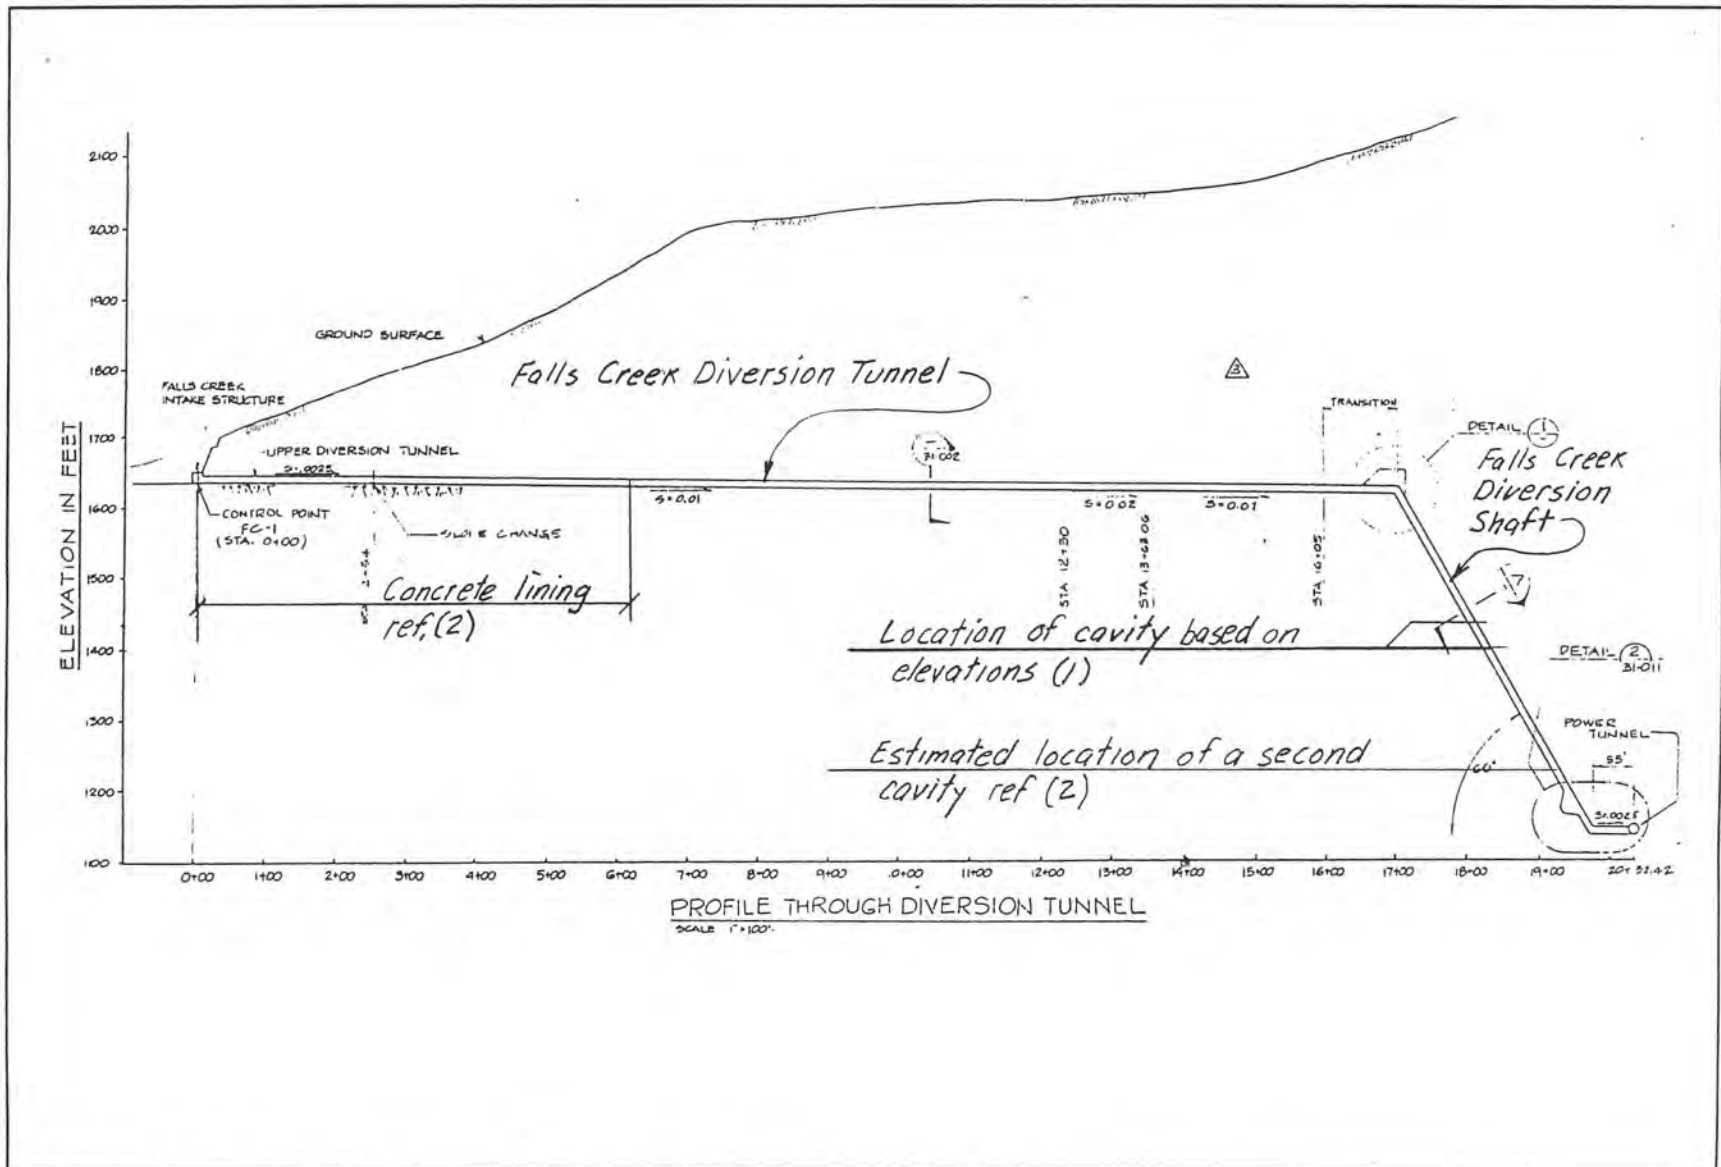
Figure A.2 Profile Falls Creek Diversion (from Kodiak Electric Association, Inc. drawing TL-31-003)

Another area of erosion in the shaft was described in the video narrative but was not photographed. If the damage is similar to that shown in Figure A.5, this area should also be repaired. This location is shown approximately on Figure A.2.

A second cavity mentioned in (2) should be investigated for possible repair.

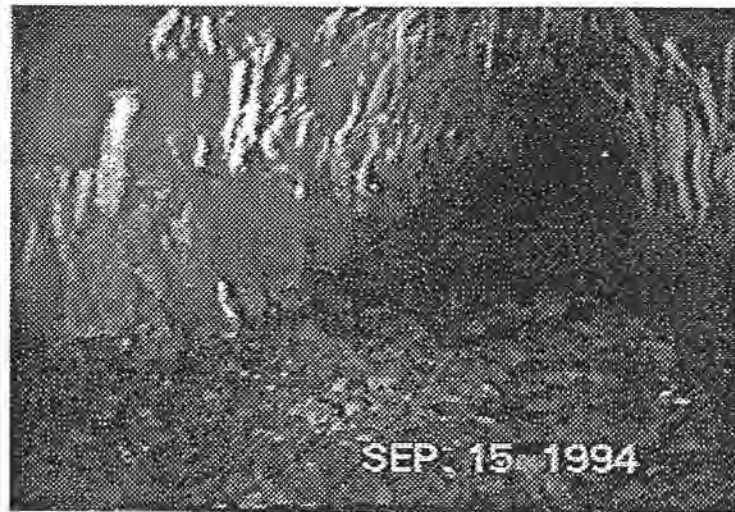
Figure A.4 View captured from video (2) showing Falls Creek Diversion Tunnel.

The reported condition of Falls Creek Diversion Tunnel indicates greater erosion and deterioration of the excavation than that encountered in the Power Tunnel. The inspection report (1) describes the Power Tunnel as: "... in very good condition with only minor rockfalls.." and "Invert erosion was minimal or absent." (1, p. C-6). Figure A.4 shows erosion and deterioration of Falls Creek Diversion Tunnel. Geologic differences between Falls Creek Diversion Tunnel and the Power Tunnel were not noted in the inspection report and geologic profiles were not available, so it is possible Falls Creek Diversion Tunnel was excavated in more fractured rock. The two tunnels were excavated differently; drill and blast excavation was used in Falls Creek Diversion Tunnel. The combination of blast damage to the rock and flow velocities on the order of 10 feet per second, probably explains the erosion in Falls Creek Diversion Tunnel. Erosion will probably continue perhaps at a reduced rate until sound rock is encountered throughout the tunnel and the tunnel cross section reaches a stable shape. Previous erosion was not identified as a problem, so continued erosion may be equally tolerable.

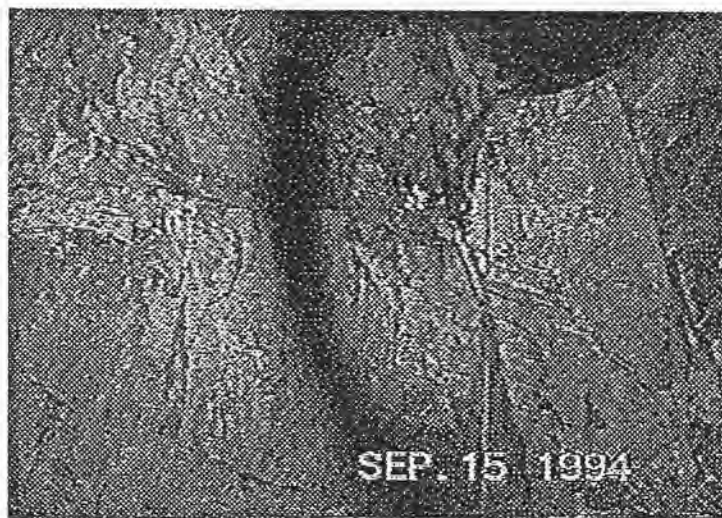
Figure A.5 View captured from video (2) showing Falls Creek Diversion Shaft near elevation 1400 to 1435 feet.

The hydraulic analysis of the system attributes the damage in Falls Creek Diversion Shaft near elevation 1400 to 1435 to hydraulic mining. Figure A.5 shows the cavity with the shaft in the upper right of the photograph. Highly fractured rock conditions were mentioned in the inspection report with the implication that erosion at that location could be due to a fault. The combination of high velocity flows and fractured rock allowed initial erosion of the rock which continued to the current shape. Based on the results of the USBR hydraulic analysis, we recommend restoration of the shaft cross section to the original diameter. Possible repair methods are discussed in the following section.

We recommend repair of Falls Creek Diversion Shaft near elevation 1400 using a steel liner with erosion resistant lining. The steel liner should be backfilled with concrete and backfill grouted near the top of the installation. Figure A.6 shows the recommended repair.
