Operation of Glen Canyon Dam Spillways - Summer 1983

Philip H. Burgi 1/, M., ASCE, Bruce M. Moyes 2/, Thomas W. Gamble 3/

**Abstract.** - Flood control at Glen Canyon Dam is provided by a 41-ft (12.5-m) diameter tunnel spillway in each abutment. Each spillway is designed to pass 138 000 ft<sup>3</sup>/s (3907.7 m<sup>3</sup>/s). The spillways first operated in 1980 and had seen very little use until June 1983. In early June the left spillway was operated for 72 hours at 20 000 ft<sup>3</sup>/s (566.3 m<sup>3</sup>/s). After hearing a rumbling noise in the left spillway, the radial gates were closed and the tunnel was quickly inspected. Cavitation damage had occurred low in the vertical bend, resulting in removal of approximately 50 yd<sup>3</sup> (38.2 m<sup>3</sup>) of concrete. Flood flows continued to fill the reservoir. Both spillways were operated releasing a total of 1 626 000 acre-ft (2.0 x 10<sup>9</sup> m<sup>3</sup>) over a period of 2 months. Extensive cavitation damage occurred in both spillways in the vicinity of the vertical bend.

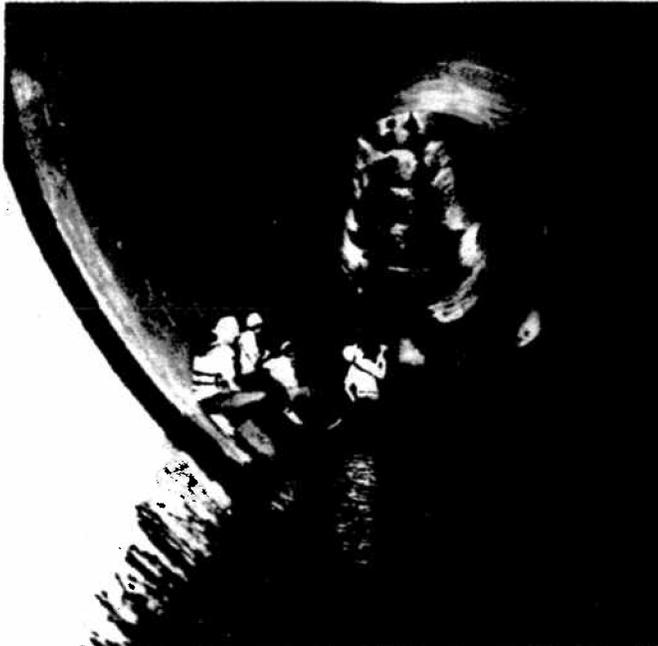
were heard coming from the left spillway. That afternoon engineers inspected the tunnel and found several large holes in the invert of the vertical bend. The damage was initiated by cavitation which had formed as a result of a calcite deposit 0.25 in (0.64 cm) high on the tunnel invert at approximately Sta. 25+00. Four-foot (1.2-m) high plywood flashboards were immediately installed on top of the four spillway gates. By June 8 it was clear that both spillways would have to be used to pass the flood without overtopping the spillway gates. An analysis of the potential for cavitation damage in the tunnel spillways indicated that if the releases could be held below 6000 ft<sup>3</sup>/s (169.9 m<sup>3</sup>/s), it would take several months of operation to produce serious damage. The fact that the left spillway was already seriously damaged and continued high inflows into Lake Powell would force higher releases through the spillways prompted a decision to continue to use the left tunnel spillway and reserve the right spillway (maintain releases of 6000 ft<sup>3</sup>/s or less) should the need for its use arise in the future. In making the decision to increase the discharge through the left spillway, it was recognized that the invert of the vertical bend and downstream tunnel would be seriously damaged. It was also recognized that the spillway flip bucket would eventually be unable to flip the jet as the velocity decreased due to increased damage, with time, along the tunnel invert. However, it was hoped that this action would direct the high energy jet downstream along the tunnel centerline producing damage in the horizontal tunnel away from the tunnel plug.

Tunnel Spillway Damage. - In early August the tunnel spillways were dewatered and engineers entered the tunnels from the downstream flip buckets. Upon entering the left tunnel it was obvious that serious damage had occurred. There was approximately 300 yd<sup>3</sup> (230 m<sup>3</sup>) of concrete, reinforcing steel, and sandstone in the flip bucket. Once inside the tunnel the first 200 feet (60 m) were relatively free of debris. A large sandstone boulder, 8 by 15 by 15 ft (2.4 by 4.6 by 4.6 m), was found in the tunnel invert some 500 ft (150 m) upstream from the bucket. Debris several feet deep was found in the invert of the tunnel downstream from the boulder. Except for some debris immediately upstream from the boulder, the invert to the vertical bend was relatively clean. Extensive damage had occurred in the vertical bend from approximately Sta. 23+90 through Sta. 26+90. Immediately downstream from the P.T. of the vertical bend, a hole 35 ft (10.7 m) deep, 134 ft (40.8 m) long, and 50 ft (15.2 m) wide had been excavated in the sandstone by the high energy flow. Three-fourths of the tunnel liner circumference had been removed in the area of the deep hole, figure 3.

a. View looking upstream across flooded hole at cavitation damage in the vertical bend. Note that the tunnel liner has been removed well above the springline August 1983.

Conclusions. - The operational experience gained at Glen Canyon Dam during the summer of 1983 has led to increased understanding of the damage caused by cavitation formation in high velocity flow. An air slot has been designed and laboratory tested to solve the problem. Repairs and installation of the air slot in each tunnel are scheduled for completion before the 1984 runoff season. Following is a summary of the conclusions or "lessons learned" from the 1983 experience at Glen Canyon.
