Memorandum
Chief, Hydraulics Branch

Denver, Colorado
August 28, 1978

Research on Abrasive Materials in Stilling Basins

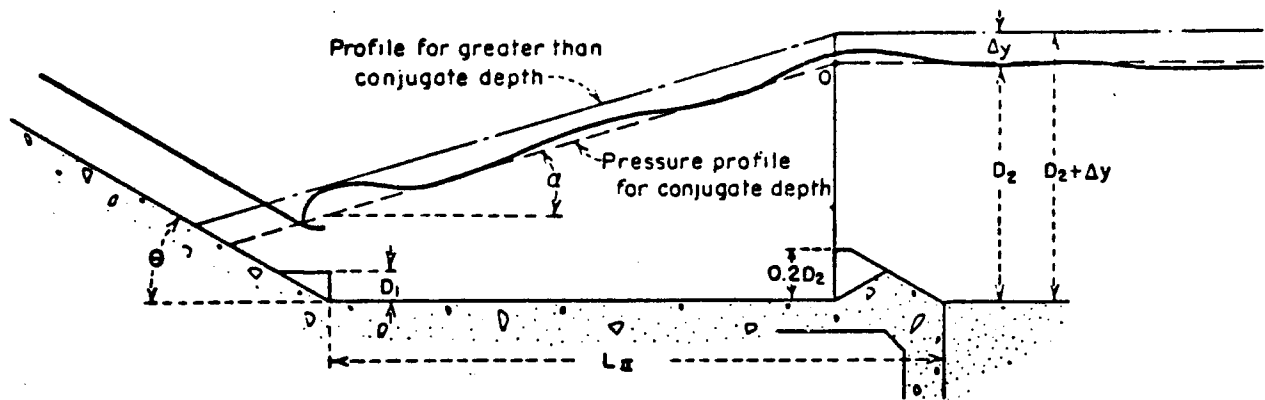
Figure 2a. Shape of jump for verification tests.

Figure 2. Difference in length of basin between verification tests and existing type II Basin data points as shown in Figure 1.

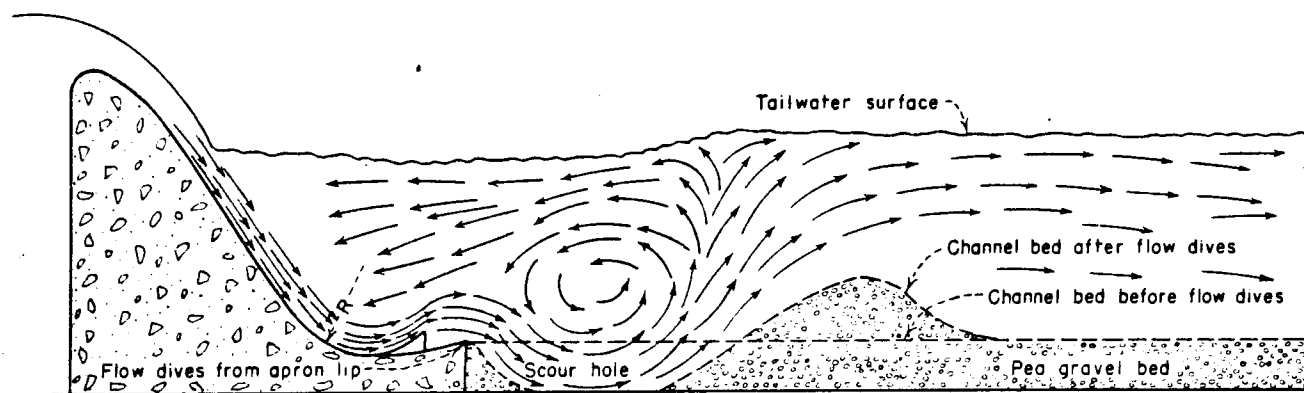
FIGURE 4 —Diving flow condition—slotted bucket.

Note: The diving flow condition occurs with the slotted bucket only when the tailwater depth becomes too great.

Possibly the above flow conditions are conducive to "ball milling" of abrasive debris, while a hydraulic jump has a better flushing process. This flushing process may be of a probability nature, whereby, there is churning of the debris but eventually it is caught in a downstream current and swept away from the jump.
