FLAMING GORGE RIVER OUTLET PIPE FAILURE ROOT CAUSE ANALYSIS

FLAMING GORGE DAM FLAMING GORGE FIELD DIVISION COLORADO RIVER STORAGE PROJECT UPPER COLORADO REGION

U.S. Department of the Interior
Bureau of Reclamation
Denver, Colorado

August 1997

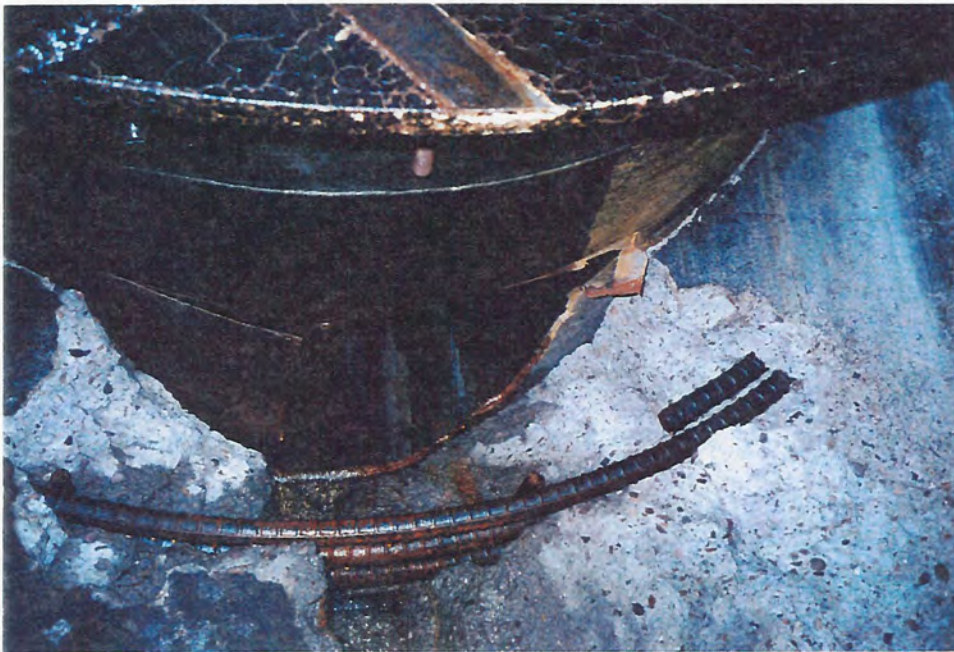
Damage to outlet pipe No. 2 included a 16 in. x 22 in. piece of one-half-inch plate steel missing from the invert of the outlet pipe (photographs 1-3) and damage to the concrete located beneath the invert. There appeared to be a significant amount of vibration prior to the rupture as evidenced by the spalled concrete located around the circumference of the outlet pipe at the steel pipe-concrete interface (photograph 4). The maximum dimensions of the damaged concrete were about 5.5 feet in the horizontal direction, 3 feet in the vertical direction, and 2 feet 3 inches upstream into the concrete. A thorough description and photographs of the concrete damage are described in Dan Mares's (D-8130) travel report dated July 7, 1997, and is included in this document as Appendix B.

Photograph 1 - Exterior view of damage to outlet pipe No. 2.

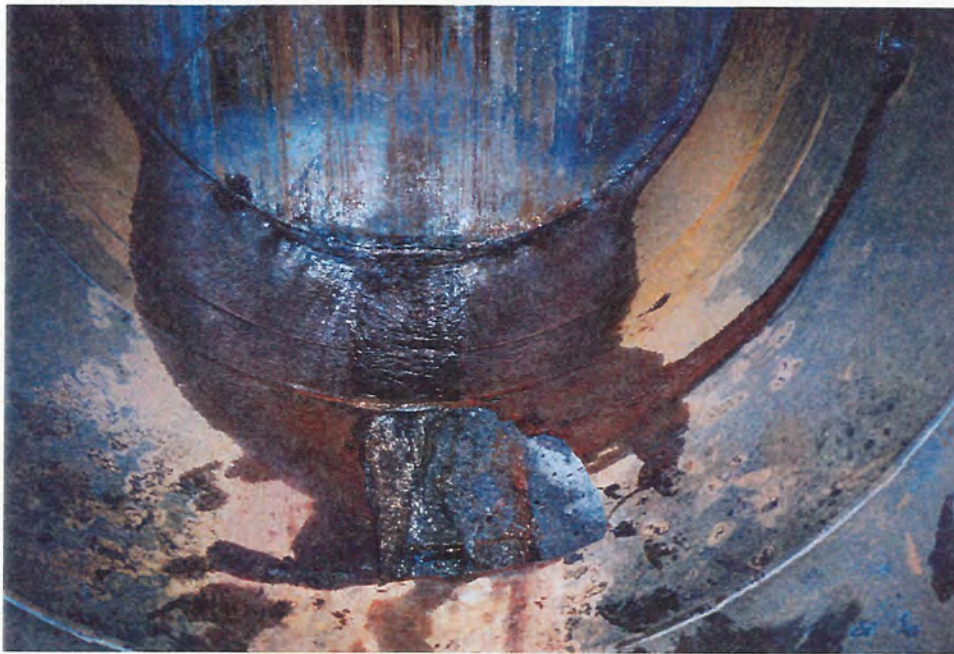
Photograph 2 - Interior view of damage to outlet pipe No. 2.

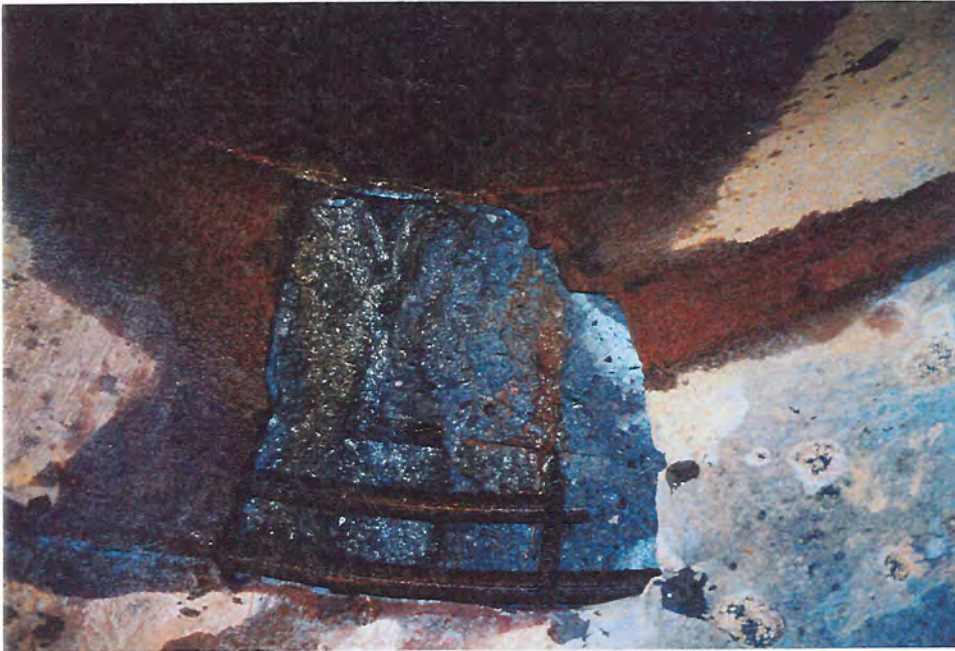
Photograph 3 - Interior view of damaged area of outlet pie No. 2.

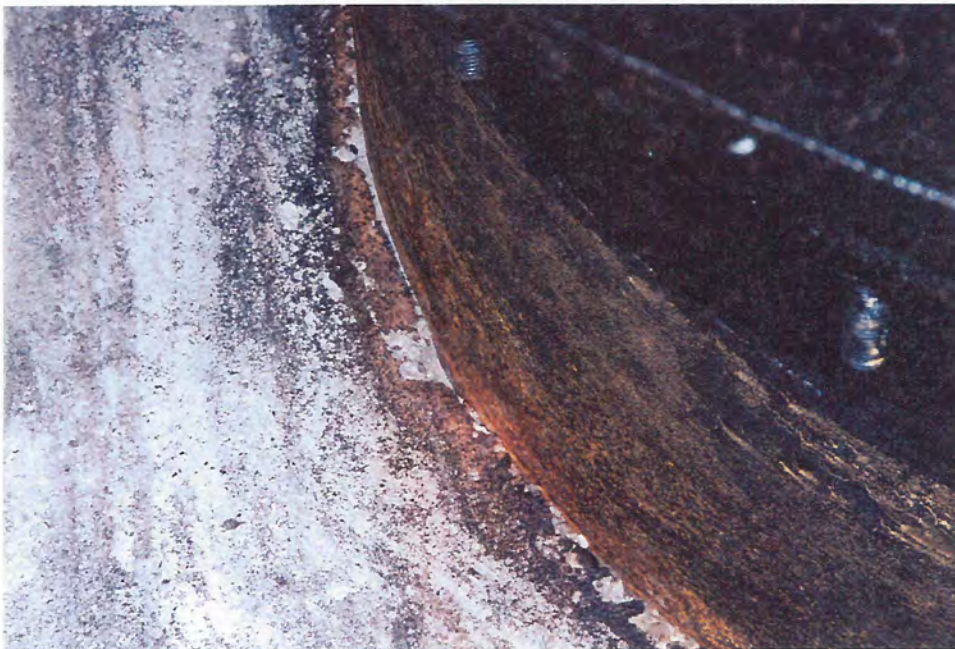
Photograph 4 - Concrete-steel outlet pipe interface. Note spalled concrete around circumference of outlet pipe which is indicative of damage caused by vibration.

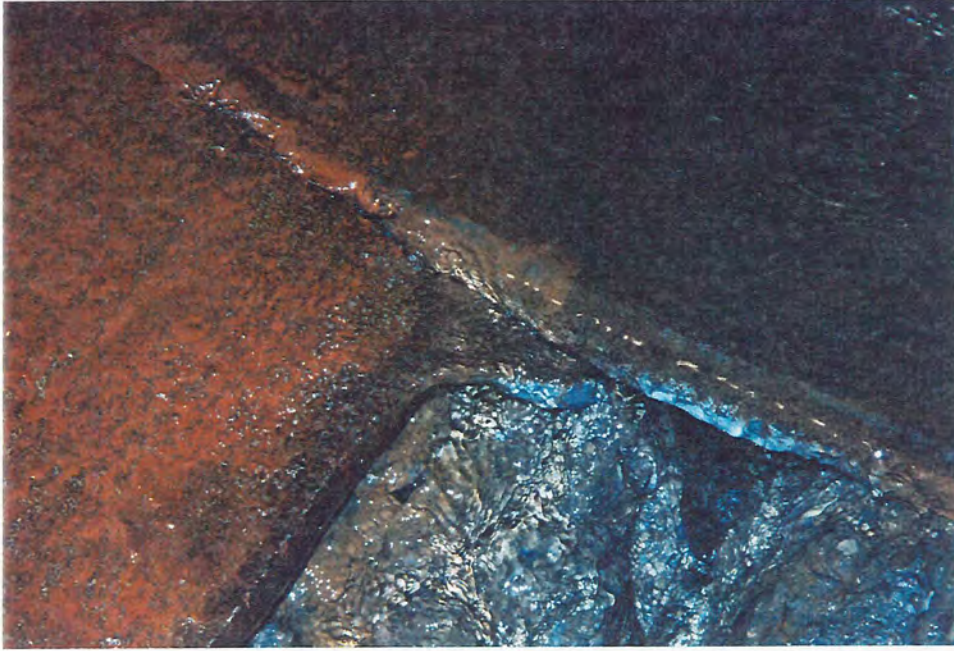
Metallurgical analysis shows that the rupture in the steel outlet pipe was initiated by the effects of cavitation damage in conjunction with the combined effects of corrosion and erosion at the location of a welded joint (photographs 5 and 6). Severe cavitation damage appears approximately 6 to 8 inches downstream of the gate slot and continues all the way to the ruptured section. Heavy metal loss was noted in this area on the invert of the outlet pipe. Some of the pits were approximately 1/4 to 3/8-inch deep in some locations. The findings of the metallurgist found the outlet pipe rupture was initiated by cavitation damage which led to corrosion and erosion damage. No material defects were found in the weld metal or the base material. A copy of the metallurgist's report is included in this document as Appendix A.

Photograph 5 - Left side of fractured weld looking upstream. Note cavitation pits.

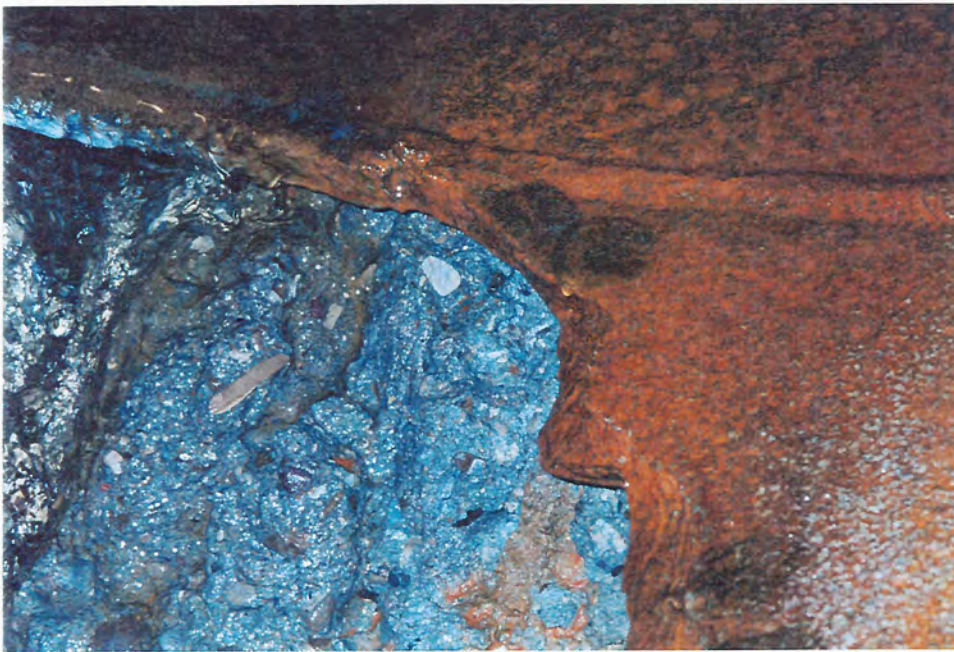
Photograph 6 - Right side of fractured weld looking upstream. Note large cavitation pit.

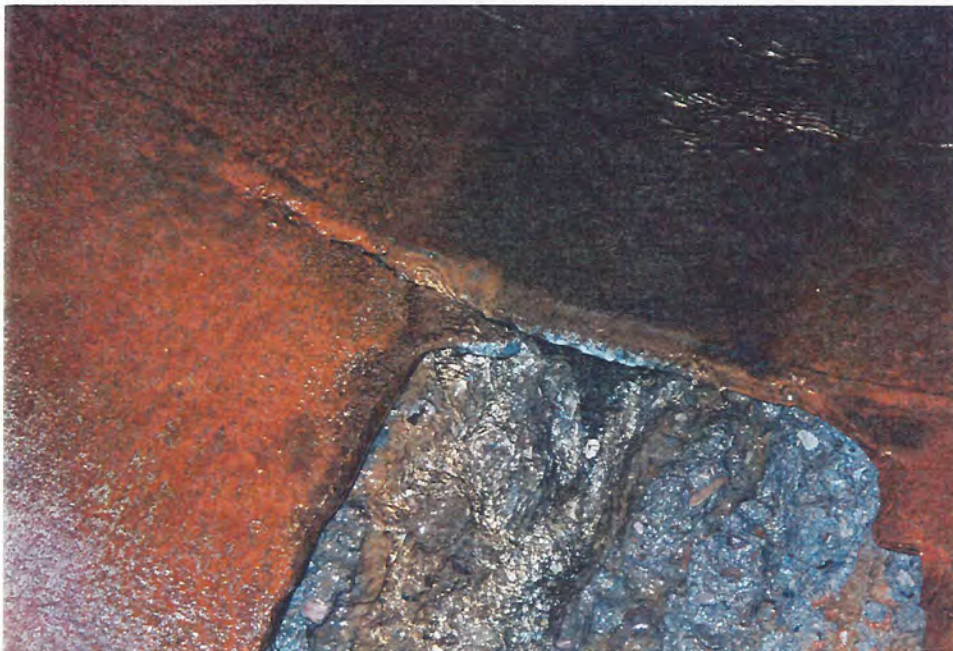
It is believed that the outlet pipe shell developed a crack between two large cavitation pits located at the welded joint of the steel pipe to the flange that bolts to the body of the ring follower gate (photographs 7 and 8). It appears that the internal pressure in the pipe initially caused the broken piece of the outlet pipe to be forced downward at the upstream end at the location of the crack in the weld. The concrete encasement most likely held the fractured piece in place for a period of time until the internal flow in the pipe forced the upstream end of the broken piece upwards. The force of the internal flow then caused a section of the pipe to bend upward, then pivot about the axis of the bend, and break at a location near the concrete-to-steel pipe interface. The broken piece then traveled down the outlet pipe and was discharged through the stay vanes located in the lower left-hand quadrant of the hollow jet valve. This was evidenced by the damage to the coal tar epoxy coating throughout the outlet pipe and by the scrape marks in the hollow jet valve body (photographs 9 and 10).

Photograph 7 - Fractured weld. Note crack extends between two large cavitation pits.

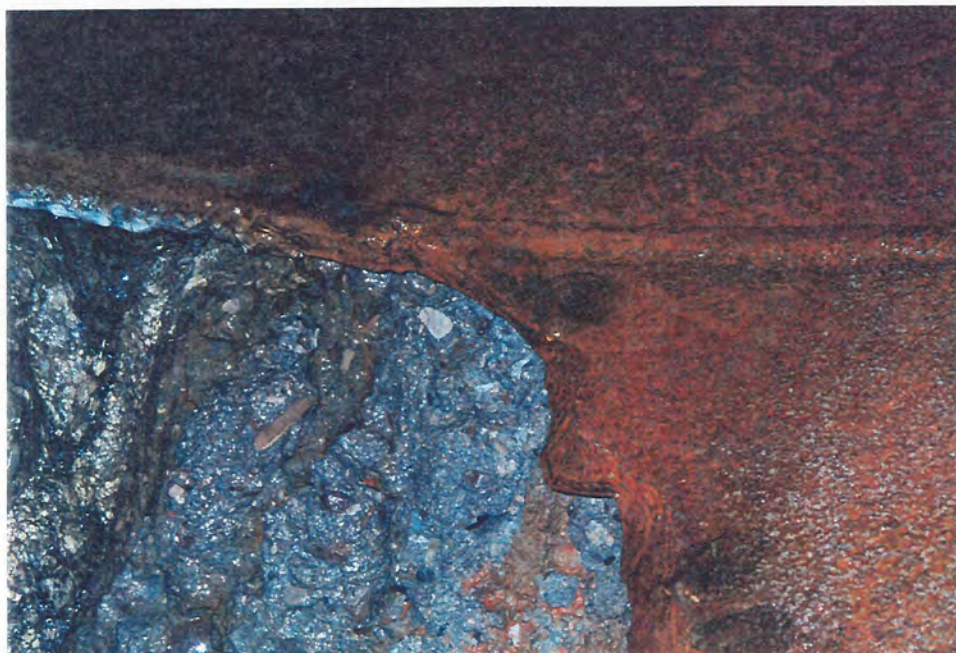
Photograph 8 - Upstream end of fractured weld. Note fractured shell that may be indicative of a crack that existed for a period of time.

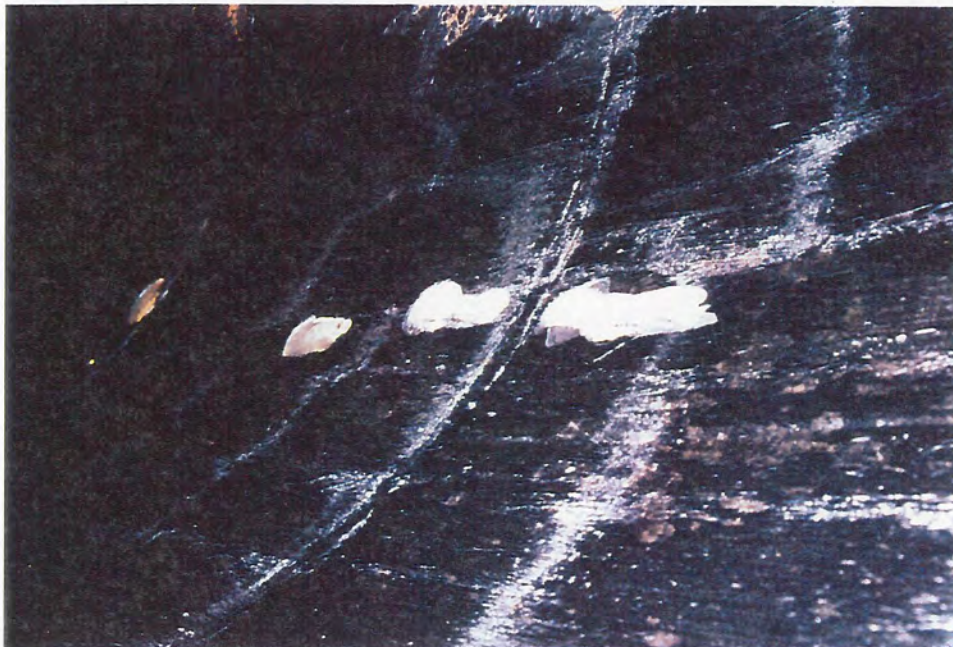
Photograph 9 - Damage to coal tar epoxy coating caused by broken piece of outlet pipe as it traveled through the outlet pipe.

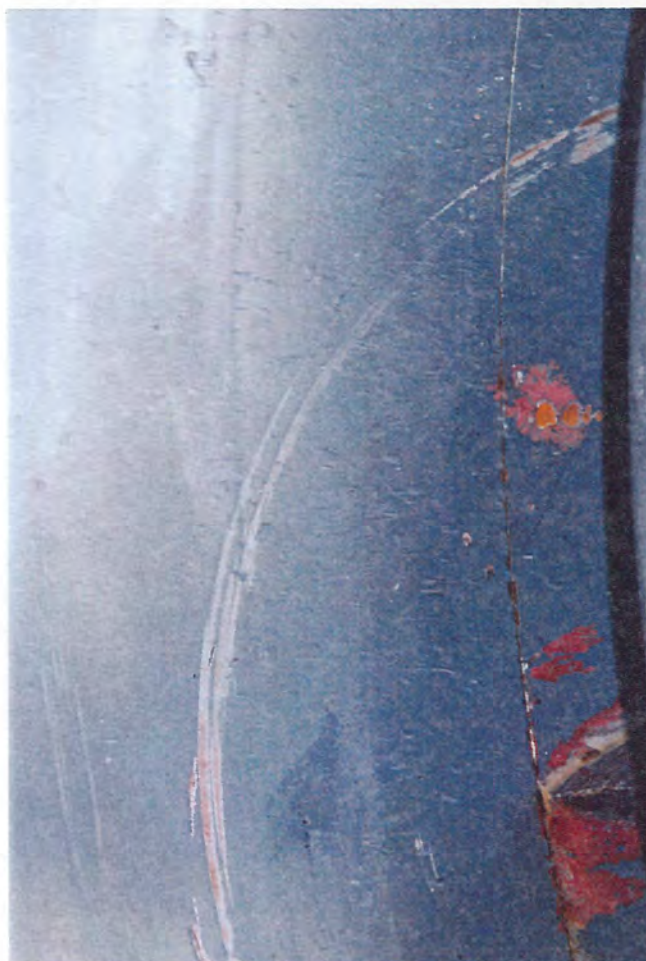
Photograph 10 - Scrape marks where broken piece of outlet pipe traveled through stay vanes of the hollow jet valve.

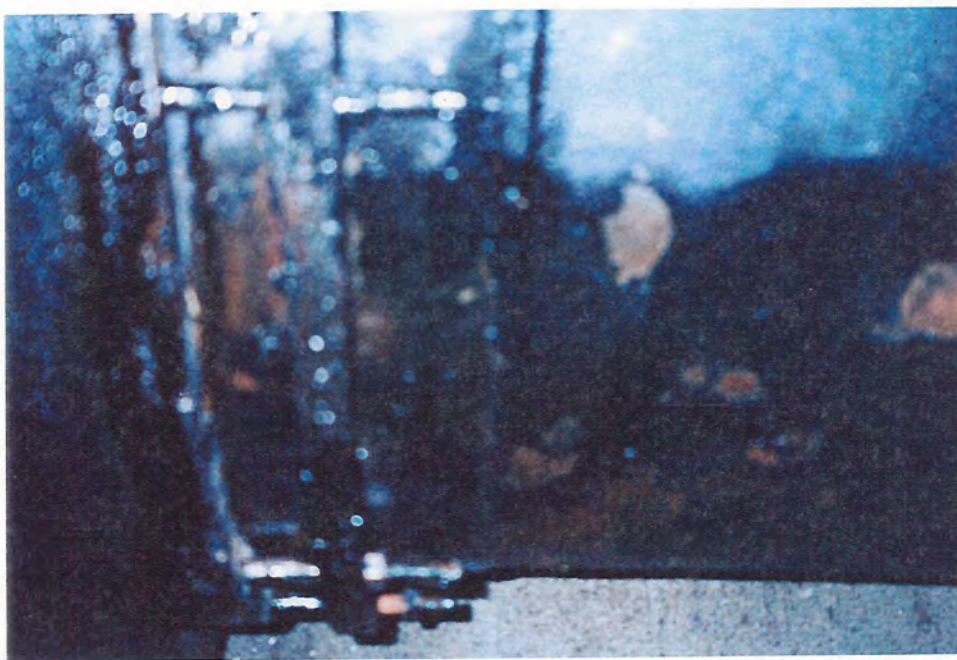
The expansion joint on outlet pipe No. 2 was missing approximately 7 bolts on the downstream side of the expansion joint and several of the nuts on the remaining bolts had backed off the threads and were loose (photographs 12 and 13). Several of the nuts on the upstream side of the expansion joint were also loose. The water leaking from the ruptured area of the outlet pipe tore off the ladder attached to the expansion joint (photograph 14). It is believed that the force of this action forced the expansion joint outer sleeve to move in the downstream direction until the metal stop was pushed against the inner sleeve located on the downstream side of the expansion joint (photograph 15). The expansion joint for outlet pipe No. 1 was inspected after the ring follower gate for outlet No. 2 was closed and was noted to be leaking. The bolts were tightened and the leakage was eliminated.

Photograph 12 - Exterior view of expansion joint on outlet pipe No. 2. Note missing bolts.

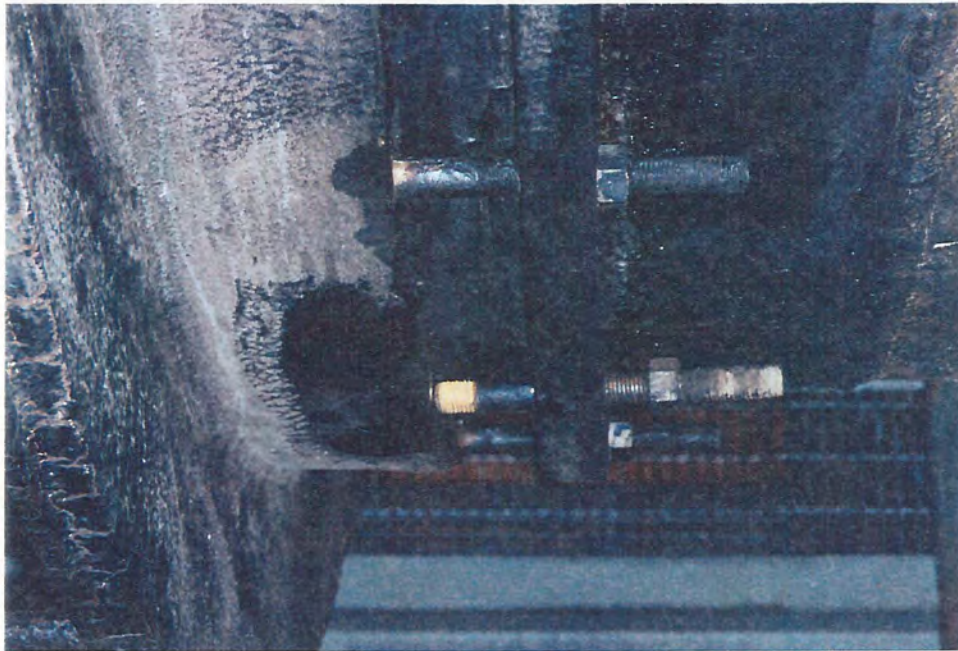
Photograph 13 - Exterior view of expansion joint on outlet pipe No. 2. Note how the nuts are backed off of the bolts.

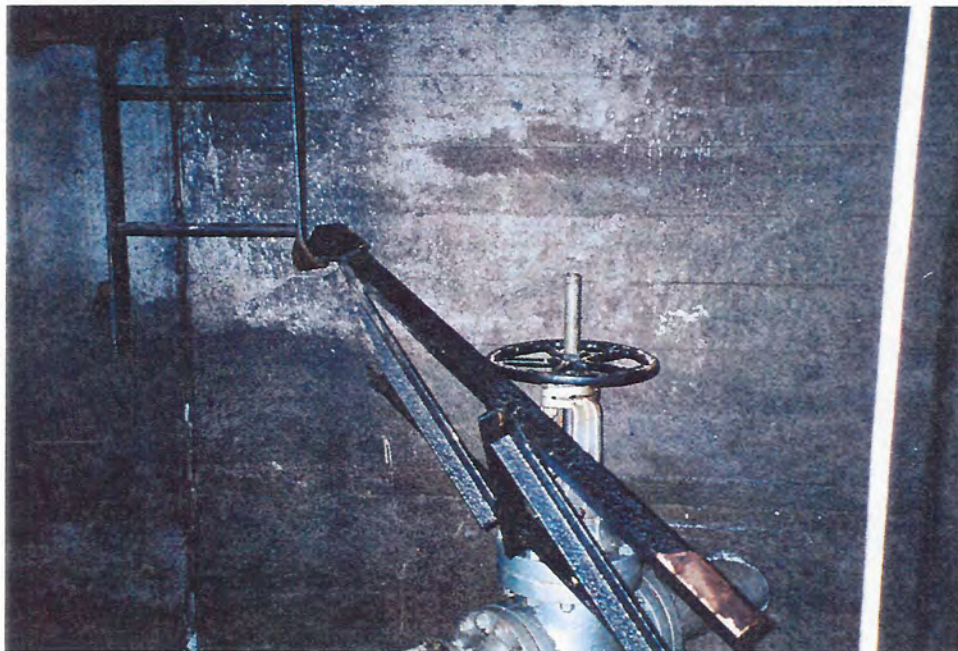
Photograph 14 - Damage caused by leakage through broken outlet pipe to access ladder which was attached to the expansion joint.

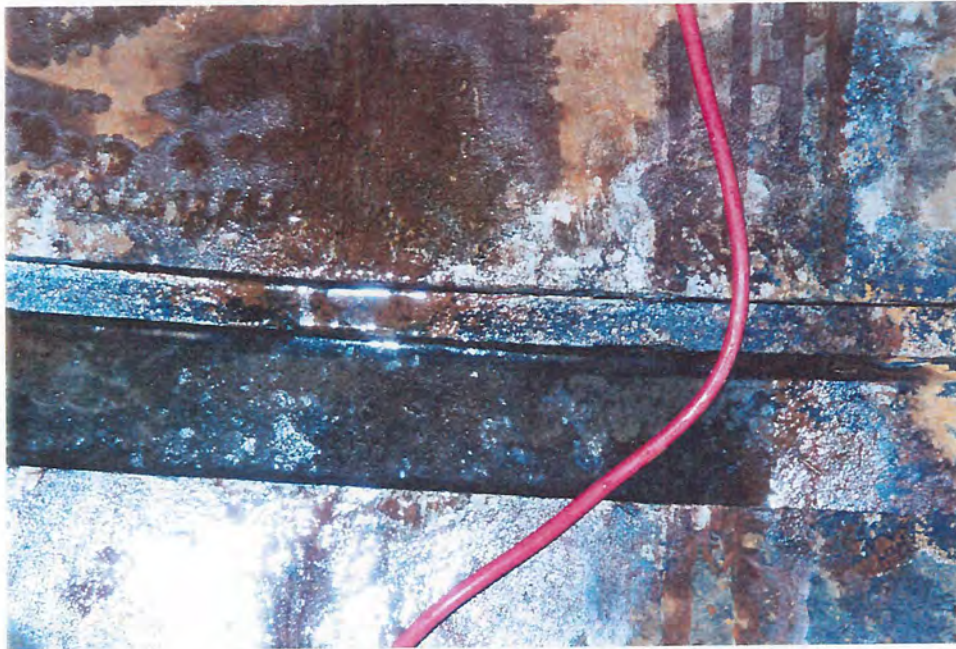
Photograph 15 - Interior view of expansion joint on outlet pipe No. 2. Note how metal stop is directly against the downstream inner sleeve.

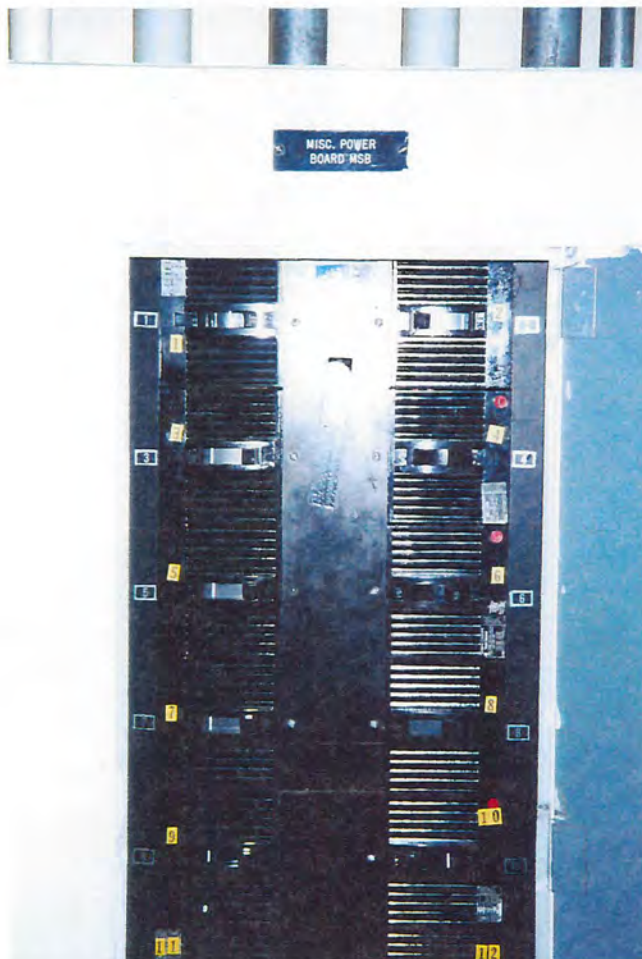
Flooding into the plant damaged a 480 vac distribution board which supplies electrical power to both the ring follower gate control and the hollow jet valves making them electrically inoperable (photograph 16). Flooding inside the gate house damaged the roll-up door of the gate control house (photographs 17 and 18). The water was approximately 3 feet deep inside the gate house at this time (photograph 19). The water in the control house entered the powerplant through a pipe chase that led to the break room and also through the door which provides access to the powerplant from the gate house (photographs 20 and 21). The water level in the break room was approximately 7 feet deep and caused the break room door to be damaged and blown off its hinges (photographs 22 and 23).

Photograph 16 - 480 vac distribution board which supplies electrical power to both the ring follower gate control and the hollow jet valves. Flood damage made them electrically inoperable.

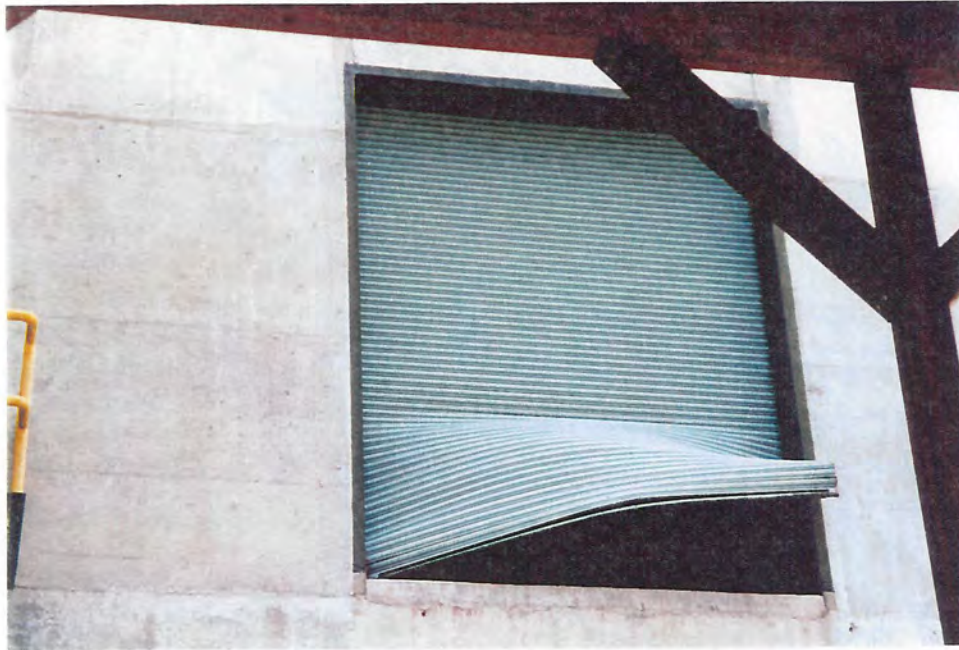
Photograph 17 - Exterior view of damage to roll-up door located in the ring follower gate control house.

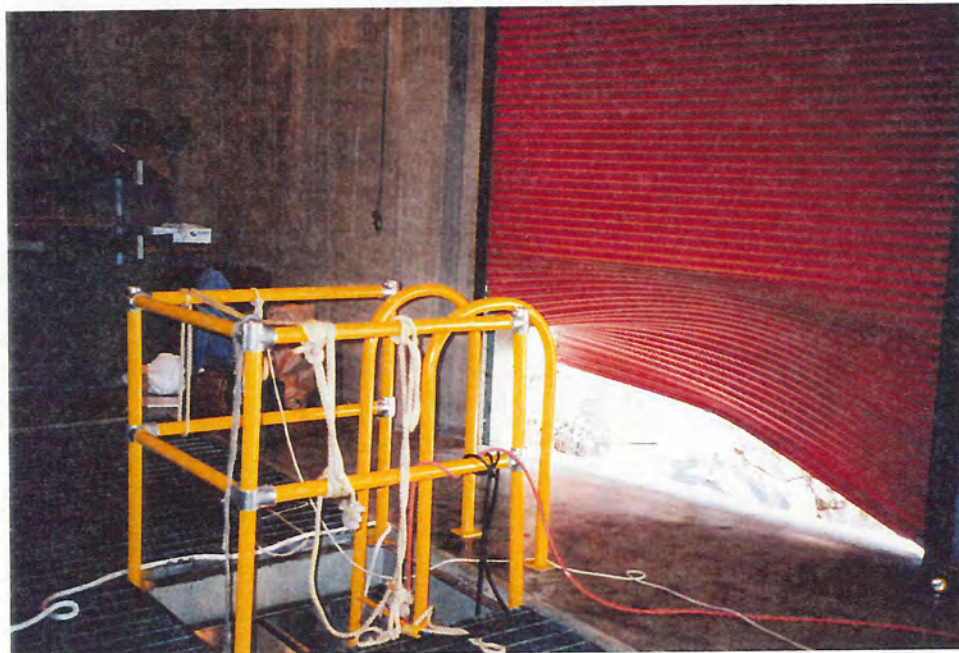
Photograph 18 - Interior view of damage to roll-up door located inside the ring follower gate control house.

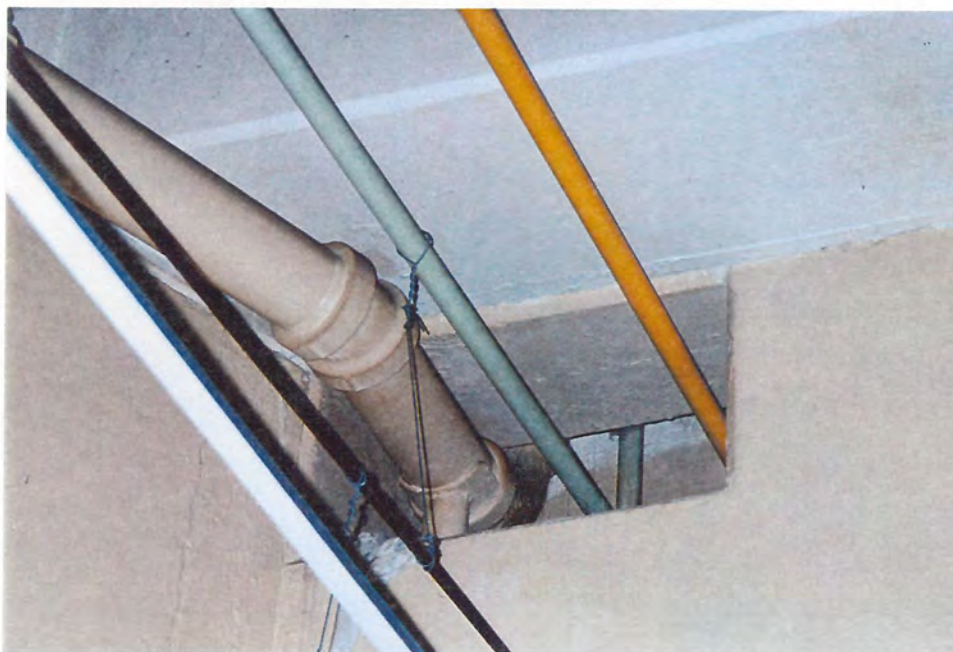
Photograph 20 - Pipe chase located between the powerplant and the control house through which water entered the powerplant.

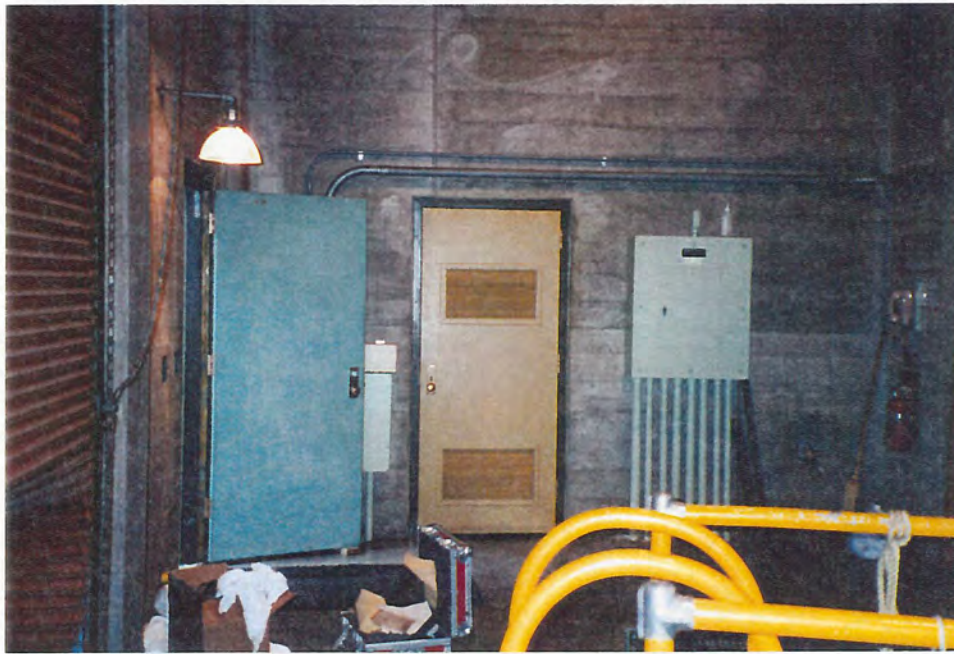
Photograph 21 - Access door between the powerplant and the ring follower gate control house through which water entered the powerplant.

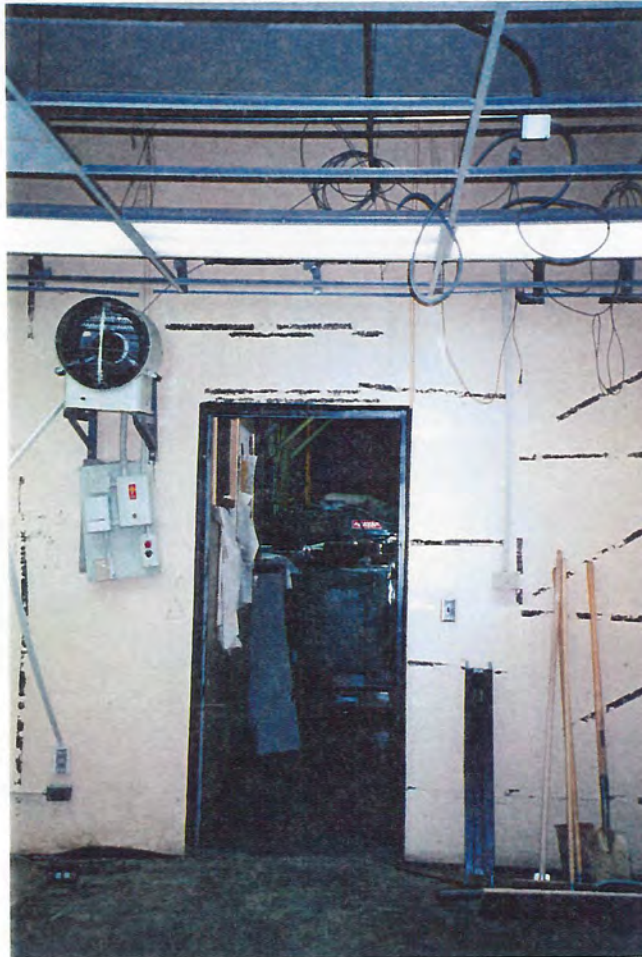
Photograph 22 - Location of break room access door which was damaged due to flooding.

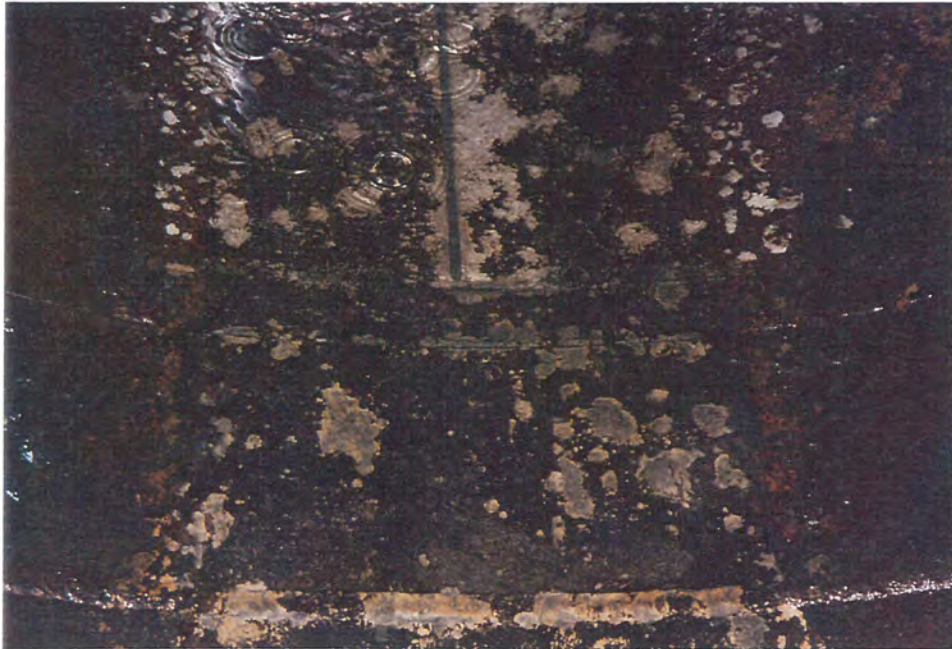
The interior of outlet pipe No. 1 was examined on July 1, 1997. There was no cavitation damage noted. There was a significant loss of the coal tar epoxy coating observed and some very minor surface rusting with no evidence of metal loss in the pipe shell (photographs 24 and 25). There was no movement observed of the expansion joint as the metal stop was centered between the inner sleeves of the expansion joint (photograph 26). Outlet pipe No. 1 was determined to be in good condition and safe to operate.

Photograph 25 - Invert of outlet pipe No. 1. Note missing coal tar epoxy but no evidence of metal loss due to cavitation.

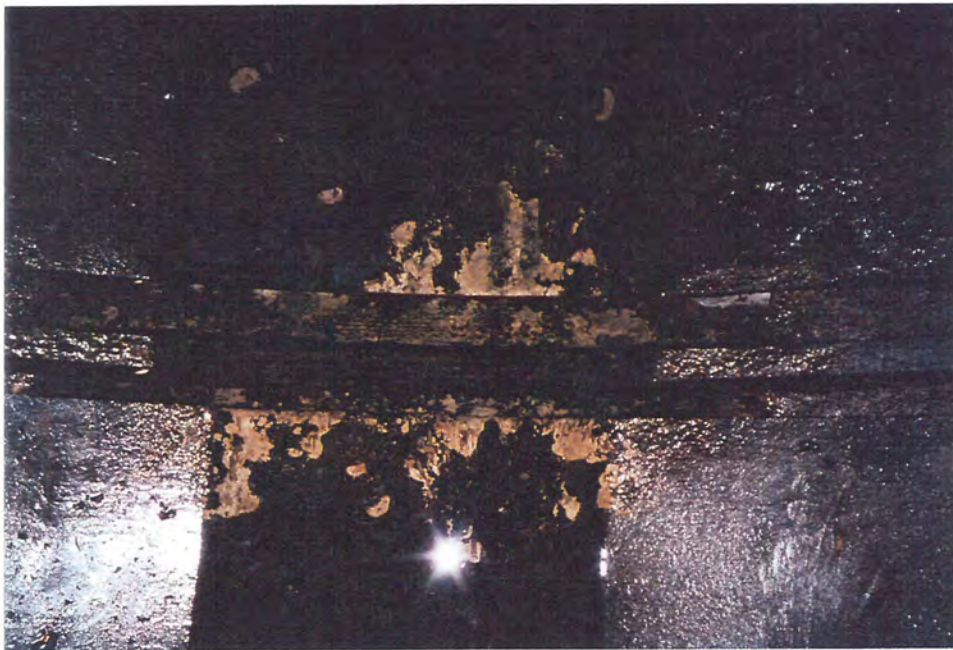
Photograph 26 - Interior view of expansion joint on outlet pipe No. 1. Note how metal stop is located between the upstream and downstream inner sleeves of the expansion joint.

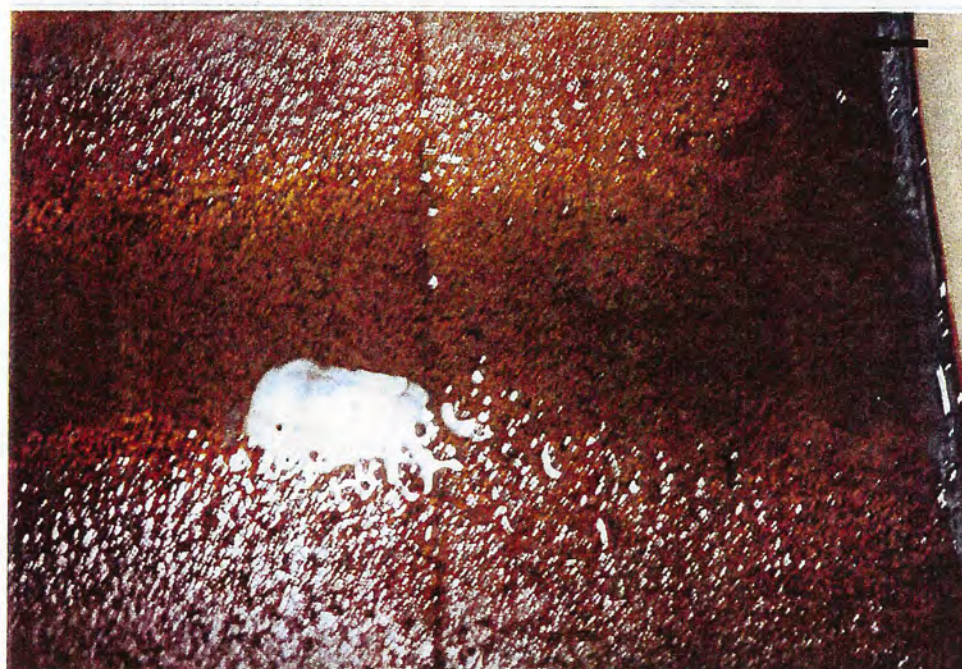
Figure 6. Area of Severe Cavitation Damage

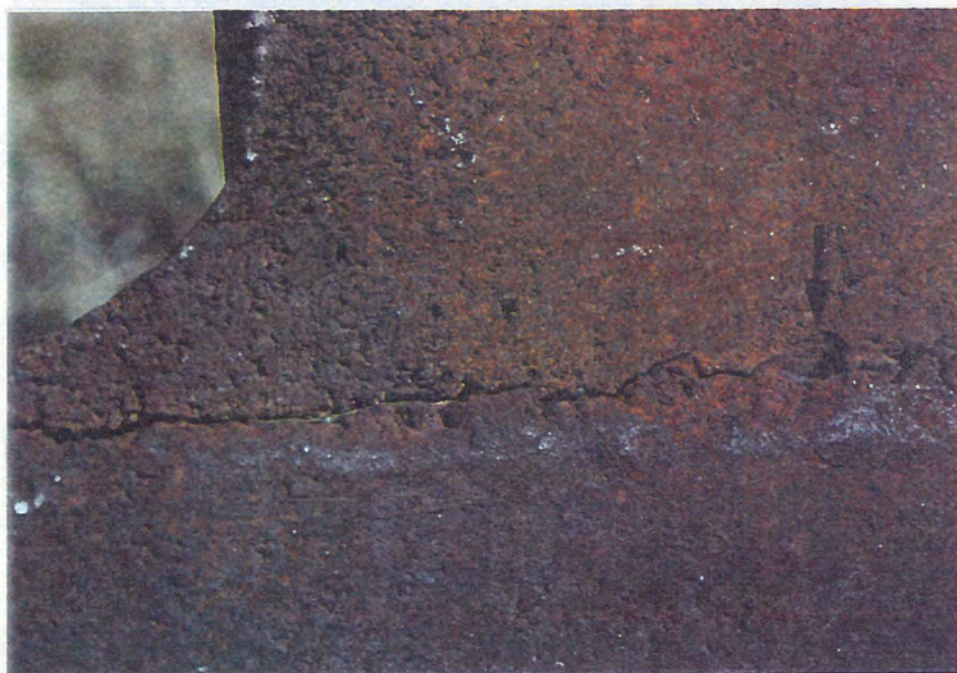
Subsequent to penetration, damage continued by the erosion mechanism culminating in rupture of the pipe. Severe pipe vibration augmented cavitation and produced some areas of low cycle fatigue.

Figure 10. Cavitation Damage and Low Cycle Fatigue

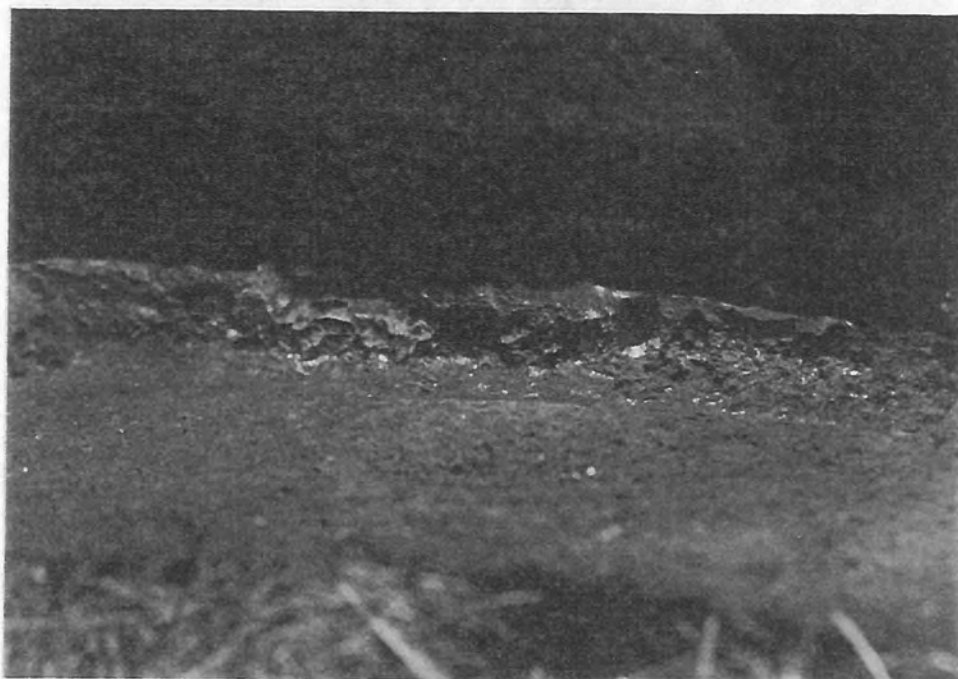
Figure 13. Cavitation Damage, Corrosion, and Erosion;
Fracture Surface

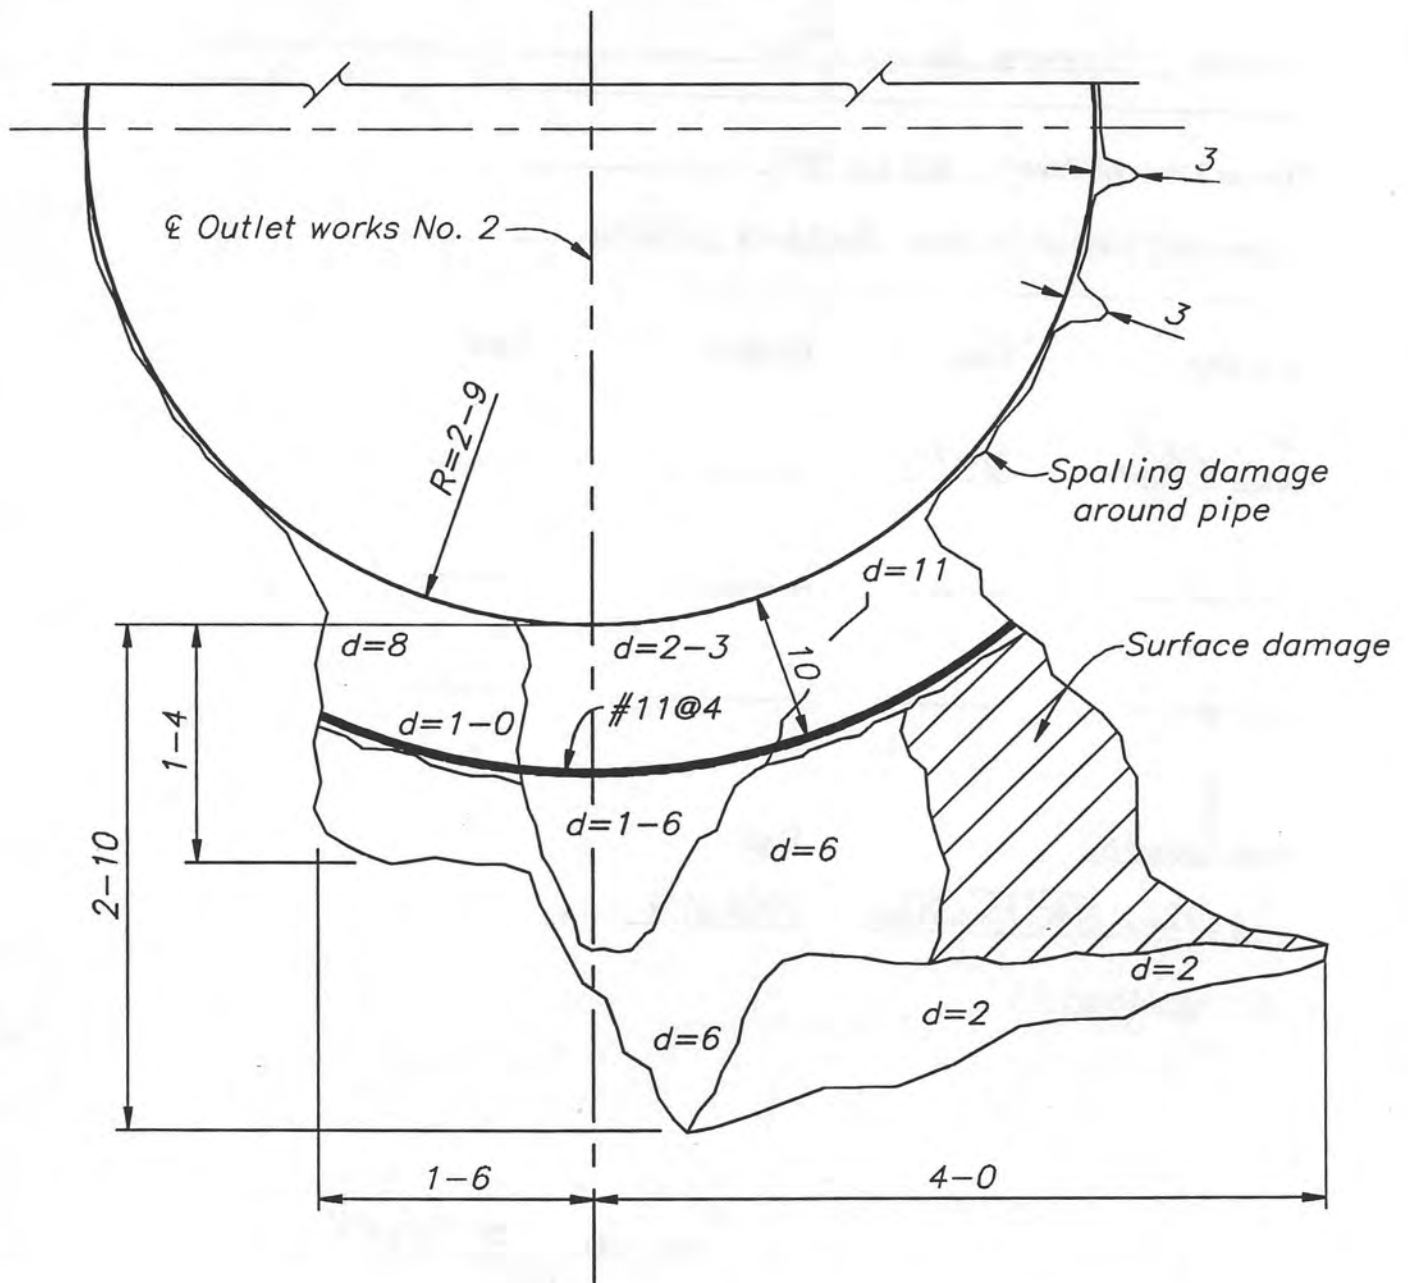
Figure 1. – Schematic showing approximate dimensions and depths of damage in the concrete.

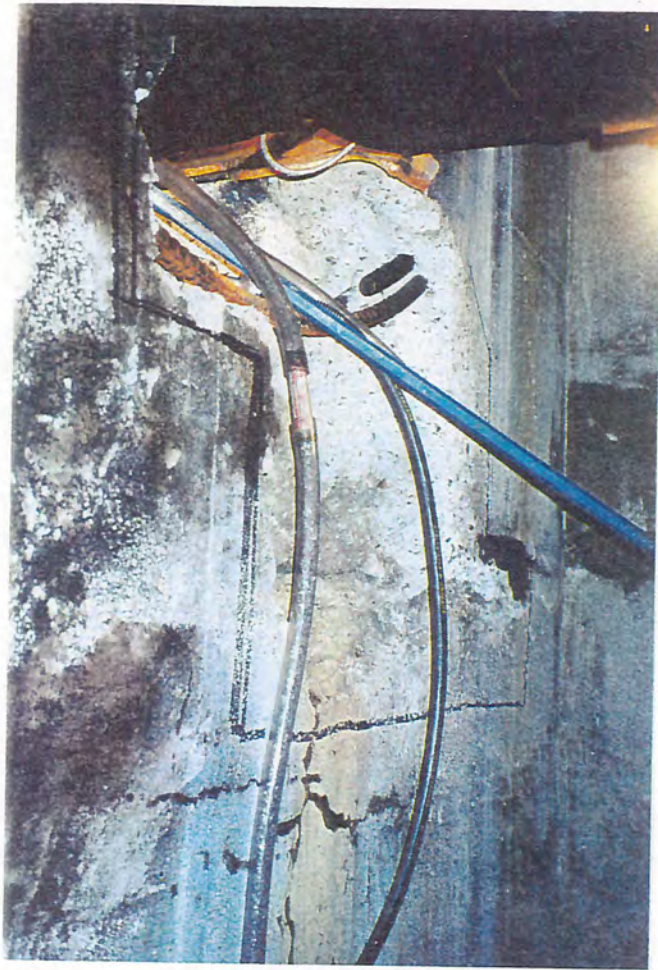
Photograph No. 1. - Showing bottom of outlet works pipe and extent of damaged concrete.

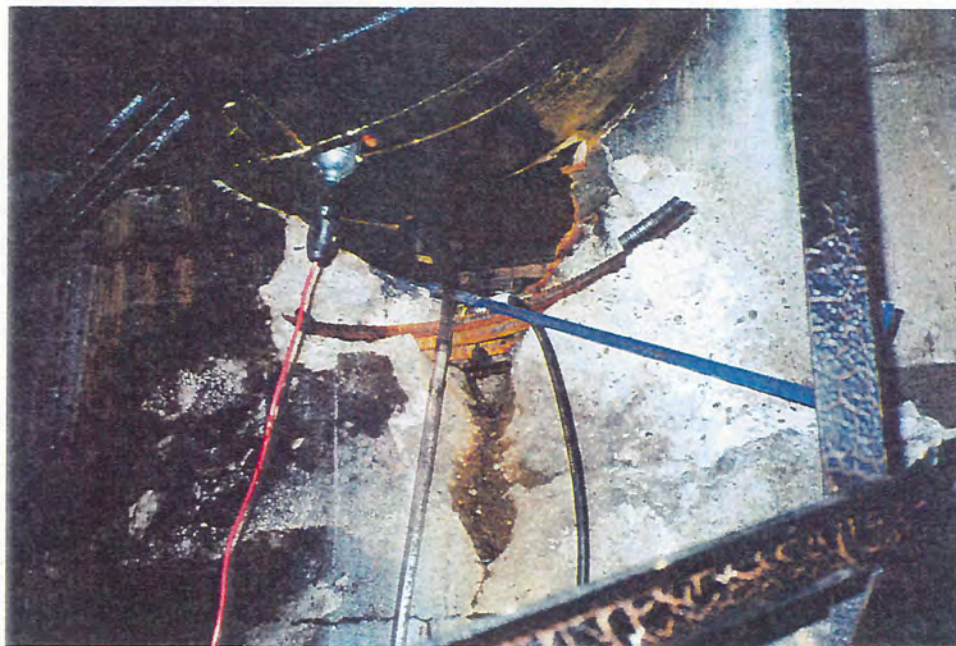
Photograph No. 2. - Showing damaged outlet pipe and concrete.

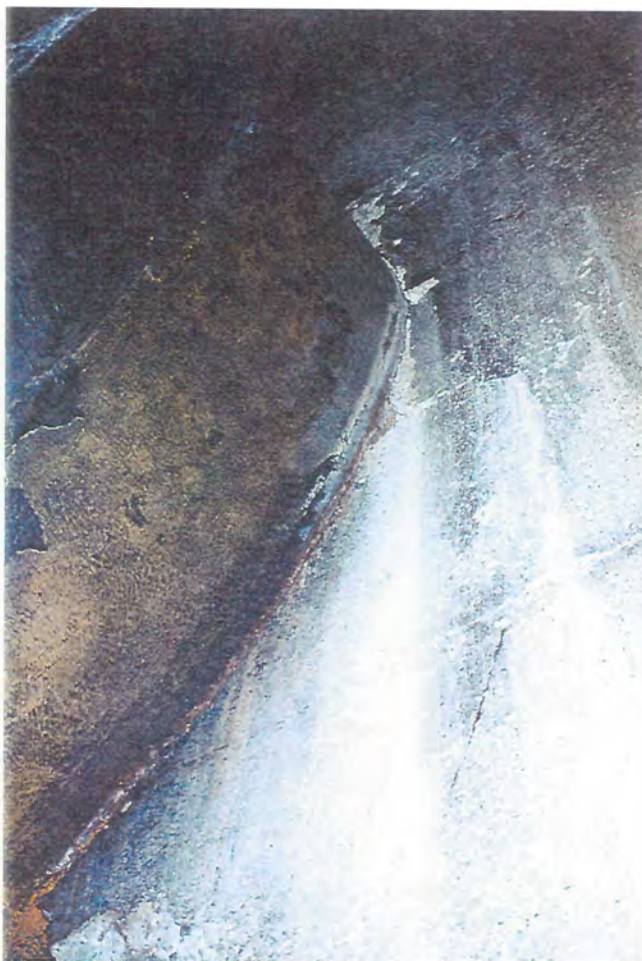
Photograph No. 3. - Note spalling around the outlet pipe.

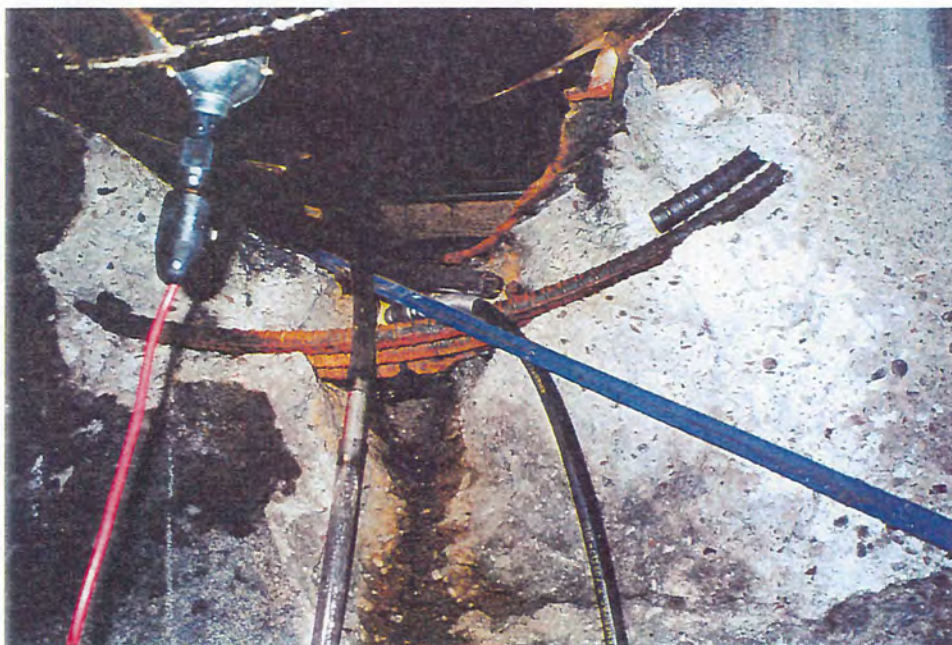
Photograph No. 4. - Showing damaged concrete and rust on reinforcement.

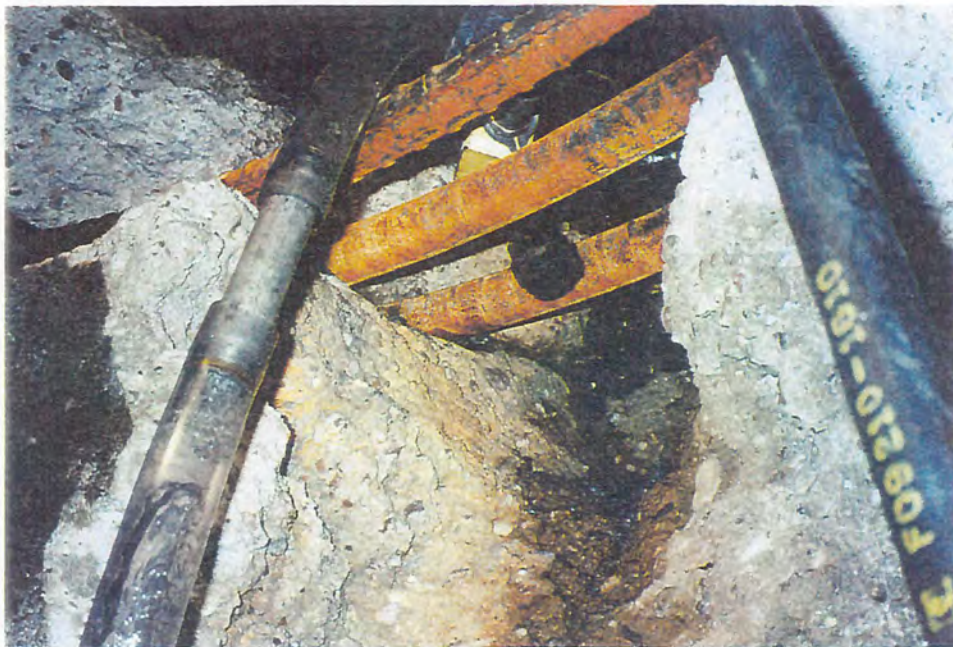
Photograph No. 5. - Showing damaged concrete and rust on reinforcement.
