**PAP-800**

**Damage Assessment for the Choke Canyon Dam Outlet Works Stilling  
Basin**

**September 1998**

**Leslie Hanna**

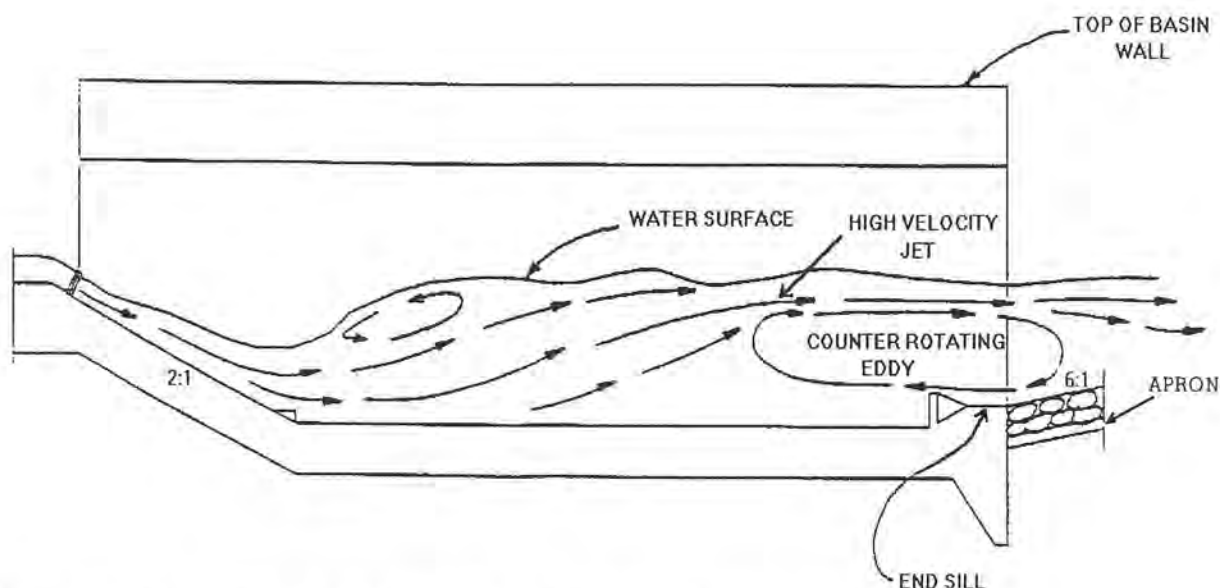
**Figure 1.** Counter-rotating eddy typical of hydraulic jump stilling basins.

It is typical of many stilling basins to experience damage caused by rock, gravel, and sand brought into the basin by back flow over the stilling basin end sill. Normal operation of a hydraulic jump energy dissipation basin can cause a reverse flow eddy over the basin end sill and lower apron as shown in figure 1. This counter-rotating eddy is driven by a high velocity jet rising off the basin floor. Riprap placed on the apron downstream of the basin end sill is typically designed to be stable under this condition. However, small material, if available, can be transported into the basin and be trapped where turbulent flow continually moves the material about the surface, eroding the concrete. The photographs of the damage occurring at the Choke Canyon stilling basin (figure 2) show a similar pattern to the damage shown in figure 3 which shows abrasion damage that has occurred at the Hoover Dam spillway.

- 5) Install a flow deflector in the basin to suppress the return flow eddy that moves material into the basin. Previous model studies conducted in our laboratory, and limited field applications have demonstrated that the installation of flow deflectors can improve a basin's flow distribution significantly, greatly reducing the potential for movement of material into a basin. However, this solution would also require a model study to ensure deflector effectiveness and proper deflector design.

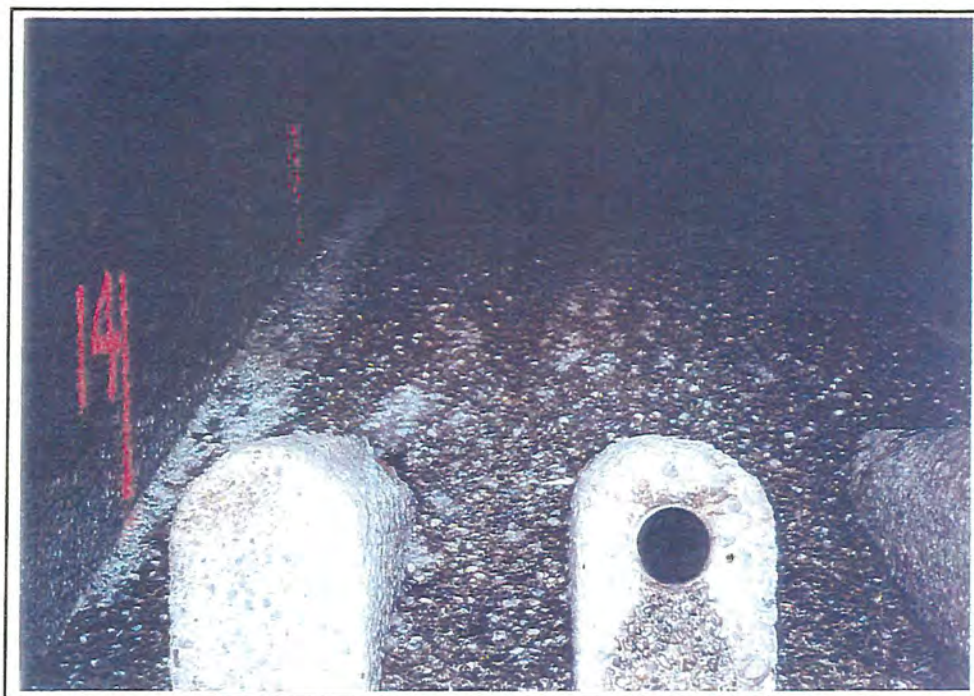
Photo No. 5

The river outlet works stilling basin was dewatered so that an inspection of the stilling basin and chute could be performed. The inspection revealed erosion of the concrete floor and side walls of the concrete outlet works chute. The estimated loss of concrete in the floor is 2 to 3 inches maximum and ½ to 1 inch maximum on the side walls. Rebar was exposed in the center energy dissipation block of the right bay.

1) Evidence indicates that the most probable cause of damage to the Choke Canyon Dam stilling basin chute, walls, and invert is abrasion damage. This assessment is based on the following:

- c) Photos of the damage indicate a pattern of damage that is consistent with that of abrasion damage. It shows a uniformly distributed roughness which is characteristic of this type of damage.

South chute exposed aggregate/rebar, looking upstream.

- 1) The source of material entering the basin should be identified and cleaned from the riprap apron downstream of the basin. It may be necessary to remove the existing riprap and have it replaced to meet original design specifications.

- 2) Cleaning the basin at regular intervals will help to minimize damage caused by abrasion.
- 3) The basin should be monitored to prevent materials from being deposited onto the riprap apron during activities such as construction.

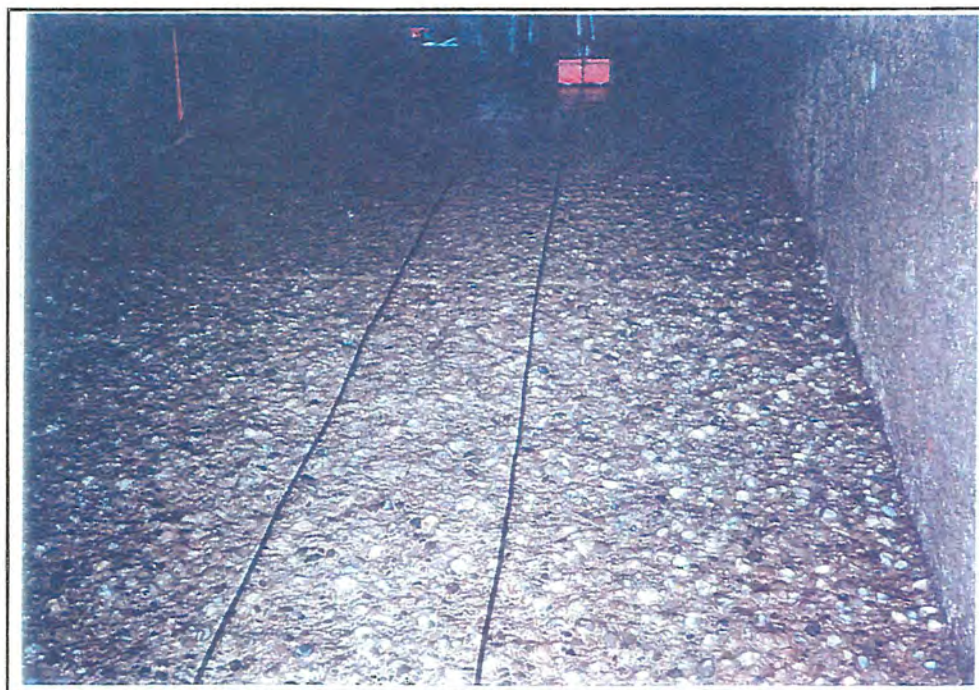
Photo No. 6

Damaged chute floor slope, looking upstream.

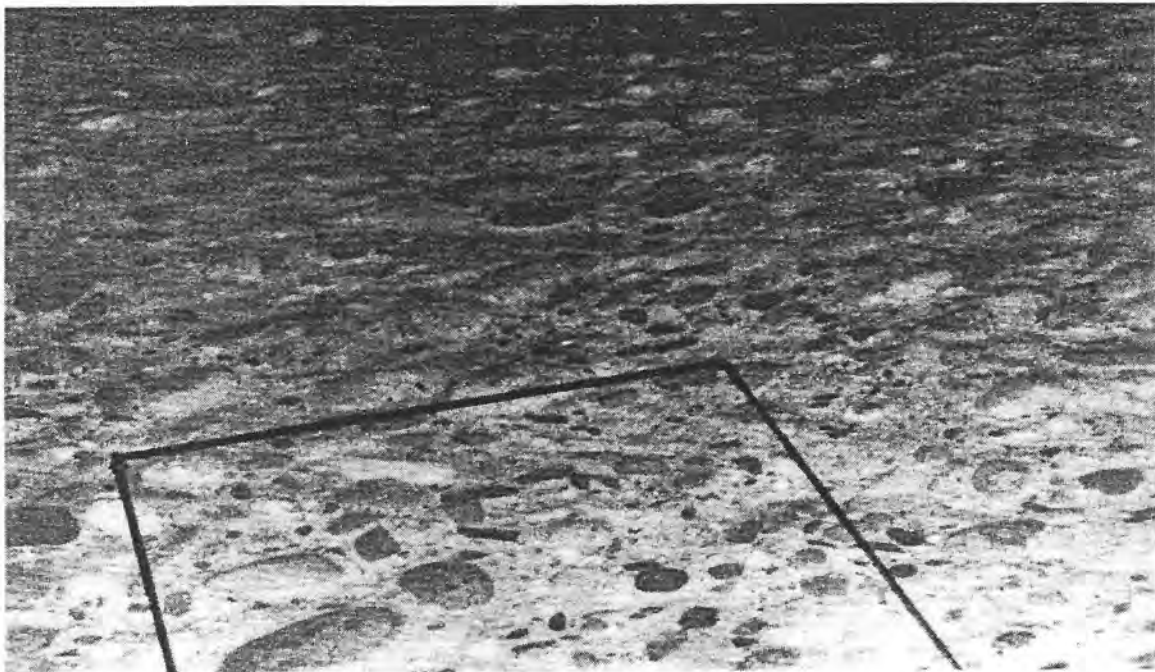
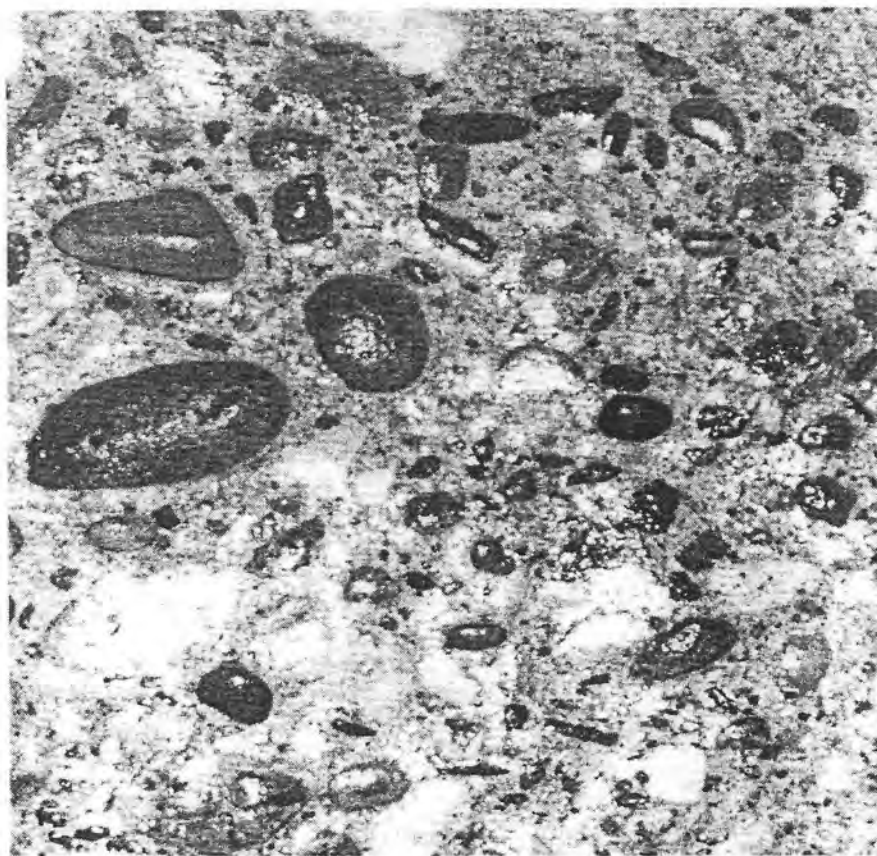
Figure 3. Abrasion damage in concrete at the Hoover Dam spillway [3].

*Uniformly distributed roughnesses refer to variations occurring over a relatively wide area. This type of irregularity is caused by erosion of a concrete surface by sand or gravel in the water passing over the surface. The effect of cavitation bubble collapse perpendicular to a concrete surface produces a surface in which the individual pieces of aggregate are cleaned of the cement. However, deep crevices and holes can be found in the matrix. It almost appears as though worms bored into the concrete. The contrast between the texture of damage by cavitation and that caused by erosion with sand laden water is apparent in concrete. With cavitation, individual polished pieces of aggregate are exposed in the damaged zone as shown in figure 4. Whereas with erosion by sandladen water, individual pieces of aggregate are polished, as with cavitation, but the underlying surface is smooth and relatively even as shown on figure 3.*

a. View of invert

b. Invert closeup

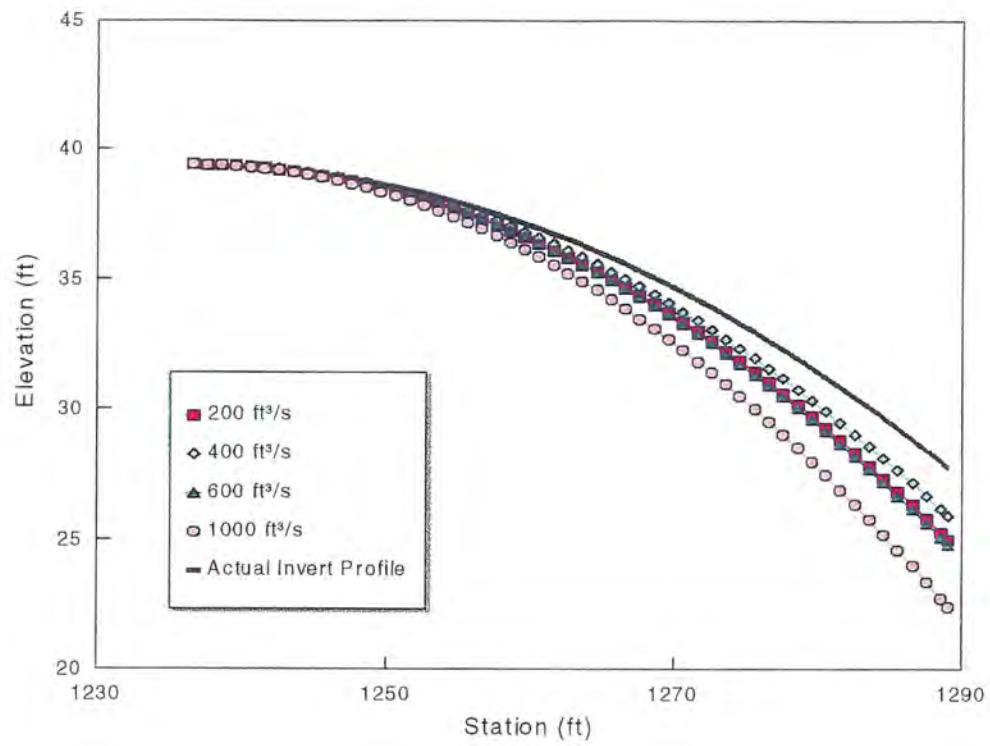
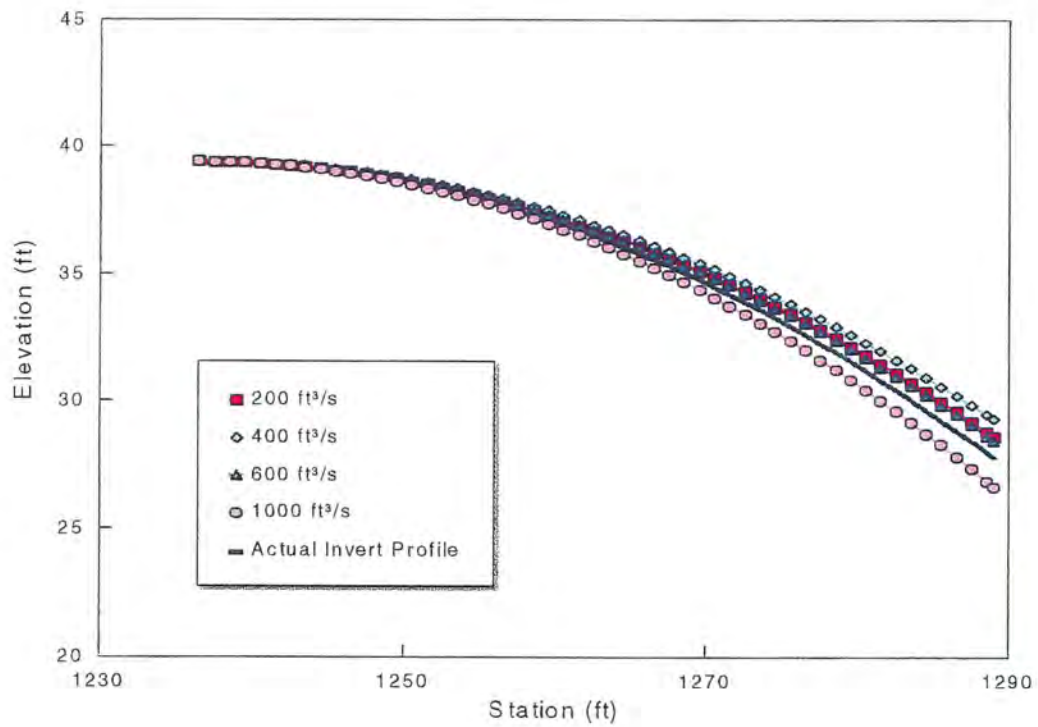
Figure 5. Chute curvature required to prevent jet from lifting from invert with factor of safety of a)  $K = 1.5$  and b)  $K = 2.0$ .

d) The abrasion high on the curved chute and side walls is characteristic of small flows where an unstable jet lifts off the invert, pulling material up the sides of the chute, then returning material down along the invert.

This equation was used to determine the tendency of the jet to lift off the chute invert. Reclamation's "Design of Small Dams" specifies that to avoid the tendency for the water to spring away from the floor the curvature should be made slightly flatter than the trajectory of a free charging jet [4]. To ensure positive pressure along the entire contact surface of the curve,  $K$  should be equal to or greater than 1.5. Figures 5a and 5b show the jet profiles calculated with a factor of safety or  $K$  value of 1.5 and 2.0 respectively for four discharges ranging from 200 to 1000  $\text{ft}^3/\text{s}$ , compared to the actual invert profile of the curved chute. The velocity head was based on the velocity entering the curved chute (calculated from FLOW 3D). Figure 5a demonstrates that for each case where  $K = 1.5$  the invert profile is flatter than the jet profile and therefore meets design criteria. However, figure 5b shows that with a safety factor of  $K = 2$ , at the lower discharges the jet no longer lies inside the invert profile. This may indicate the possibility that under certain operating conditions, the jet may become unstable and lift off the chute invert at the lower discharges. This possibility was confirmed with FLOW 3D which shows instability and the breaking up of the jet at 200  $\text{ft}^3/\text{s}$  (figure B-5). Although under this condition pressures are still not low enough to cause a significant amount of cavitation damage, this condition can result in material being pulled up the sides of the chute then returning material down the invert. This will produce abrasion damage in those areas.
