WILLOW CREEK FEEDER SYSTEM

GAME RANGE REACH EROSION CONTROL AND BANK STABILIZATION PLAN

US Department of the Interior
U.S. Bureau of Reclamation

MAY 15, 2000

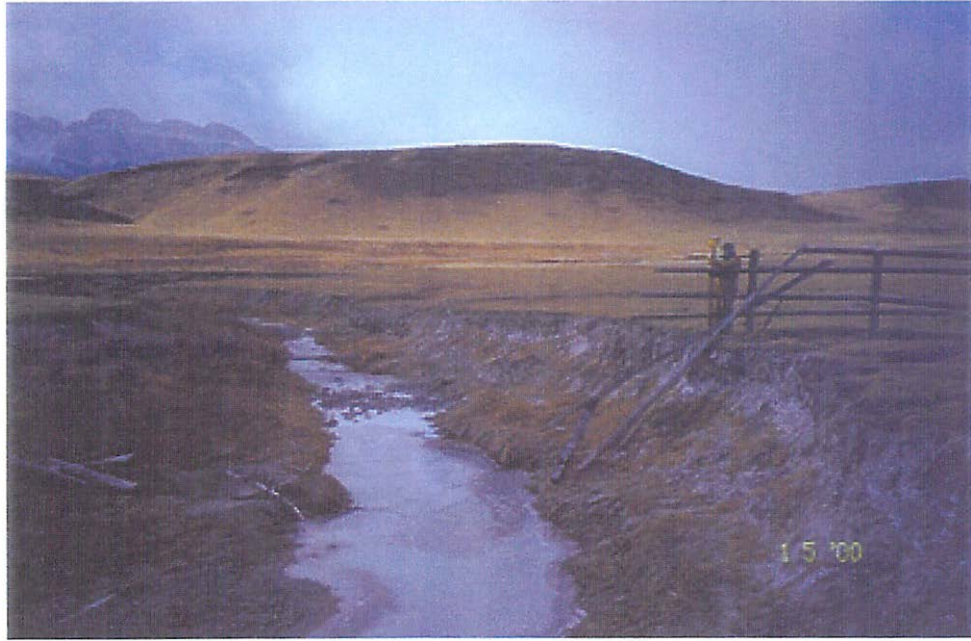
Photograph 0570-22. View from DS looking US at Bottom Reach.

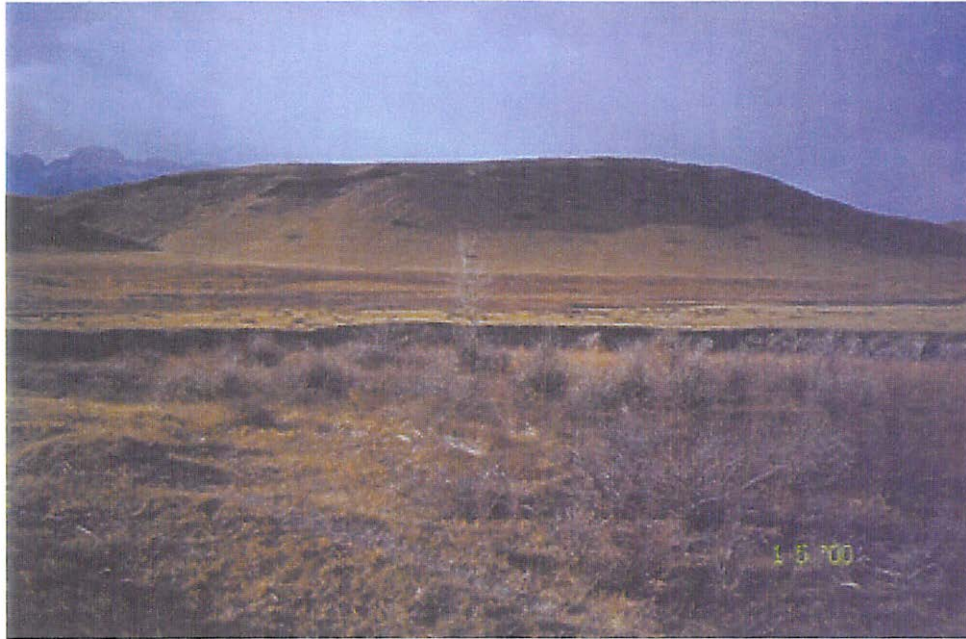
Photograph 0570-10. Left bank looking at chute of Loop #1. Panned left from Photograph 0570-11.

Photo Station : 4+00
 Upstream Station : 8+00
 Downstream Station : 5+40
 Bank Stabilization : Medium priority barbs or longitudinal peaked stone toe protection on left bank
 : Bend Diameter: 160 ft; Channel Width: ~30 ft; Barb Length: 7.5 ft; Barb
 Spacing: 16.3 – 33.8 ft; No. of Barbs: 16 - 8

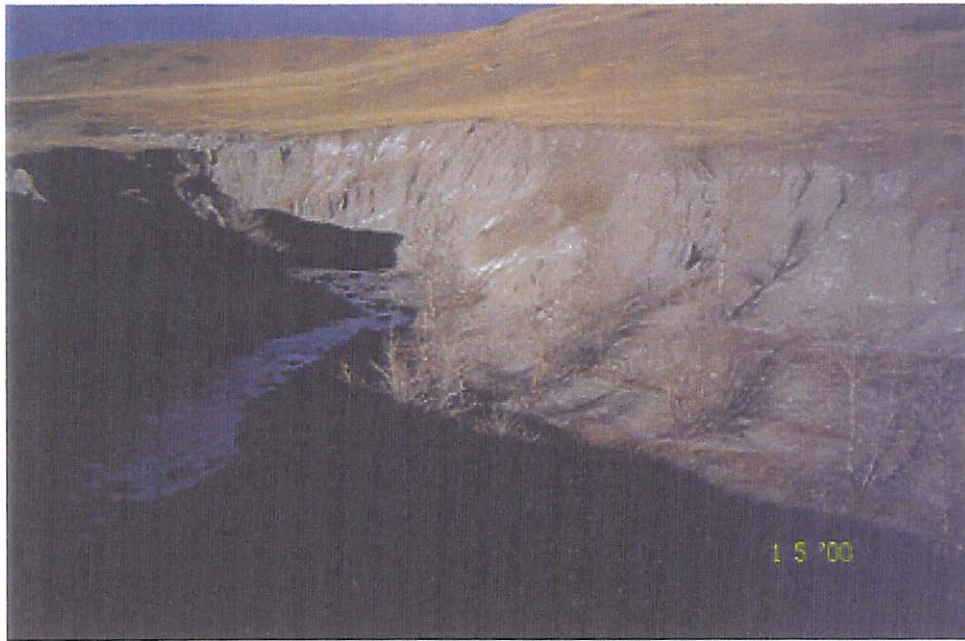
Photograph 0570-39. Looking US at Bend #0, foreground, Bend #1 at top.

Photo Station : 34+20
 Bank Stabilization : Low priority longitudinal peaked stone toe protection on left bank.

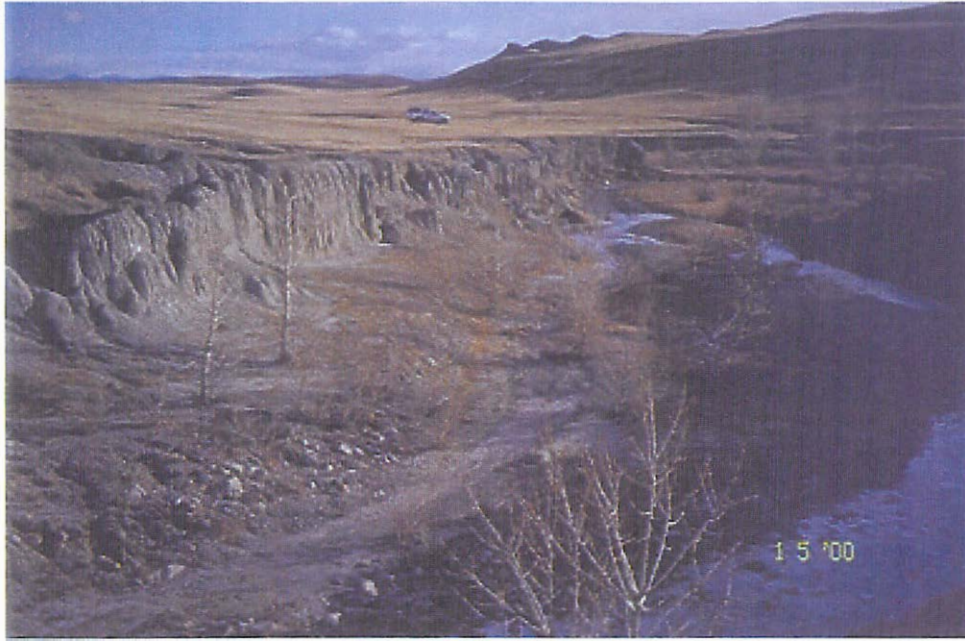
Photograph 0570-41. Left bank, looking DS of Bend #0 point bar & Gully #2. Panned left from Photograph 0570-40.

Photo Station : 35+50
 Upstream Station : 35+50
 Downstream Station : 33+50
 Bank Stabilization : Barbs or longitudinal peaked stone toe protection on right bank of Bend #0.
 Bend Diameter: 200 ft; Channel Width: ~30 ft; Barb Length: 15.0 ft; Barb
 Spacing: 47.9 - 52.7 ft; No. of Barbs: 4 - 3

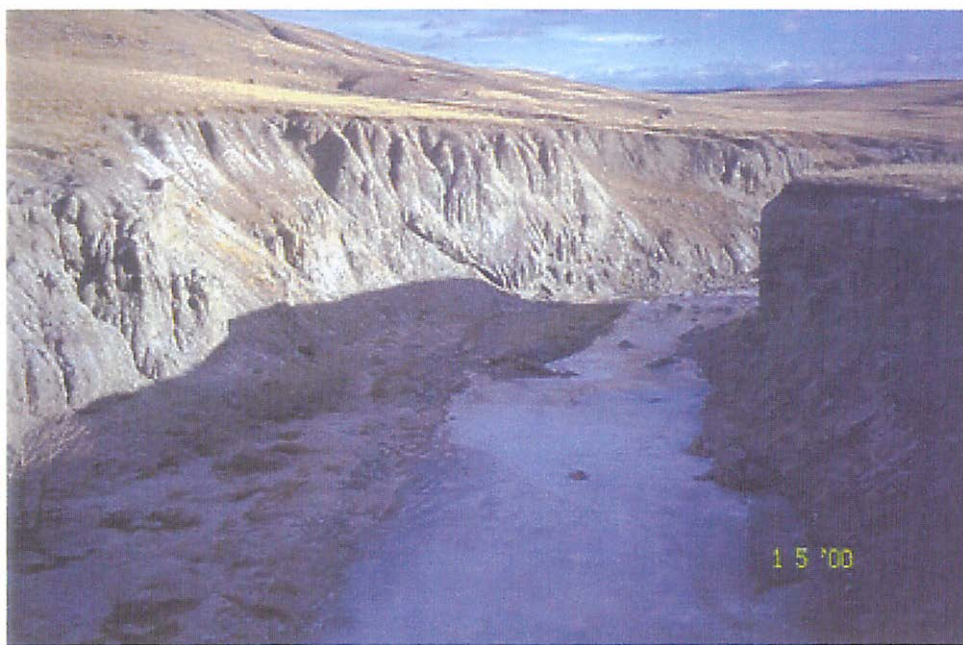
Photograph 0570-43. Left bank looking DS at Bend #1.

Photo Station : 35+50
 Bank Stabilization : Longitudinal peaked stone toe protection on right bank. Low priority longitudinal peaked stone protection toe on left bank.
 Upstream Station : 38+00
 Downstream Station : 35+50

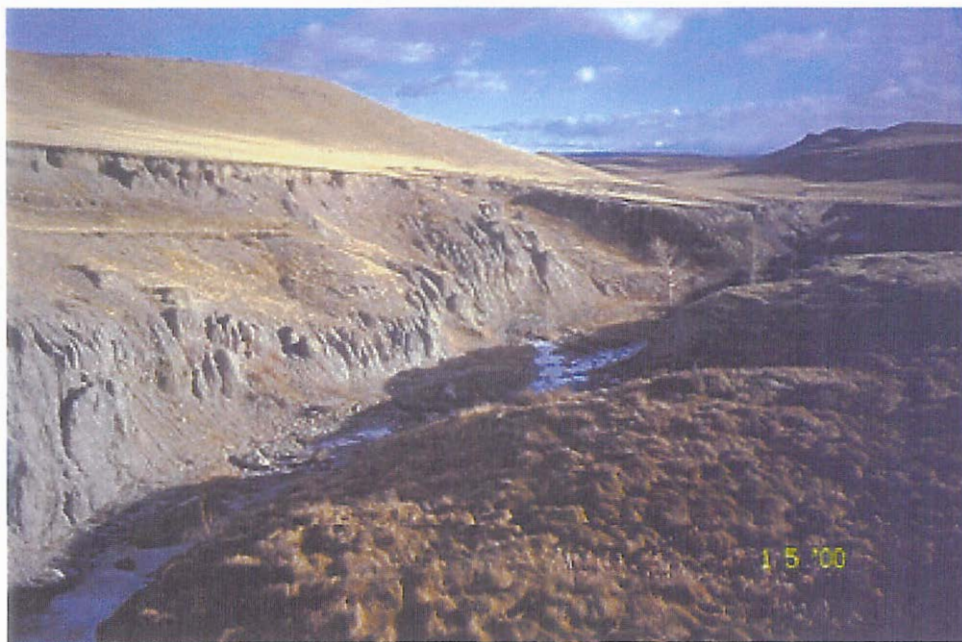
Photograph 0570-49. Left bank, looking DS at Bend #6.

Photo Station : 41+80
 Bank Stabilization : Longitudinal peaked stone toe protection on left bank.
 Upstream Station : 47+00
 Downstream Station : 43+00

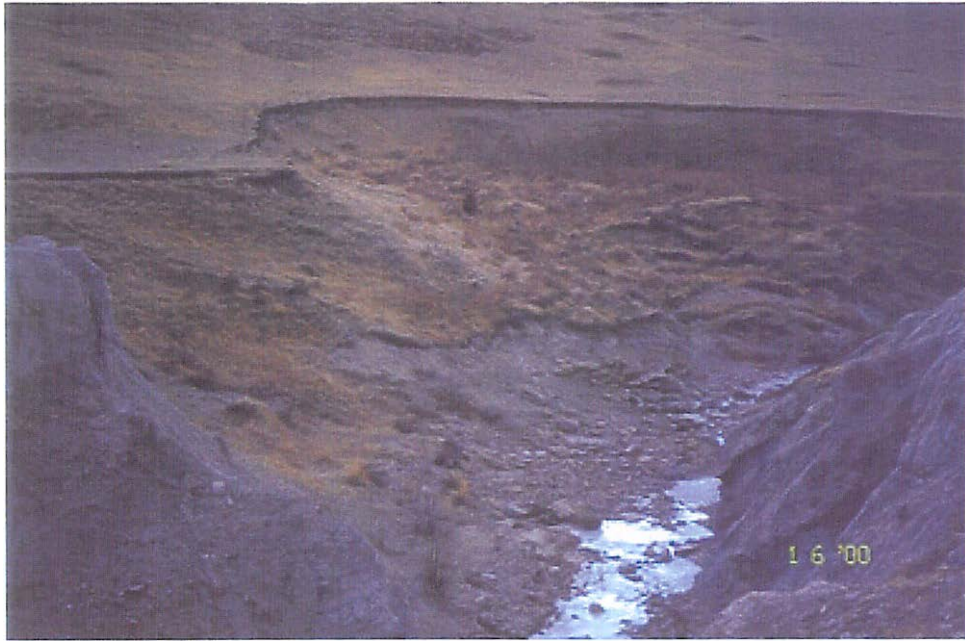
Photograph 0898-18. Right bank Bend #8, in middle slide.

Bank Stabilization : None, except mine rock from channel and revet both banks.

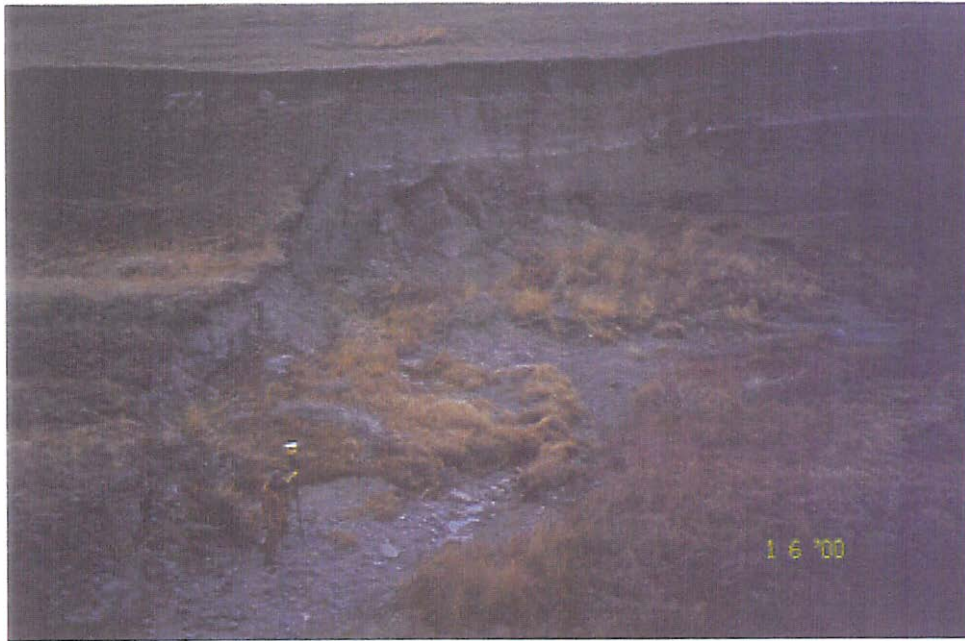
Photograph 0898-27. Closer view of Photograph 0898-25. Will Gonzales.

Photo Station : 55+90
Bank Stabilization : Medium priority longitudinal peaked stone toe protection on right bank. High priority headcut stabilization structure at 56+00.
Upstream Station : 61+10
Downstream Station : 56+00

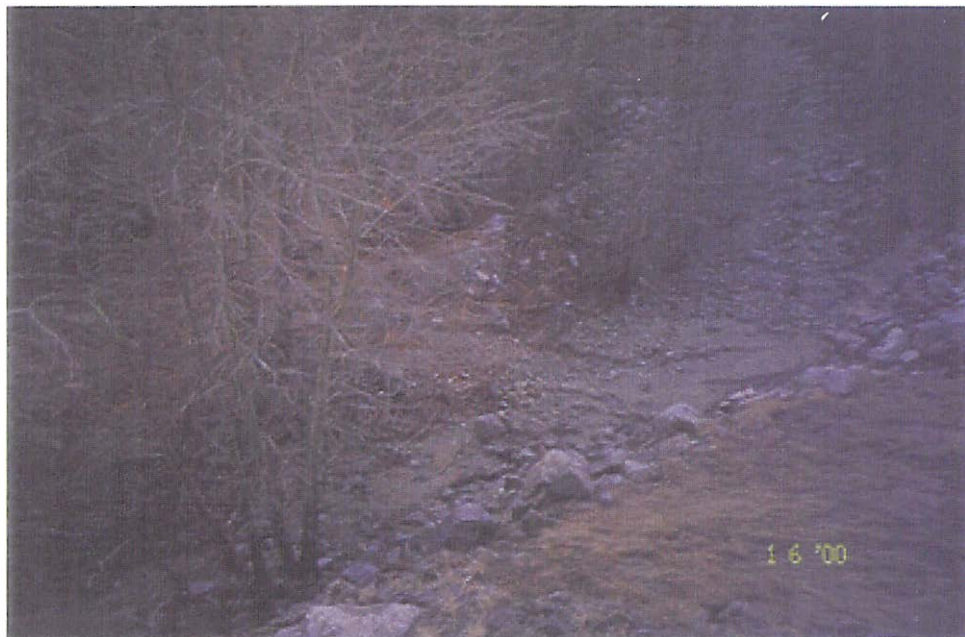
Photograph 0898-69. Left bank longitudinal peaked stone toe protection in Bend #26.

Photo Station : 84+20
 Bank Stabilization : None. Repairs to existing longitudinal peaked stone toe protection.

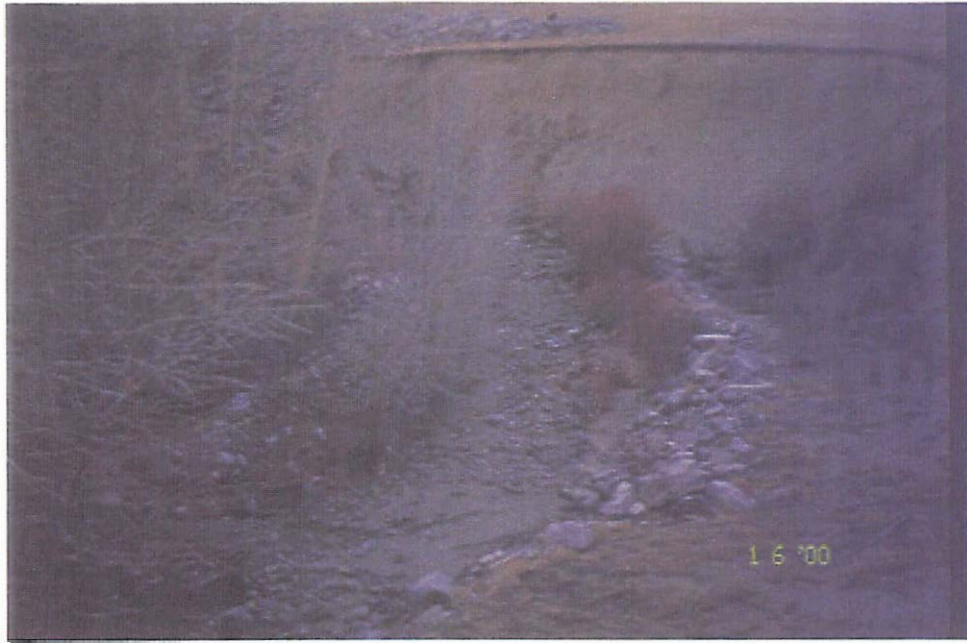
Photograph 0898-70. Both banks, looking US into Bend #26, DS of headcut. Panned up and US from Photograph 0898-69.

Photo Station : 84+20
 Bank Stabilization : Repair existing longitudinal peaked stone toe protection.

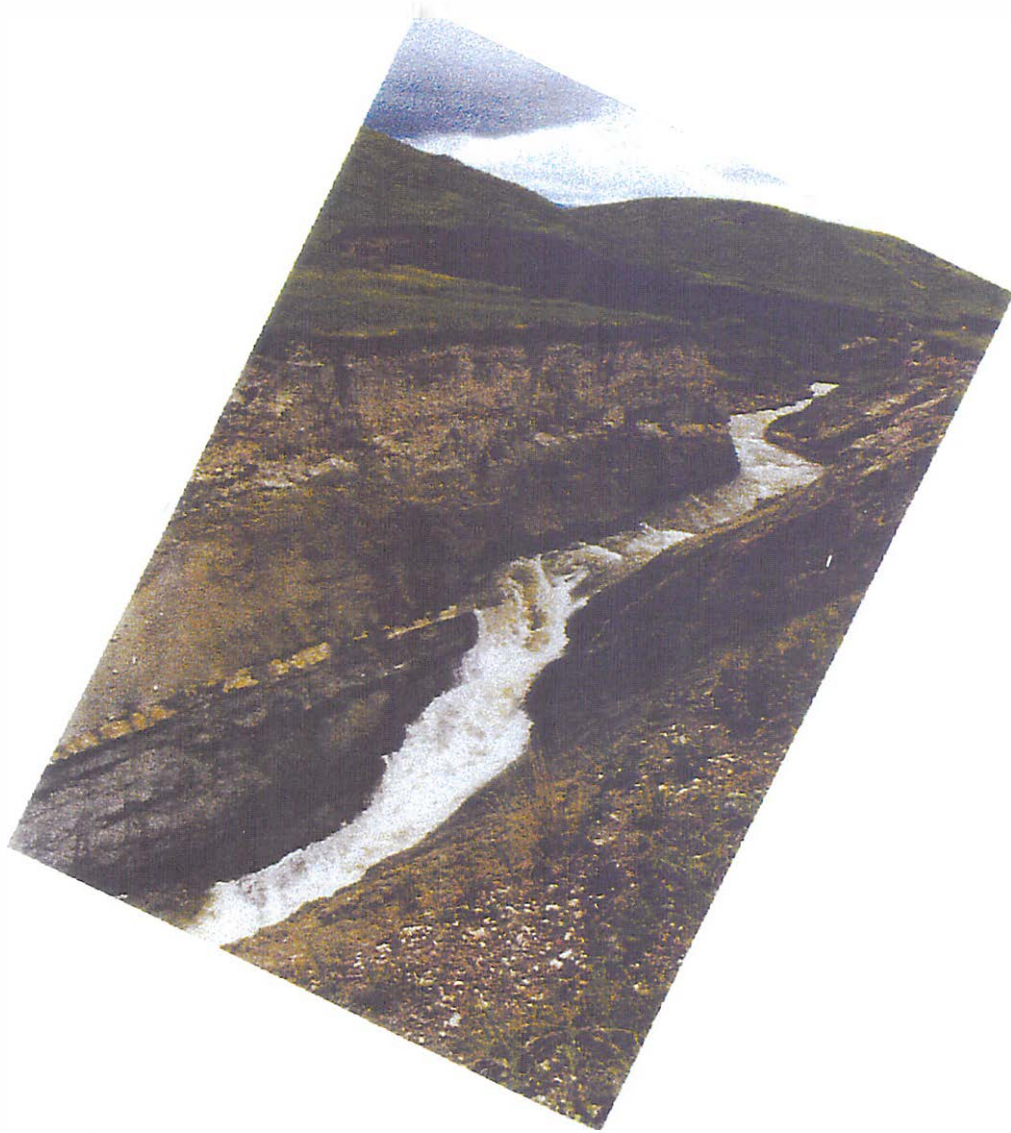
Figure 14. The “Kayak” chute. Note relative position of head cut in this photograph from July 2, 1997.

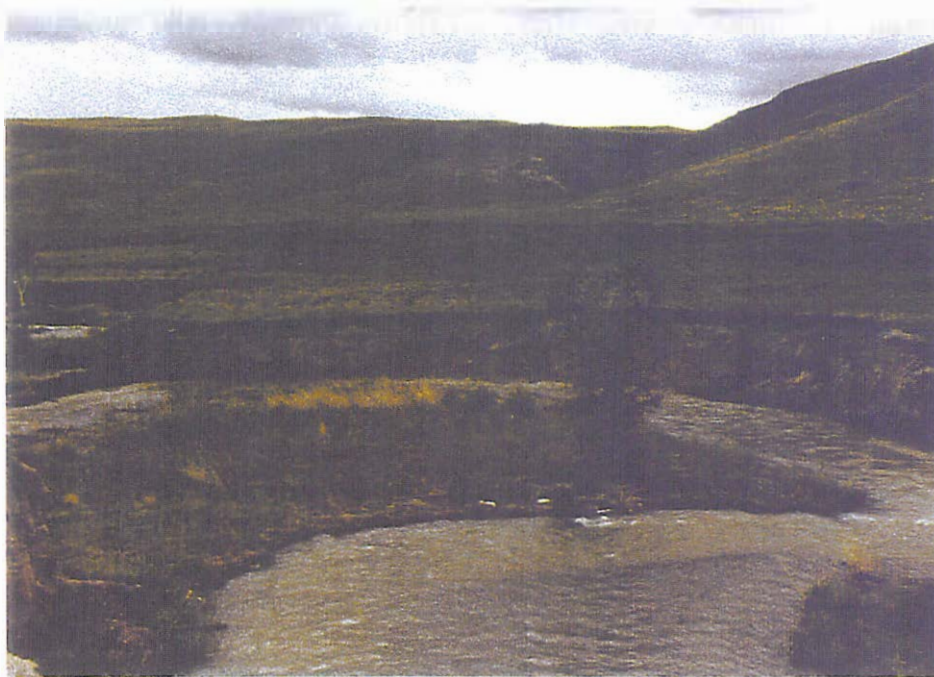
Figure 15. Feeder system with flows eroding outside of Loop #5 on July 2, 1997.
