Technical Memorandum No. Hv-D8560-2001-1

Lower Colorado
Boulder Canyon
Hoover Dam Penstock System
Evaluation of tie rods at the A-1 penstock junction,
Upper Arizona Penstock

U.S. Department of the Interior
Bureau of Reclamation

October 2001

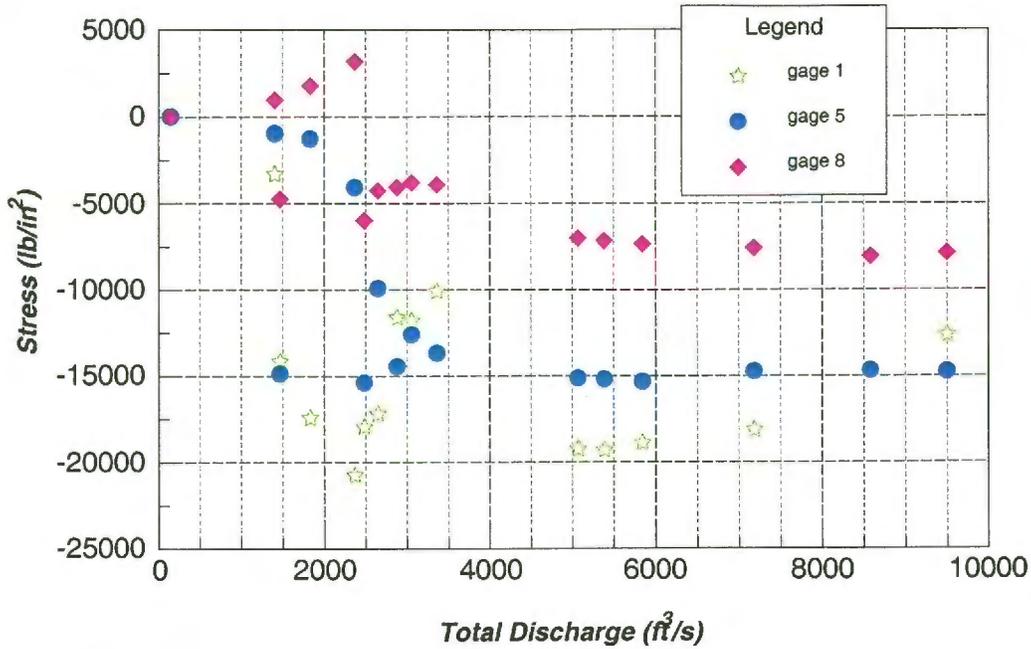
Figure 9.- Stress data from gages 1, 5, and 8 for the May tests.

Data from the May test (fig. 9) show an approximately constant stress for discharges between 5,000 and 9,500 ft³/s for gages 5 and 8, on the downstream tie rod. Gage 5, which faces the main penstock, has a stress of -15,000 lb/in², and gage 8, at 90 degrees to 5, facing downstream to the main penstock, has a stress of -7,500 lb/in². A study of these stresses indicates that the hydrostatic loading on the tie rod, does not account for these magnitudes. The mean stress due to changes in static loads with increasing flow and decreasing pressure would be less than 300 lb/in². The stresses appear to be a result of flexure of the pipe plate in the vicinity of the tie rod. The external stiffening bar provides fixity restraint in the direction of the main penstock. Normal

to the plate there is minimal restraint afforded to the pipe in its circumferential direction. Due to flexure of the pipe, the tie rod is forced to deflect, resulting in high bending stresses.

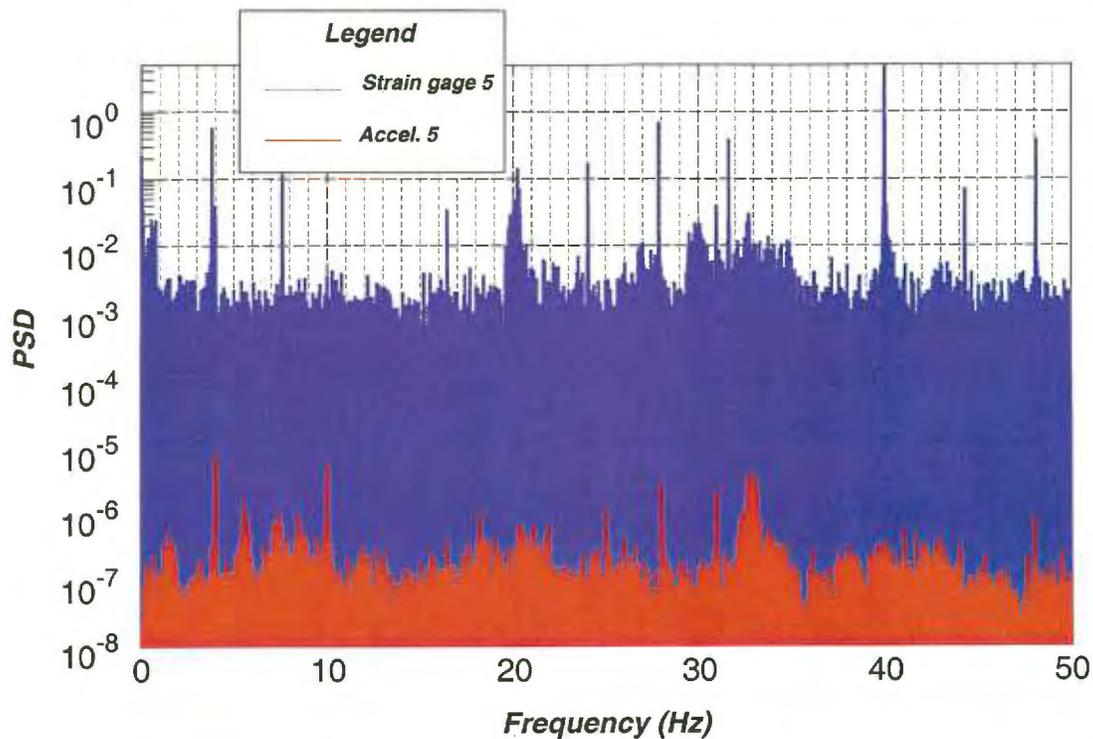
There was some correlation between frequencies in the analysis of time series from the strain gages and accelerometers. All data were collected simultaneously. Each sensor shows correlation at a frequency of 3.8 Hz, 48 Hz, 67.6 Hz, and 96 Hz. Figure 10 shows the frequency content of strain gage 5 and accelerometer 5, up to 50 Hz. The blade passing frequency of the runner is 48 Hz.

Figure 10.- Frequency content of strain gage and accelerometer time series, Run 13, March 2001 tests.

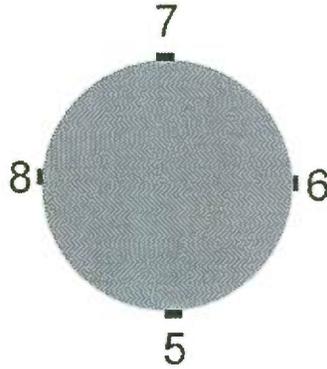
Downstream Tie Rod: Based on the operational stresses, we assumed a maximum stress just below yield of 34 ksi. This maximum stress will occur at location 5 (fig. 13), and is assumed to have an axial stress $f_a=18$ ksi, and a bending stress $f_b=16$ ksi. Assuming no bending occurs at 8, only an axial stress of 18 ksi will be present. Using these assumptions, the net stress at location 7 will be 2 ksi, ($f_a=18$ ksi and $f_b=-16$ ksi).

Figure 13.- Cross section of downstream tie rod, see figure 6 for flow orientation.

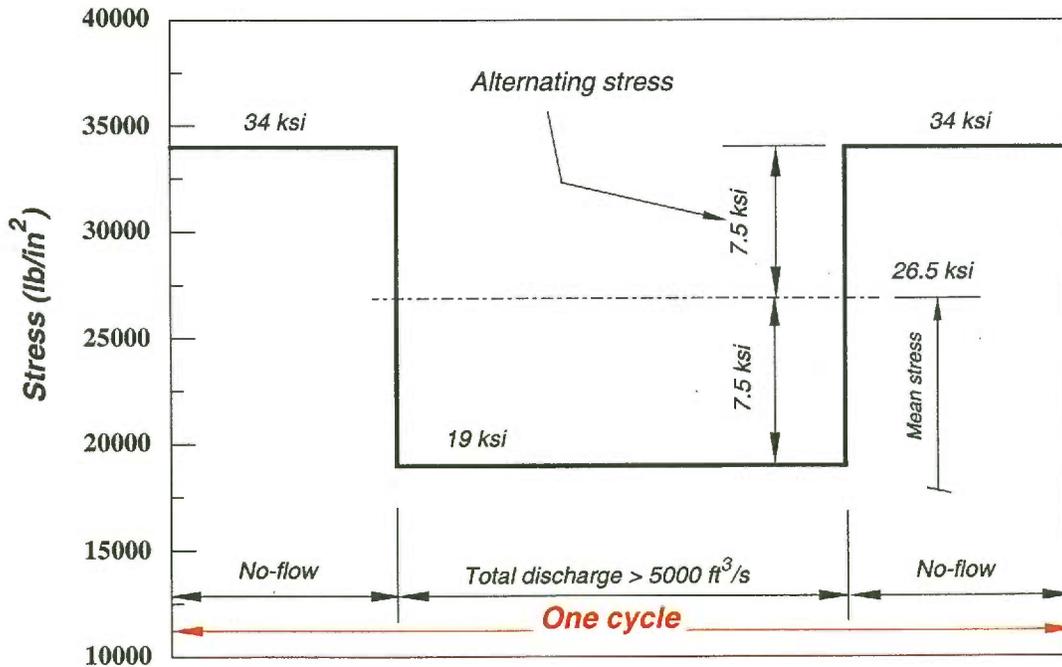
Data from the March 13, 2001 test showed the maximum stress at 5 was -15 ksi, and at 8 was -7.5 ksi. Assuming no bending at 8, the axial stress is -7.5 ksi and the bending stress at 5 is -7.5 ksi. Details of these operating cycles are shown in fig. 14, 15, and 16 for the locations 5, 8, and 7 respectively.

Figure 14.- Stresses at downstream tie rod location 5

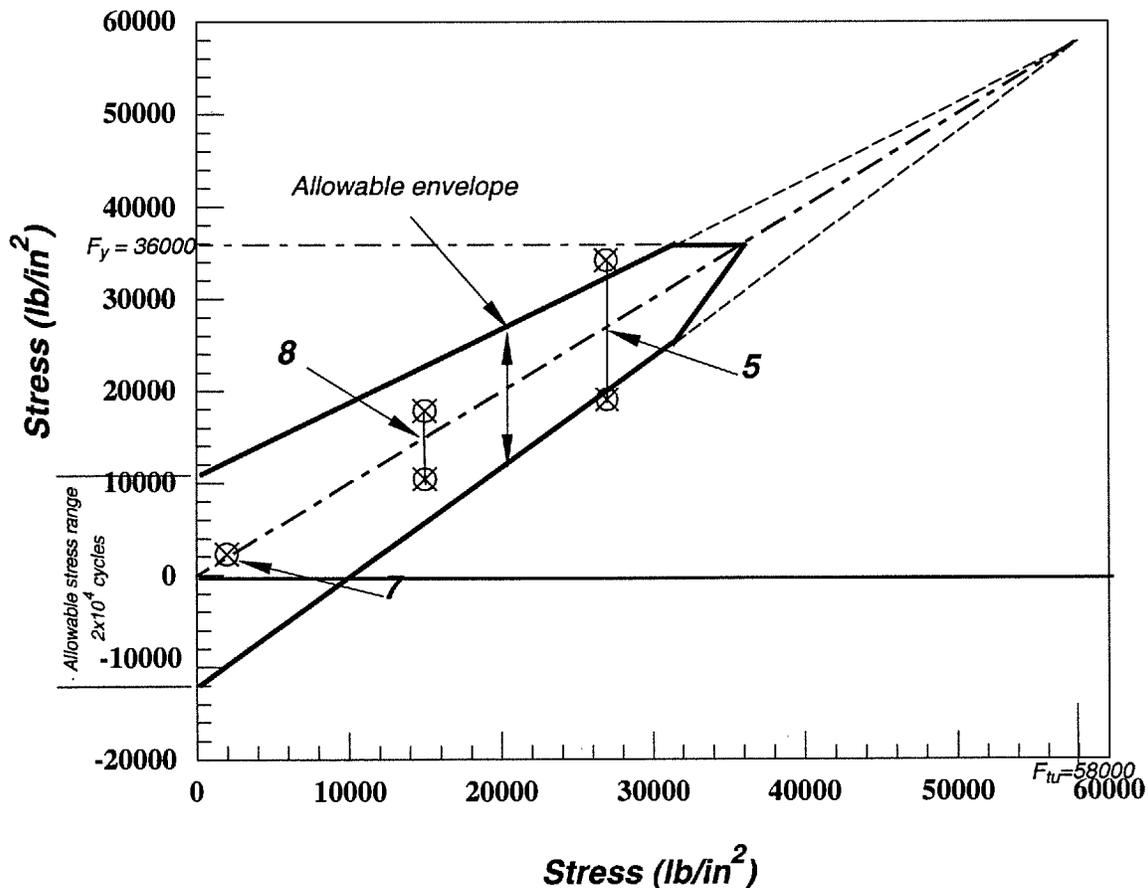
The stresses detailed here are nominal in the tie rod, and also affect the threads. Using "Recommendations For the Fatigue Design of Steel Structures," ECCS-Technical Committee-6-Fatigue, 1985, the allowable stress range for a thread with 20,150 cycles is 23 ksi, (reference Table B2.1).

The three stress cycles are shown on a Modified Goodman diagram, fig. 17. Stresses at location 5 lie outside the allowable envelope, indicating the potential for a crack to form at the first thread.

Figure 17.- Modified Goodman Diagram for stresses in downstream tie rod at A-1 lateral.

At the next penstock outage, propose installation of strain gages on both tie rods at the most upstream lateral. The gage installation would be similar to that which was performed this year. The testing would record stresses during:

Analysis of the data will determine whether the fluctuating mean stress, arising from the operation of the units, is large enough to affect the structural life of the tie rods. In addition, external strain gages on the penstock near the tie rod location will help in determining whether the penstock shell is deforming, causing increased loading in the tie rods.

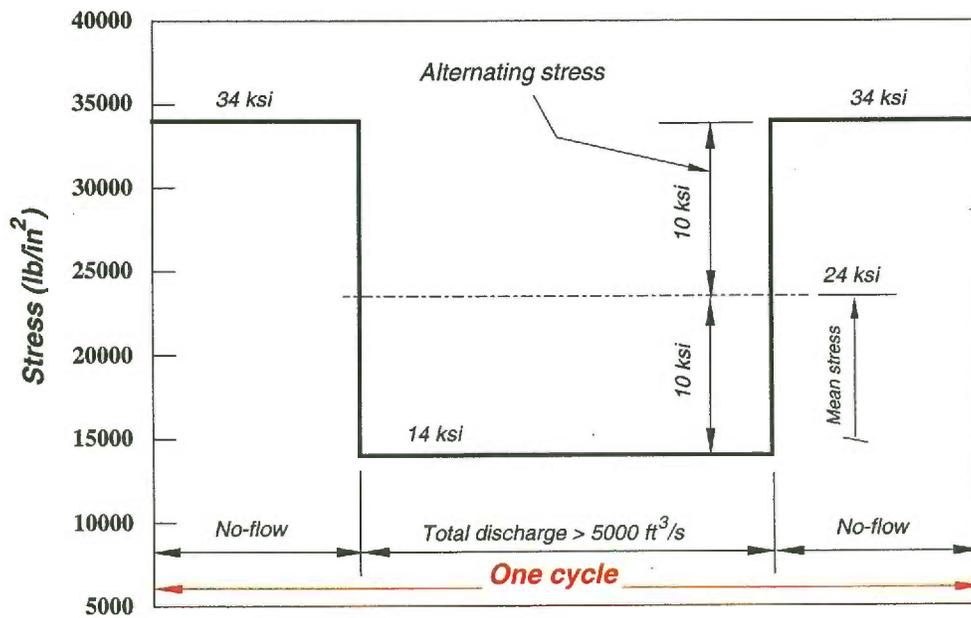
Upstream Tie Rod: The no-flow stress conditions will be assumed to be the same as those described for the downstream tie rod. Test data from March 13, 2001, showed a maximum stress of -20 ksi, occurring at location 1 (fig. 18). At location 4, the axial stress was -7.5 ksi, which resulted in a bending stress of -12.5 ksi at location 1.

Figure 19.- Stresses at upstream tie rod location 1.

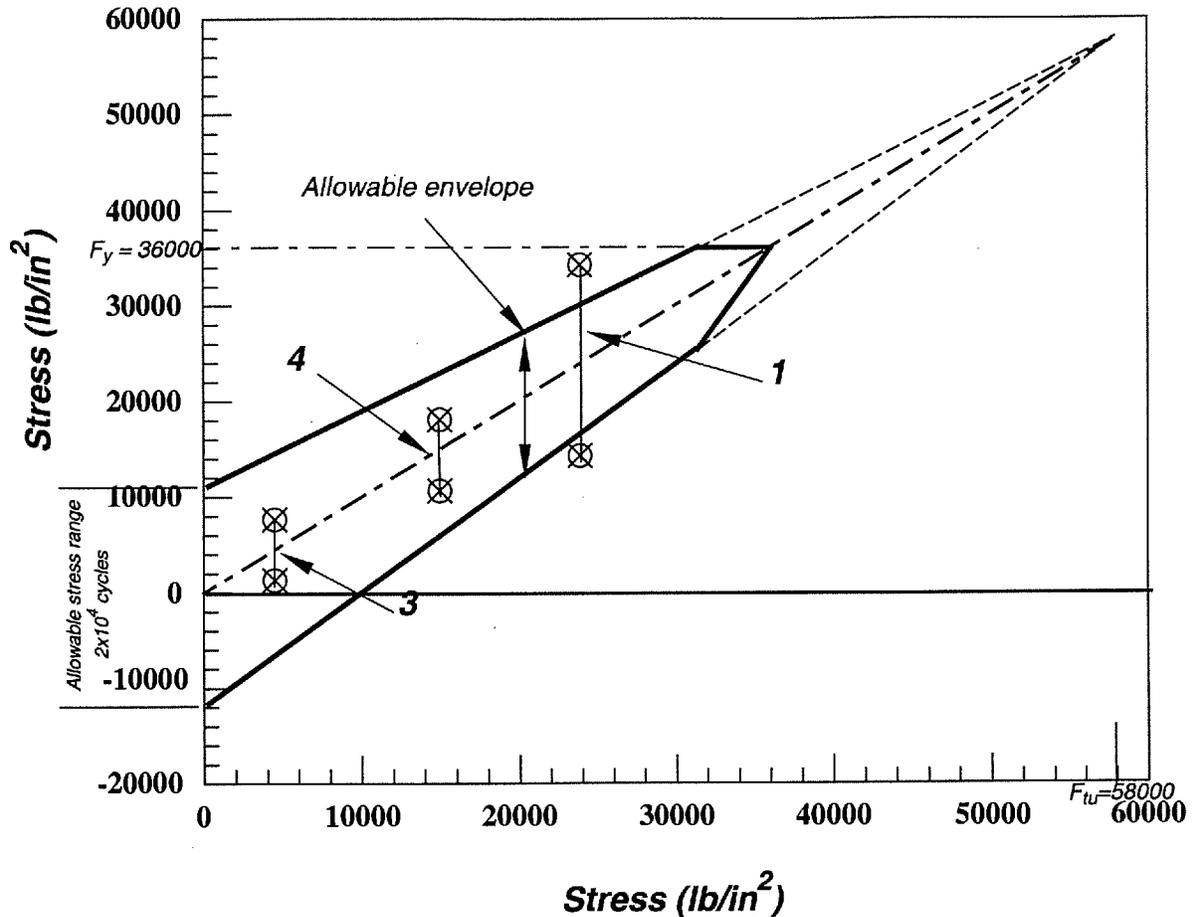
The three stress cycles are also shown on a Modified Goodman diagram, figure 22. Stresses at location 1 lie outside the allowable envelope. There is a possibility of a crack forming at the first thread below location 1.

Figure 22.- Modified Goodman diagram for the stress cycles at three locations on the upstream tie rod, A-1 lateral.
