**Red Bluff Diversion Dam
Fishway Attraction Study**

Spillway Operation Test

**Conducted for
Red Bluff Field Office**

**Brent Mefford
Tracy Vermeyen
Joe Kubitschek
Joel Sturm**

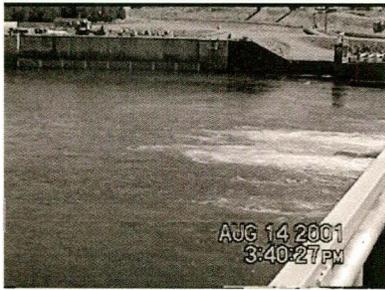
Figure 5 - Photographs of surface flow conditions during test 1.

Hydraulic Jump Stability - Releases from gates 5,6, and 7 produced a bubble plume that extended to approximately the spillway endsill (figure 5). The hydraulic jump downstream of gates 5, 6, and 7 appeared very stable. The gate openings tested provided a ratio of tailwater depth to hydraulic jump conjugate depth greater than one for all gates (table 1). Reclamation Engineering Monograph 25 recommends a ratio greater than 1 for good jump stability.

View of white water turbulence downstream of gates 5, 6 and 7.

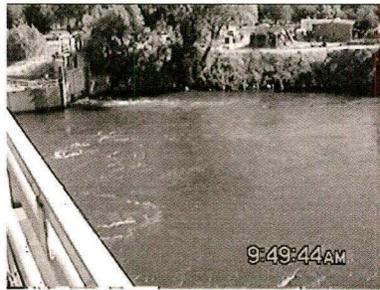
View of surface flow conditions downstream of the left bank fishway.

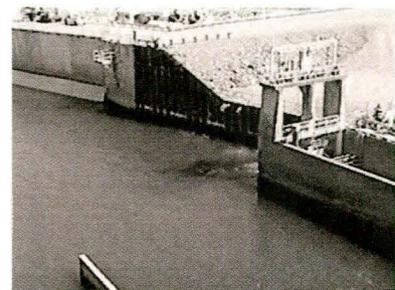
View of surface flow conditions downstream of the right bank fishway.

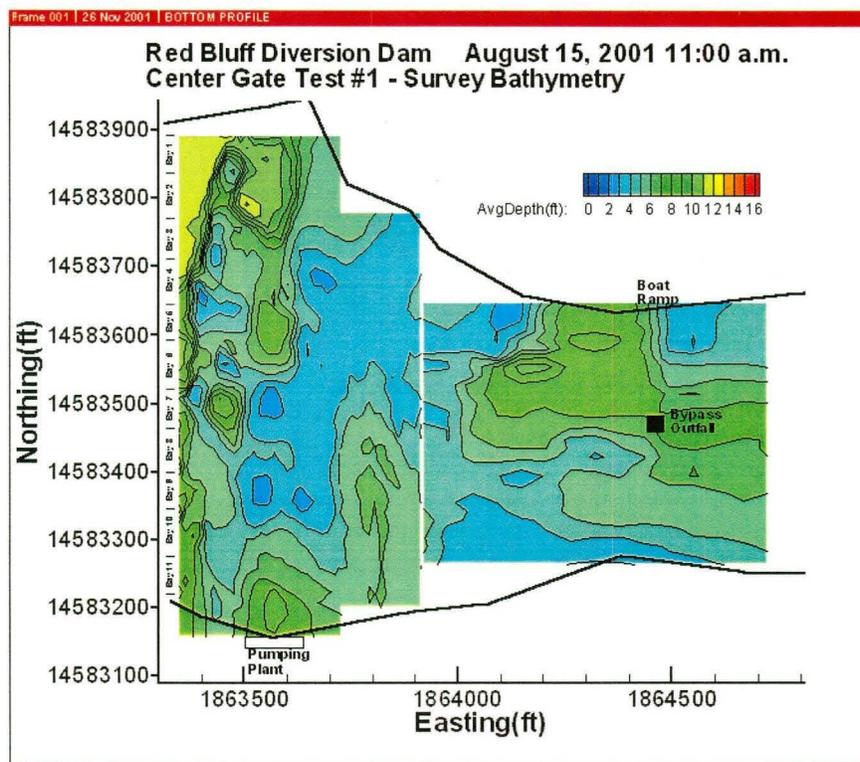
Figure 6 - River bathymetry downstream of Red Bluff Diversion Dam after test 1.

River Bathymetry and Flow Conditions Downstream of the Spillway - Figure 6 gives the post test river bathymetry. Figure 7 shows the change in depth between pre and post test 1 conditions. Scouring in the center of the river was accompanied by deposition near each bank downstream of the fishway entrances. The large river center flows scoured material downstream of gates 5,6, and 7 exposing the spillway apron endsill and downstream riprap. Deposition of 6 ft to 8 ft occurred in front of the pumping plant downstream of bays 10 and 11 and downstream of bays 1 and 2. The rapid movement of material toward the river banks was driven by the lateral spread of spillway releases as the flow impacted the extensive alluvial deposit immediately downstream of the center gates. The dive inspection indicated the riprap was not affected by the test flow. River velocities measured during the test using an ADCP are given in figure 8. The flow field for a distance of nearly 600 ft downstream of the dam is poorly defined due to sediment deposits and the wide channel. Strong flows were measured about 300 ft downstream of the spillway apron along both river banks. The flow likely resulted from the movement of spillway flow around the river centered deposits rather than fishway flows. The ADCP data shows fishway flow rapidly mixed with spillway flows. Fishway flow velocities were not discernable from other spillway driven flow velocities beyond 50 to 75 ft downstream of the fishway entrance.

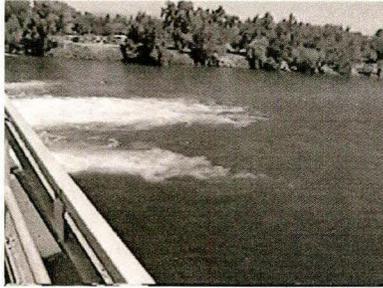
Figure 9 - Photographs of surface flow conditions during test 2.

Hydraulic Jump Stability - Releases from gates 5, 6, and 7 produced a bubble plume that extended well beyond the spillway endsill, as shown in figure 9. The hydraulic jump downstream of gates 5, 6, and 7 remained stable with the increased flow of test 2. The gate openings tested provided a ratio of tailwater depth to hydraulic jump conjugate depth greater than one for all gates, (table 2).

View of white water turbulence downstream of gates 5, 6 and 7.

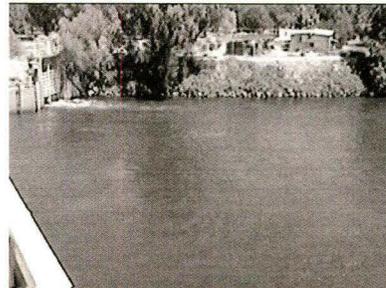
View of surface turbulence downstream of the left bank ladder.

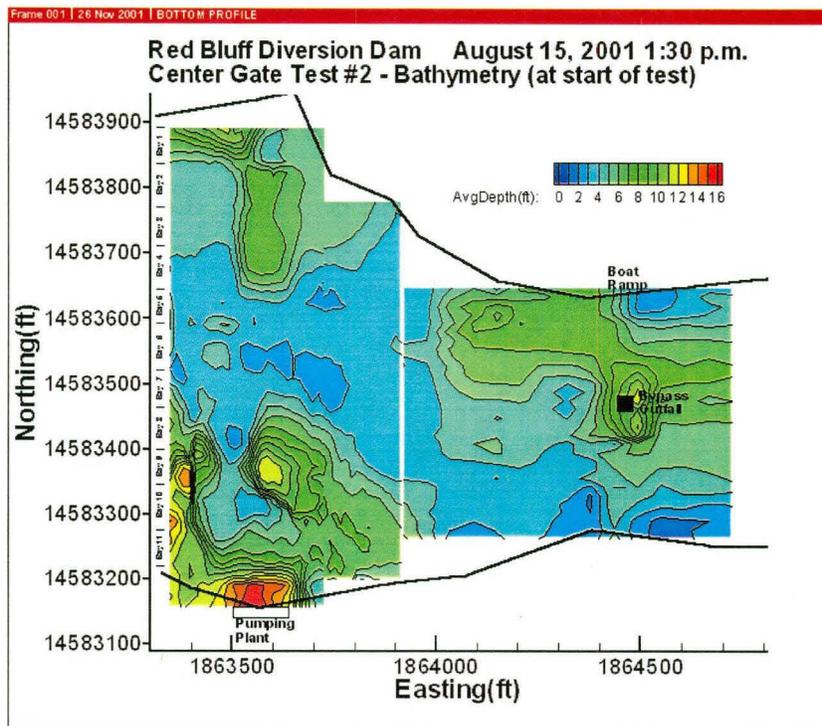
Figure 10 - River bathymetry following test 2.

River Bathymetry and Flow Conditions Downstream of the Spillway - The high river centered releases continued to move alluvial material downstream and toward both banks. The dive inspection found no indication that the riprap apron was affected by the test flow. Figure 10 gives the post test 2 river bathymetry and figure 11 shows the change in depth between test 1 and post test 2 conditions. By the end of test 2, the flow releases had cut channels toward each bank through the remaining alluvial deposit in the center of the river. The flow resulted in 4 to 6 ft of material deposition in the river downstream of bays 1, 2, 3, 4, and 11. River velocities measured during the test are given in figure 12. The large river center alluvial deposit continued to control flow patterns upstream of the fish screen bypass outfall. Similar to test 1, fishway flows were not distinguishable in the velocity measurements taken 100 ft downstream of the spillway endsill.

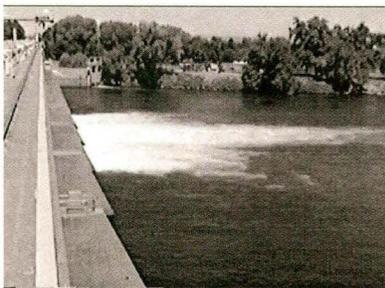
Figure 13 - Photographs of surface flow conditions during test 3.

Hydraulic Jump Stability - Releases from gates 5, 6, and 7 produced a bubble plume that extended well downstream of the spillway endsill, as shown in figure 13. The hydraulic jump downstream of gates 5, 6, and 7 remained stable. The flow through gate 6 yielded a ratio of tailwater depth to hydraulic jump conjugate depth of just under 1.0, (table 3).

View of white water turbulence downstream of gates 5, 6 and 7. Surface turbulence extended well downstream of the stilling basin endsill.

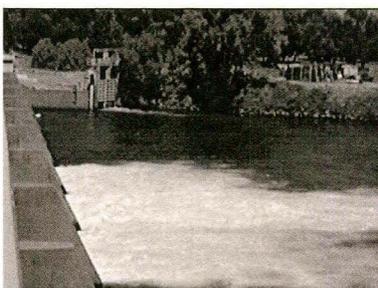
View of surface flow conditions exiting the left bank fishway.

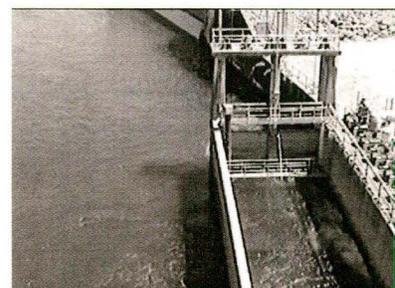
View of surface flow conditions exiting the right bank fishway.

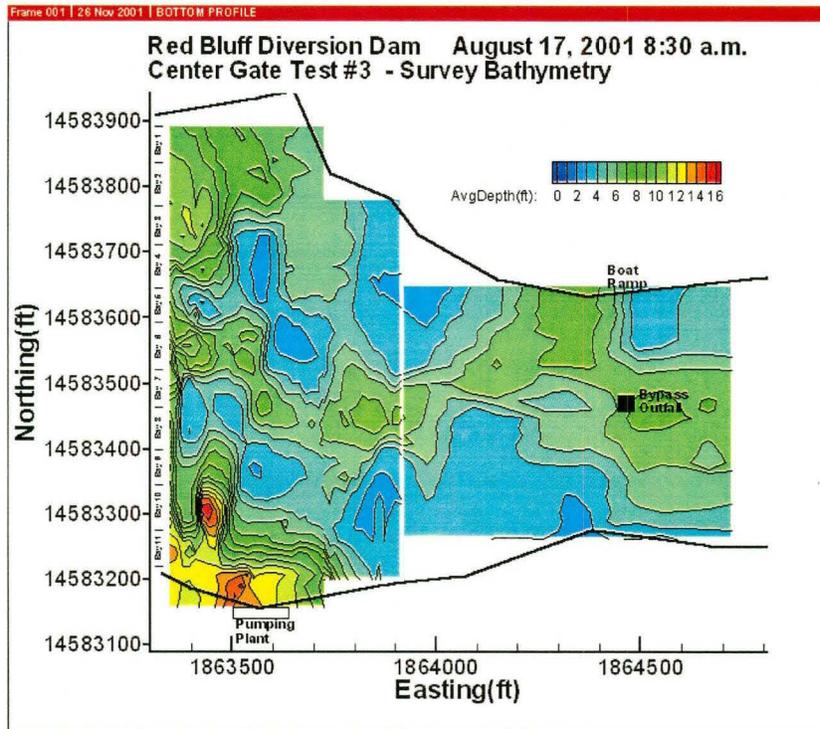
Figure 14 - River bathymetry following test 3.

River Bathymetry and Flow Conditions Downstream of the Spillway - The high river centered releases continued to move alluvial material downstream and toward both banks. Test 3 flows scoured a channel that extended about 800 ft downstream of the spillway (figure 14). Material removed during test 3 deposited downstream of bays 1 through 4 and 8 through 11 (figure 15). The dive inspection found no indication the riprap apron was affected by the test flow. River velocities measured during the test are given in figure 16. Similar to tests 1 and 2, fishway flows were not distinguishable in velocity measurements taken 100 ft downstream of the spillway endsill.
