**Red Bluff Diversion Dam
Fishway Attraction Study**

Spillway Operation Test

**Conducted for
Red Bluff Field Office**

**Brent Mefford
Tracy Vermeyen
Joe Kubitschek
Joel Sturm**

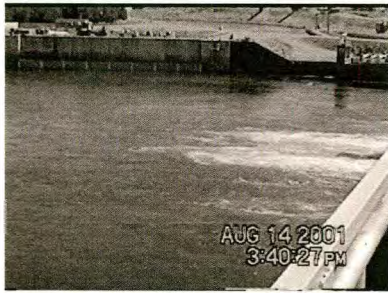
Figure 5 - Photographs of surface flow conditions during test 1.

Hydraulic Jump Stability - Releases from gates 5,6, and 7 produced a bubble plume that extended to approximately the spillway endsill (figure 5). The hydraulic jump downstream of gates 5, 6, and 7 appeared very stable. The gate openings tested provided a ratio of tailwater depth to hydraulic jump conjugate depth greater than one for all gates (table 1). Reclamation Engineering Monograph 25 recommends a ratio greater than 1 for good jump stability.

View of white water turbulence downstream of gates 5, 6 and 7.

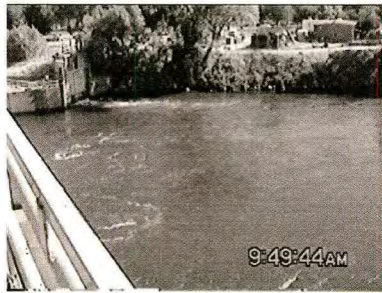
View of surface flow conditions downstream of the left bank fishway.

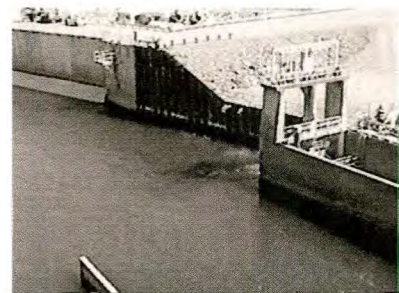
View of surface flow conditions downstream of the right bank fishway.

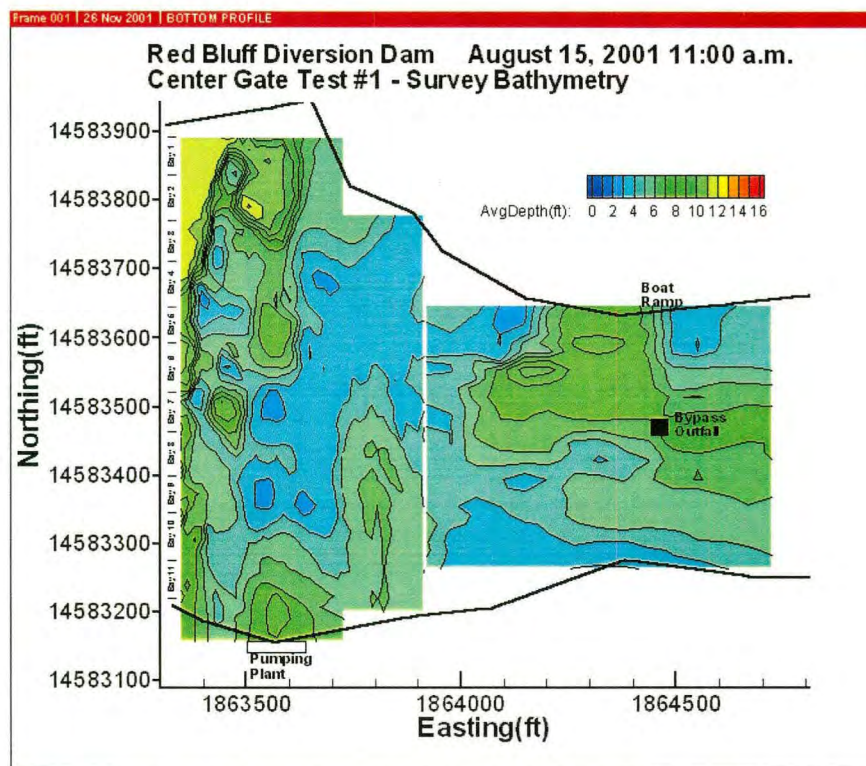
Figure 6 - River bathymetry downstream of Red Bluff Diversion Dam after test 1.

River Bathymetry and Flow Conditions Downstream of the Spillway - Figure 6 gives the post test river bathymetry. Figure 7 shows the change in depth between pre and post test 1 conditions. Scouring in the center of the river was accompanied by deposition near each bank downstream of the fishway entrances. The large river center flows scoured material downstream of gates 5,6, and 7 exposing the spillway apron endsill and downstream riprap. Deposition of 6 ft to 8 ft occurred in front of the pumping plant downstream of bays 10 and 11 and downstream of bays 1 and 2. The rapid movement of material toward the river banks was driven by the lateral spread of spillway releases as the flow impacted the extensive alluvial deposit immediately downstream of the center gates. The dive inspection indicated the riprap was not affected by the test flow. River velocities measured during the test using an ADCP are given in figure 8. The flow field for a distance of nearly 600 ft downstream of the dam is poorly defined due to sediment deposits and the wide channel. Strong flows were measured about 300 ft downstream of the spillway apron along both river banks. The flow likely resulted from the movement of spillway flow around the river centered deposits rather than fishway flows. The ADCP data shows fishway flow rapidly mixed with spillway flows. Fishway flow velocities were not discernable from other spillway driven flow velocities beyond 50 to 75 ft downstream of the fishway entrance.

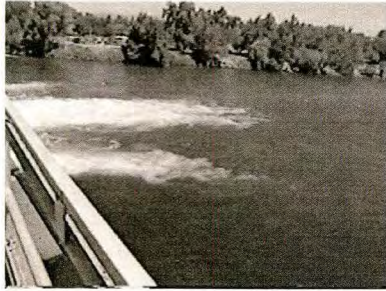
Figure 9 - Photographs of surface flow conditions during test 2.

Hydraulic Jump Stability - Releases from gates 5, 6, and 7 produced a bubble plume that extended well beyond the spillway endsill, as shown in figure 9. The hydraulic jump downstream of gates 5, 6, and 7 remained stable with the increased flow of test 2. The gate openings tested provided a ratio of tailwater depth to hydraulic jump conjugate depth greater than one for all gates, (table 2).

View of white water turbulence downstream of gates 5, 6 and 7.

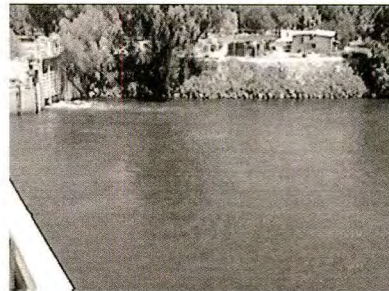
View of surface turbulence downstream of the left bank ladder.

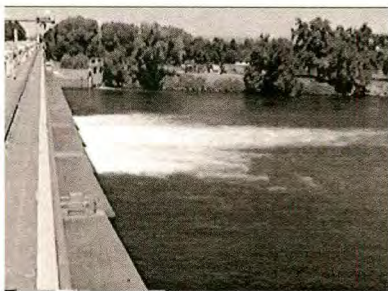
Figure 13 - Photographs of surface flow conditions during test 3.

Hydraulic Jump Stability - Releases from gates 5, 6, and 7 produced a bubble plume that extended well downstream of the spillway endsill, as shown in figure 13. The hydraulic jump downstream of gates 5, 6, and 7 remained stable. The flow through gate 6 yielded a ratio of tailwater depth to hydraulic jump conjugate depth of just under 1.0, (table 3).

View of white water turbulence downstream of gates 5, 6 and 7. Surface turbulence extended well downstream of the stilling basin endsill.

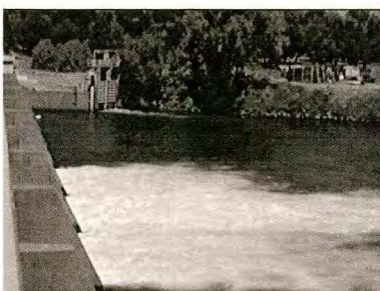
View of surface flow conditions exiting the left bank fishway.

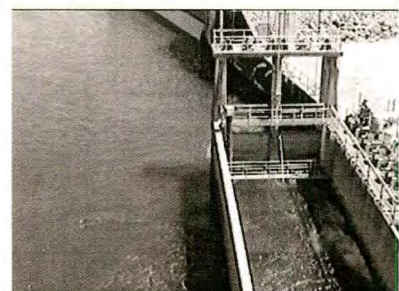
View of surface flow conditions exiting the right bank fishway.

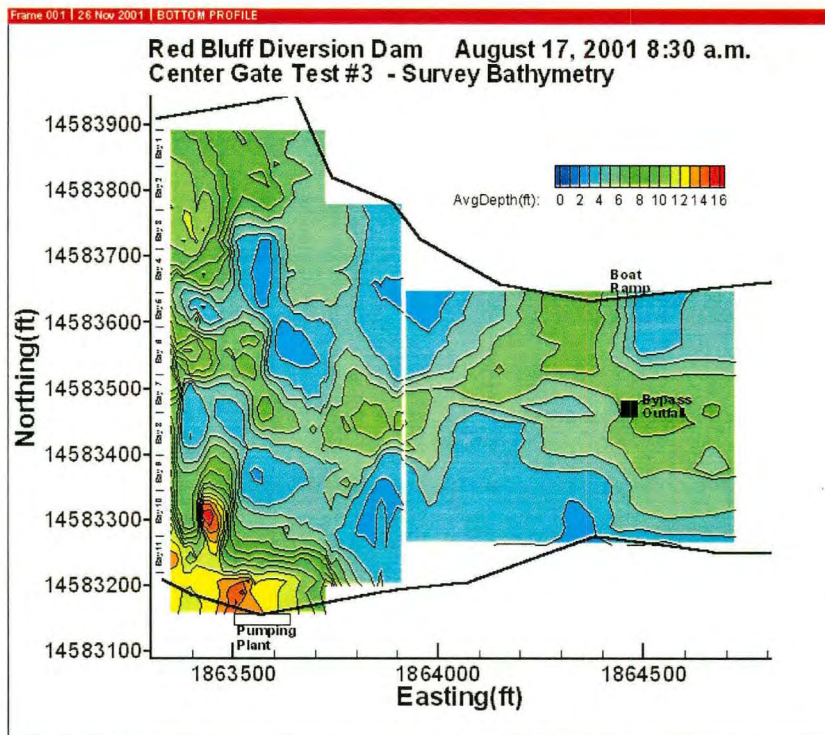
Figure 14 - River bathymetry following test 3.

River Bathymetry and Flow Conditions Downstream of the Spillway - The high river centered releases continued to move alluvial material downstream and toward both banks. Test 3 flows scoured a channel that extended about 800 ft downstream of the spillway (figure 14). Material removed during test 3 deposited downstream of bays 1 through 4 and 8 through 11 (figure 15). The dive inspection found no indication the riprap apron was affected by the test flow. River velocities measured during the test are given in figure 16. Similar to tests 1 and 2, fishway flows were not distinguishable in velocity measurements taken 100 ft downstream of the spillway endsill.
