Technical Memorandum No. EVMAA-8668460-2008-1

## **El Vado Dam Middle Rio Grande Project, New Mexico**

**Issue Evaluation — Service Spillway – Operational Testing &  
Dynamic Analysis**

**August 2008**

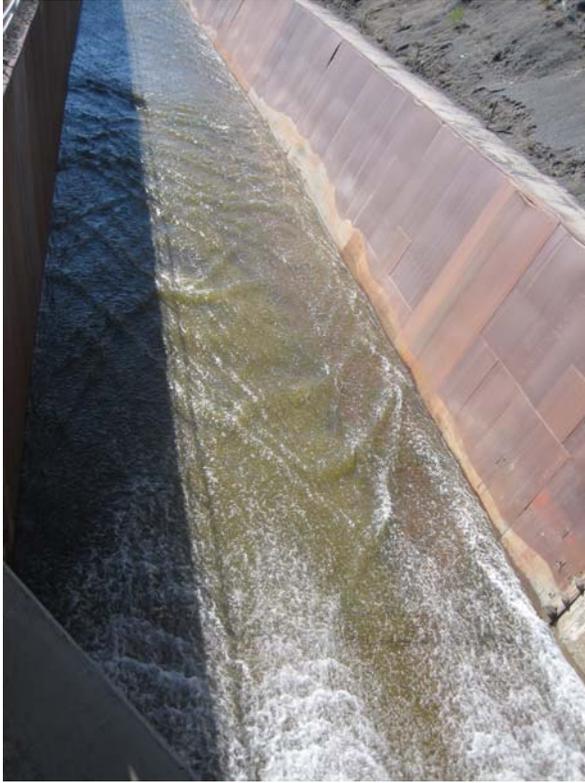
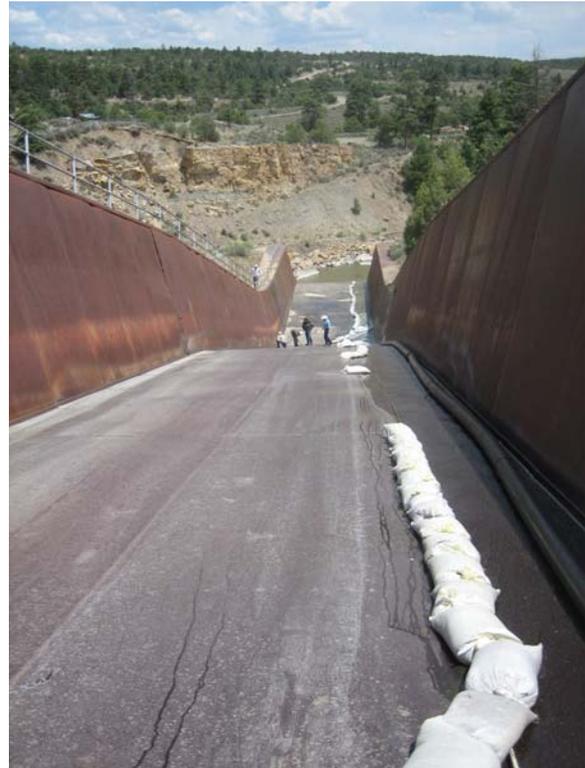
**Figure 1: Views down the steel-plate-lined spillway at El Vado Dam.**

An initial site visit on June 9-10, 2008 focused on the amount of dewatering effort that would be required in order for our planned testing to occur. The spillway floor plates over the lower one-half end of the spillway and at minimum three-quarters of the channel width must be dry and completely free from the leakage flows. Leakage flow rates were estimated at between 50-100  $\text{ft}^3/\text{s}$  during this first site visit, figure 1a.

Testing was accomplished during the week of June 23, 2008. Leakage had been reduced and contained to the right side of the spillway allowing access to the areas that required instrument placement and installation, figure 1b. The test plan called for a modal survey of several spillway plates, a review of the data, and then selection and installation of strain gages and accelerometers that would be waterproofed and monitored during the operational tests.

**a) leakage through gate in early June 2008**

**b) leakage controlled and diverted to the right side of the spillway invert.**

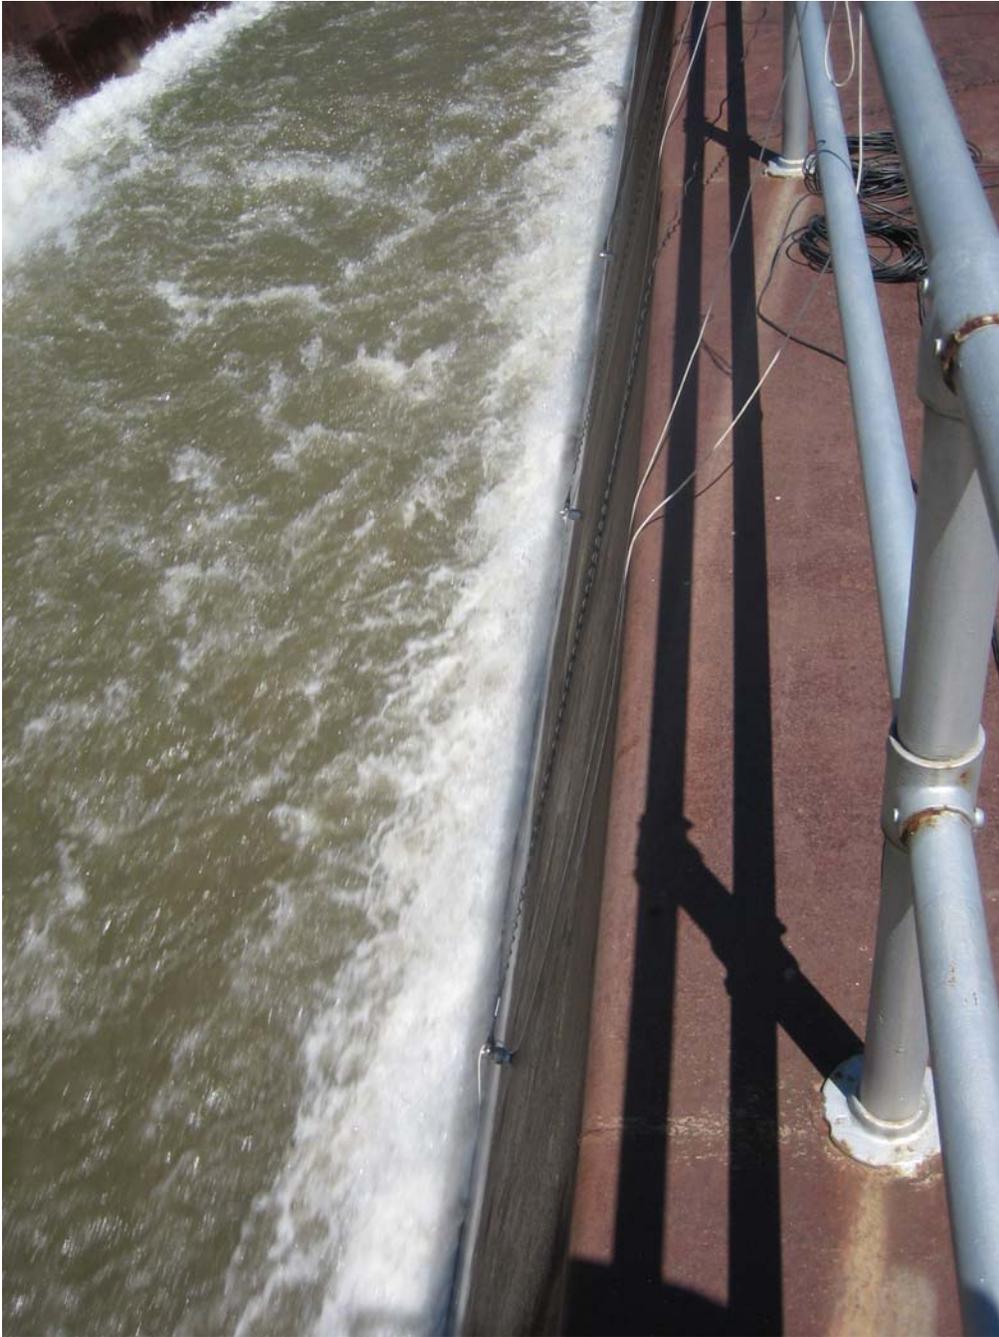
**Figure 9: Flow of  $2700 \text{ ft}^3/\text{s}$  passing by location 1, note sidewall accelerometers above water level.**

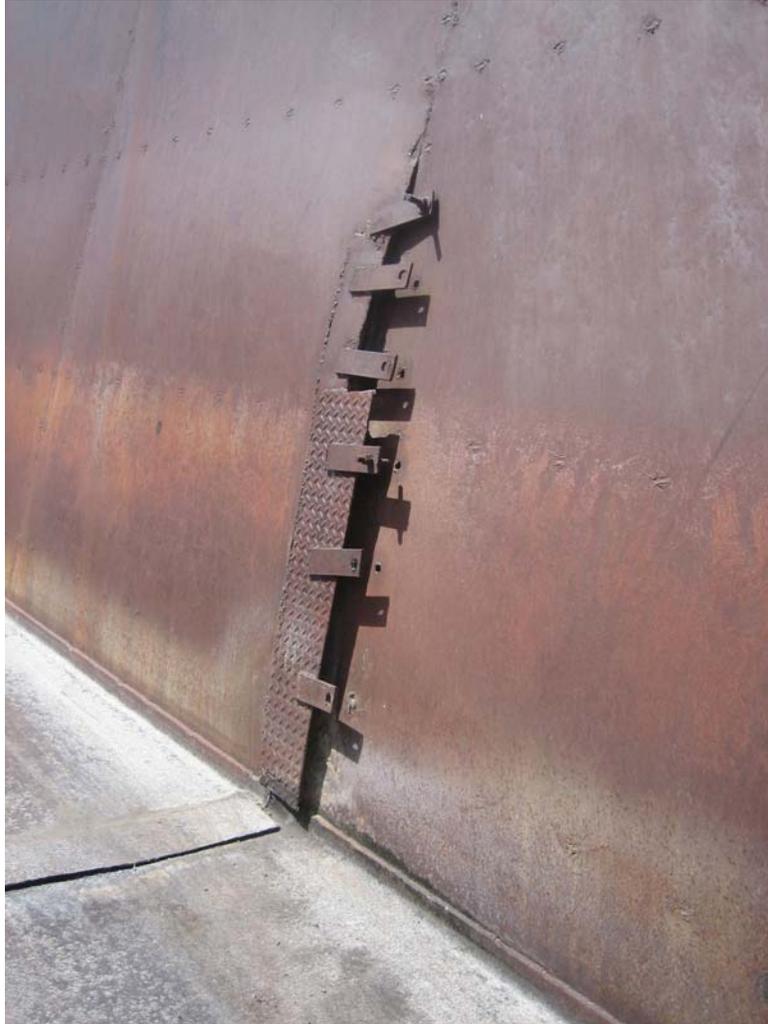
Flow tests were performed on the spillway at El Vado Dam. The structure is constructed of welded-steel plates on a structural steel frame that sits on an earth foundation and which is approaching 75 years in-service. Major rehabilitation was performed in the past (over 50 years ago) and the standard maintenance approach has been to attempt to repair cracks and broken welds with weld repairs. These repairs have been somewhat successful, however many repairs have resulted in additional cracks to the heat-affected zones. Various techniques of welding and bolting plates to try and repair cracks or gaps in the lining have had some success. However, plates have been overstressed with some of these repairs and failures to the lining remain, figure 20.

Thermal stresses were apparently overlooked in the original design. These stresses are the most likely cause of observed or existing cracks around the plug welds since historical operations appears to be rather minimal. Failed plug welds could lead to a situation where much lower uplift hydrostatic differentials would cause failure (e.g., if all the plug welds for a single plate failed, the effective unsupported area in an uplift condition would significantly increase).

**Figure 20: Attempts to close cracks and broken welds by covering with plates.**

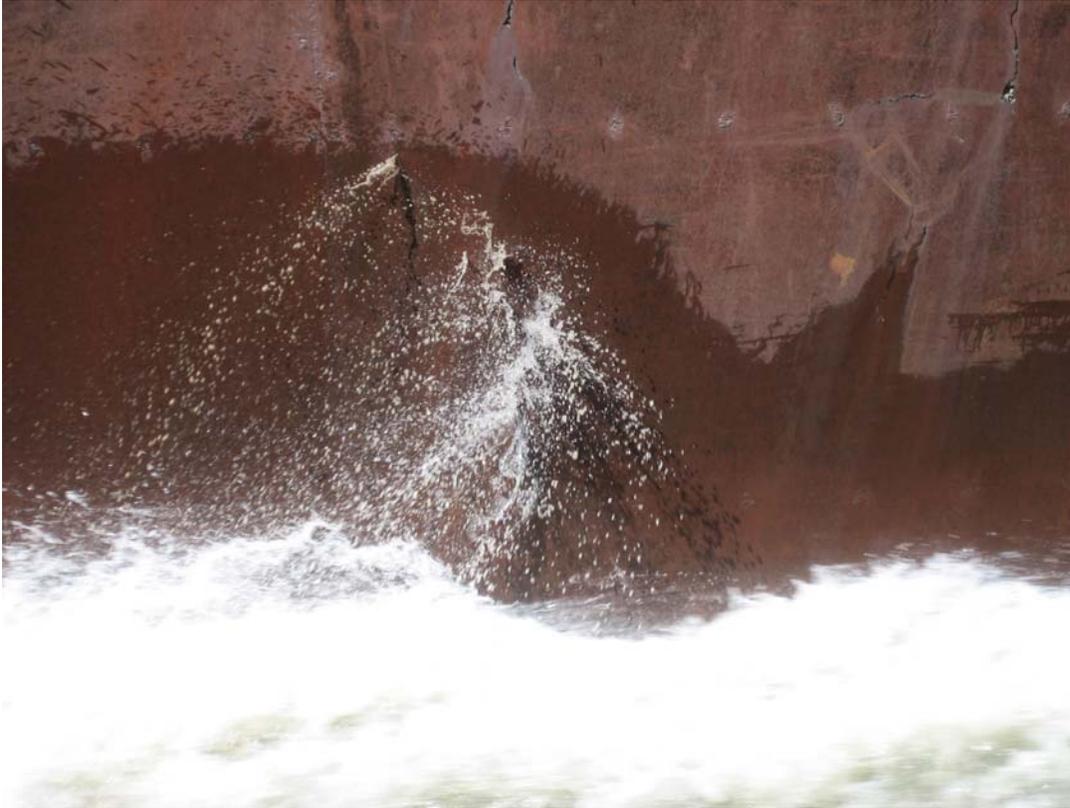
Hydrostatic head, underneath or behind the lining plates, due to leakage in upper sections of the spillway, results in loading on the side plates and creates the potential for failure. Along the location where instrumentation was located, one of the side panels with existing cracks (presumably due to corrosion) deflected outwards and backing material was washed out during testing at 2700 ft<sup>3</sup>/s, figure 21. Normal drain flows at least doubled in volume and went from a relatively clear to cloudy appearance during testing. Another side panel further upstream was observed to bulge with deflections approaching 1 ft resulting in permanent deformation after the flow test. The theoretical stresses for this load condition indicate potential failure of the plate consistent with observations during operational testing.

Over time, the foundation material has apparently compressed, migrated, and/or been removed entirely resulting in large voids under the invert lining plates and behind the wall plates. In fact voids have been identified during recent inspections. The voids (or at least unsupported plates) are also apparent when walking on the spillway as large deflections were observed for many of the plates. The modal analysis also gave indications of voids behind the plates due to large structural response from very small energy inputs. The loss of foundation reaction significantly changes structural performance. With voids under a large area of a single plate, the plate is supported only by the underlying framework. The resulting membrane and bending stresses in the plates will likely result in failure with around 13 ft-6 in of hydrostatic differential. To date, it appears there have been no large (near design flow) discharges through the spillway, and consequently failure has not occurred. However, if in the future a discharge producing flow depths greater than 13 ft-6 in, or an upward hydrostatic head differential approaching 13 ft-6 in were to occur, the invert lining plates are expected to crack open allowing water to flow under the plates, causing further erosion of the foundation material and potential undercutting of the spillway.

Figure 21: Head differential behind wall lining plates producing flow of water and material out into the spillway channel at 2700 ft<sup>3</sup>/s.

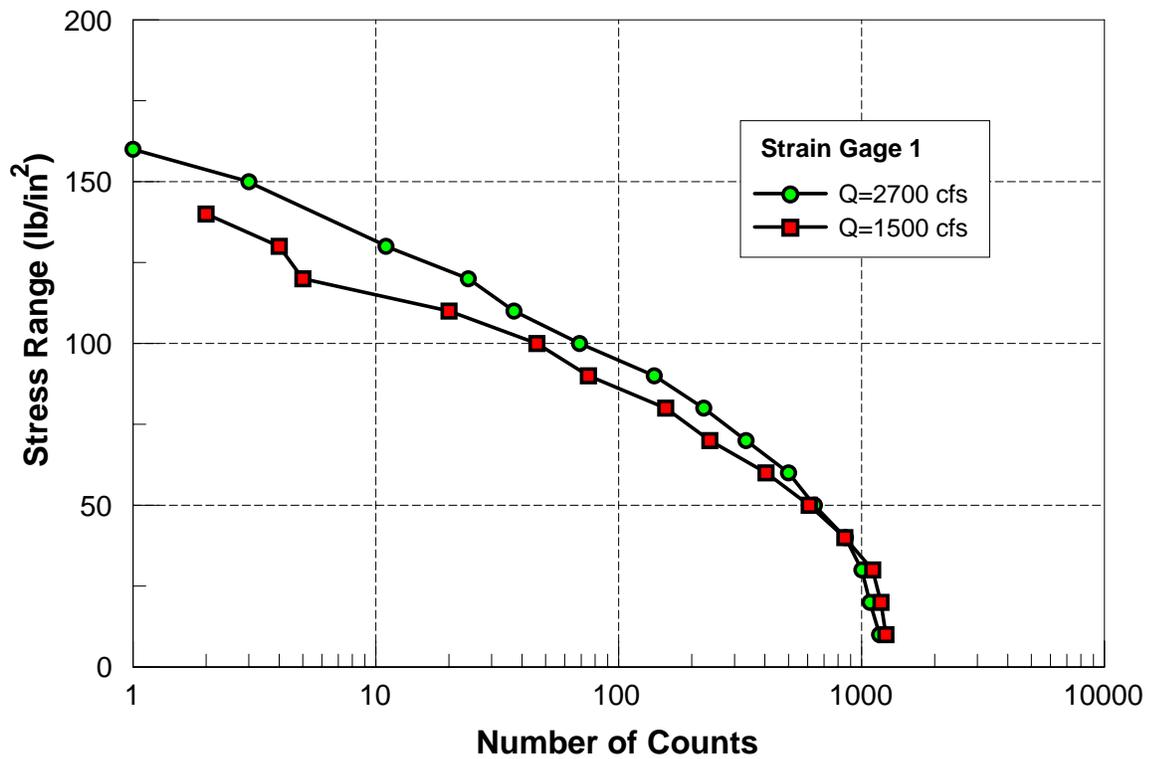
The dynamic stresses recorded for the test flows were very low. Stress time histories along with stress range pair histograms were developed using the rainflow counting method (ASTM E 1049-85). This method of data analysis is useful to evaluate fatigue as it reduces a spectrum of varying stress into a set of simple stress reversals, allowing application of Miner's rule to determine fatigue life of a structure with complex loading. Strain gage 2 was not working properly and will be disregarded in this analysis. Table 4 shows the mean stresses for the two different flow conditions. Figures 22-24 show stress range count histograms for the three working strain gages at each of the flow conditions tested. The stress range pairs follow fairly closely to a Gaussian distribution for this facility and the locations and flows tested. The maximum stress range recorded was 225 lb/in<sup>2</sup> for gage number 4. The stress range allowable for plug welds is 8,000 lb/in<sup>2</sup> for 2 x 10<sup>6</sup> cycles (i.e. infinite fatigue life); therefore fatigue failure for a discharge of 2,700 ft<sup>3</sup>/s is not expected. In the case of maximum spillway discharges, the plates would likely be deflecting differently and it is not possible to extrapolate the measured stresses to higher discharges.

Figure 22: Histogram of stress range counts for strain gage 1 for the two discharges.

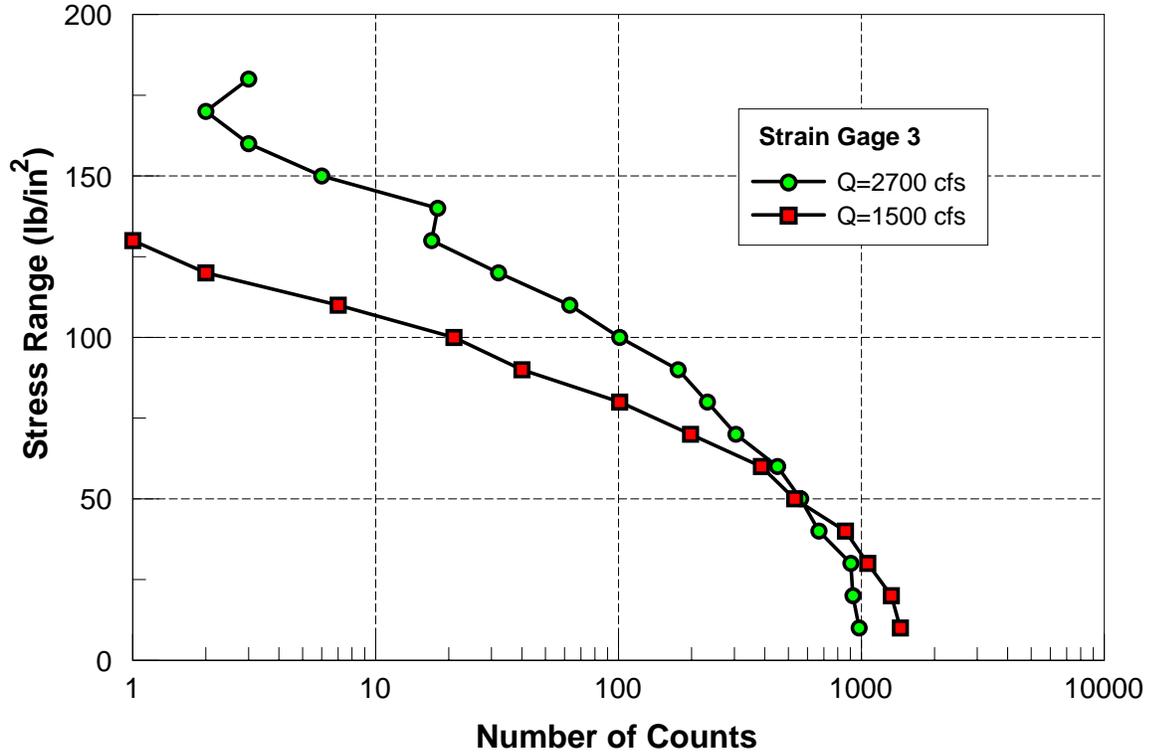
Figure 23: Histogram of stress range counts for strain gage 3 for the two discharges.

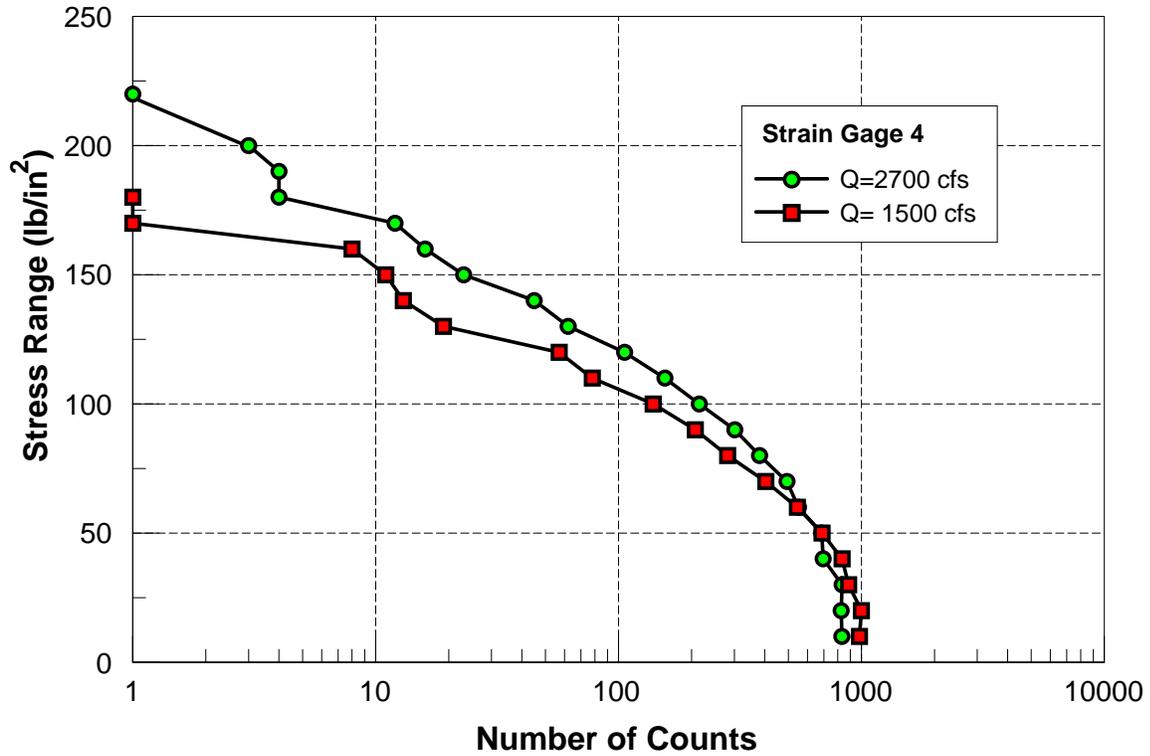
Figure 24: Histogram of stress range counts for strain gage 4 for the two discharges.
