**ENGINEERING EVALUATION OF THE RED BLUFF RESEARCH
PUMPING PLANT ON THE SACRAMENTO RIVER IN NORTHERN CALIFORNIA:
1995-1998**

**A Summary Report
Red Bluff Research Pumping Plant
Report Series: Volume 6**

September 1999

**U.S. Department of the Interior
Bureau of Reclamation**

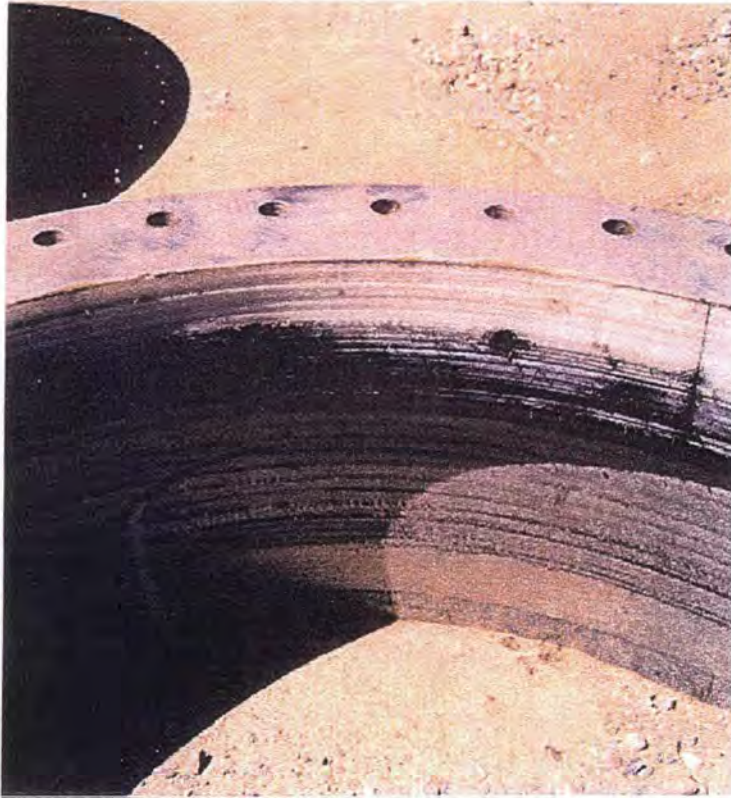
Rotating Seal. Within the 8-hour period of the initial burn-in test, shavings of UHMW (Teflon) seal material (between fixed pipe and rotating pump) were discovered in the discharge channels of the Archimedes pumps, and were accumulating on the wedge-wire screens. Upon closer inspection of the pump, it was determined that sediment from the river was migrating through the packing and lodging between the seal and the fixed roller pipe. This caused the seal to wear excessively. The pumps were shut down and the seal and packing were disassembled. Sediments in the size range of 1/8 inch and smaller had lodged between the UHMW seal and the fixed pipe, causing scoring and excessive wear of the relatively soft seal material, figure 14. Sediment traps were considered as a means to eliminate the sediment from the water prior to entering the intake manifold. This solution was quickly discounted due to the detrimental effects it would have on the inlet velocity and its low probability of success. A redesign of the seal was needed to allow operation with any amount and size of suspended sediments that may be pumped from the river. After several months of unsuccessfully working with the manufacturer to develop a solution without success, Reclamation designers developed a seal which could be manufactured and installed quickly and inexpensively. The seal eliminated large quantities of mechanical equipment and consisted

Figure 14. UHMW seal ring. Wear and scoring on UHMW seal ring on Archimedes pumps, due to sediment intrusion.

of two brass rings and a rubber seal, figure 15. The seals have performed well with little to no leakage or wear since installation.

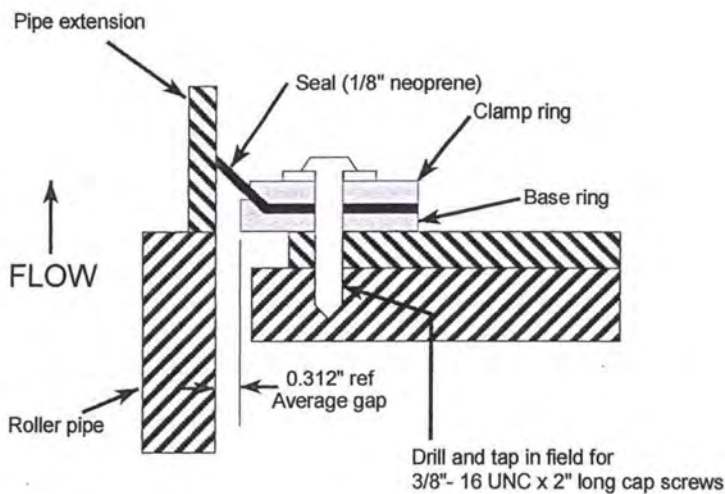
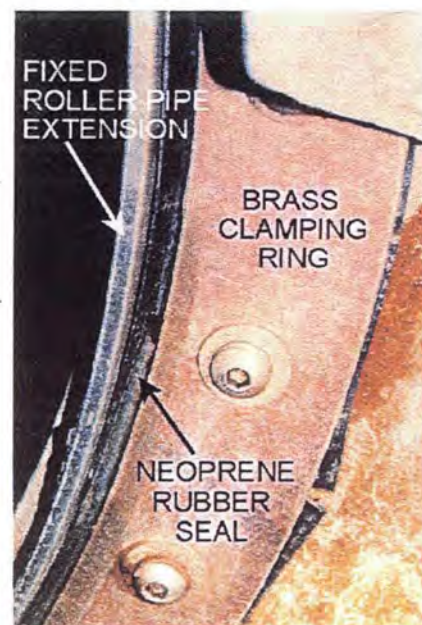
Figure 15. Schematic of modified Archimedes inlet seal. Detailed schematic of modified rotating seal installed in the two Archimedes pumps at RBRPP, photo shows detail of actual installation.

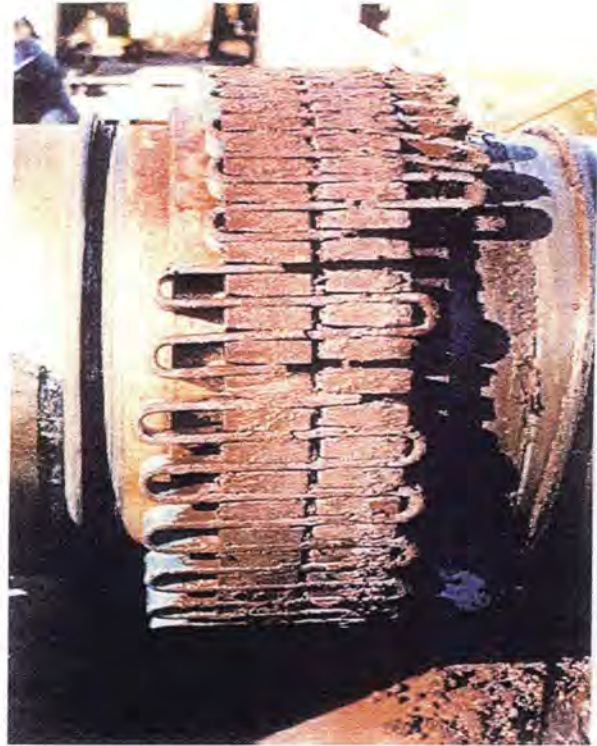
Low-Speed Coupling Failure. In late May 1996, both pumps were dewatered and a major inspection was performed. The inspection began with the low-speed couplings due to the known failure on pump 2. The low-speed couplings, manufactured by Falk Couplings, are used to couple the gear box reducer to the pump thrust bearing. The couplings used in the Archimedes pumps were model 1000T series tapered grid steel flex couplings with split covers, type T10, size 1200T. The service manual gives the alignment limits for installation of the couplings as a maximum offset of 0.015 inch and within 0.027 inch of angular alignment. Lubrication specifications also require the coupling to be filled with 12.5 lbs of grease prior to operation. Upon disassembly of the unit, it was noted that the coupling cover of pump 2 had a circumferential break between the center coupling fastener and the fastener on the driven side. After removal of the cover, subsequent inspection showed the grid had broken into several pieces, figure 16. Wear marks on the cover indicated that the coupling had broken and was rubbing on the cover. An estimated 1-2 lbs of grease was recovered from the coupling. The grease was very thick and extremely dry. Excessive wear was observed on the hub grid teeth on both the drive and driven hubs. Measurements of the mean tooth thickness for the new coupling had been 0.765 inch on both coupling halves. The measured thickness of the disassembled driven coupling hub teeth was between 0.610 to 0.630 inch and for the drive hub 0.657 to 0.682 inch, indicating a maximum wear of 0.155 inch and 0.108 inch, respectively. The low-speed coupling offset and angularity were then measured. The offset was 0.110-inch top to bottom and 0.21-inch side to side. The face-to-face angularity measurement looking toward the driven unit are given in Table 1. These measurements reflect a maximum angularity of 0.226-inch top to bottom and 0.033-inch side to side.

Figure 16. Damaged low-speed coupling. Damage to low-speed coupling, Pump 2 (broken grid)

When the low-speed coupling on pump 2 failed, pump 1 was inspected. It was discovered that it had been operating with a lack of grease in the coupling, resulting in the coupling cover being noticeably hot to the touch. Fourteen pounds of grease was added to the coupling per Falk's requirement, to allow for continued operation of pump 1. After the grease was added, the cover temperature during operation was very close to the ambient temperature. The pump 1 continued to operate, providing supplemental irrigation deliveries through May 16, 1996. Once the gates at RBDD went in, pump 1 was taken out of service, the coupling cover was removed, and the interior was inspected. The grids were broken similarly to pump 2. Marks were present on the inside surface of the coupling cover indicating that the coupling had broken and was wearing on the cover. Wear patterns on the hub teeth were consistent with those seen on pump 2. Measurements taken on the grid hub teeth showed the thickness of the teeth ranged from 0.692 to 0.705 inch on the driven hub and 0.746 to 0.754 inch on the drive, for a maximum wear of 0.073 and 0.019 inches, respectively. The angularity and offset of the coupling were then measured. The offset was 0.077-inch top to bottom. The face-to-face angularity measurements looking toward the driven unit are given in Table 2.

The low-speed couplings on both pumps were replaced in June 1996. The low-speed and high-speed couplings were realigned by Precision Balancing Service (PBS) using laser alignment equipment. The original alignment was performed using dial indicators. Realignment consisted of adding shims under the motor and gear box. A total of more than *1 inch* of shims was needed to bring the motor into alignment. The new couplings were filled with grease as per the manufacturer's installation procedures. The couplings were checked for alignment by PBS after 80 hours of operation and no change in the alignment of the low-speed coupling was found on either pump. Improper alignment and lack of lubrication by the contractor during initial construction caused the failures in the low-speed couplings on each pump.

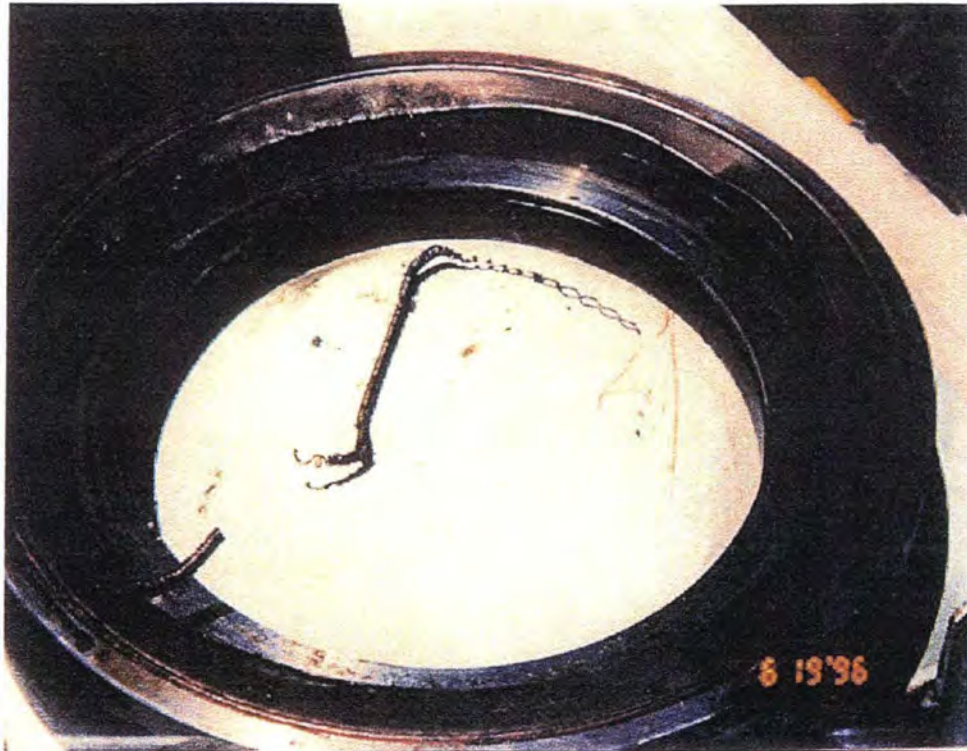
Due to the discovery of the metal shavings in the pump 2 thrust bearing housing, pump 1 was checked to determine if there were metal shavings in the housing. The oil was drained from Pump 1. Inspection of the oil showed a large amount of small metal flakes in the oil. Analysis of the oil was inconclusive as to the source of the metal flakes, but there were elevated levels of copper and iron as well as large particles detected in the oil. The FAG Bearing representative was contacted and the analysis of the oil discussed. The level of large particles obtained from the sample was of great concern to the bearing manufacturer, but the level of copper and iron were not greater than might be expected during initial running of the pump. Upon removal of the lip seal, visual observations indicated that the seal had suffered severe damage at some time. The steel shell was partially crushed, the rubber torn in many areas, and the garter spring was broken with portions missing. Damage also included a portion of the steel shell that had the appearance of a pry mark on it, figure 17. The lip on the cover that the seal rides on was grooved from seal wear and required machining. The missing portion of the spring and part of the rubber were in the bottom of the housing laying next to the roller bearing. The only way to inspect the internal surfaces of the bearing itself was to disassemble the bearing from the housing. There also had been deformation of the set screw on the locknut. The barrel and thrust bearing assembly of pump 1 were removed from the bay, figure 18. The thrust bearing assembly was shipped to Allied Engineering in Alameda, California for disassembly and inspection. Inspection of the bearing showed a small piece of the broken spring in between

Figure 17. Damaged seal ring from thrust bearing. *Damaged seal ring, note broken spring and pry marks on steel shell.*

The damage to the outer race of the bearing on Pump 1 made the bearing unserviceable in its present condition. A new bearing from FAG Bearing was ordered and installed in the housing by Allied Engineering. The locknut was reassembled using a fabricated wrench to torque the locknut to the required 24,000 ft-lbs. The seal lip on the cover was machined to provide a good sealing surface for the oil lip seal. Larger dowel pins were added and the thrust bearing pump was cleaned and reassembled. The pry marks on the seal indicated probable damage to the seal on pump 1 when the pump arrived on site. The pry marks were located in an area that was not accessible during the erection and corresponded to the location of the garter spring break. The broken spring had entered the interior of the thrust bearing and was caught in the rollers causing irreparable damage to the races and rollers.

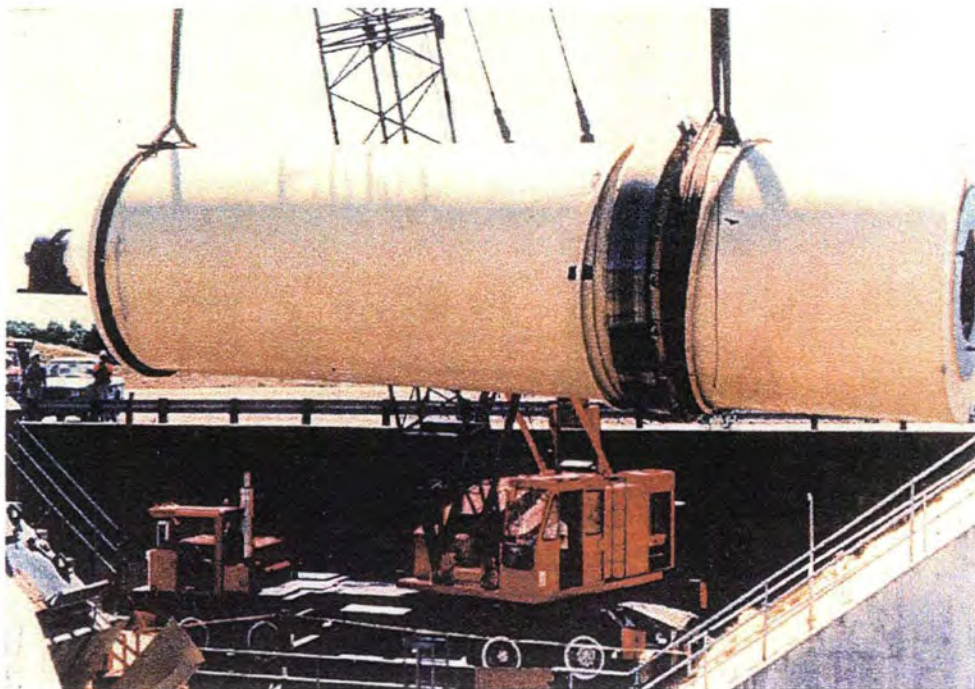
Figure 18. Removal of Pump 1 from bay. *Removal of pump 1 by mobile crane in order to repair thrust bearing.*

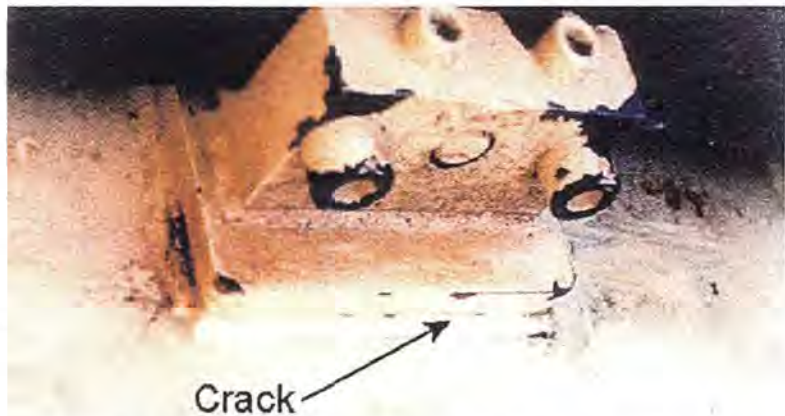
Saddle plates and self-aligning roller bearings. During the removal of pump 1 it was discovered that the welds between the saddle plate and pump barrel on saddle plates 15 and 16 were cracked, figure 19. The connection between the pump barrel and the power wear ring consists of 18 saddle plates welded to the exterior of the barrel with spacer blocks that are bolted to the saddle plates and pinned and bolted to the power wear ring. The power wear ring is a forged steel ring 5-inches thick and 19-inches wide. The inside radius of the ring is 3 inches larger than the external radius of the pump barrel. The crack on saddle plate 15 extended around the entire plate, and on 16, one end was cracked. Measurements of the welds showed that the weld on saddle block 15 was a 1/4-in fillet, and on saddle block 16 the weld was 3/8-in. Inspection of the remaining saddle block welds showed that all were undersized. It was apparent that during the manufacturing of the pumps, the welds were not correctly sized to allow insertion of alignment shims between the saddle plates and pump barrel at erection.

Figure 19. Saddle blocks on Pump 1. Saddle blocks used to attach wearing ring at lower bearing location. Note crack along perimeter of weld.

Both Archimedes pumps exhibited the same problems; and although pump 2 did not have the cracking associated with the undersized welds, the size of the welds were consistent with those on Pump 1. The welds were sand blasted to remove the paint and a magnetic particle inspection was performed to determine the extent of the welding defects. Lack of fusion, incomplete penetration, and cracking were found in the fillet welds. The repair was achieved with the roller ring in place and on-site. CPC hired a consultant, Welding Instruction Inspection

and Consulting Services, Inc. (WIICS) to oversee the repair. WIICS performed magnetic-particle inspection and dye-penetrant tests on the repaired welds before final acceptance. The repairs were completed and accepted by WIICS and CPC.

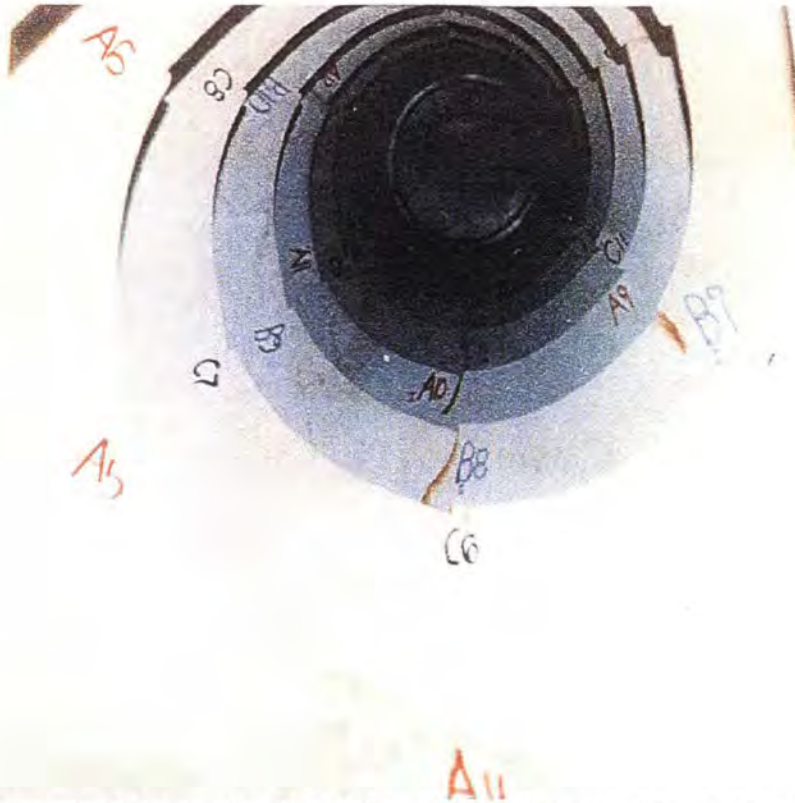
Cracking of Internal Flights. In July 1996, cracks were discovered on the internal flights, forming at the heat-affected zones of the flight-to-flight segment butt welds. The cracks were propagating perpendicular to the welded segments, radially into the parent metal. The cracks varied in length throughout the pump, and some of the larger cracks were long enough to allow the plates to offset. The pump manufacturer (CPC) was contacted and the problem explained to them. They offered no immediate recommendation but showed concern that operating the pumps at river elevations greater than the design maximum elevation (240.5 ft) could cause excessive loading on the flights. Pump 1 had 1023.55 hours of operation when eleven cracks ranging from 1/4- to 5-1/8-inches long were discovered, figure 20. The cracks in Pump 1 extended into the flight plates in a direction perpendicular to the plate edge. The crack propagation was in a curved direction extending away from the plate-to-plate weld, figure 21. Several of the plates were offset across the crack by as much as 3/16 inch and the crack was opened by 1/8 inch. Pump 2 was also inspected and the same pattern of cracking was found. Pump 2 had 417 hours of operation and eight cracks between 1- to 4-inches long were found.

Figure 20. Cracks on the flights of Archimedes Pump 1. View looking up the barrel of Pump 1, cracking of the flights, note that crack visibility was enhanced by rust.

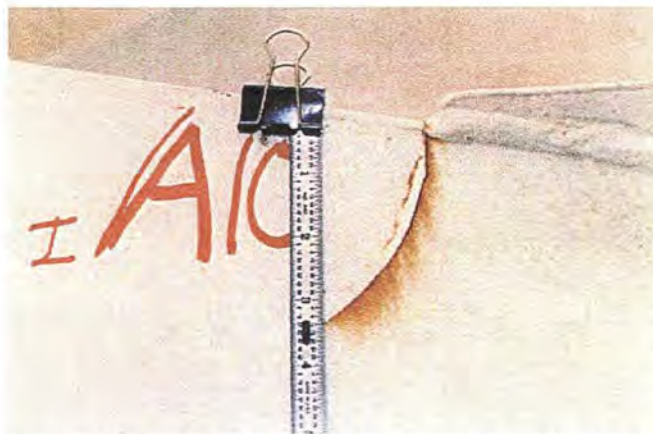
Figure 21. Typical fatigue crack propagation. Cracking generally propagated perpendicularly from the edge of the weld. Note the abrupt material transition at the weld, responsible for stress concentration.

The cracks started at the interface of the triangular plates at the end of the butt weld. Using visual inspection, the first crack in pump1 was found 8 ft-11 inches from the inlet, with the last crack 19 ft-11 inches from the inlet. There was a total of eleven cracks. The centerline of the roller ring is 12 ft from the inlet. The cracks found in pump 2 were in the same areas. The poor contour and workmanship of the welds at the interface provided a stress riser which led to the fatigue damage.

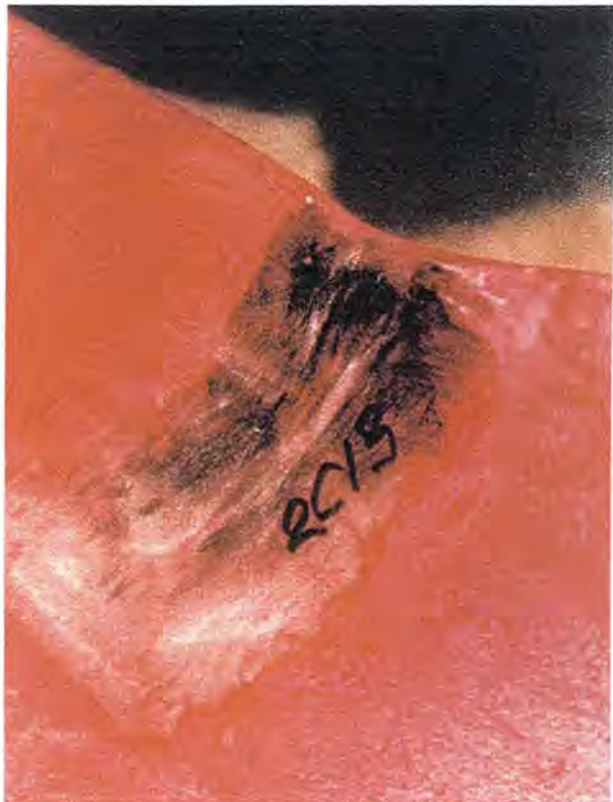
Figure 22. Weld repair to Archimedes flights. Weld repair on cracked flight. Note contoured joint at plate interface.

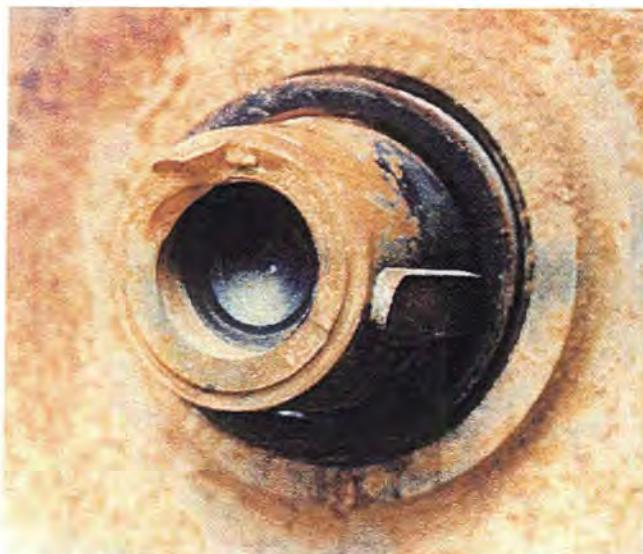
Figure 26. Broken shaft on Wemco pump. *First occurrence of broken shaft, likely due to fatigue damage.*

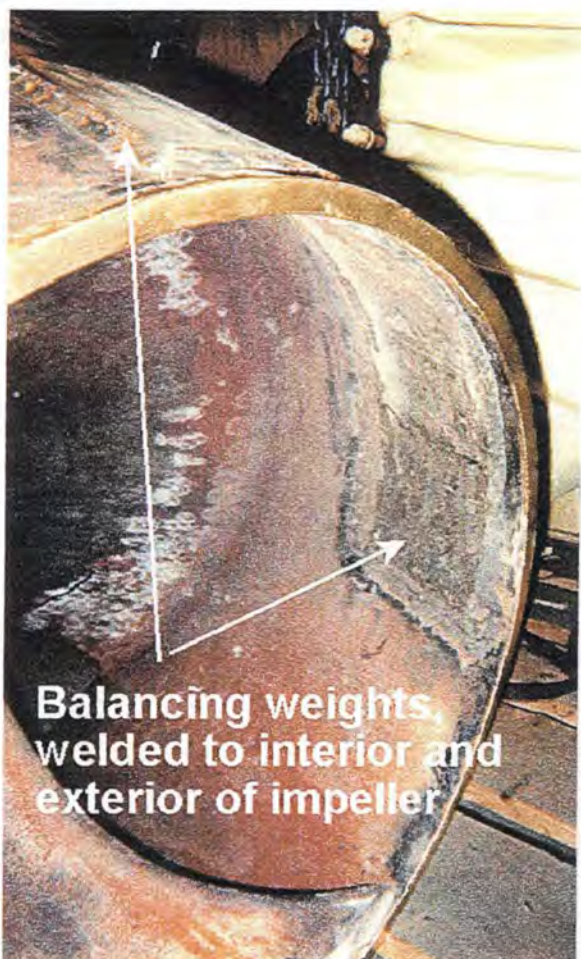
Figure 27. Balancing weights added to Wemco impeller. *Steel plates were welded to the interior and exterior surfaces of the impeller to allow dynamic balance.*
