TECHNICAL MEMORANDUM

Bureau of Reclamation

Cavitation on Stepped Spillways – Lab Studies of Damage Potential

DATE: December, 29, 2010

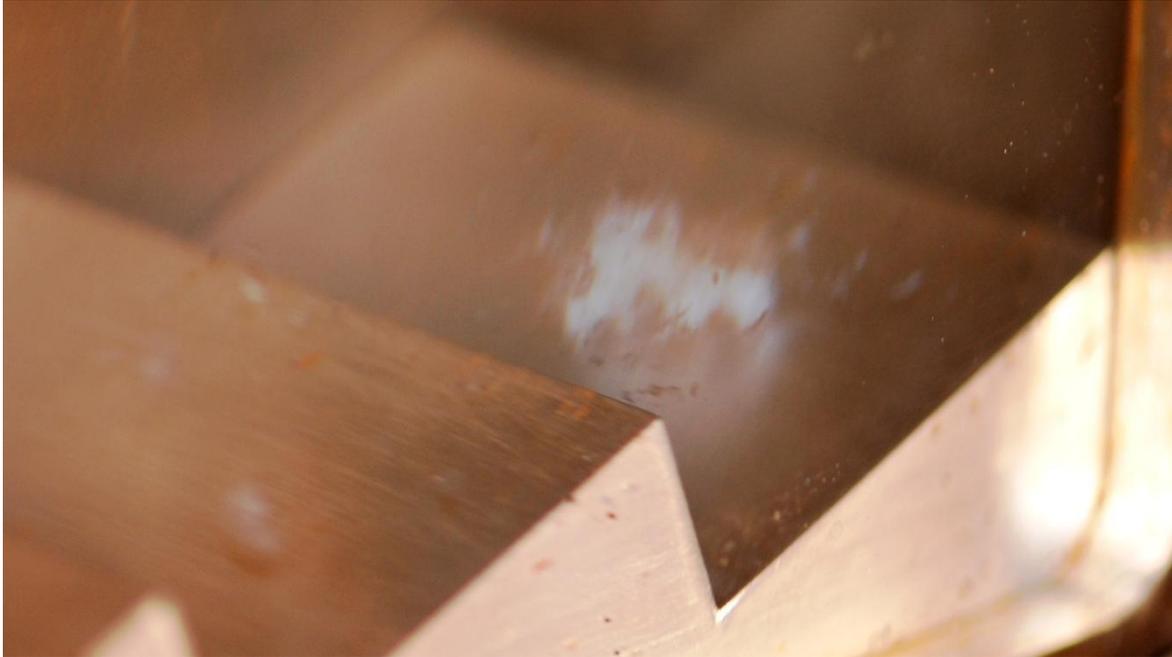
a) Snapshot of cavitation on mild slope in the impact zone.

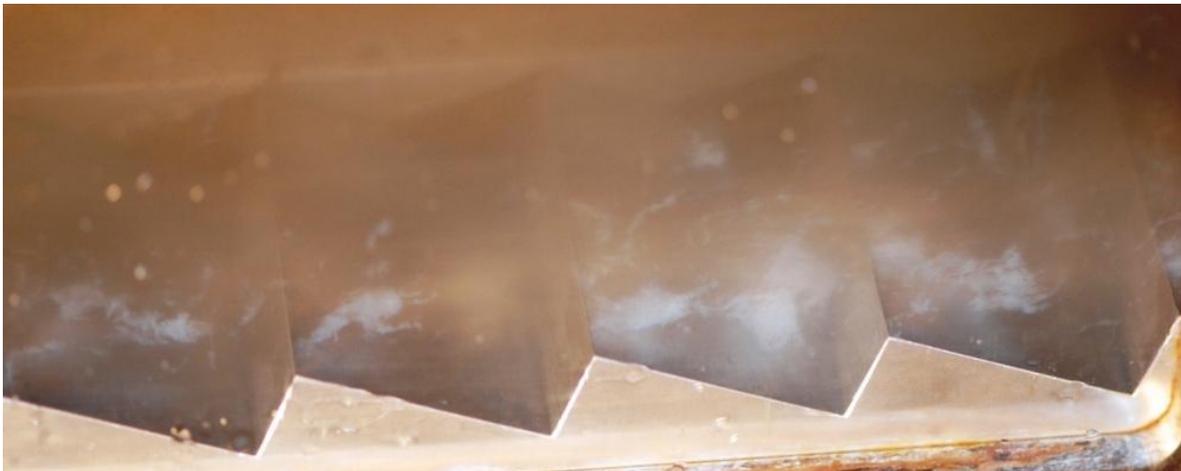
b) Snapshot of cavitation on the steep slope, note cavitation seems to be generated more at the step tips.

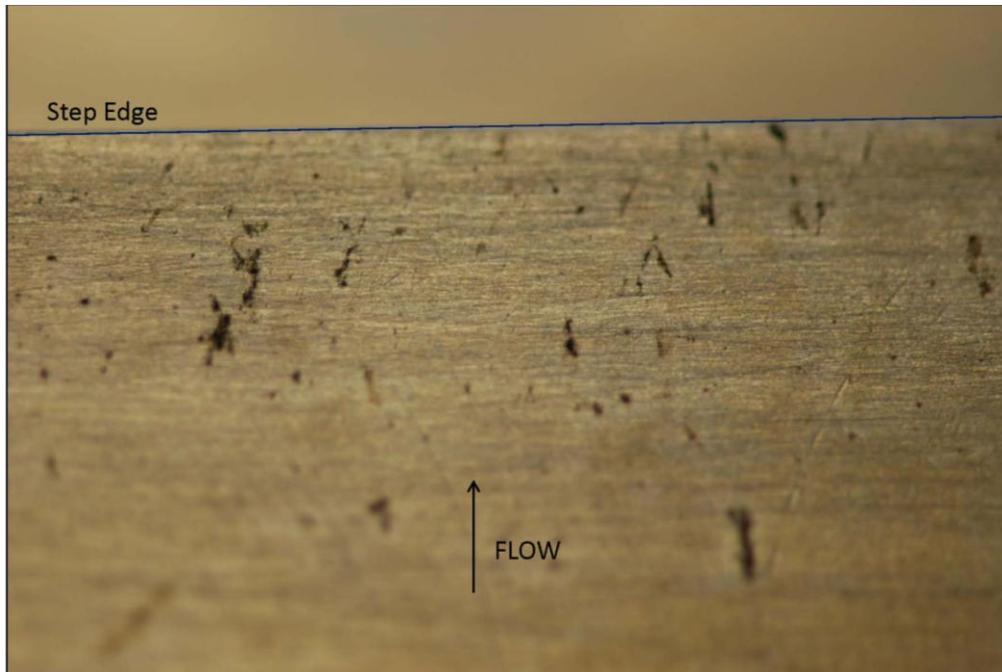
The damage to the mild sloped steps exhibited the typical incubation period often found when studying damage. No pitting was noted at one hour, but by the second hour, some pitting was evident. The shape of the pits is a bit different from that typical of singular bubble collapse. Elongated erosion holes were found in many locations along the length of the stepped section. The orientation was usually in the streamwise direction or a small angle to that direction. No pits of this type had a lateral orientation. This shape of damage is likely due to vortices imploding close to the step surfaces.

Testing at near prototype velocities (>20 m/s) on annealed aluminum did result in pitting and elongated holes within the impact zone on the 1V:2.48H steps. The aluminum steps were exposed to a velocity of 22 m/s for a period of 6 hours. Consistent damage from step to step was observed. Still images show similar cavitation patterns as were observed in the larger LAPC modeling. The steep slope showed little if any damage. A couple of pits were observed on the annealed aluminum steps on the vertical face just below the step tip. This zone corresponds to an extreme low pressure zone identified by other researchers (Amador, et.al. 2009). The damage that occurred was in the absence of any air entrainment and so it is yet to be seen if prototype damage will occur in the presence of naturally entrained air.

- a) Close up of damage to a step after 6 hours of operation at 22 m/s, on the mild slope (1V:2.48H) depth of pits varies but none are very deep. Most interesting features are the elongated voids in basically a streamwise orientation.

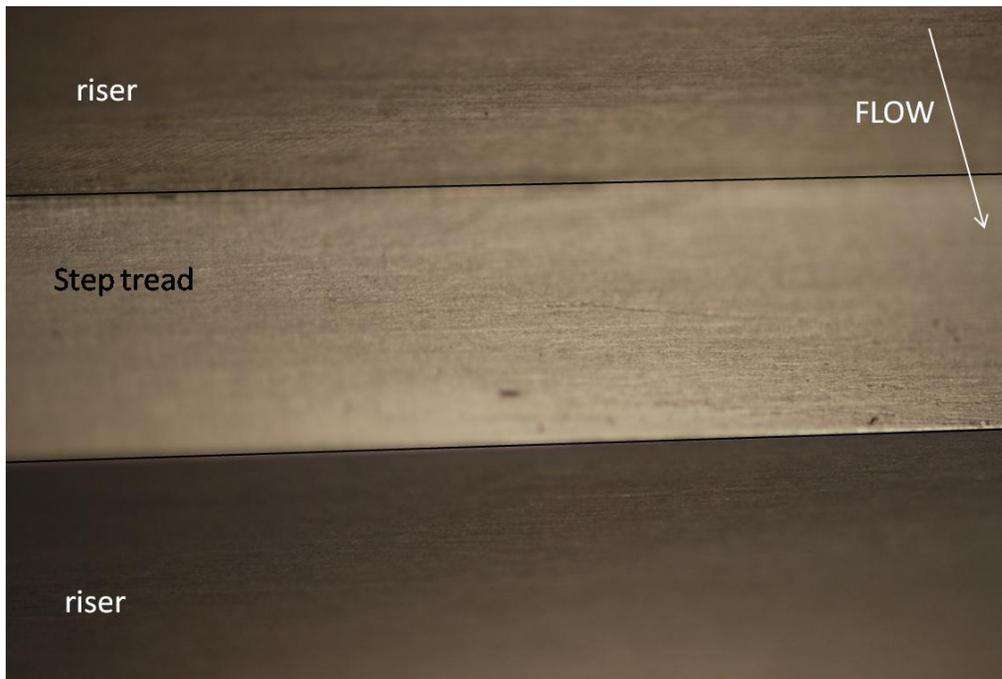
The reduced-scale sectional model using the high-head pump was operated at a s of 0.31, for a total of 6 hours. The mean velocity within the test section was 22.5 m/s. Snapshots of the cavitation present in the high-head facility are shown in figure 4. Pitting was observed after about 2 hours of operation. The number of pits increased with additional time however it was not a linear increase. Figure 5a shows typical damage on the steps. All pitting appeared in the impingement area on the horizontal tread of the steps. A new set of undamaged steps were placed in the test rig in reverse direction to simulate a very steep slope. Only a couple of pits were noted after the 6 hours of operation and these were in the low pressure area on the vertical step face, just below the step tip, figure 5b.

- b) Close up of step after 6 hours of operation at 22 m/s, on the steep slope (1V:0.4025H). Little if any pitting occurred. No elongated damage as in (a) shown above.
